Final Acceptance – Punchlist from DPW Stormwater

Project Name:	All About Storage
EDARP Filing Number(s):	CON2164
ESQCP Number:	N/A
Attendees:	DPW: Joshua Augustenborg, Ben Jones, Christina Prete and Brad Walters
Date of Walk-Thru:	February 2, 2023
Walk-Thru Number:	1

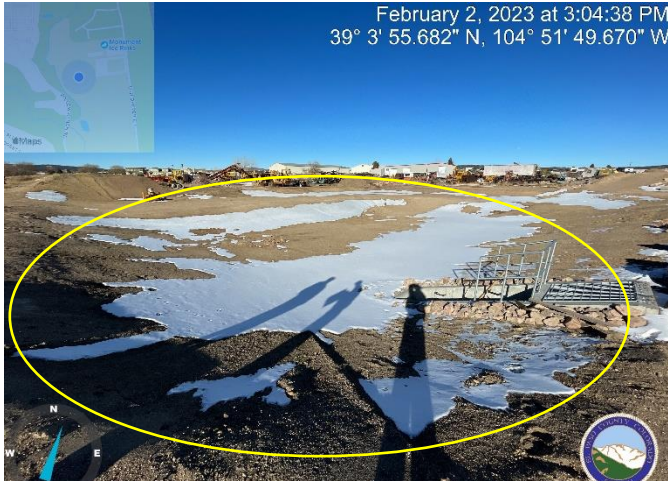
Photo 1: Stabilize entire Pond.

- Stabilize Pond (see Note 8 of Standard Notes for El Paso County Grading and Erosion Control Plans on Sheet 4 of 5 of the approved Construction Drawings). Reference Photo 1.

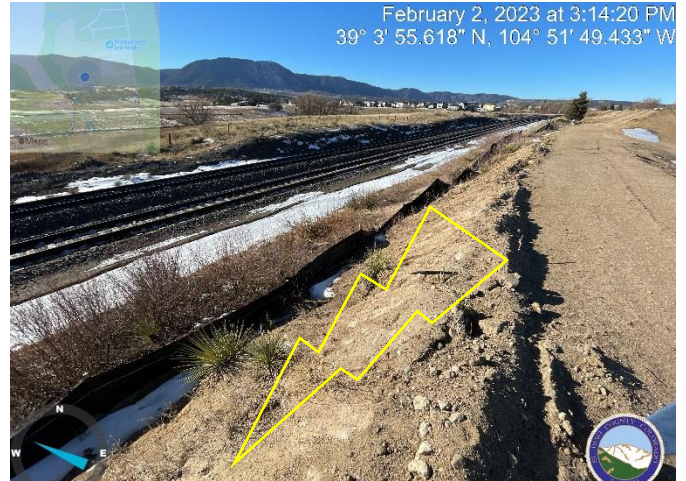
- Stabilize slope at west perimeter of the Site (see Note 8 of Standard Notes for El Paso County Grading and Erosion Control Plans on Sheet 4 of 5 of the approved Construction Drawings). Slope appears to be steeper than 3:1 and may require ECB, please confirm. Reference Photo 2.

Photo 2: Stabilize slope at west perimeter of the Site.

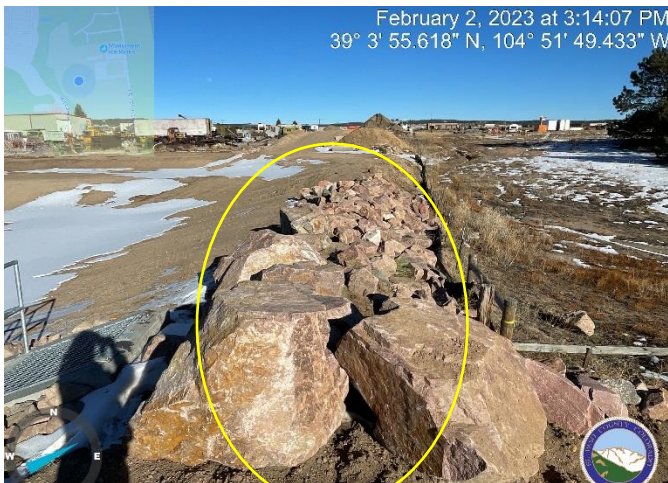
Photo 3: Install emergency spillway riprap per plan.

- Emergency spillway calls for Type VL riprap (d50 = 6"). Install per plans (see Detail A on Sheet 2 of 5 of the approved Construction Drawings). Reference Photo 3.

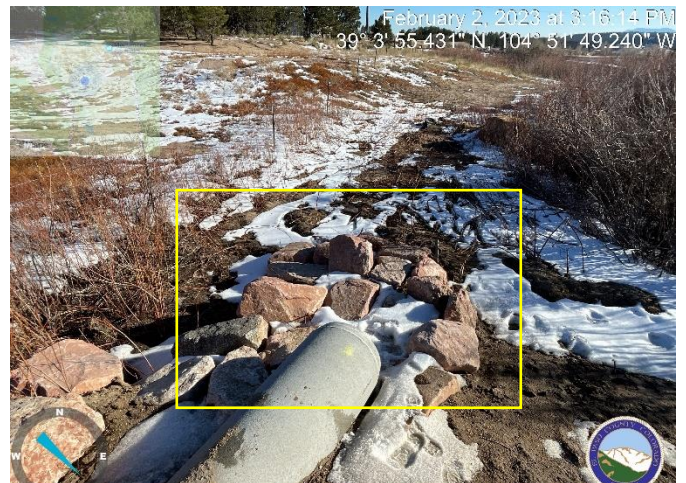
Photo 4: Install riprap pad at outlet pipe per plan.

- Riprap pad at outlet pipe calls for Type VL riprap (d50 = 6"). Install per plan (see Detail A on Sheet 2 of 5 of the approved Construction Drawings). Reference Photo 4.

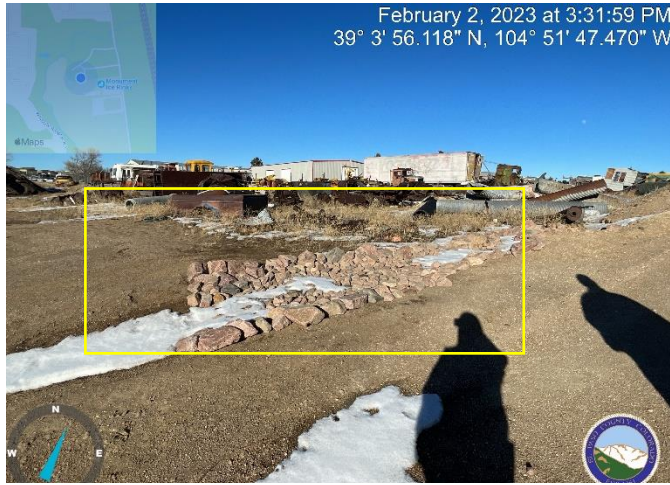
Photo 5: Verify riprap rundown in As-Built Drawings.

- Riprap rundown north of maintenance access road is not shown on the approved Construction Drawings. Verify in As-Built Drawings. Reference Photo 5.
- Stockpiles south of maintenance access road need to be removed and slopes stabilized. Reference Photo 6.

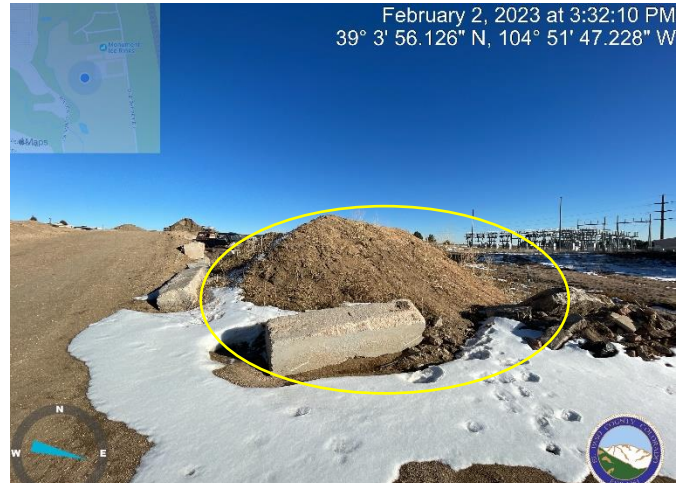
Photo 6: Remove stockpiles south of maintenance access road.

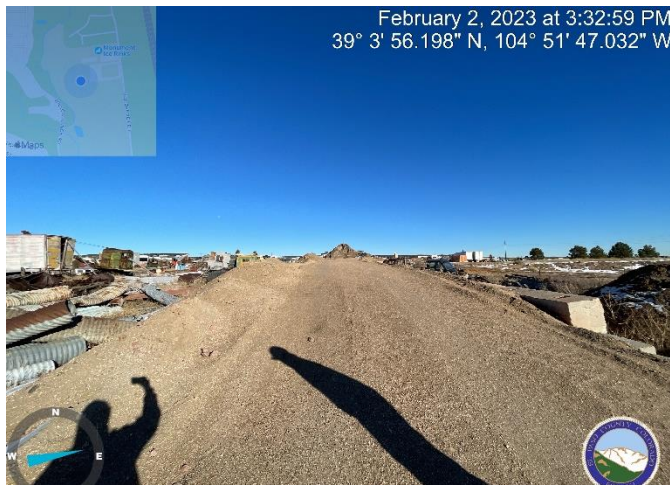
Photo 7: Verify length and slope of maintenance access road in As-Built Drawings.

- Maintenance access road extends to access gate and appears to be steeper than 12%. Verify length in As-Built Drawings. Reference Photo 7.
- Regrade Pond walls to address erosion along southern perimeter. Reference Photo 8.

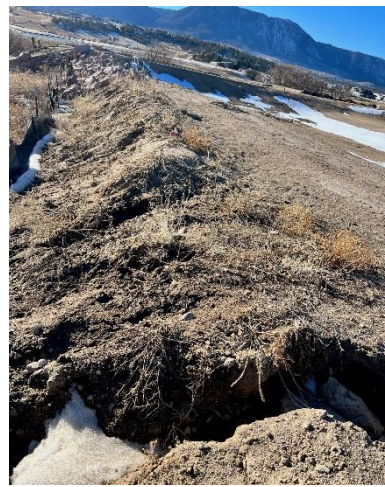
Photo 8. Regrade Pond walls to address erosion along southern perimeter.
