Final Acceptance (FA) Punchlist
EPC - DPW - Stormwater Section

Project Name:	Lorson Ranch East F1
EDARP Filing Number(s):	SF188, CON1958
ESQCP Number:	ESQ182
Attendees:	DPW SW: Natasha Grimaldo, Ben Jones Stormwater Engineers: Mikayla Hartford and Glenn Reese walked the site on 2/28/2023. Developer: John Chavez
Date of Walk-Thru:	2/14/2023
Walk-Thru Number:	1 st

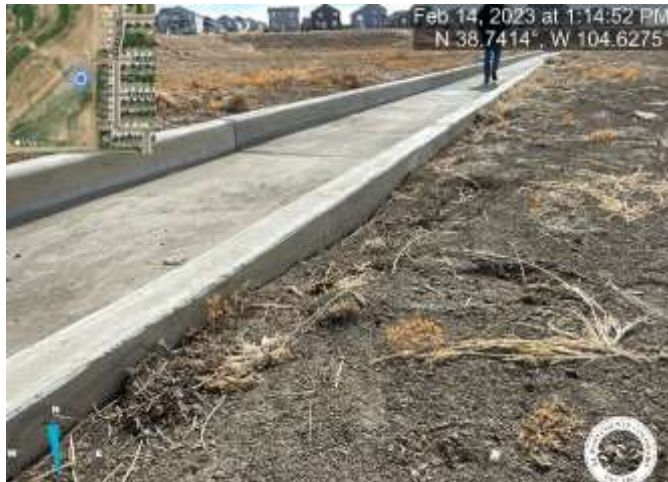
Photo 1: Pond C5: Raise pond bottom to top of trickle channel curb with a 3% slope towards trickle channel for positive drainage.

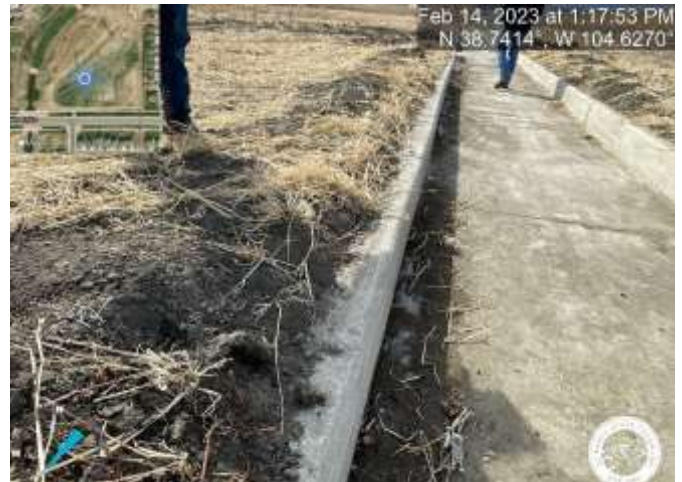
Photo 2: Pond C5: Remove sediment to match the top of trickle channel curb with a 3% slope towards trickle channel for positive drainage.

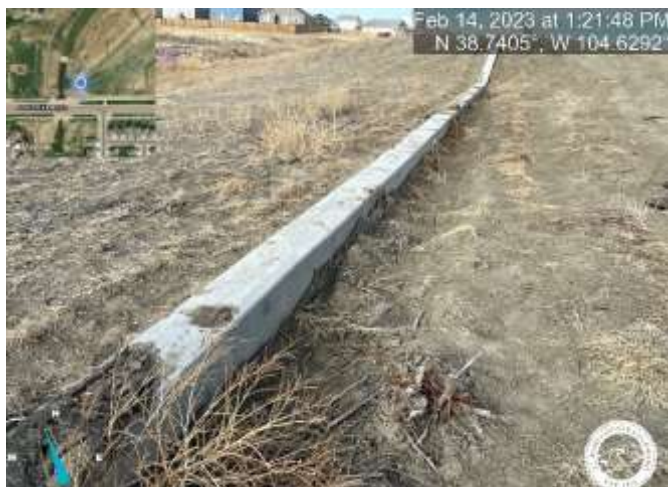
Photo 3: Pond C5: Raise grade to be flush with the Overflow Cutoff Wall.

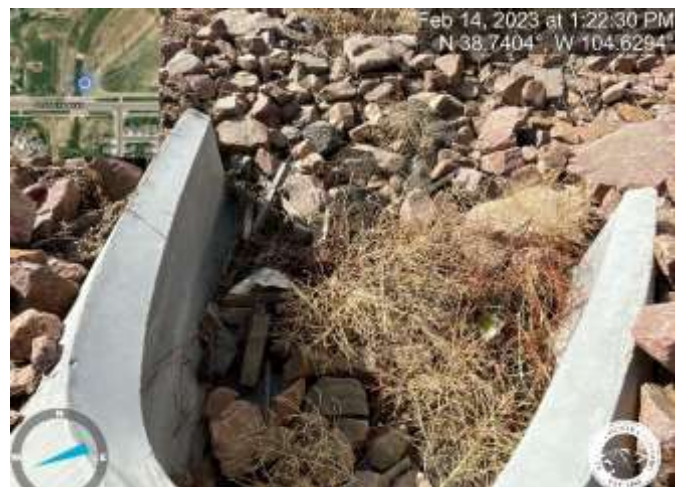
Photo 4: Pond C5: Remove sediment and debris from outlet pipe.

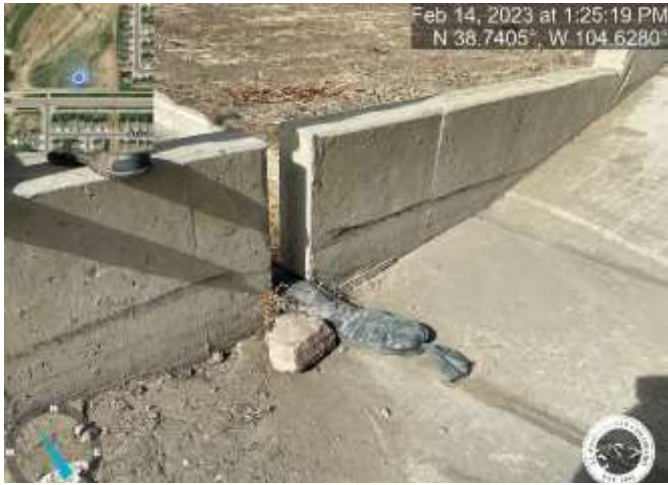
Photo 5: Pond C5: Remove rock sock from forebay notch.

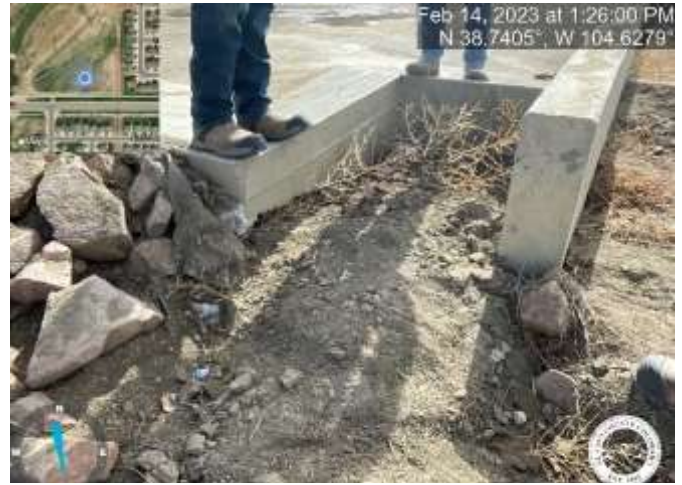
Photo 6: Pond C5: Implement 9" D50 rip rap per specification on forebay B. Reference page C9.2 Lorson Ranch F1 Street, Storm Sewer, and Pond Construction Plans.

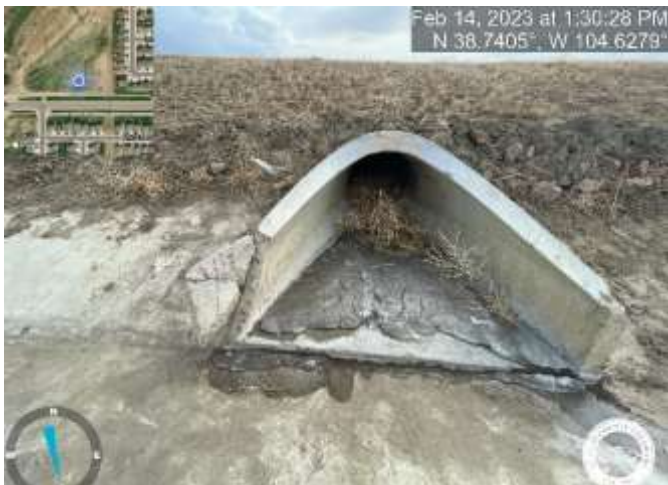
Photo 7: Pond C5: Repair flared end section on inlet pipe to forebay B.

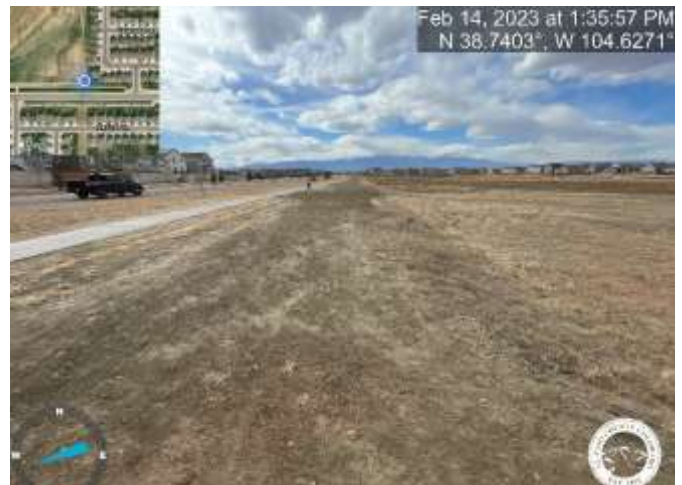
Photo 8: South perimeter of Pond C5: Failure to achieve uniform vegetative cover with an individual plant density of at least 70 percent.

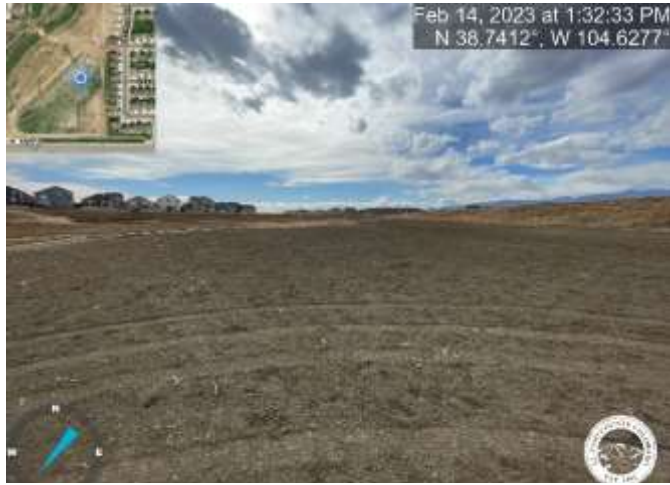
Photo 9: Pond C5: Failure to achieve uniform vegetative cover with an individual plant density of at least 70 percent in pond bottom.

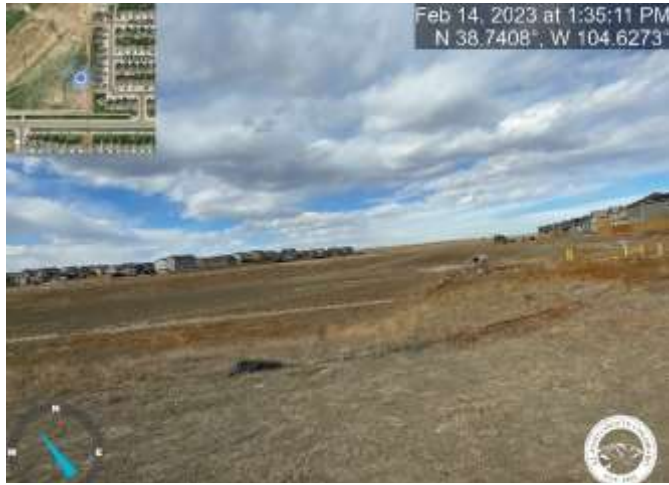
Photo 10: Pond C5: Remove silt fence that was cut to the ground just east of pond C5.

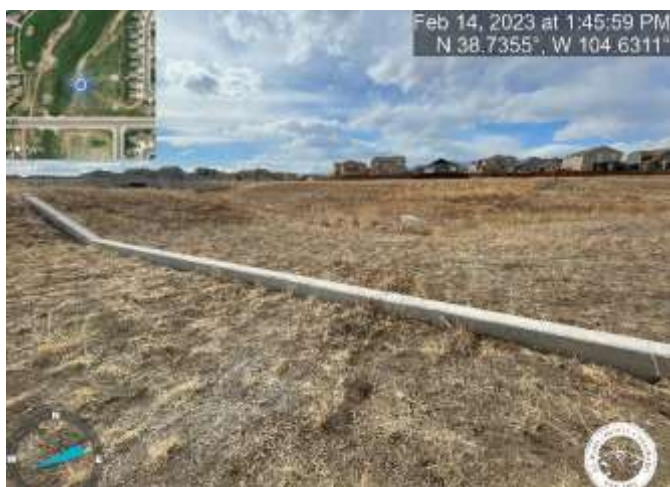
Photo 11: Pond D2: Raise grade to be flush with the Overflow Cutoff Wall.

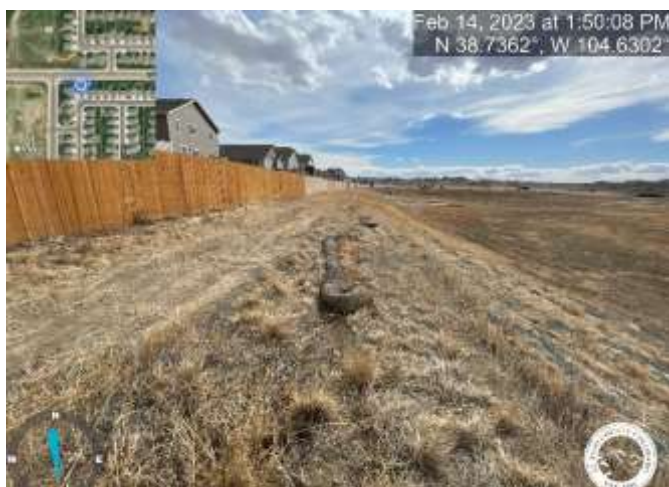
Photo 12: Remove temporary controls measures along the east perimeter.

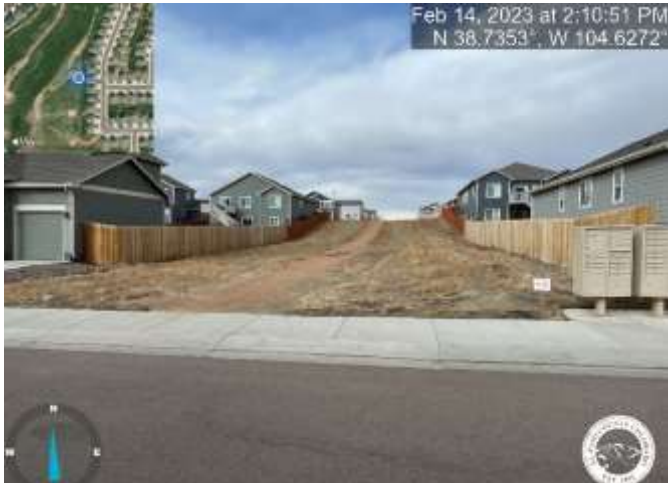
Photo 13: Remove temporary control measure (straw wattle) from all Tract areas.

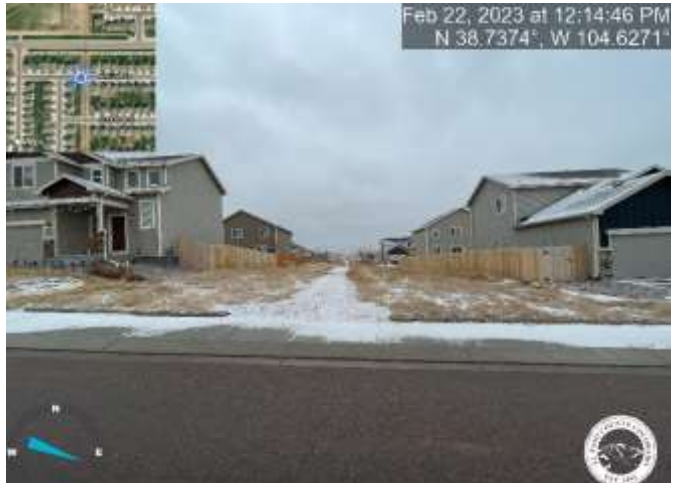
Photo 14: Remove temporary control measure (straw wattle) from all Tract areas.

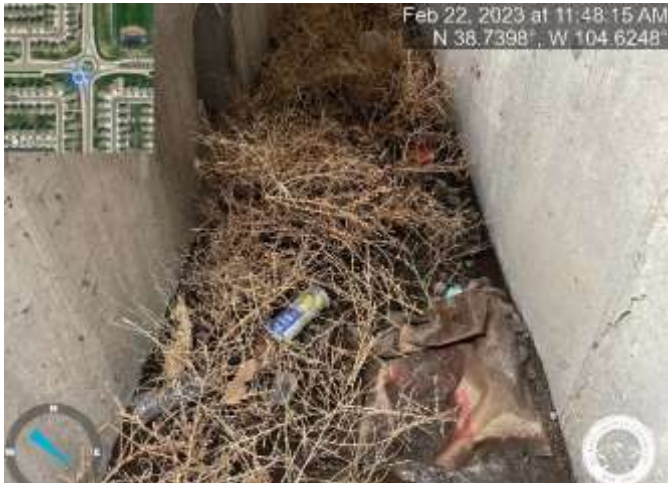
Photo 15: Inlet DP-29: Remove sediment and debris from inlet (inlet is marked with a green dot on the lid).

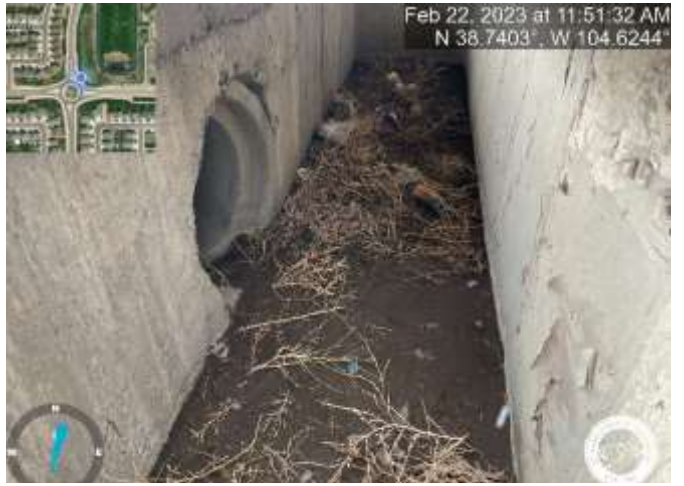
Photo 16: Inlet DP-33: Remove sediment and debris from inlet (inlet is marked with a green dot on the lid).

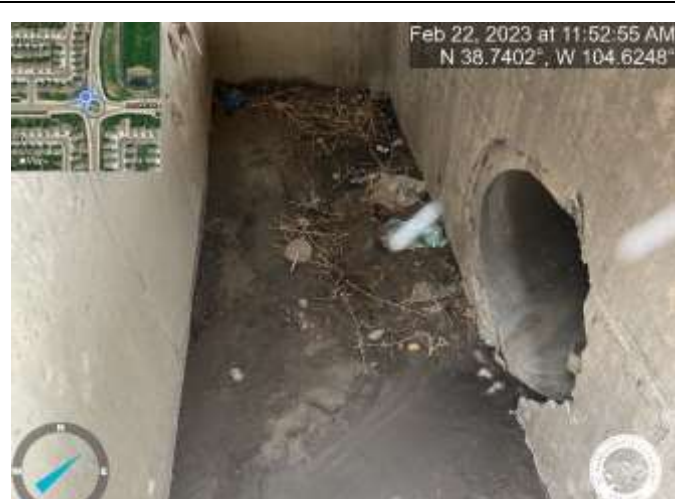
Photo 17: Inlet DP-34: Remove sediment and debris from inlet (inlet is marked with a green dot on the lid).

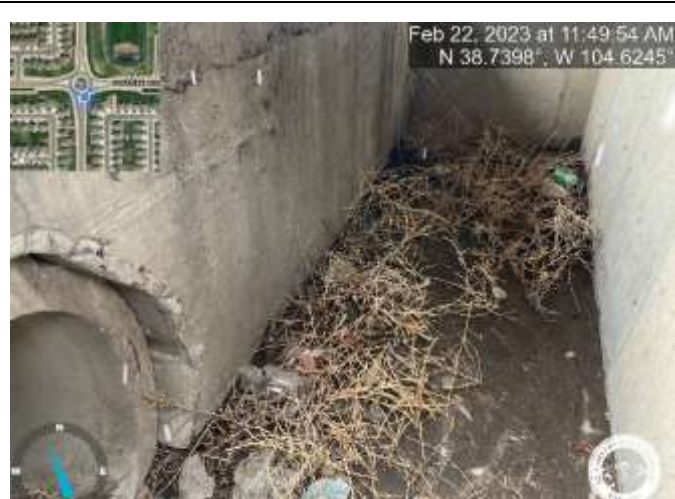
Photo 18: Inlet DP-30: Remove sediment and debris from inlet (inlet is marked with a green dot on the lid).

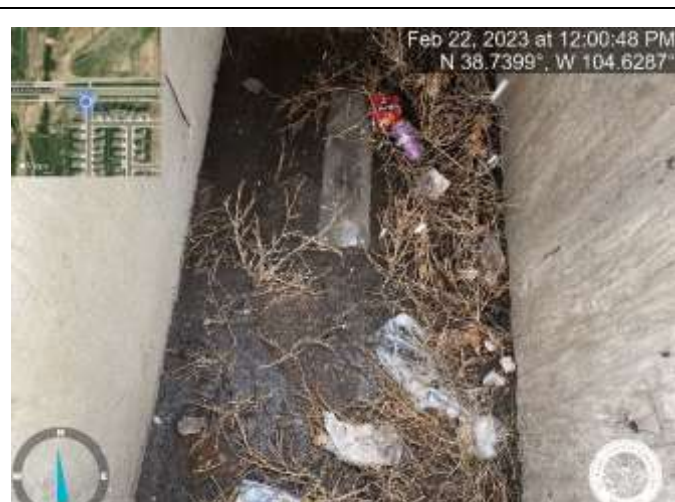
Photo 19: Inlet DP-41: Remove sediment and debris from inlet (inlet is marked with a green dot on the lid).

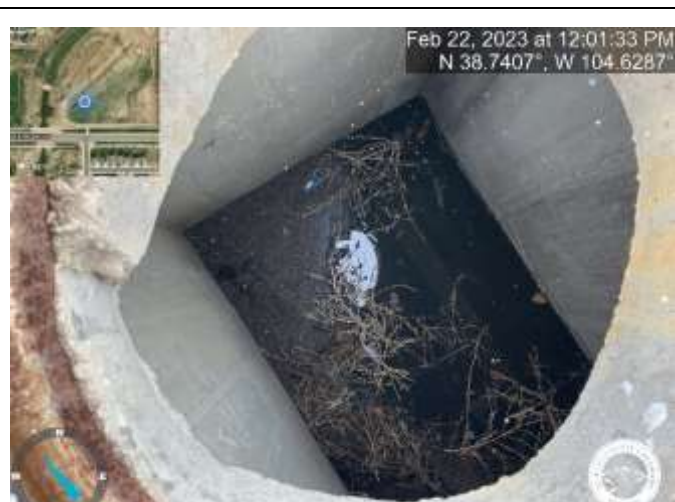
Photo 20: Inlet DP-40: Remove sediment and debris from inlet (inlet is marked with a green dot on the lid).

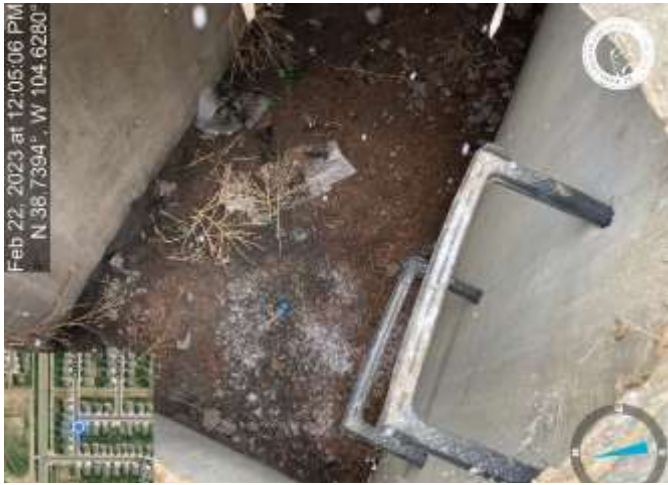
Photo 21: Inlet DP-39: Remove sediment and debris from inlet (inlet is marked with a green dot on the lid).

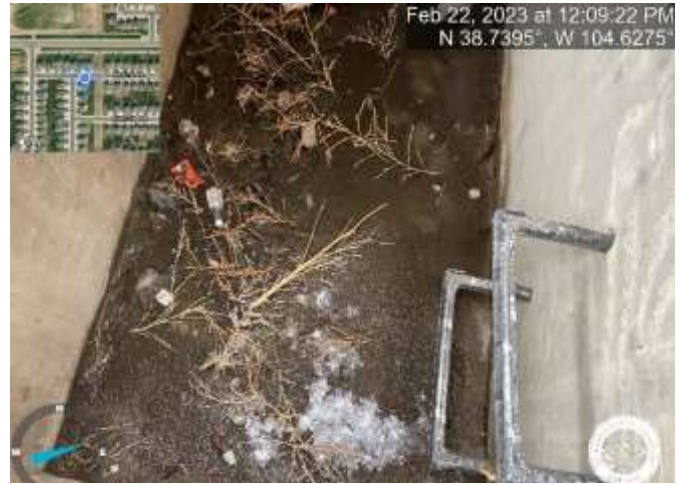
Photo 22: Inlet DP-38: Remove sediment and debris from inlet (inlet is marked with a green dot on the lid).

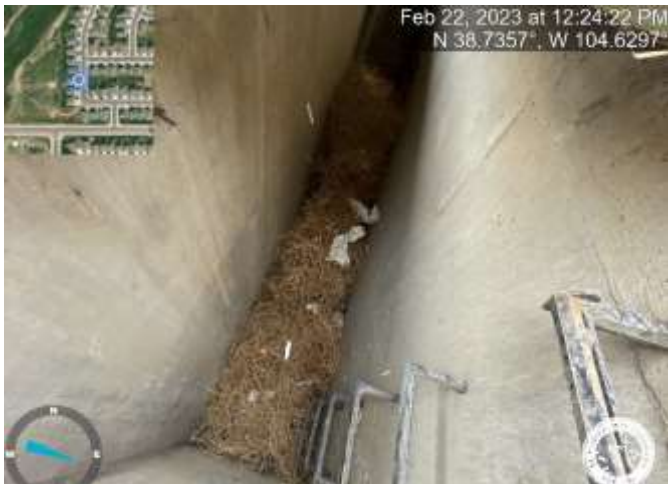
Photo 23: Inlet DP-56: Remove sediment and debris from inlet (inlet is marked with a green dot on the lid).

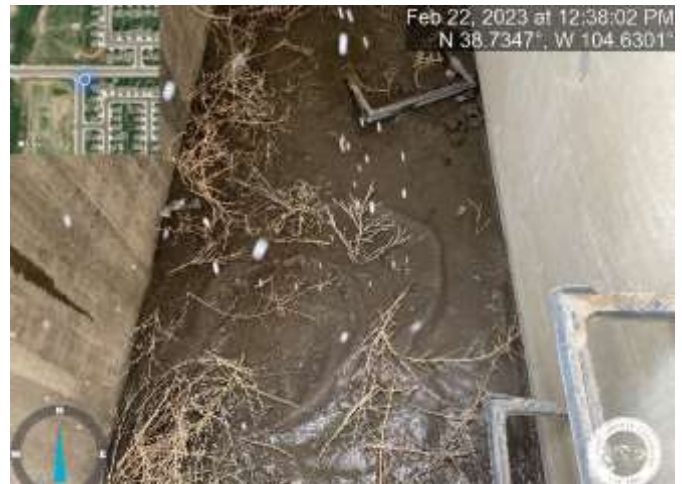
Photo 24: Inlet DP-60: Remove sediment and debris from inlet (inlet is marked with a green dot on the lid).
