Final Acceptance (FA) Punchlist
EPC - DPW - Stormwater Section

Project Name:	Lorson Ranch East F1
EDARP Filing Number(s):	SF188, CON1958
ESQCP Number:	ESQ182
Attendees:	DPW SW: Natasha Grimaldo Developer: N/A
Date of Walk-Thru:	11-13-2023
Walk-Thru Number:	4 th

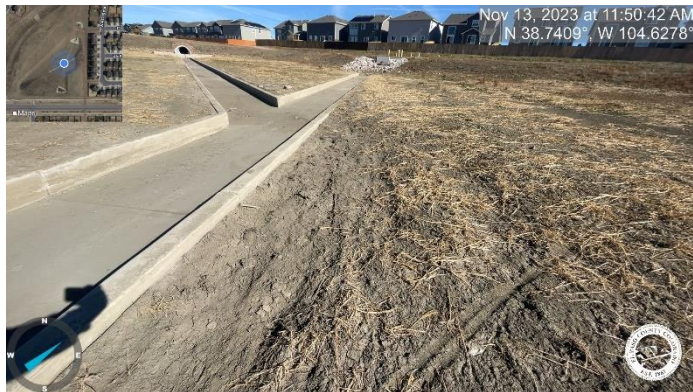
Photo 1: Pond C5: Raise pond bottom to top of trickle channel curb with a 3% slope towards trickle channel for positive drainage.

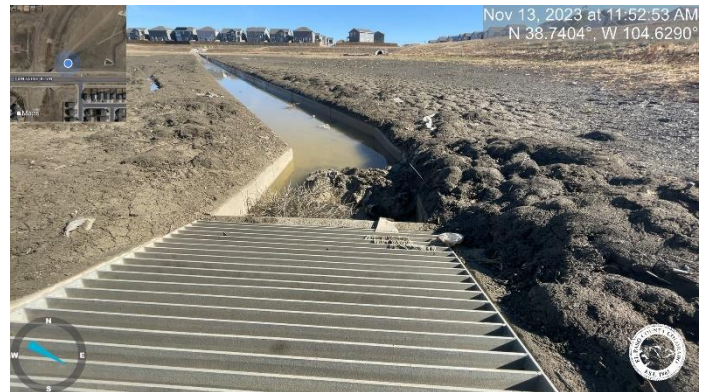
Photo 2: Pond C5: Remove sediment to match the top of trickle channel curb with a 3% slope towards trickle channel for positive drainage.

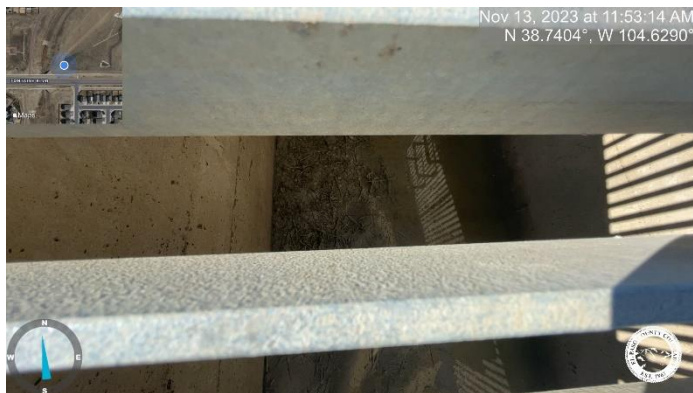
Photo 3: Pond C5: Remove sediment and debris from outlet structure micropool.

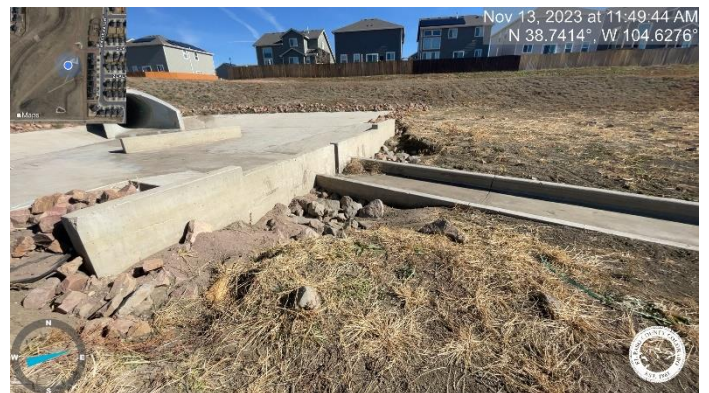
Photo 4: Pond C5: Fill in undercut areas on Forebay A and B.

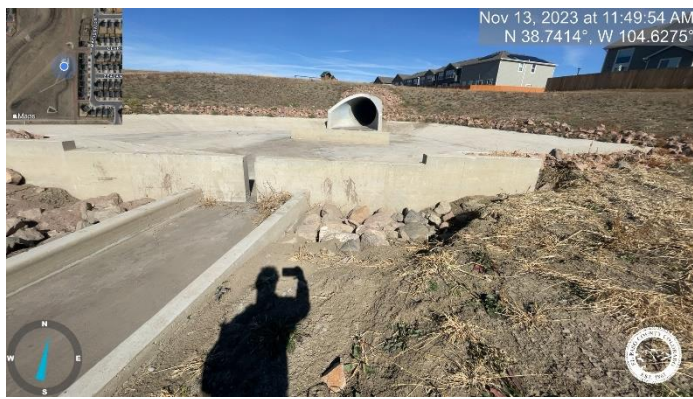
Photo 5: Pond C5: Fill in undercut areas on Forebay A and B.

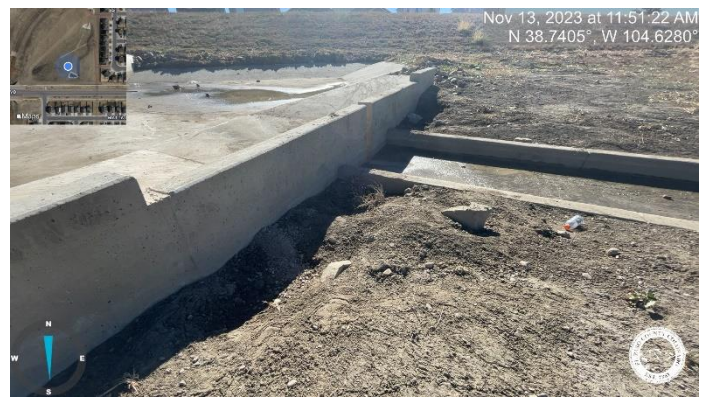
Photo 6: Pond C5: Fill in undercut areas on Forebay A and B.

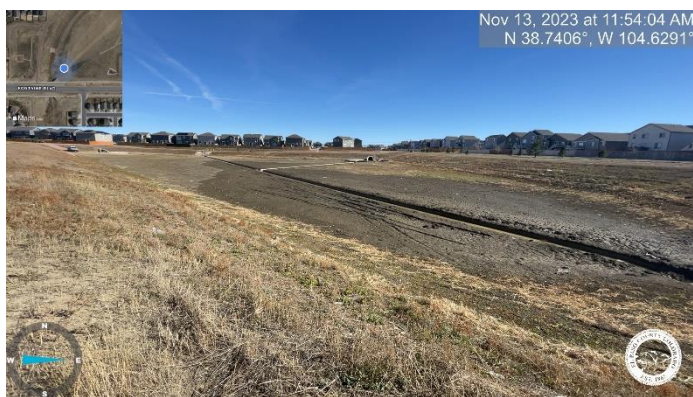
Photo 7: Pond C5: Failure to achieve uniform vegetative cover with an individual plant density of at least 70 percent in pond bottom.

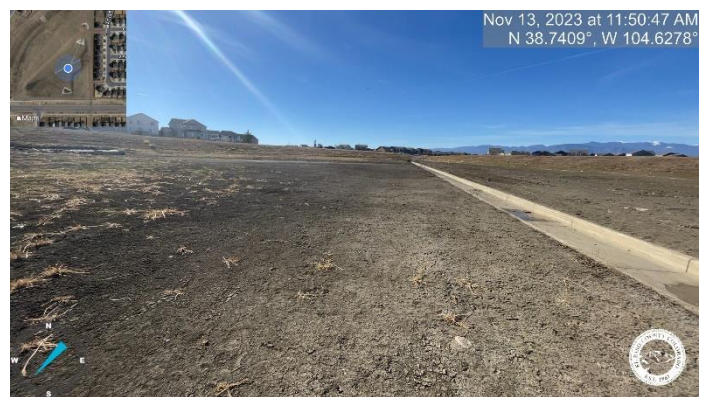
Photo 8: Pond C5: Failure to achieve uniform vegetative cover with an individual plant density of at least 70 percent in pond bottom.

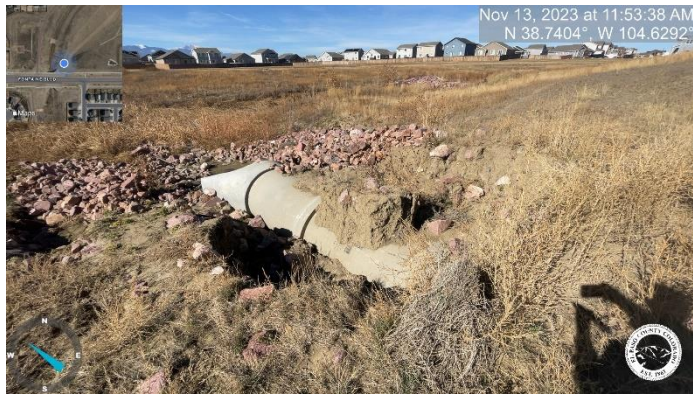
Photo 9: Pond C5: Repair blowout about outlet pipe and implement stabilization.

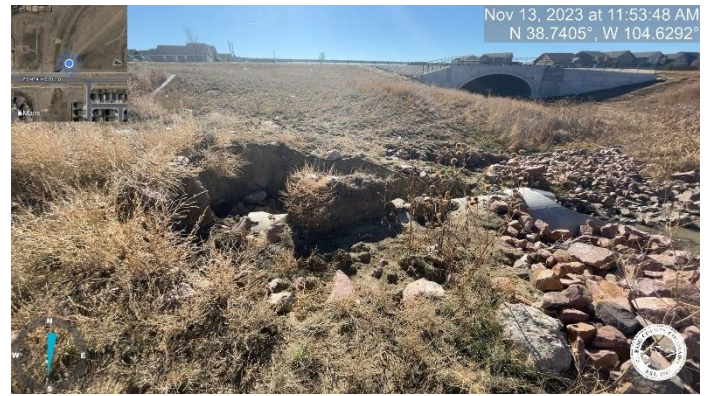
Photo 10: Pond C5: Repair blowout about outlet pipe and implement stabilization.

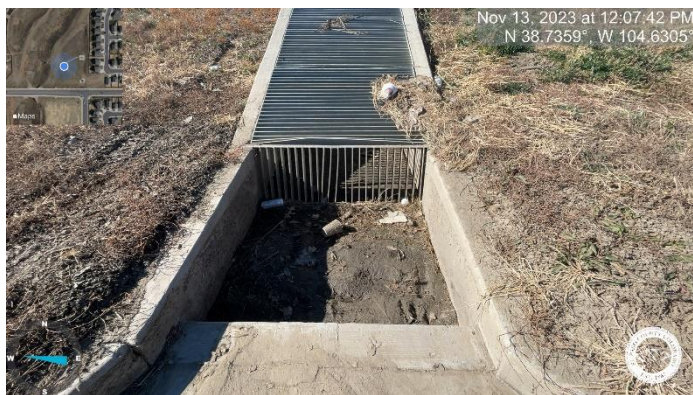
Photo 11: Pond D2: Remove sediment and debris from outlet structure micropool.

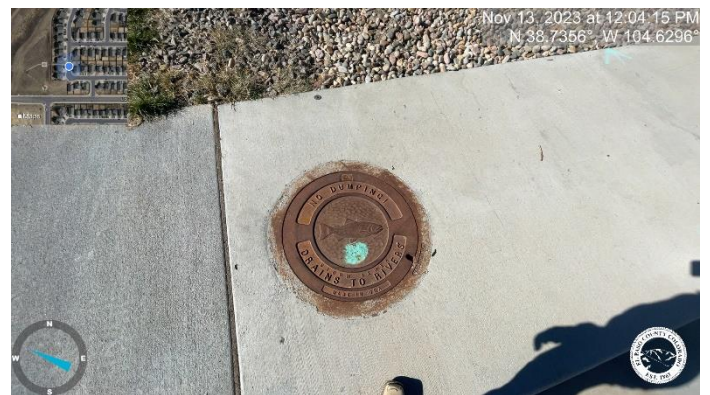
Photo 12: All Inlets will be checked during the next walk. Inlets are marked with a green dot.

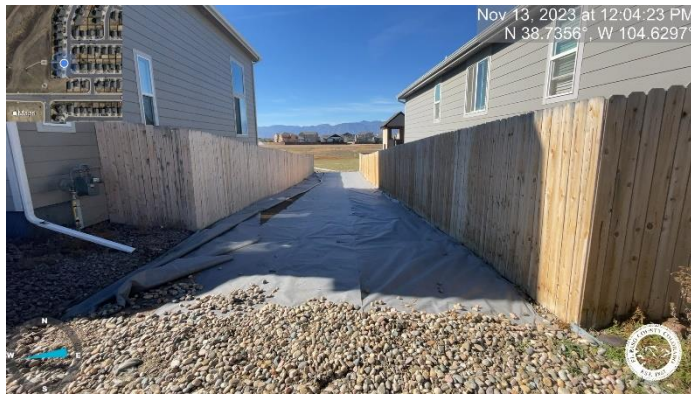
Photo 13: Implement final stabilization (landscaping river rock).

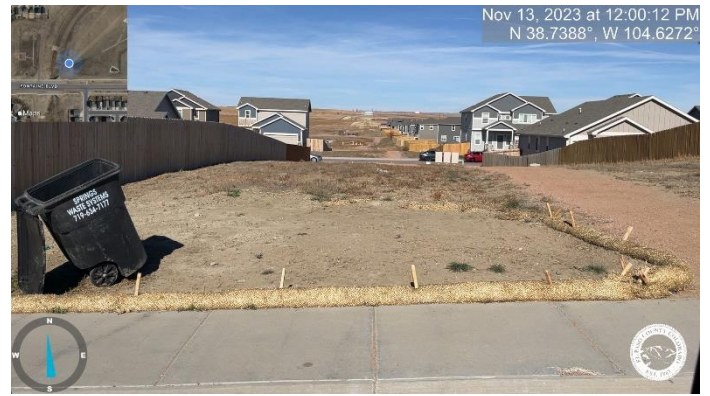
Photo 14: Failure to stabilize and achieve uniform vegetative cover with an individual plant density of at least 70 percent.

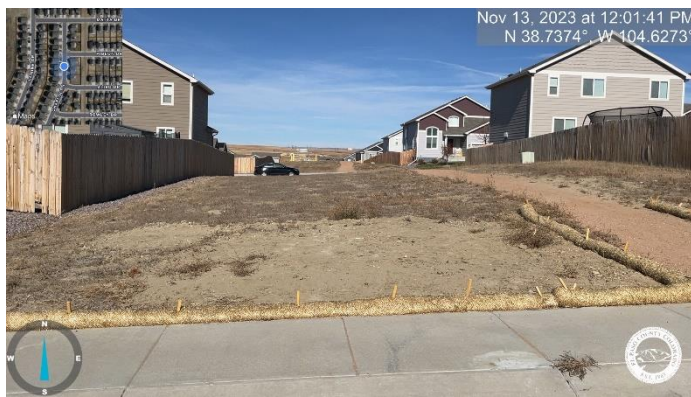
Photo 15: Failure to stabilize and achieve uniform vegetative cover with an individual plant density of at least 70 percent.

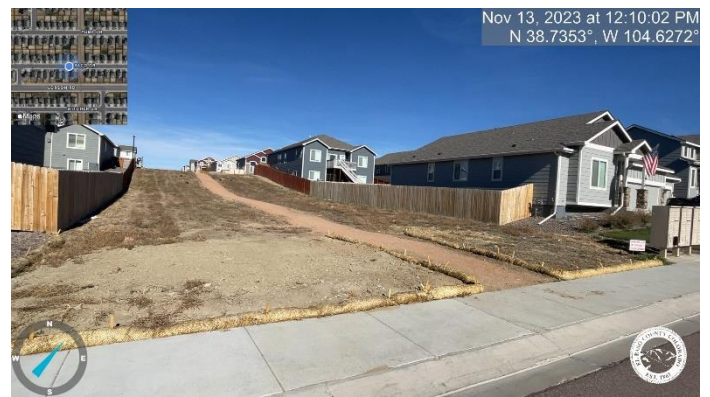
Photo 16: Failure to stabilize and achieve uniform vegetative cover with an individual plant density of at least 70 percent.
