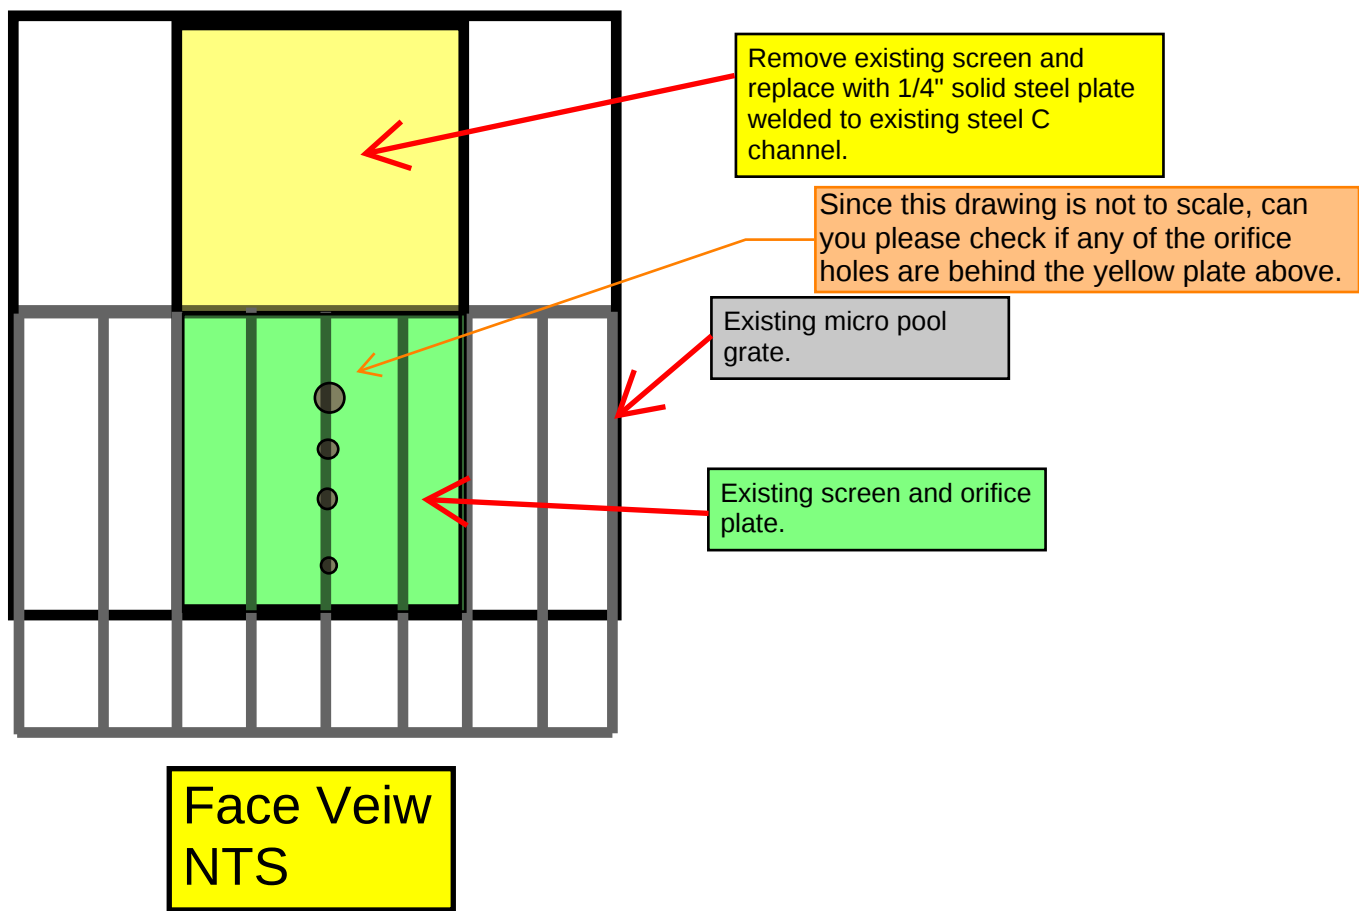
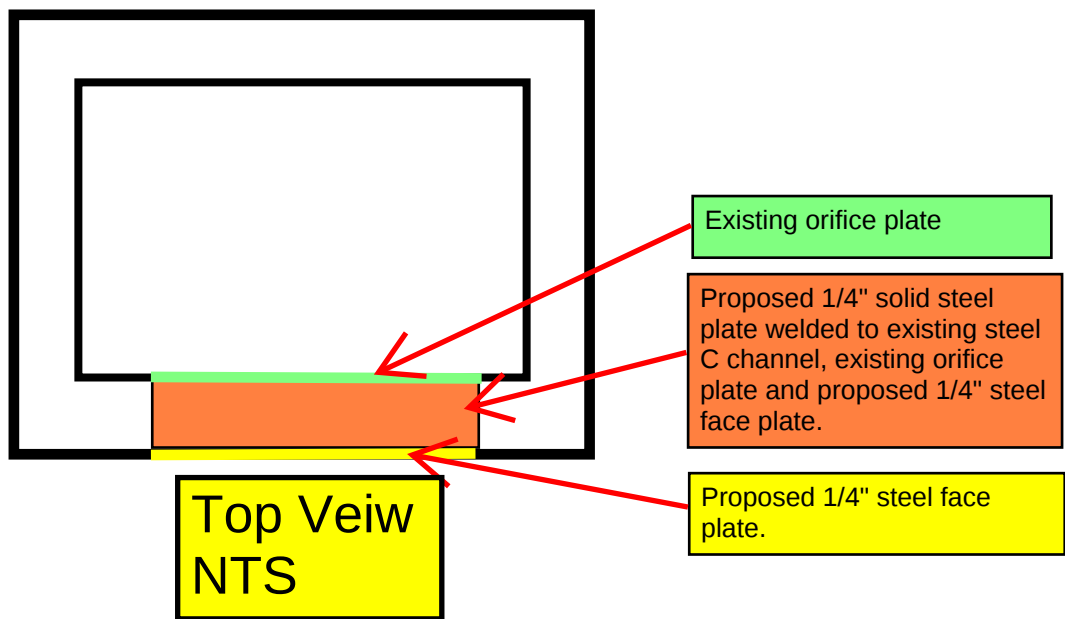
As a general comment, why was this the solution proposed? In our punchlist all we asked for was the gap at the top (in the horizontal plane) by covered up. The new plate/cover in the vertical plane (the yellow area below) was definitely not requested or necessary and will mess with the intended hydraulic functionality of the pond.

For future reference: this type of modification should have been sent to the County for review before the contractor was instructed to install it, to avoid misinterpretations of our punchlist items.
