EL PASO COUNTY CONSTRUCTION STORMWATER SITE INSPECTION REPORT

Facility Name: Woodmoor WSD #1 Lake Pump Station #2 and Pipeline	Permittee: Lake Woodmoor Sanitation District
Date of Inspection: 06/14/2022	Weather Conditions: Sunny
Permit Number: ESQCP 2124	Disturbed Acreage: ~5 acres
Phase of Construction: Active	Site Qualified Stormwater Manager: Blake Deilke
Inspector Name: Molly Galloway	Site Contact Info: 720-390-9163

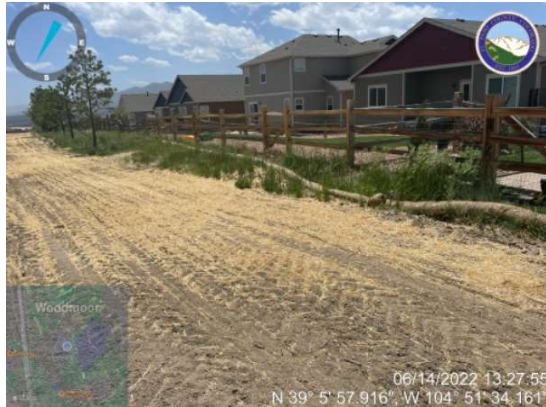
Disturbed areas have been temporarily stabilized and seeded.

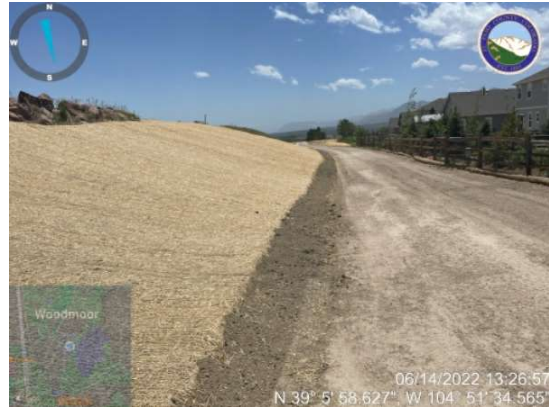
3:1 slopes that were disturbed have been matted with ECB.

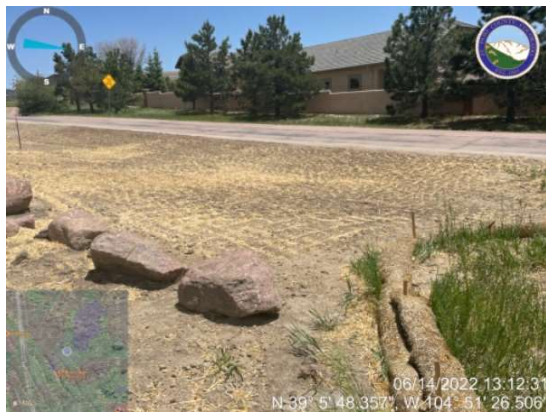
Disturbed areas have been temporarily stabilized and seeded. Straw wattle perimeter control measures remain in place.

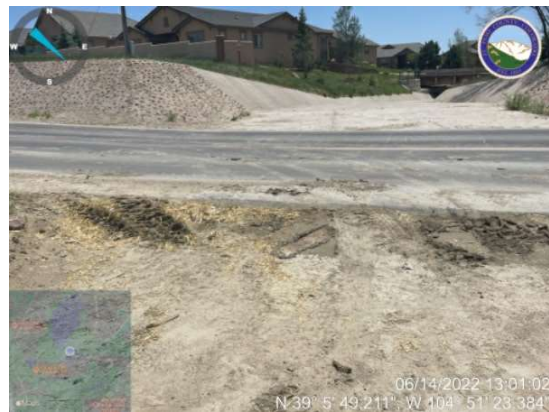
Sediment tracking near Lake Woodmoor dam occurring on Lake Woodmoor Drive. Increase street sweeping program.

Location	Missing Control Measure	Description of Corrective Action
Muddy areas along Lake Woodmoor Drive	Street sweeping control measure	Now that VTCs have been removed from egress/ingress areas, implement street sweeping where sediment tracking is occurring along paved roads.

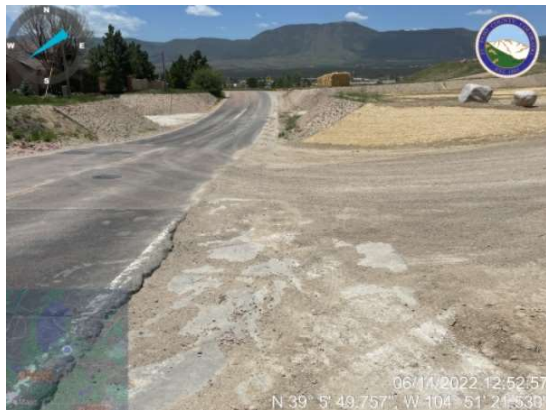
Sediment tracking near Lake Woodmoor dam occurring on Lake Woodmoor Drive. Increase street sweeping program.

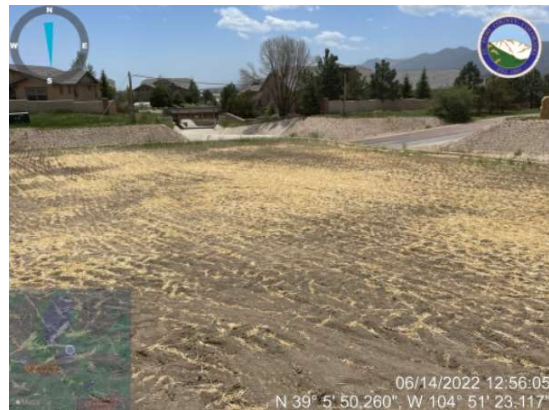
Disturbed areas have been temporarily stabilized and seeded. Straw wattle perimeter control measures remain in place.
