Re: Plot Plan Review 14625 Millhaven Place

Lot 51, Cathedral Pines Filing No. 2

El Paso County, Colorado

Subsurface Soil Investigation

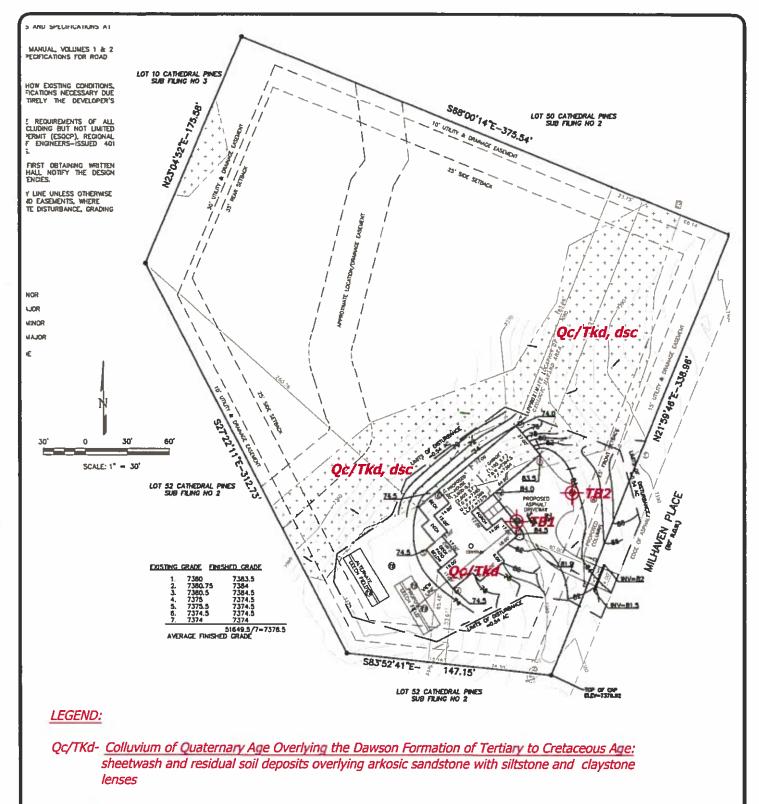
JOB NO.: 180542 FIG NO.: 1 APPENDIX A: Entech Engineering, Inc. Subsurface Soil Investigation, November 6, 2014, Entech Job No. 141476

The site was observed on April 2, 2018 by personnel of Entech Engineering, Inc. The house corners were staked at the time of this investigation. The Geology/Engineering Geology Map is presented in Figure 1. The above referenced Subsurface Soil Investigation by Entech Engineering, Inc. is presented in Appendix A.

According to the Soil, Geology and Wastewater Study, portions of the site are mapped as downslope creep areas. The areas with the potential for downslope creep have been delineated more accurately since the house corners have been staked and are indicated on Figure 1. These areas are acceptable as building sites; however, we would anticipate accelerated lateral and vertical movement of the near surface soils in the downslope creep areas. Portions of the proposed house encroach on downslope creep areas. The foundation should be stepped into the slope with downslope creep areas to a depth that achieves a 3 to 1 projection from the toe of the slope. Additional foundation reinforcement, such as tie-beams, buttresses or counterforts are recommended. The need for additional reinforcement at the extent of foundation benching should be determined at the time of the time of the open excavation observation.

A no-build area was placed in the original plot to avoid the downslope creep area. The downslope creep area particularly in the area of the proposed house, will not prohibit development. It is our opinion the proposed house location is acceptable for the site conditions and the no-build area should be modified to accommodate the proposed plan. Foundation design parameters have been provided in the Subsurface Soil Investigation.

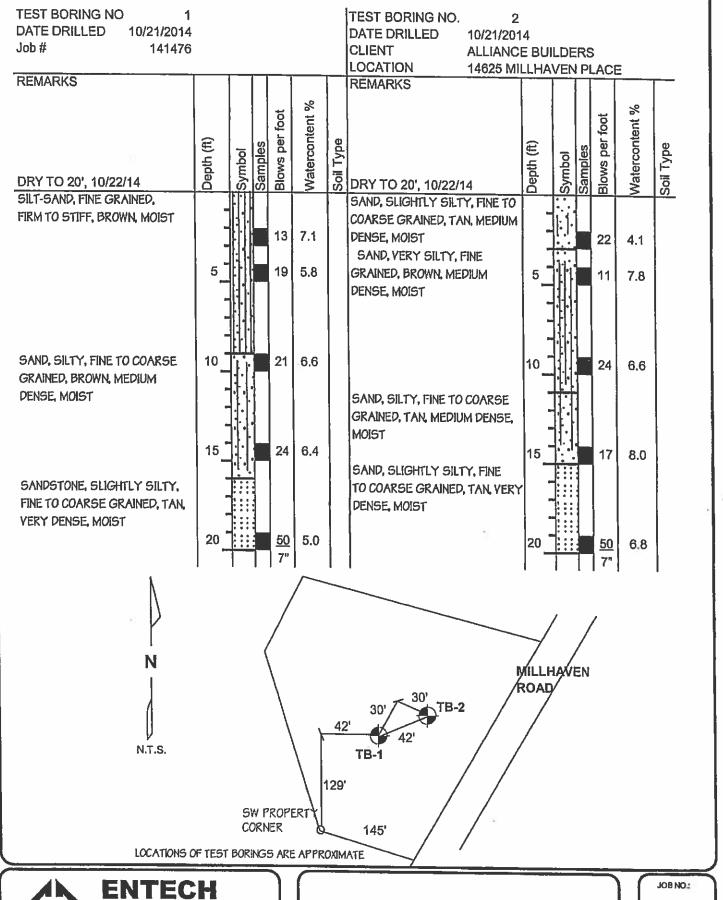
JOB NO.: 141476 FIG NO.:

Soil types observed in the test borings drilled on this site were found to consist of silt-sand and very silty to slightly salty sand overlying slightly silty sandstone.

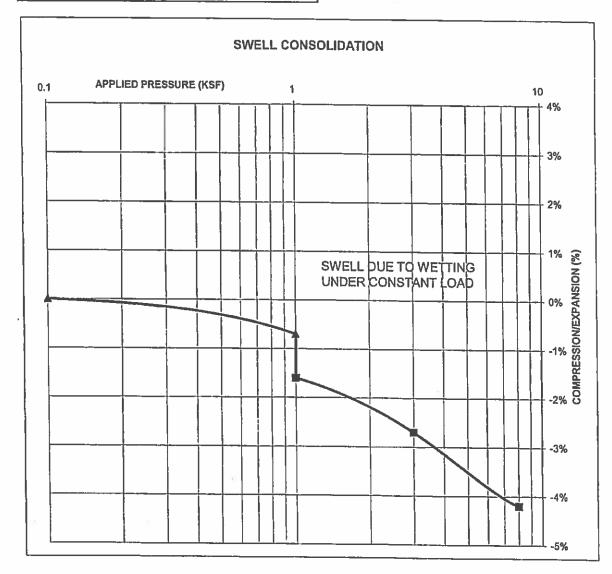
CONSOLIDATION TEST RESULTS

Swell/Consoildation testing resulted in a consolidation of 0.9%, which is in the moderate consolidation range for a sample of very silty sand from Test Boring No. 2 at a depth of 10 feet.

SAMPLE FROM: 2 DEPTH(ft) 10
DESCRIPTION SAND, SILTY
NATURAL UNIT DRY WEIGHT (PCF) 105
NATURAL MOISTURE CONTENT 7.6%
SWELL/CONSOLIDATION (%) -0.9%

Collapsible silt-sand and very silty sand were encountered in the test borings at the anticipated footing depth. It is recommended that a 3 foot layer of the soils below foundation members be moisture-conditioned and recompacted in place. This will require an overexcavation of 2 feet, scarification and moisture-conditioning and compacting the subgrade and then replacing the excavated soil. The backfill soils should be compacted in lifts not to exceed 6 inches after compaction, while maintaining a minimum of 95% of its maximum Modified Proctor Dry Density, ASTM-1557. The soils should be placed at a moisture content conducive to adequate compaction, and frequent density tests should be taken. The overexcavated site should be inspected by a representative of Entech Engineering, Inc. prior to fill placement and the first density test should be conducted when 18 inches of fill have been placed.
