EL PASO COUNTY CONSTRUCTION STORMWATER SITE INSPECTION REPORT

Facility Name: Forest Lakes Filings 5-7	Permittee: Jim Boulton (FLRD #2)
Date of Inspection: 02/04/2021	Weather Conditions: Partly Cloudy
Permit Number: EGP 194, ESQCP 1958	Disturbed Acreage: 79/287 acres
Phase of Construction: Active	Site Qualified Stormwater Manager: Mark Sherwood
Inspector Name: Molly Galloway	Site Contact Info: Mark Sherwood

Facility Name: Forest Lakes Filings 5-7

Date: 02/04/2021

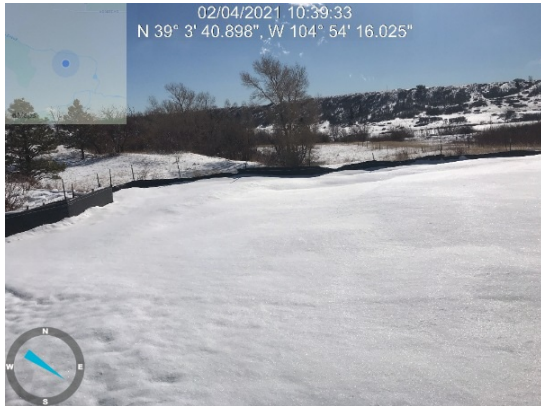
Unable to inspect filings 6-7 due to snow cover.

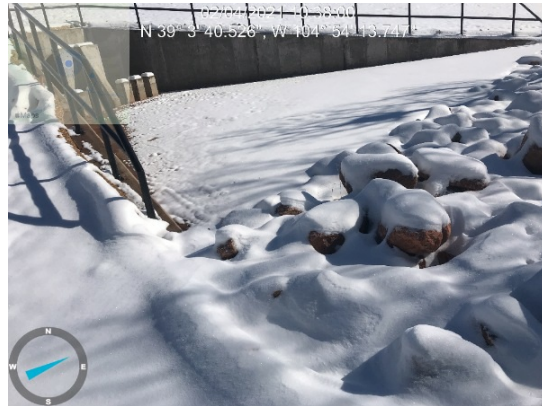
Outlet structure at end of F5 unable to be inspected due to snow cover.

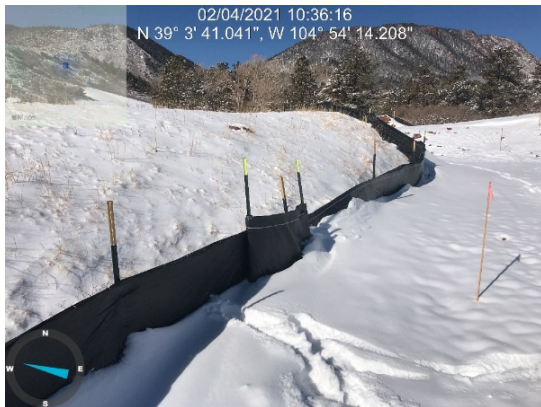
Wireback silt fence maintenance has occurred along end of F5.

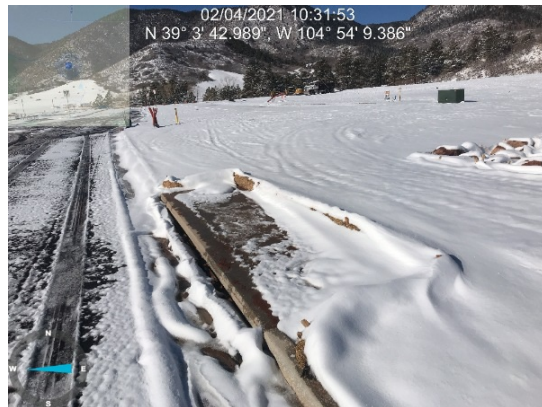
Unable to fully inspect curb inlet protections along Mesa Top Drive in F5 due to snow cover.

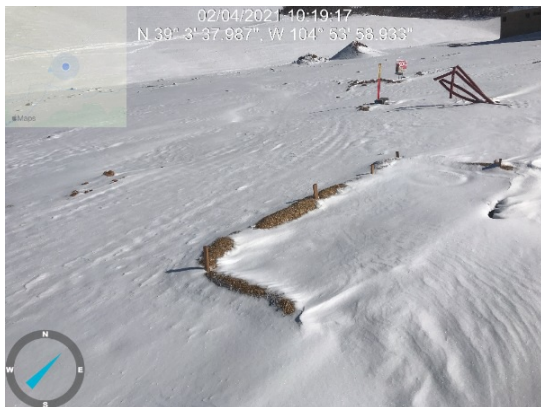
Unable to fully inspect curb inlet protections along Mesa Top Drive in F5 due to snow cover.

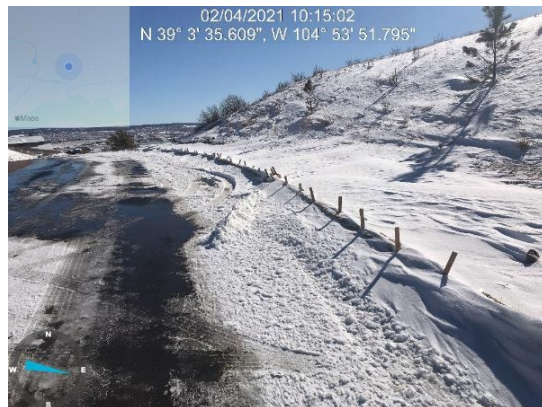
Perimeter control measures implemented along Forest Lakes Drive entrance where MVEA /waterline disturbance occurred.
