**SOILS AND GEOLOGY STUDY  
PYRAMID MOUNTAIN ROAD  
PARCEL NO. 83230-00-026  
EL PASO COUNTY, COLORADO**

October 7, 2025

Revised April 1, 2026

Entech Job No. 251469  
PBK/LLL/JCG

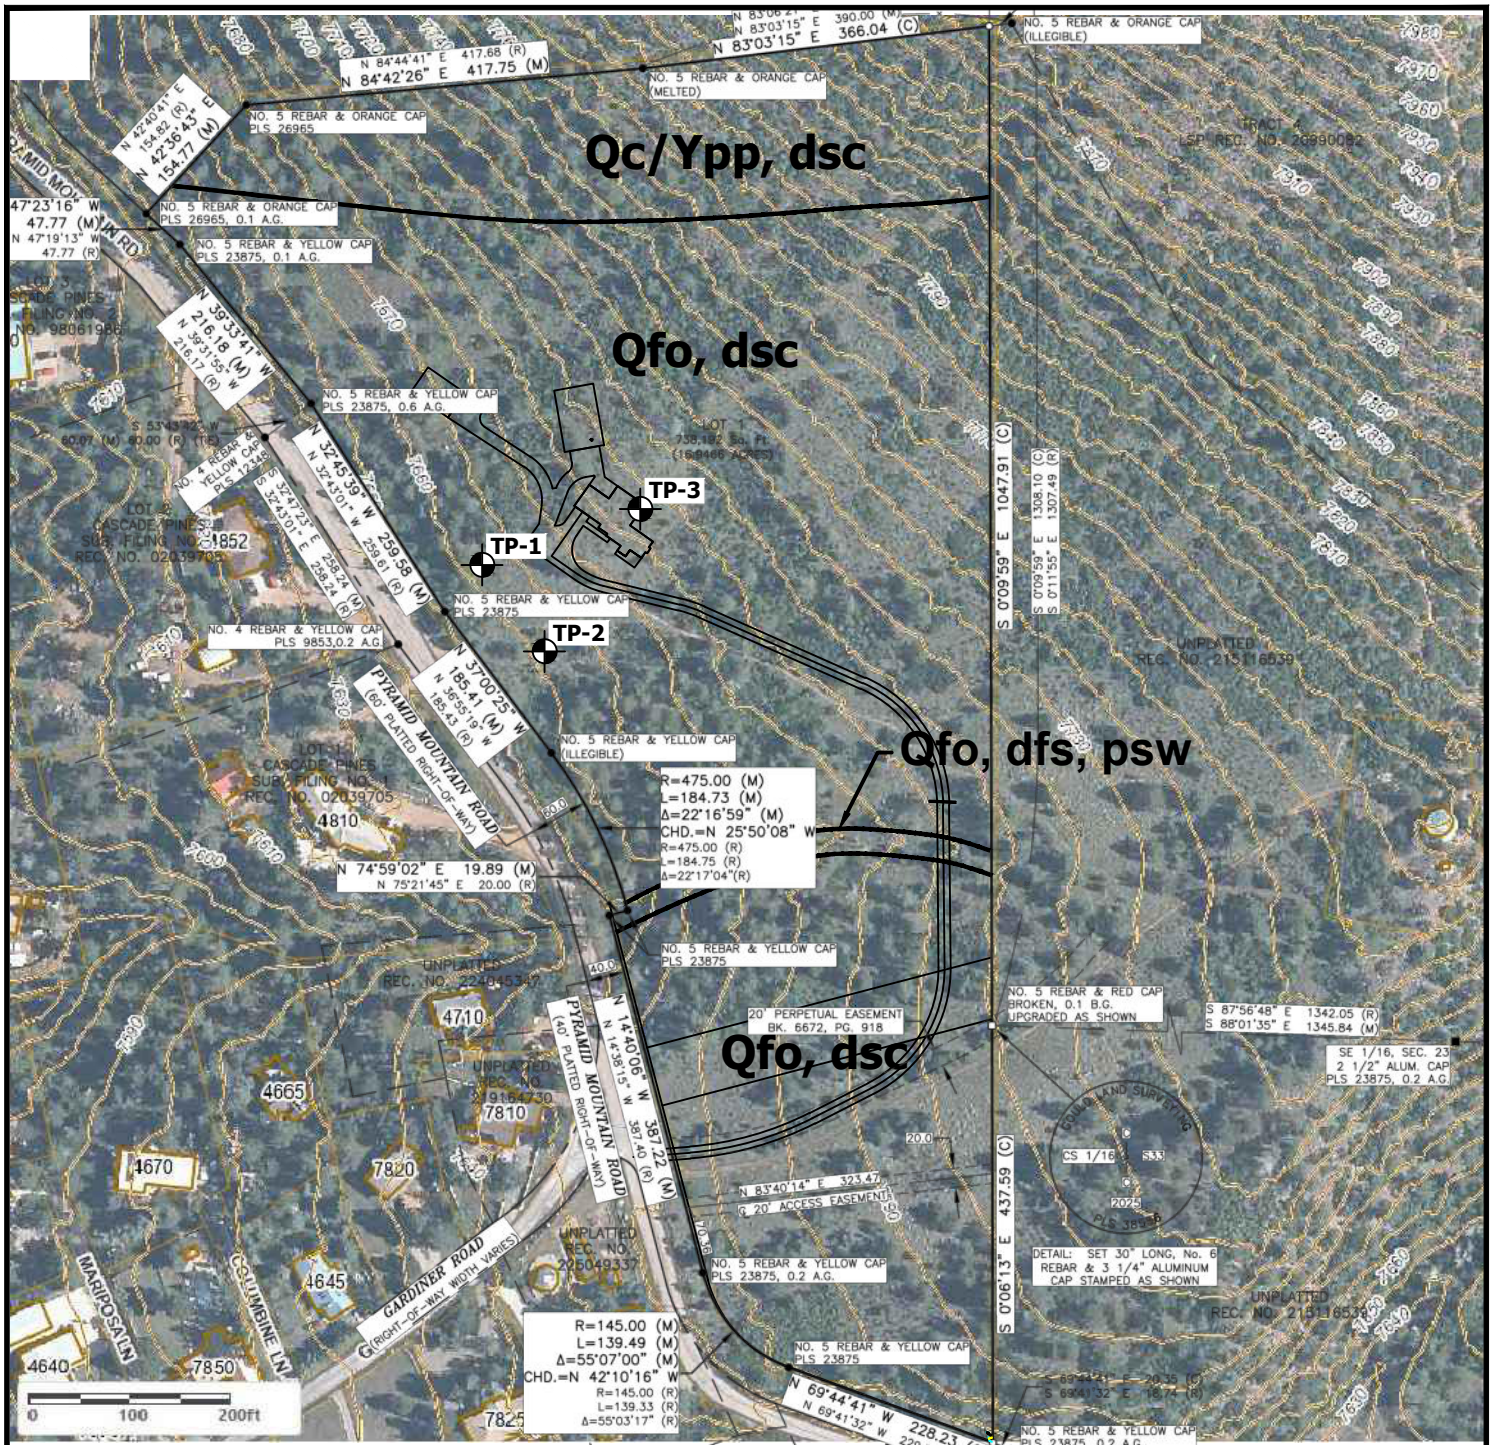
FIG. 6**

Detailed mapping has been performed on this site to produce a Geology/Engineering Geology Map (Figure 6). This map shows the location of various geologic conditions the developers should monitor during the planning, design, and construction stages of the project. No significant geologic hazards were identified on the site; however, the following constraints have been identified on the site: downslope creep and potentially unstable slopes. These constraints and recommended mitigation techniques are presented below:

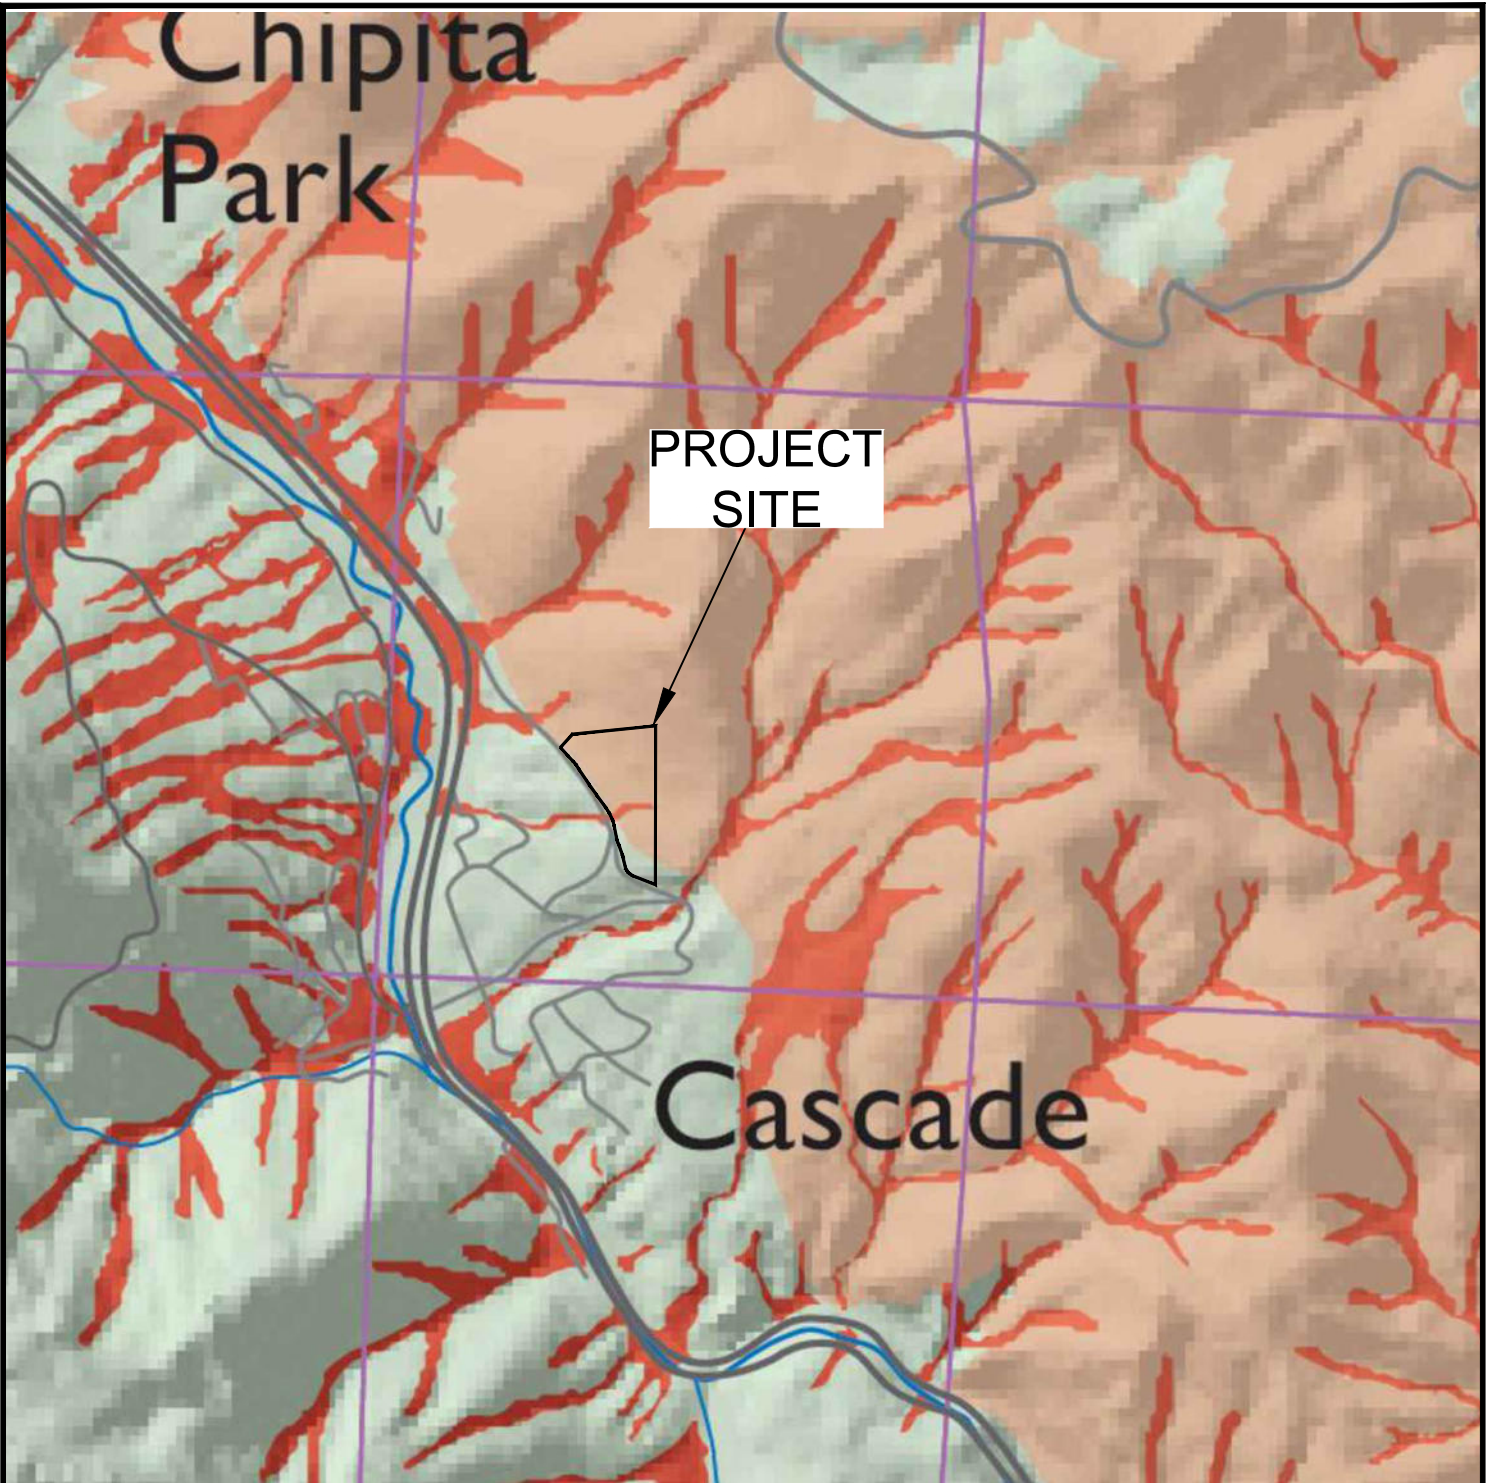
**FIG. 9**

Portions of the site are mapped as susceptible to debris flows according to the Debris Flow Susceptibility Map of El Paso County, Colorado, by McCoy, Morgan, and Berry (Reference 10) and is shown in Figure 9. These areas are associated with the minor drainage swale in the southern portion of the site. There is the potential for debris flows to initiate during heavy rainfall events in this area. The area identified with this hazard on this site will be avoided by the proposed residence, however, the proposed gravel driveway will cross this drainage. Culverts should account for the potential of hyper-concentrated sediment laden flows and be adequately sized by a qualified drainage engineer. Specific drainage studies are beyond the scope of this report.

Mitigation: Channel armoring consisting of riprap and/or other forms of erosion protection should be utilized in areas of concentrated flows to include permanent channel armoring to prevent accelerated erosion, creating unstable conditions. Riprap sizing should be based off potential flow velocities. The erosion protection must utilize proper fabric/grid grading to prevent piping and undermining. Erosion control measures and riprap sizing should be determined by a qualified professional.

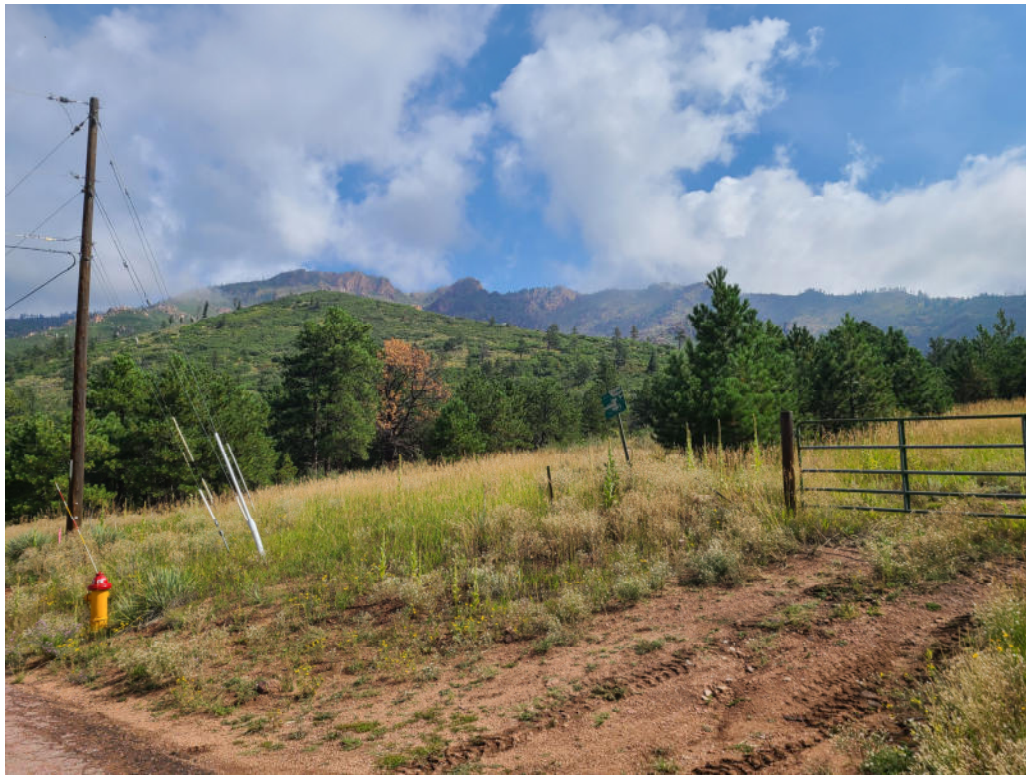
**Looking north from the southern portion of the site.**

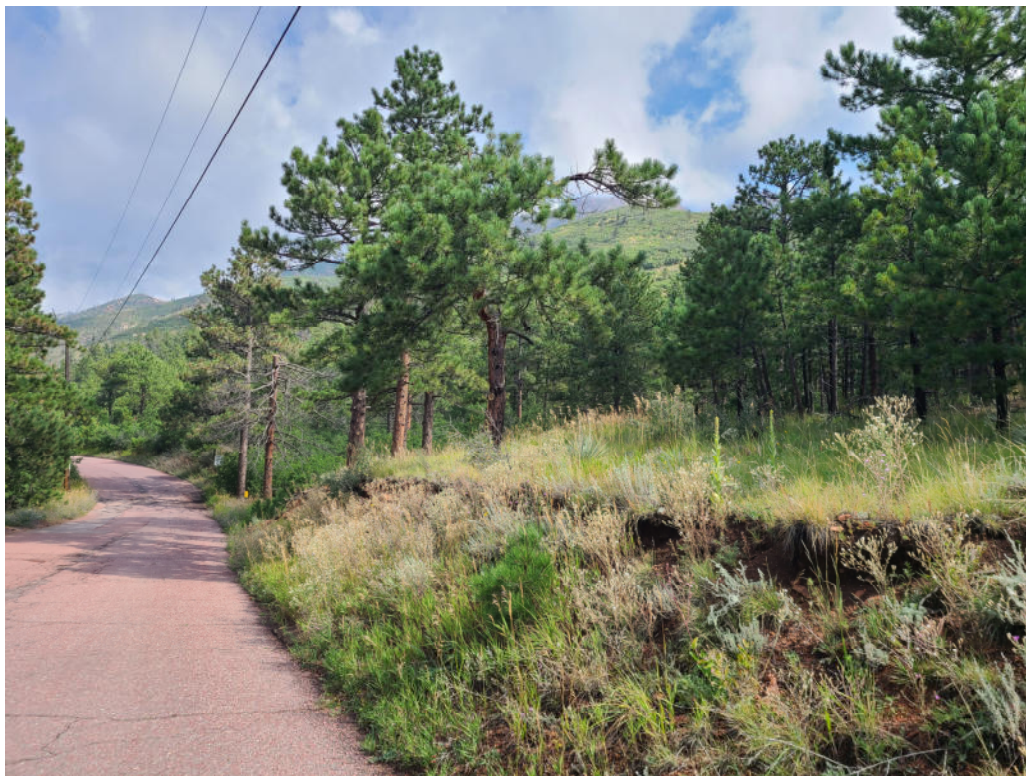
**Looking northeast from the western portion of the site.**

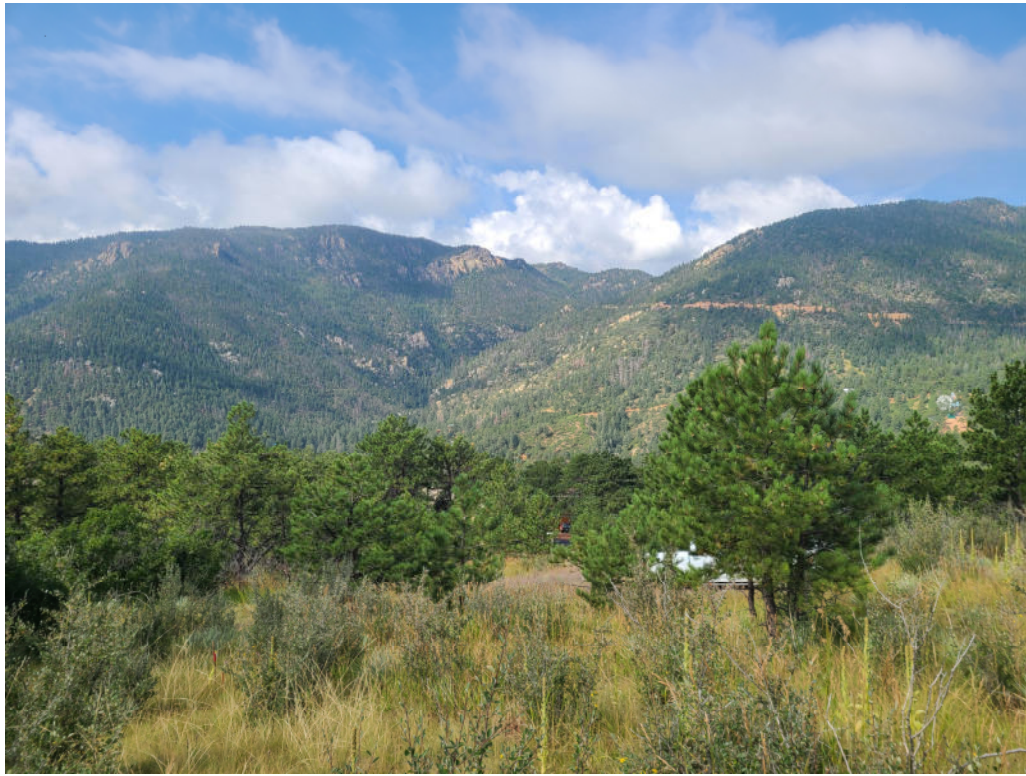
**Looking northeast  
from the southwestern  
portion of the site.**

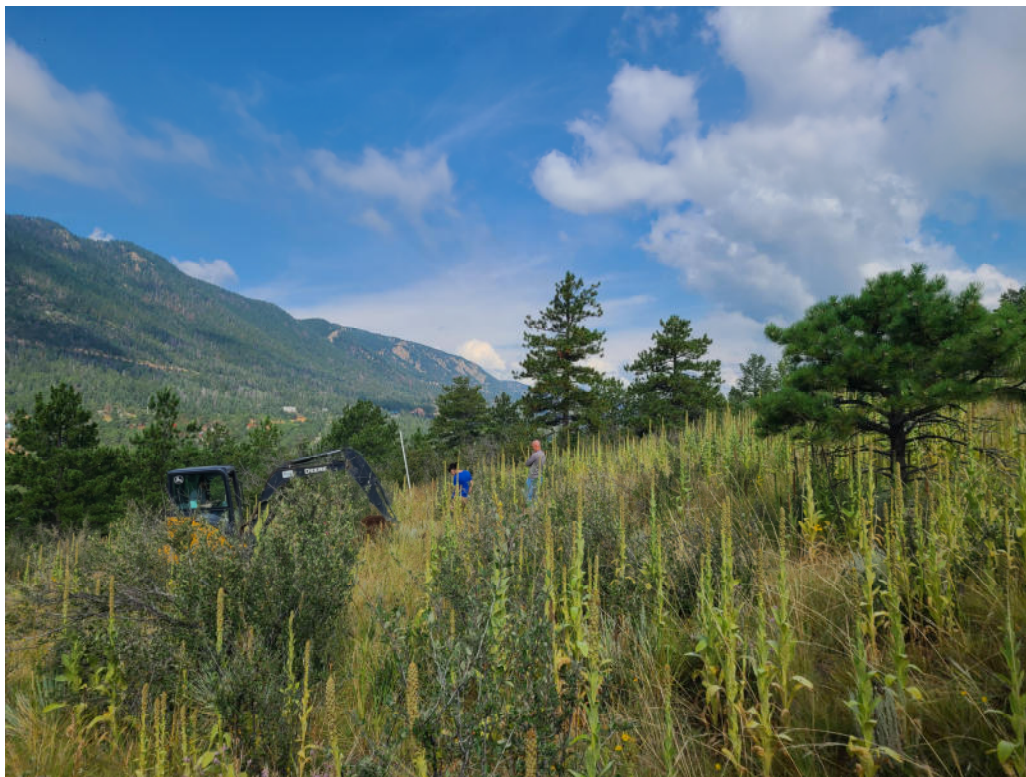
**Looking east from the  
southwestern  
portion of the site.**

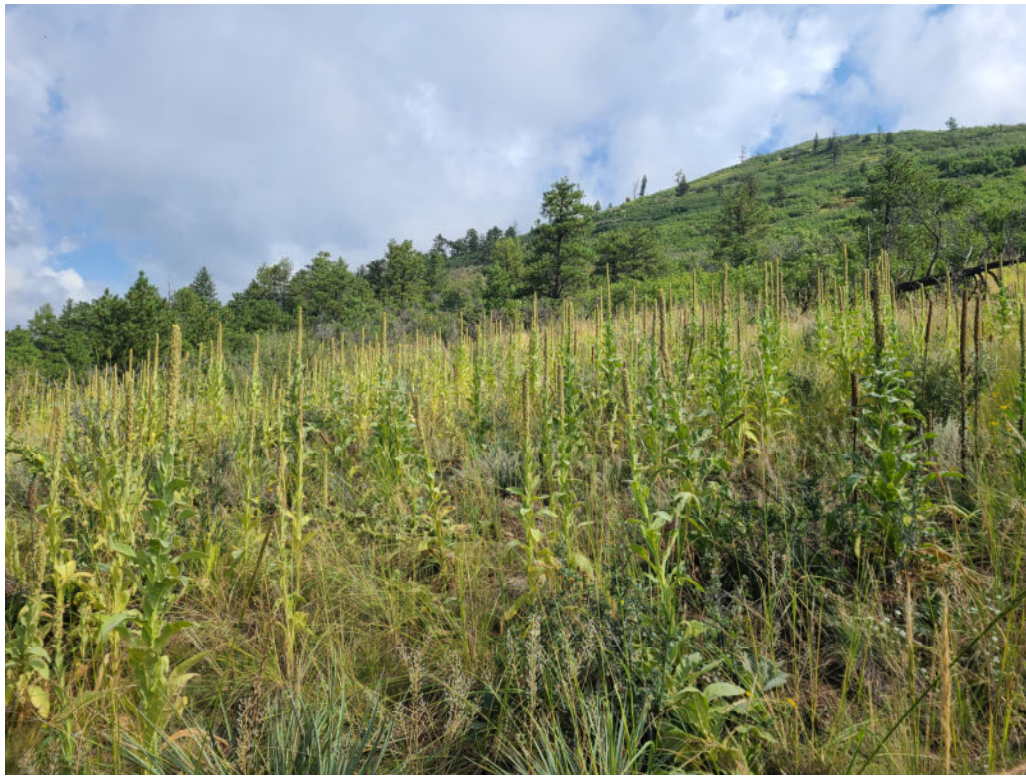
**Looking northeast  
from the southwestern  
portion of the site.**

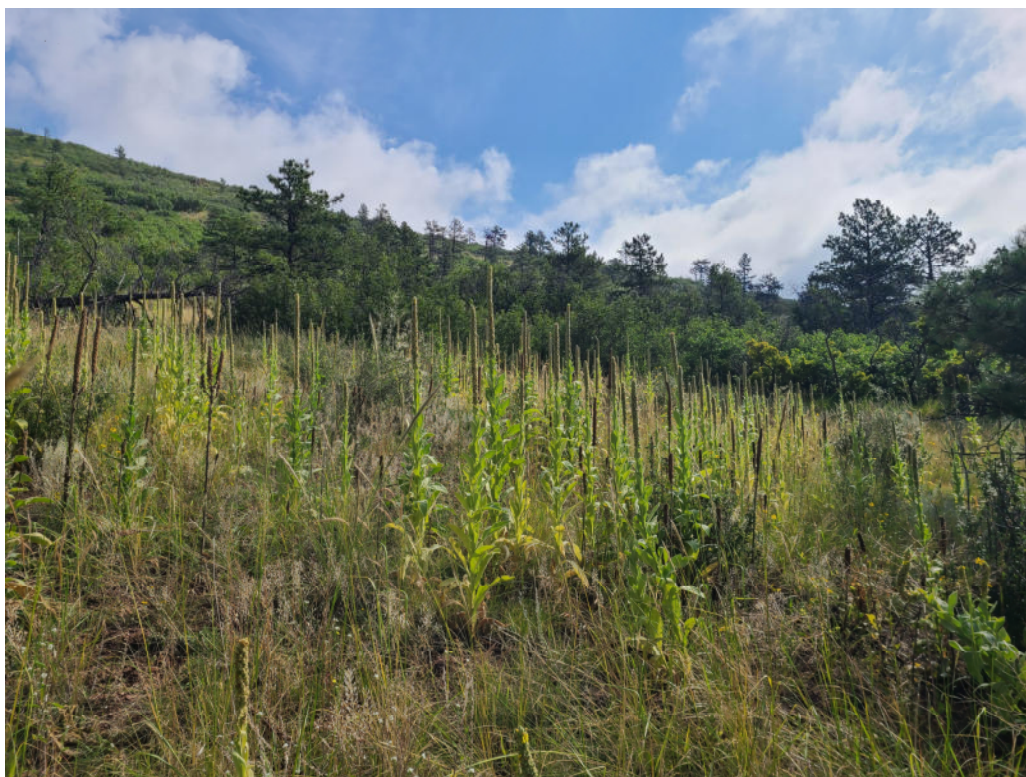
**Looking east from the  
southwestern portion  
of the site.**

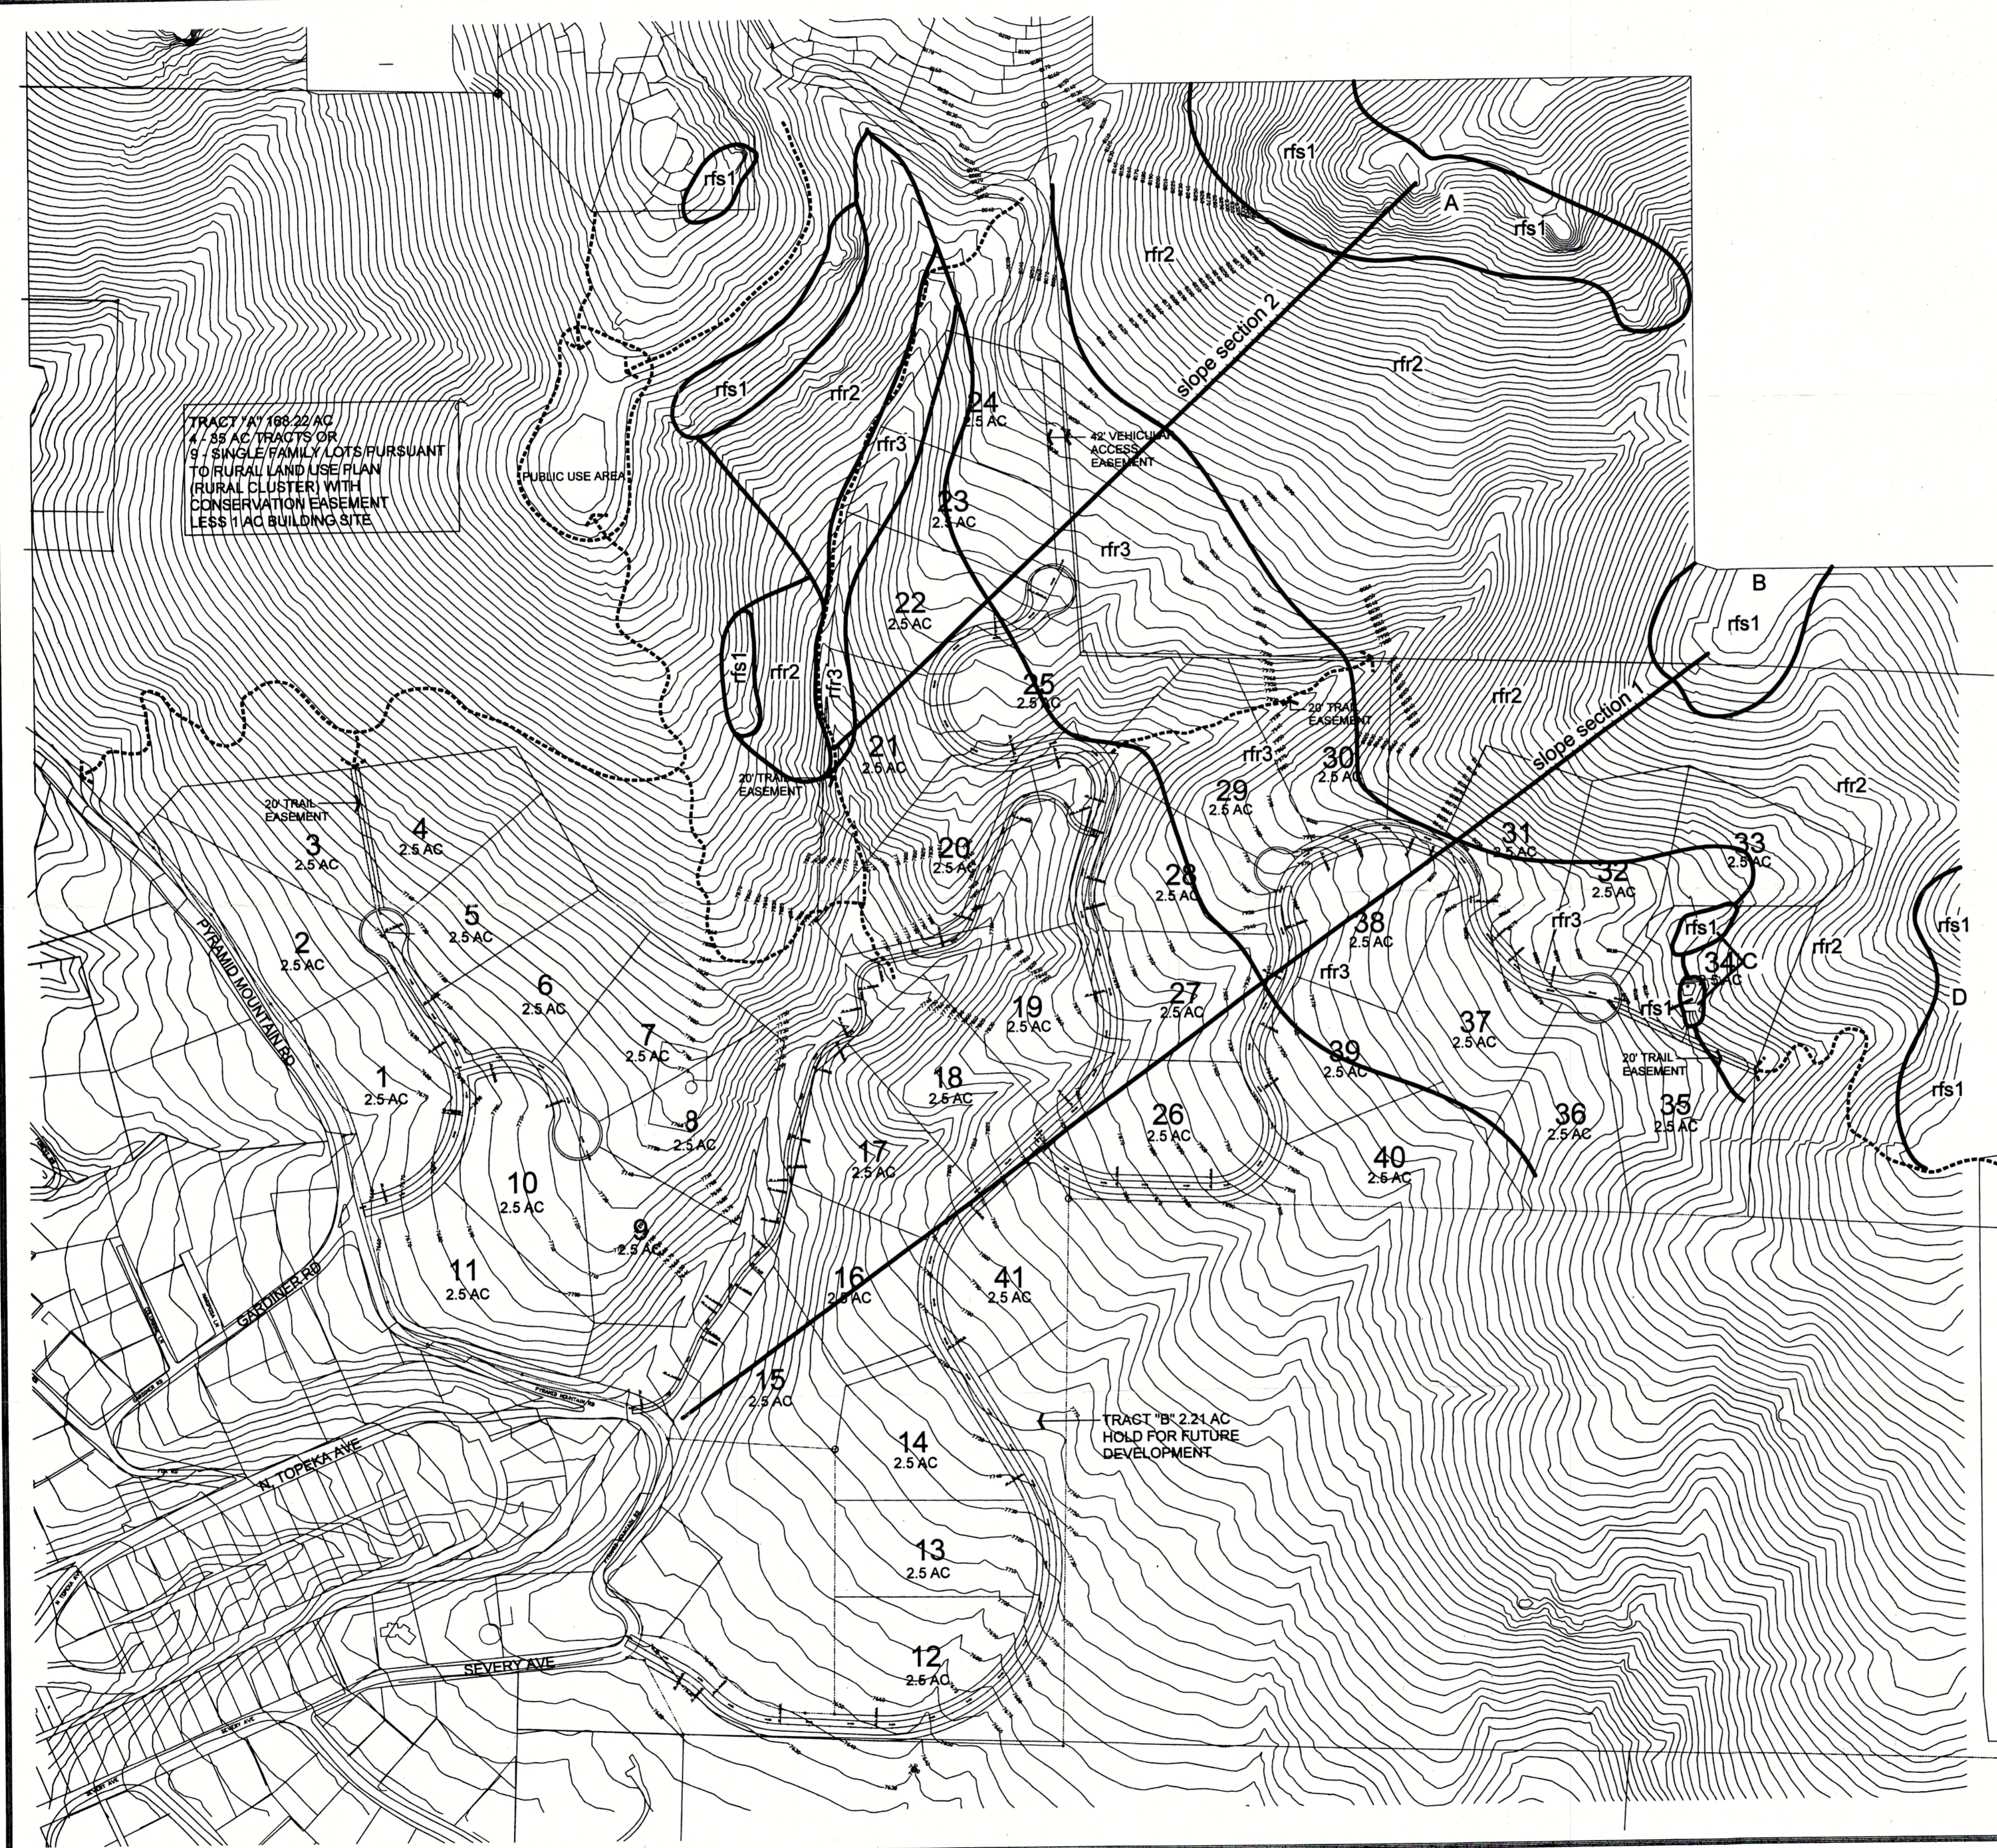
Areas on the steeper hillsides have been identified as having rockfall hazards. In these areas, granite cliffs and boulders are exposed and produce boulder and cobble size talus. The hazard affects areas lying topographically below this area. On all the lots affected by rockfall where structures are proposed in the rockfall hazard zone, mitigation for rockfall hazard will be required. The rockfall zones have been divided into three separate zones based on the severity of the hazard. Areas lying topographically below the RF-3 zone would be considered reasonably safe from rockfall. Existing rockfall zones are shown on the Rockfall Map, Figure 2. Grading will affect the location of these zones.

Rockfall Source Area A (as indicated on Figure 2) contains many rocks and catchment structures may be more feasible in this area to mitigate the rockfall hazard to Lots 23 through 25. Additionally, there is sufficient room in the RFR-3 zone where rocks are slowing down and the catchment structure may require less stringent design, depending upon its location within the zone. Rockfall from source areas on the northwestern portion of the site is stopped in the drainage at the rear of Lots 21 through 24. Rockfall Source Areas B, C and D contain fewer rocks and it may be more feasible to stabilize the rocks in place in these areas in lieu of the catchment structure option. Source Areas B through D affect Lots 28 through 39. Structures on these lots will require the foundation walls above grade and berms on the upslope side of the foundations in addition to the source rock stabilization. The drainage at the rear of Lots 29 and 30 controls rockfall characteristics between Rockfall Source Areas A and B-D.

Mitigation: Stabilization of the area can include removal of loose blocks of rock, often referred to as scaling. Other techniques include stabilization of loose blocks mechanically and may involve pinning the loose rocks to the face of the cliff to prevent dislodgment. This may be accomplished with Portland cement grout, gunite or a combination of mechanical rock bolts and/or cable lashing.

Mitigation: Mitigation within the RFR-2 hazard zone will greatly reduce the potential for rockfall within the building areas below. Mitigation techniques include those discussed for the RFS-1 zone. Another option is the use of structures in this zone designed to stop rocks before they reach the proposed building areas. These structures could include walls or fences that are specifically designed by a qualified professional engineer or geologist to absorb the impact of moving boulders or debris and stop them. Drainage should be directed around the structures to avoid areas of ponding water or sediment buildup. These types of structures do require periodic maintenance to prevent debris from building up behind the catchment structure and reducing its effectiveness. A Rockfall Analysis was conducted using CRSP Computer Software in order to determine the rockfall characteristics and the effectiveness of catchment structures on this site. Results of this analysis are discussed later in this report.
