EL PASO COUNTY CONSTRUCTION STORMWATER SITE INSPECTION REPORT

Facility Name: Shekowski Residence- Jayden Homes	Permittee: Chris Palmer Jayden Homes
Date of Inspection: 02/09/2022	Weather Conditions: Cloudy
Permit Number: ESQ225/CDR2119	Disturbed Acreage: 7731/24291 total sq ft
Phase of Construction: Active	Site Qualified Stormwater Manager: Chris Palmer
Inspector Name: Molly Galloway	Site Contact Info: 719-213-7986

Shekowski Residence- Jayden Homes

02/09/2022

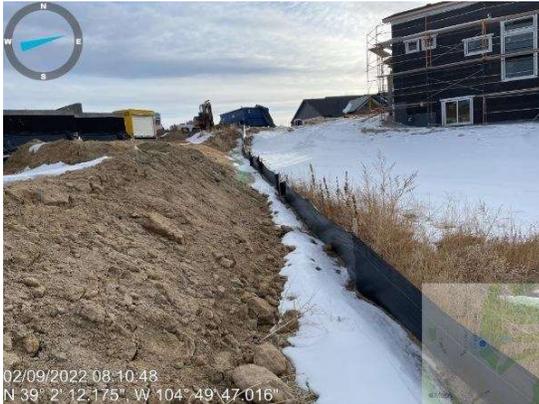
Silt fence installed along Southwest perimeter of lot.

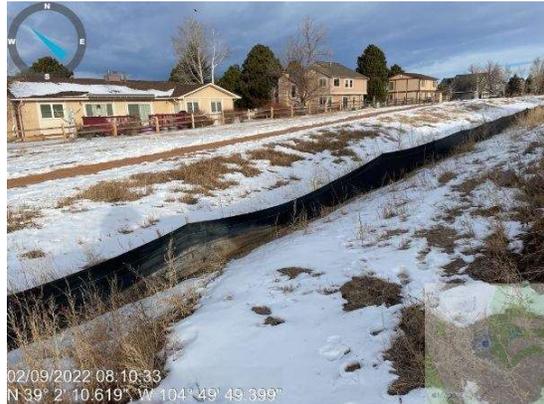
Rear silt fence is being maintained.

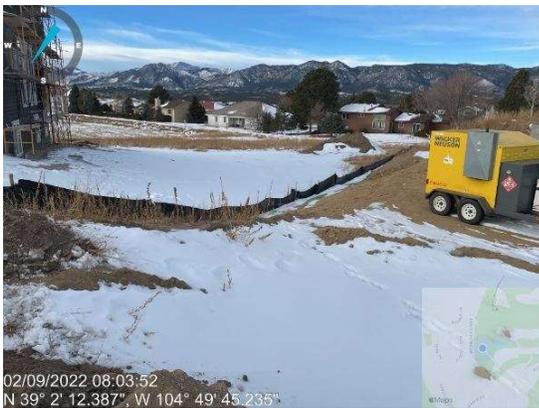
Perimeter controls have been implemented per GEC plans.

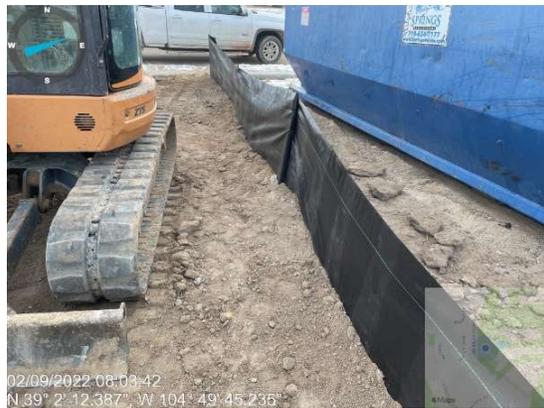
Silt fence perimeter control measure will continue to be maintained.
