Preliminary Acceptance Punchlist
El Paso County – Department of Public Works - Stormwater Section

Project Name:	Upland Flats
EDARP Filing Number(s):	CON2159, SF2112
ESQCP Number:	ESQ2139
Attendees:	DPW SW: Joshua Augustenborg, Erica Rylander, Ben Jones DPW Development Services: Brad Walters Developer: Brett Lewis, Nate Leblanc
Date of Walk-Thru:	10/18/2023
Walk-Thru Number:	1

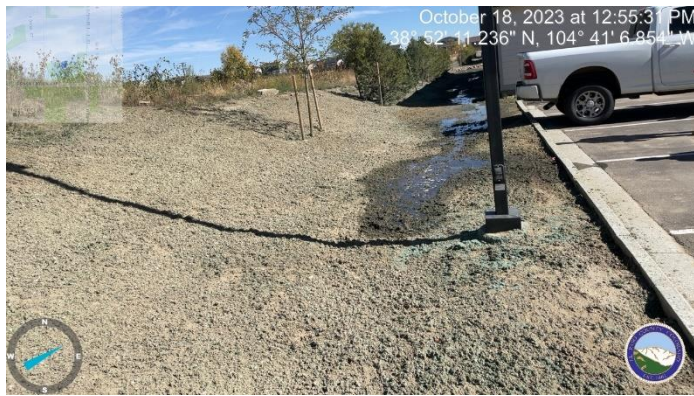
Photo 1: Erosion Control Blanket (ECB) is called out in multiple locations throughout site. Hydro mulch was applied instead. Monitor for adequate vegetation and erosion in these areas throughout Defect Warranty Period.

- Erosion Control Blanket (ECB) is called out in multiple locations throughout site. Hydro mulch was applied instead. Monitor for adequate vegetation and erosion in these areas throughout the Defect Warranty Period. Reference Photo #1.
- At southeast corner, southwest corner, and along south perimeter, bring grade up to be flush with curb and sidewalk to prevent standing water in right-of-way. Reference Photo #s 4 and 5.

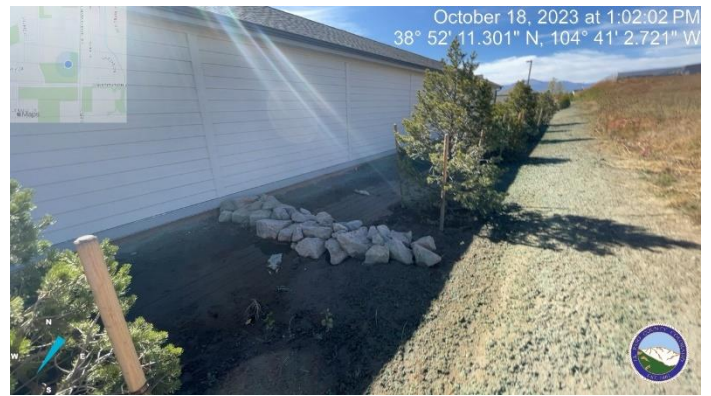
Photo 2: North Limits of construction (LOC) check dams *should* be extended in length to prevent bypassing. Monitor throughout defect warranty period.

- North Limits of construction (LOC) check dams *should* be extended in length to prevent bypassing. Monitor throughout defect warranty period. Reference Photo #2

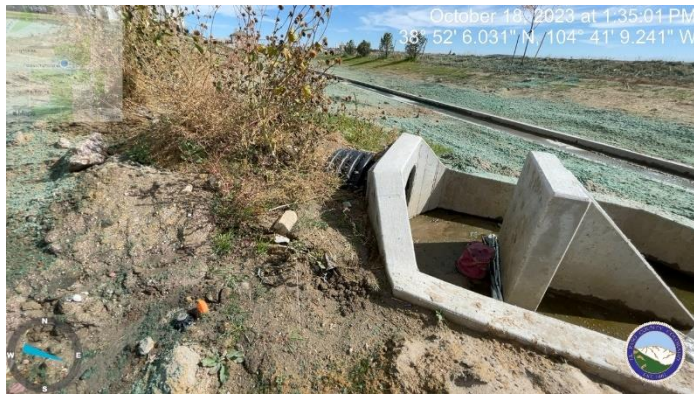
Photo 3: Bring up grade to be flush with forebays and trickle channel throughout.

- Reestablish maintenance access road at east end of EDB. Reference Photo #11.
- Bring up grade to be flush with forebays and trickle channel throughout. Reference Photos # 3

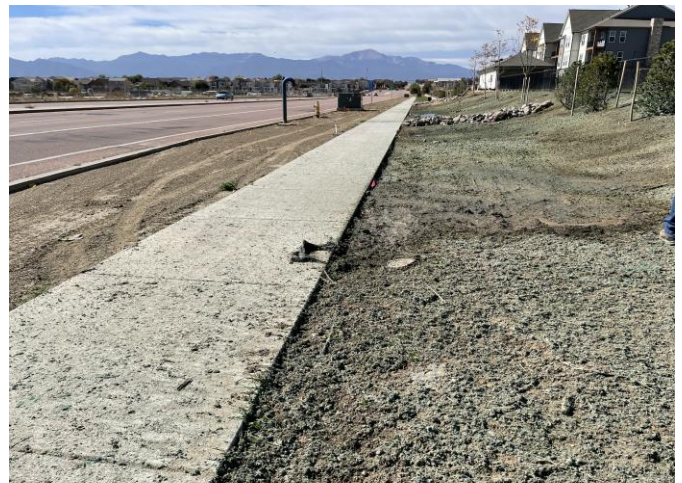
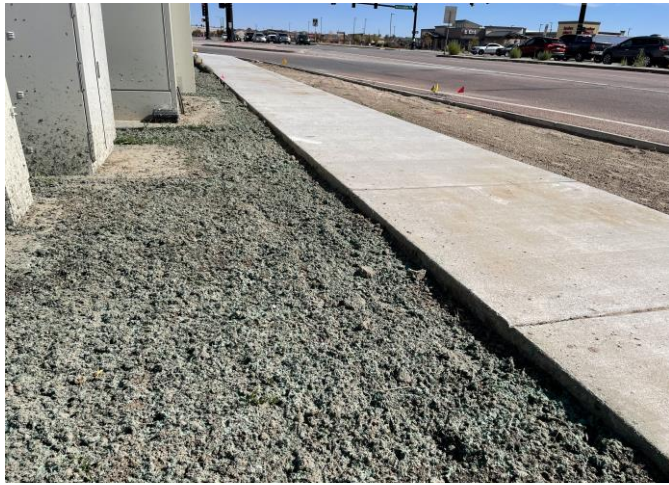
Photo 4: Bring grade up at south end of site to be flush with curb and sidewalk to prevent standing water in right-of-way.

Photo 5: Bring grade up at south end of site to be flush with curb and sidewalk to prevent standing water in right-of-way.

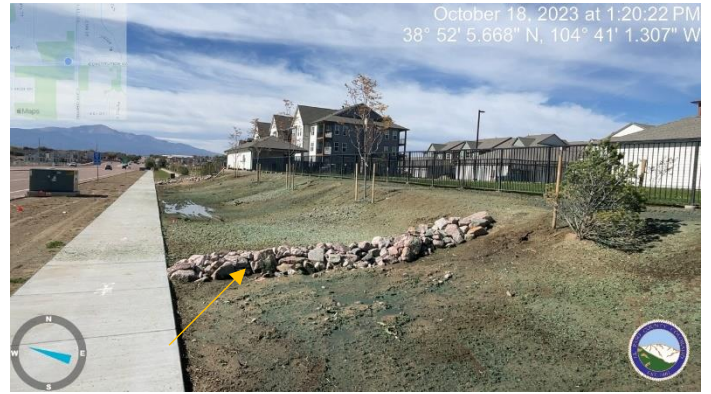
Photo 6: South side Limits of Construction (LOC) check dams are installed at bottom of slope. Plans call for Installation at top of slope. Reference GEC sheet C 303.

- Missing drainage swale south of dog park per approved plans. Reference Grading and Erosion Control Plan (GEC) Sheet C303. Reference Photo #7.
- Check dams along the south perimeter are installed in the wrong location. Plans call for installation of check dams in swale at top of slope. Reference GEC Sheet C303. Reference Photo #6.
- Curb cut on north side of garages, east of Building 6, was not installed per approved plan. Ensure stormwater flows from the north swale and east swale to Extended Detention Basin to meet water quality treatment requirements.
- The swale at southwest corner of site appears to be lower than emergency spillway. Verify elevation.
- Fine-grade swale at southwest corner of site for positive drainage.

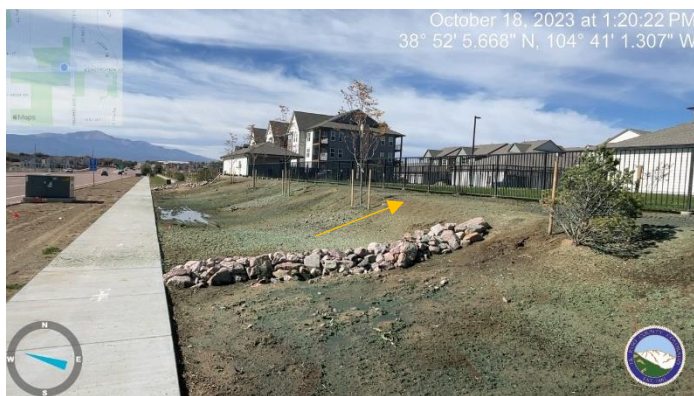
Photo 7: Missing drainage swale south of dog park per approved plans. Reference GEC sheet C 303.

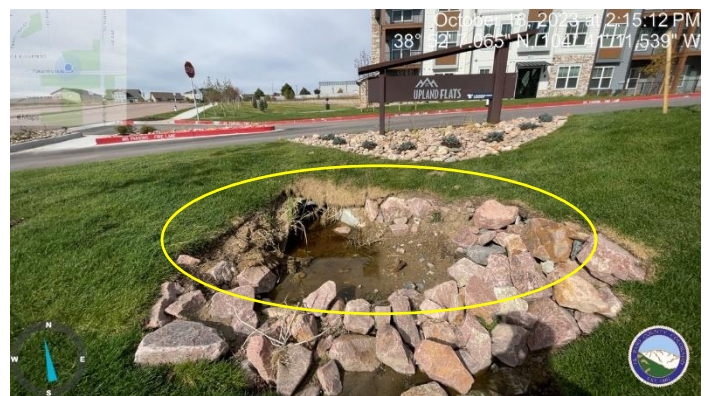
Photo 8: Remove sediment from culvert at south entrance.

- Remove sediment from culvert at south entrance. Reference Photo #8.

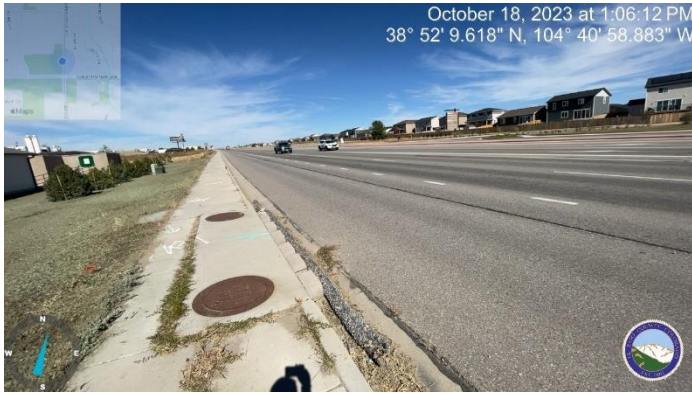
Photo 9: Inlet protection on Marksheffel Rd can be removed.

- Remove curb Inlet protection on Marksheffel Road. Reference Photo #9.
- Finish grouting pipe collar to existing inlet on southwest corner of Akers Drive. Reference photo #19.

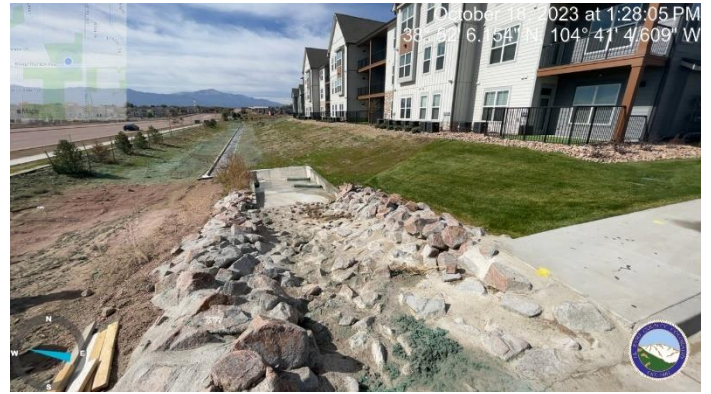
Photo 10: Show grouted riprap rundown at east side of EDB on as-builts.

- Show grouted riprap rundown at east side of EDB on as-builts.
- Show elliptical outlet pipe and pipe invert on as-builts.

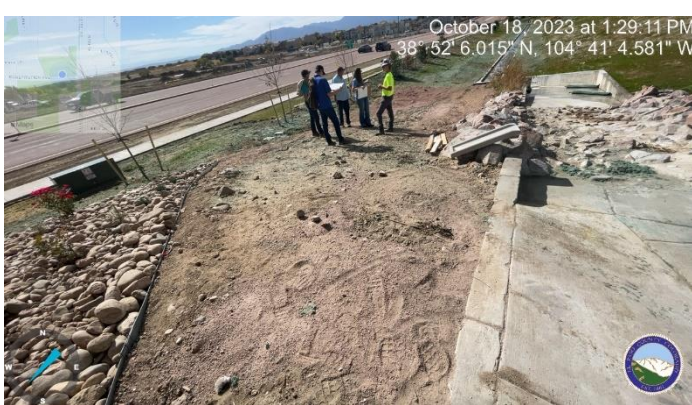
Photo 11: Reestablish maintenance access road on east end of EDB.

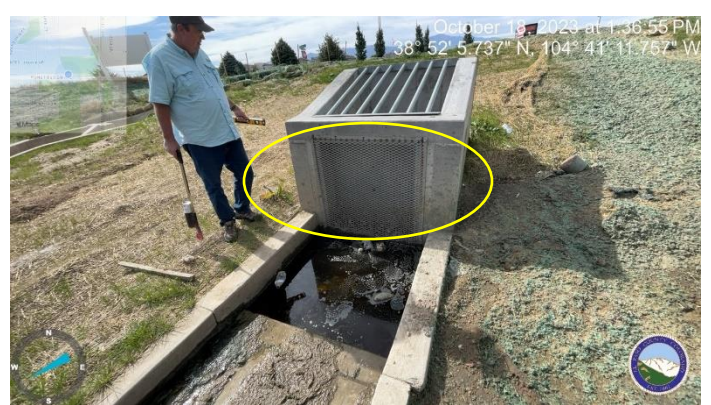
Photo 12: Stainless steel trash screen is not per plan detail. Plans call for No.93 Johnson vee wire or equivalent. Reference CDs sheet C 626.

- Stainless steel trash screen is not per plan detail. Plans call for No. 93 Johnson Vee Wire or equivalent. Reference Construction Drawings (CDs) Sheet C626. Reference Photo #12.

- Remove sediment from micropool at outlet structure. Reference Photo #12.
- Remove irrigation heads and install maintenance access road on west end of EDB per approved plan. Reference CDs Sheet C626. Reference Photos #13 and 14.

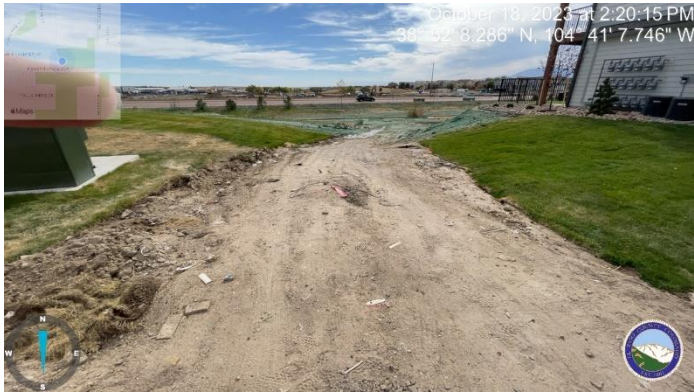
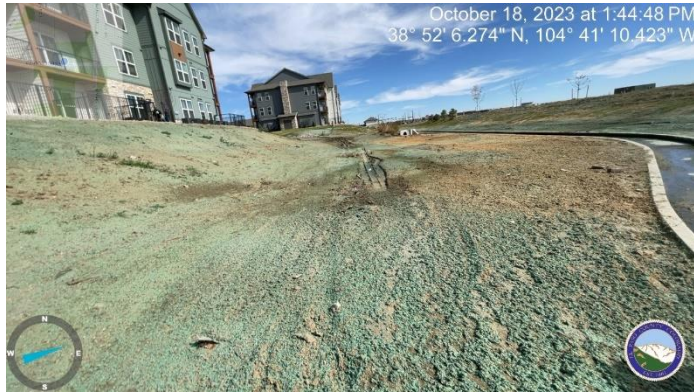
Photo 13: North maintenance access rd. needs to be reestablished. Plans call for installation alongside trickle channel. Reference sheet C 626 of the CDs.

Photo 14: North maintenance access rd. needs to be reestablished. Plans call for installation alongside trickle channel. Reference sheet C 626 of the CDs.

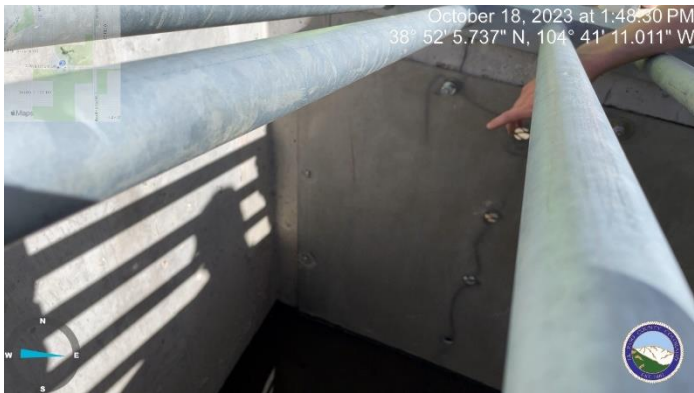
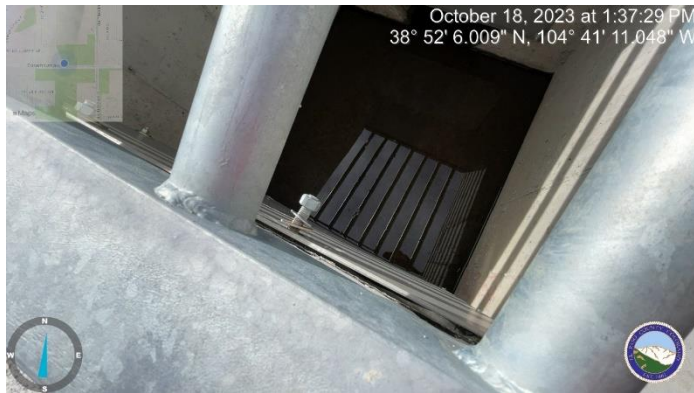
Photo 15: Neoprene gasket installed behind orifice plate at outlet structure is deteriorated and needs to be replaced. Orifice plate bolts and nuts are missing from structure.

Photo 16: Neoprene gasket installed behind orifice plate at outlet structure is deteriorated and needs to be replaced. Orifice plate bolts and nuts are missing from structure.

- Neoprene gasket installed behind orifice plate at outlet structure is deteriorated and needs to be replaced.
- Orifice plate bolts and nuts are missing from structure. Ensure the orifice plate is flush with outlet structure. Reference Photos #15 and 16.

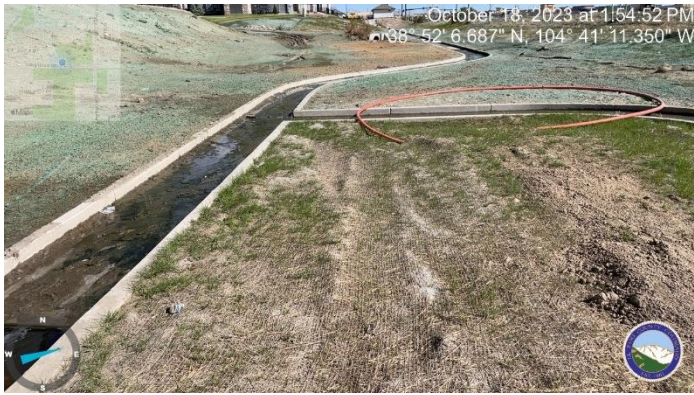
Photo 17: Remove sediment from trickle channel throughout EDB. Regrade pond bottom between outlet structure and Forebay A.

- Remove sediment from trickle channel throughout EDB. Reference Photo #17.
- Fine-grade EDB bottom for positive drainage between outlet structure and Forebay A. Reference Photo #17.

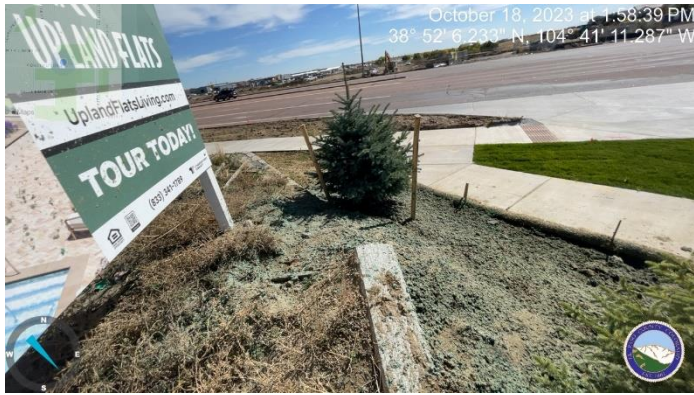
Photo 18: Build up surrounding area to meet flush top of emergency spillway cut off wall. Reference CDs Sheet C626.

- Build up surrounding area to meet top of emergency spillway cut off walls. Reference CDs Sheet C626. Reference Photo # 18.
- Outlet structure and pipe holding water. Missing 2.5% slope invert in bottom of outlet structure.

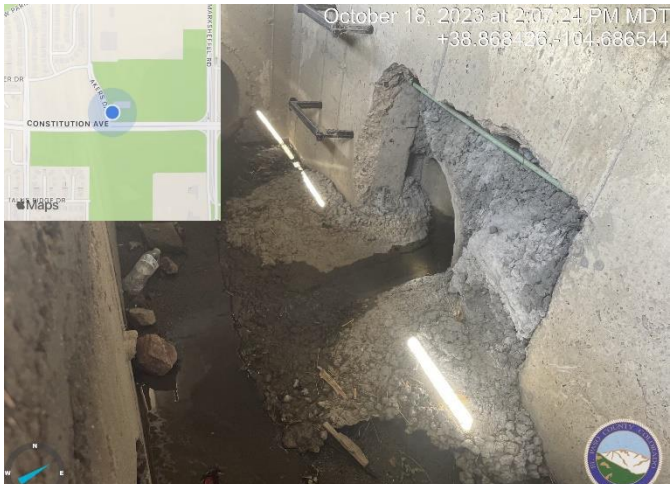
Photo 19: Finish grouting pipe collar to existing inlet on southwest corner of Akers Drive.
