**ENTECH**  
ENGINEERING, INC.

March 24, 2020

Re: Soil, Geology and Geologic Hazard Evaluation  
Mancave Storage/ Mini RV Storage  
Bent Grass Meadows Drive  
El Paso County, Colorado

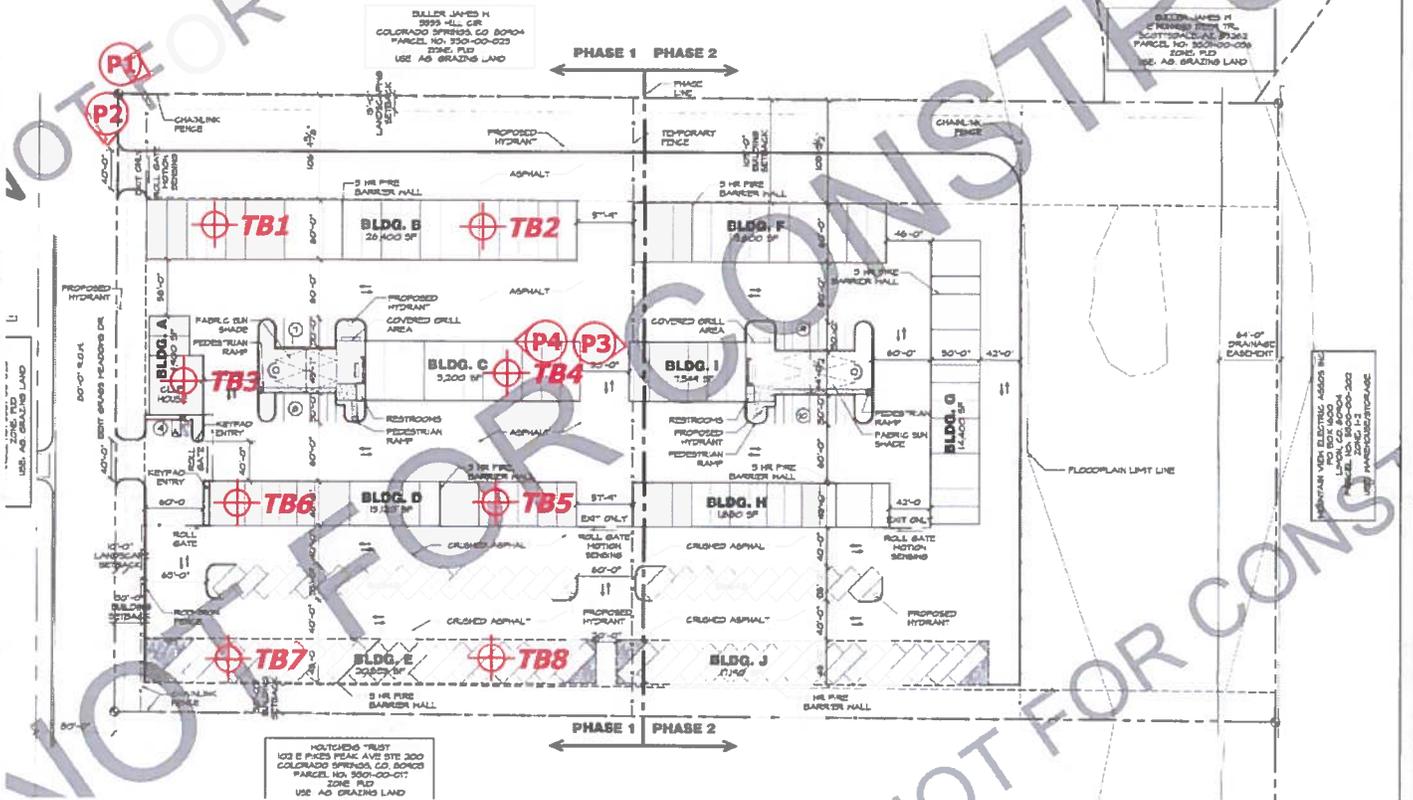
FIG NO.:  
**3**

The site consists of a 17.35-acre parcel. Proposed development consists of a storage and mini RV storage facility with nine storage buildings, a club house and parking areas. The storage facility will be serviced by municipal water and sewer. The Development Plan is presented in Figure 3.

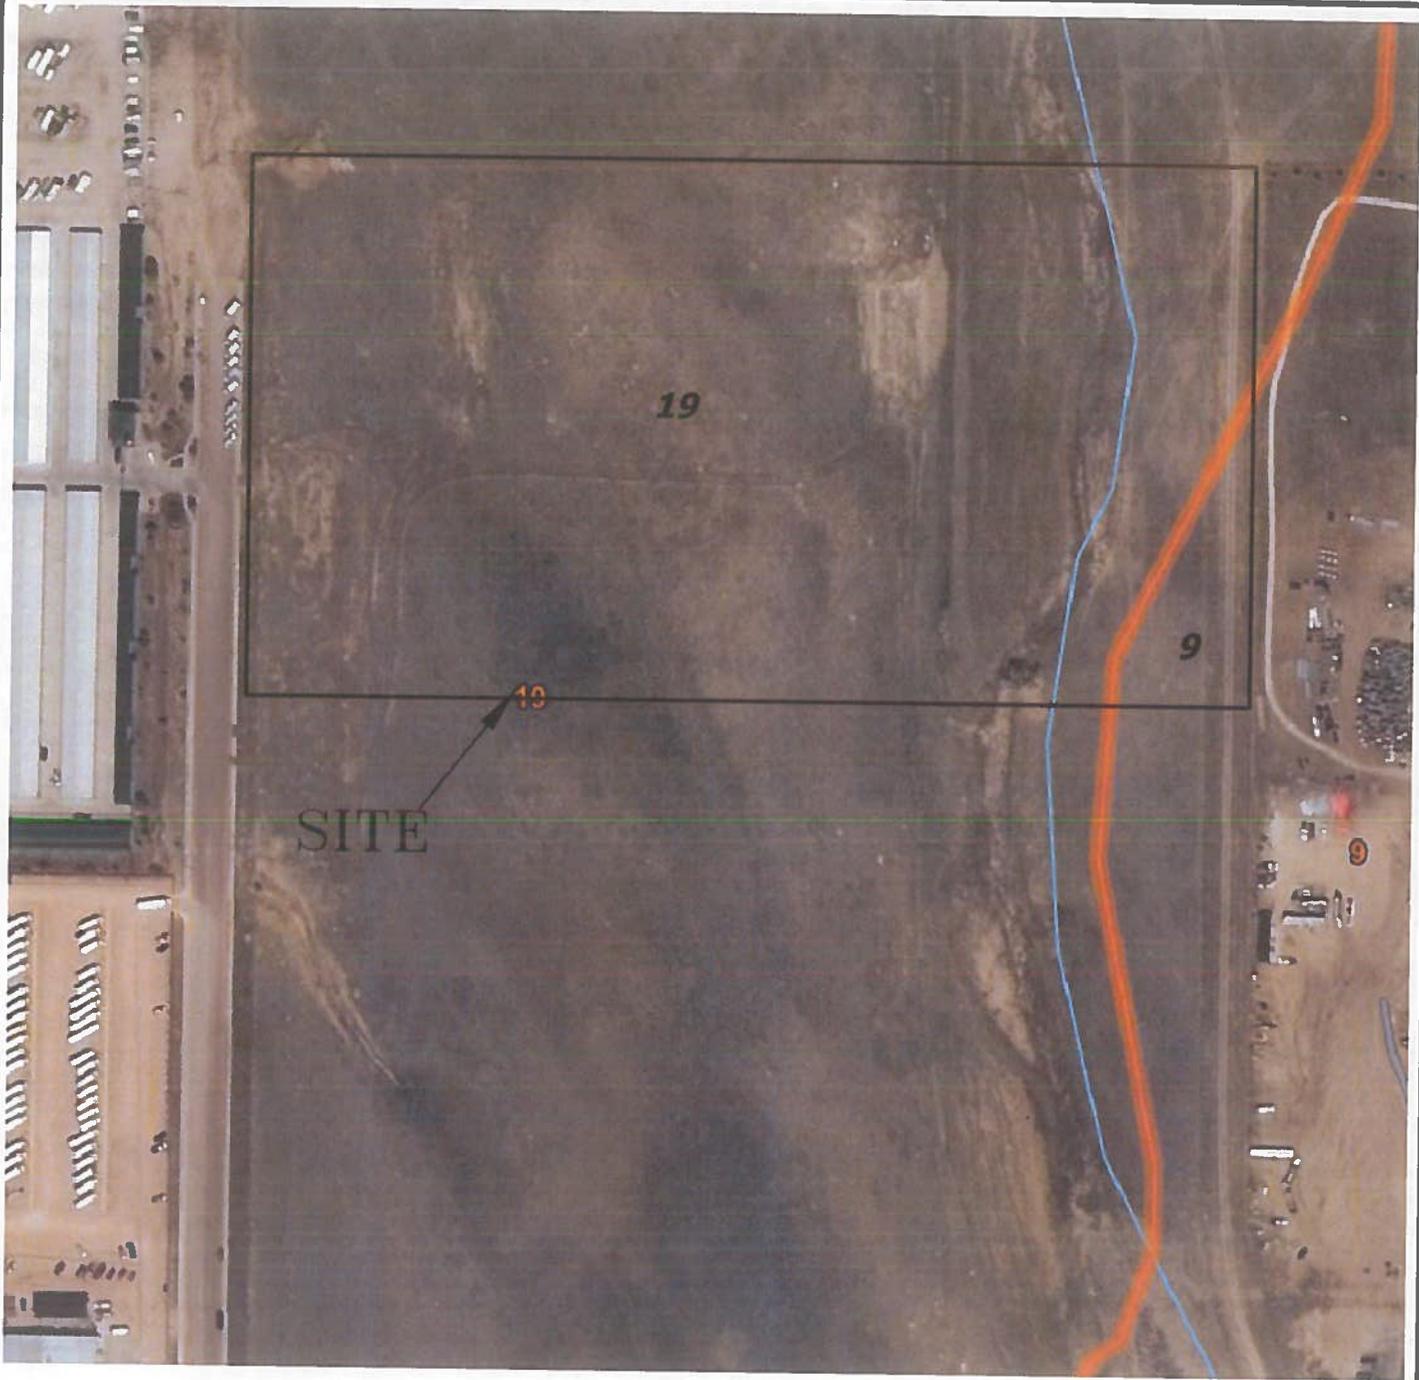
FIG NO.:  
 4

The Natural Resource Conservation Service (NRCS) (Reference 2, Figure 3), previously the Soil Conservation Service (Reference 3) has mapped two soil types on the site. Complete descriptions of the soils are presented in Appendix C. In general, the soils consist of gravelly sandy loam, loamy sand, and sand. The soils are described as follows:

The soils have been described to have slow to rapid permeabilities. The soils are described as well suited for use as homesites. Possible hazards with soils erosion are present on the site. The erosion potential can be controlled with vegetation. The soils have been described to have moderate erosion hazards (Reference 2).

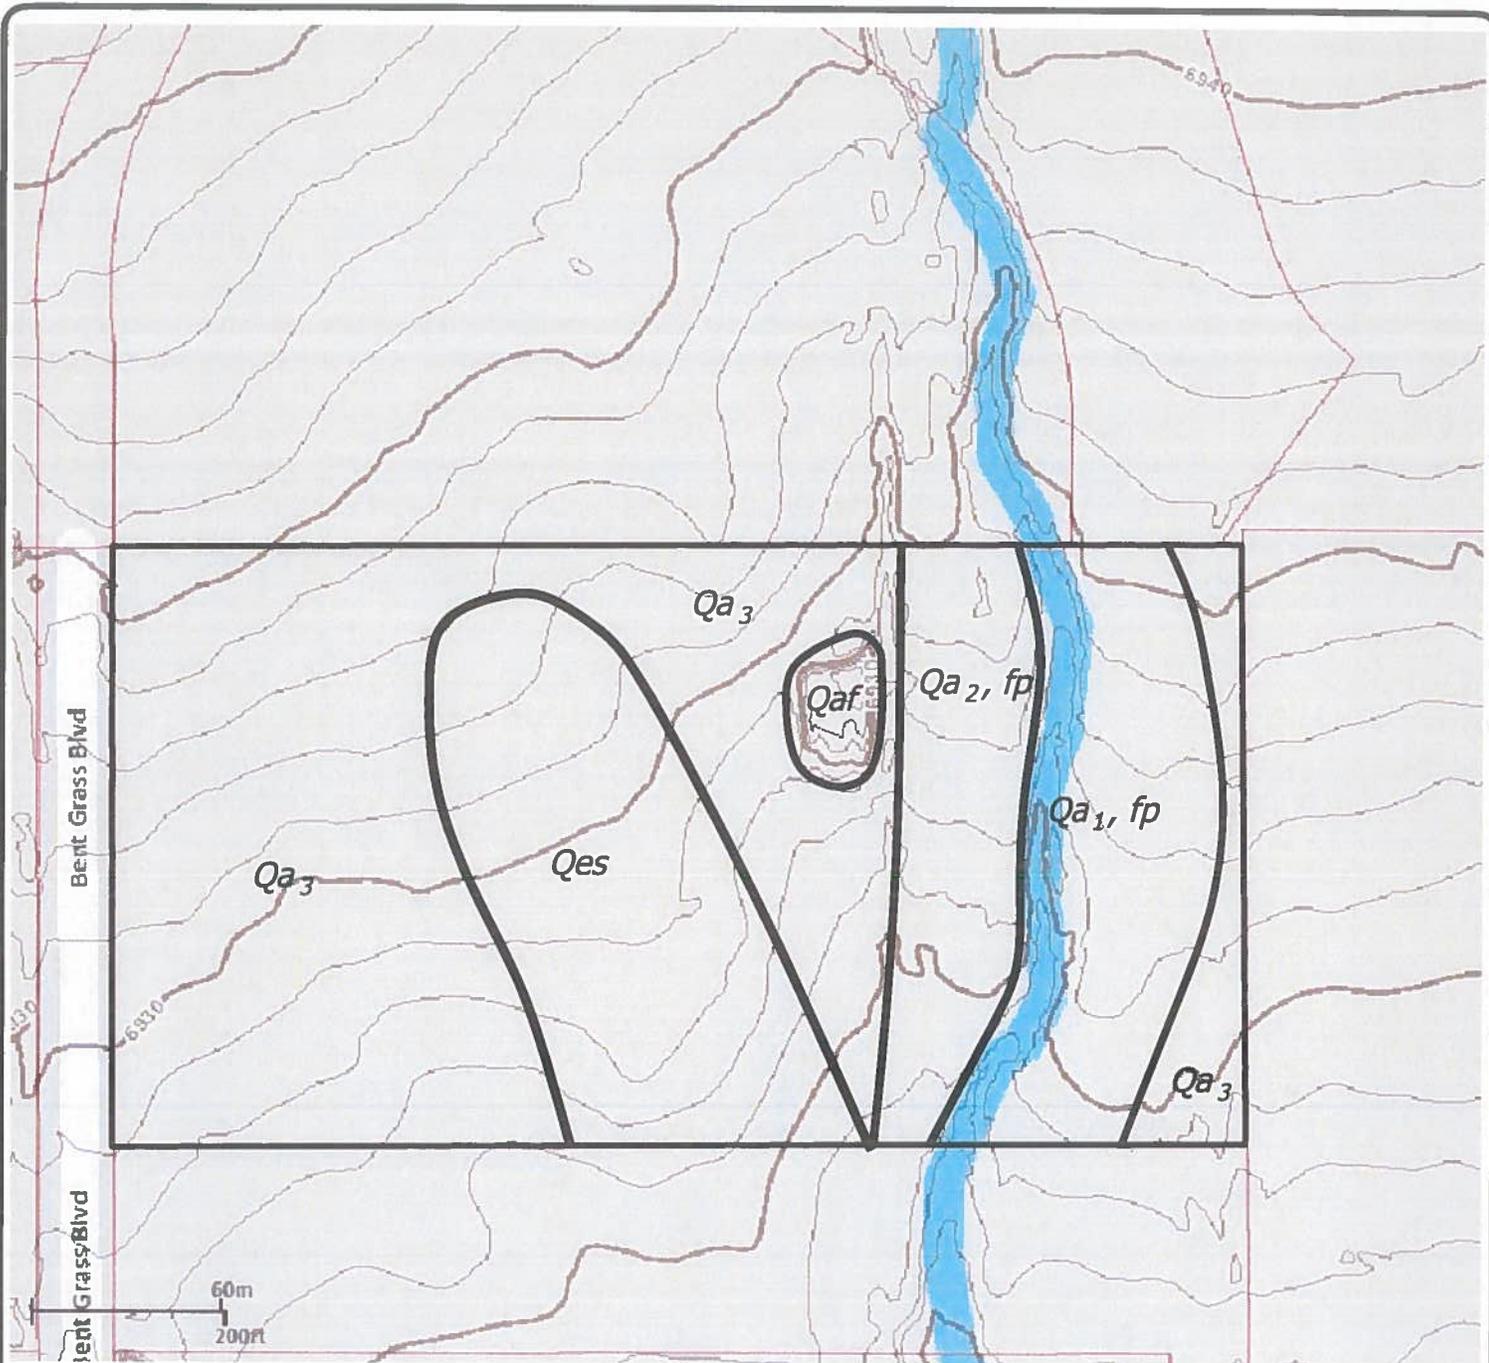
FIG NO.:  
6

**Qaf**      **Artificial Fill of Late Holocene Age:** These are man-made fill deposits associated with fill piles observed in the eastern portion of the site. Areas of fill other than those mapped may be encountered.

The soils listed above were mapped from site-specific mapping, the *Geologic Map of the Falcon Quadrangle* distributed by the Colorado Geologic Survey in 2012 (Reference 4, Figure 5), and the *Geologic Map of the Pueblo 1° x 2° Quadrangle*, distributed by the US Geological Survey in 1978 (Reference 6). The test borings used in evaluating the site are included in Appendix B. The Geology Map prepared for the site is presented in Figure 6.

Fill associated with an existing fill stockpile was observed in the eastern portion of the site.

Mitigation: It is anticipated that the fill piles will be removed during site grading. Areas of fill other than those encountered may be encountered. The fill piles are considered uncontrolled. Any uncontrolled fill encountered beneath foundations should be removed and recompacted at a minimum of 95% of its maximum Modified Proctor Dry Density, ASTM D-1557.

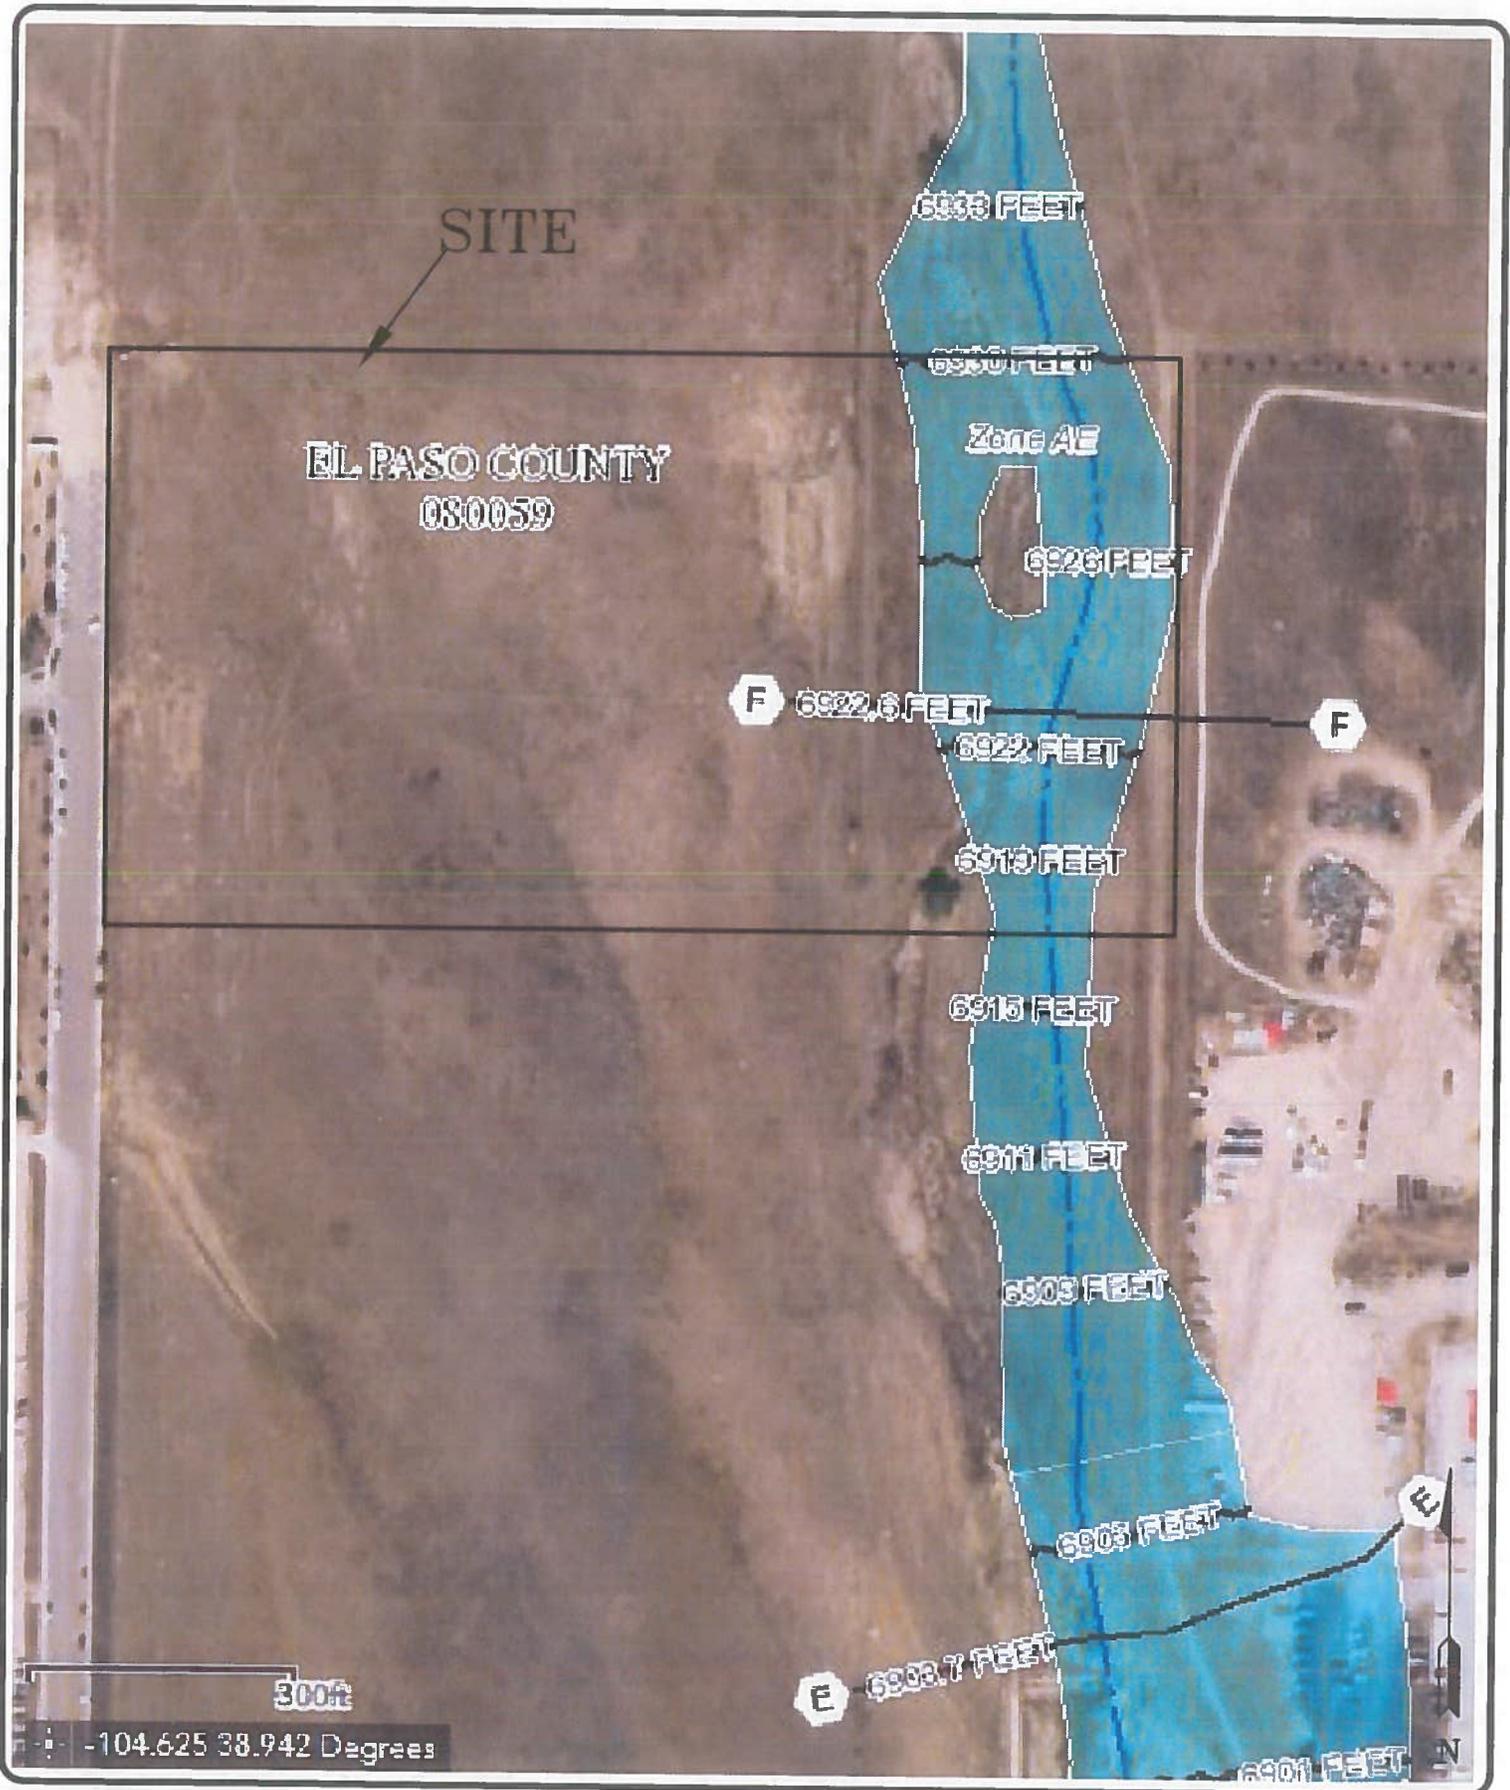
FIG NO.:  
7

The eastern portion of the site lies within a floodplain according to the FIRM Map, No. 08041CO553G (Reference 9, Figure 7). The proposed development is located at a higher elevation and away from the floodplain. Finished floors must be a minimum of one foot above the floodplain level. Any site grading considered should be modified to direct surface flows around the structures or roads, or carried off-site so as to not produce any areas of ponded water. Additionally, subsurface perimeter drains may be required. Specific drainage studies and exact floodplain locations are beyond the scope of this report.
