Re: Addendum to Soil, Geology and Geologic Hazard Study
Latigo Business Center
El Paso County, Colorado
Entech Job Nos. 56382 and 56392

**SOIL, GEOLOGY
AND GEOLOGIC HAZARD STUDY
LATIGO BUSINESS CENTER, LOTS 1-3
WOODMEN ROAD
EL PASO COUNTY, COLORADO**

**SOIL, GEOLOGY
AND GEOLOGIC HAZARD STUDY
LOTS 4 AND 5, LATIGO BUSINESS CENTER
A REPLAT OF LATIGO BUSINESS
AND INDUSTRIAL CENTER, FILING NO. 1
WOODMEN ROAD
EL PASO COUNTY, COLORADO**

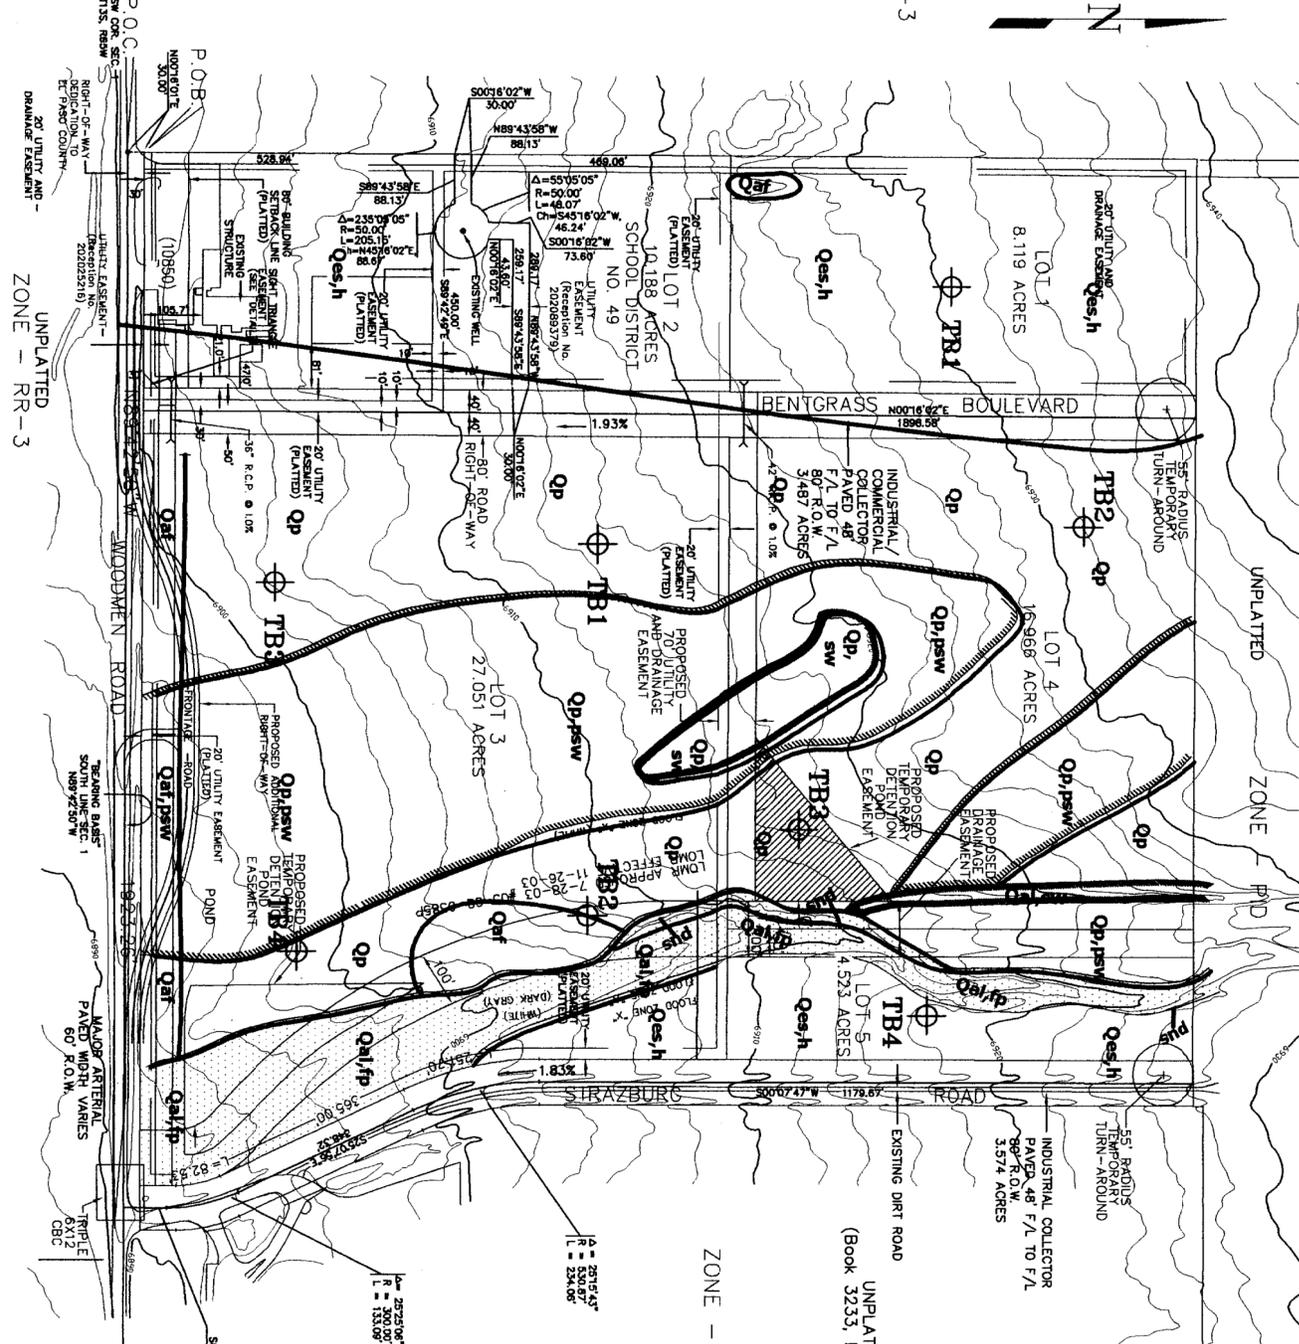
As requested, the revised preliminary plat has been reviewed with respect to geologic hazards and conditions on the above-referenced site. This letter serves as an Addendum to both the Soil, Geology, and Geologic Hazard Studies performed by Entech Engineering, Inc. dated August 28, 2002 for Latigo Business Center, Lots 1-3 (Job No. 56392) and Lots 4 and 5 Latigo Business Center, Filing No. 1 (Job No. 56382). The sites are combined under Latigo Business Center, Lots 1-5 on the revised preliminary plat, received from LDC, Inc. June 25, 2004. The revised Geology and Engineering Geology Map is presented in Figure 1.

The revised preliminary plat lot layout is virtually unchanged from the lot layout reviewed in the original reports. The lot numbers and a street name have changed. According to the revised preliminary plat, the existing floodplain is to be rerouted and contained in a drainage easement. This will allow for more buildable area on Lot 5. Temporary Detention Ponds are proposed, as well. Drains may be necessary in areas adjacent to the Detention Ponds and in the floodplain area, even after filling, to prevent the intrusion of water into areas below grade. Drains may also be necessary in other areas of the site identified as seasonal shallow groundwater (sw) and potentially seasonal shallow groundwater (psw) as discussed in the reports. Finished floor levels should be a minimum of one foot above the floodplain level. Approval of the proposed drainage plan will be required prior to construction in the existing floodplain. All soft, wet, or organic soils should be removed prior to any filling.

Other hazards that affect construction on this site include artificial fill, expansive soils, potentially unstable slopes, and hydrocompaction. It is anticipated that the small extent of potentially unstable slopes will be regraded during site improvements associated with the proposed drainage easement. Slopes should be regraded to no steeper than 3:1 unless held by retaining walls. Mitigation for artificial fill, expansive soils, loose soils, and hydrocompaction have been discussed in the Soil, Geology and Geologic Hazard reports. These conditions can be satisfactorily mitigated with proper engineering design and construction practices.

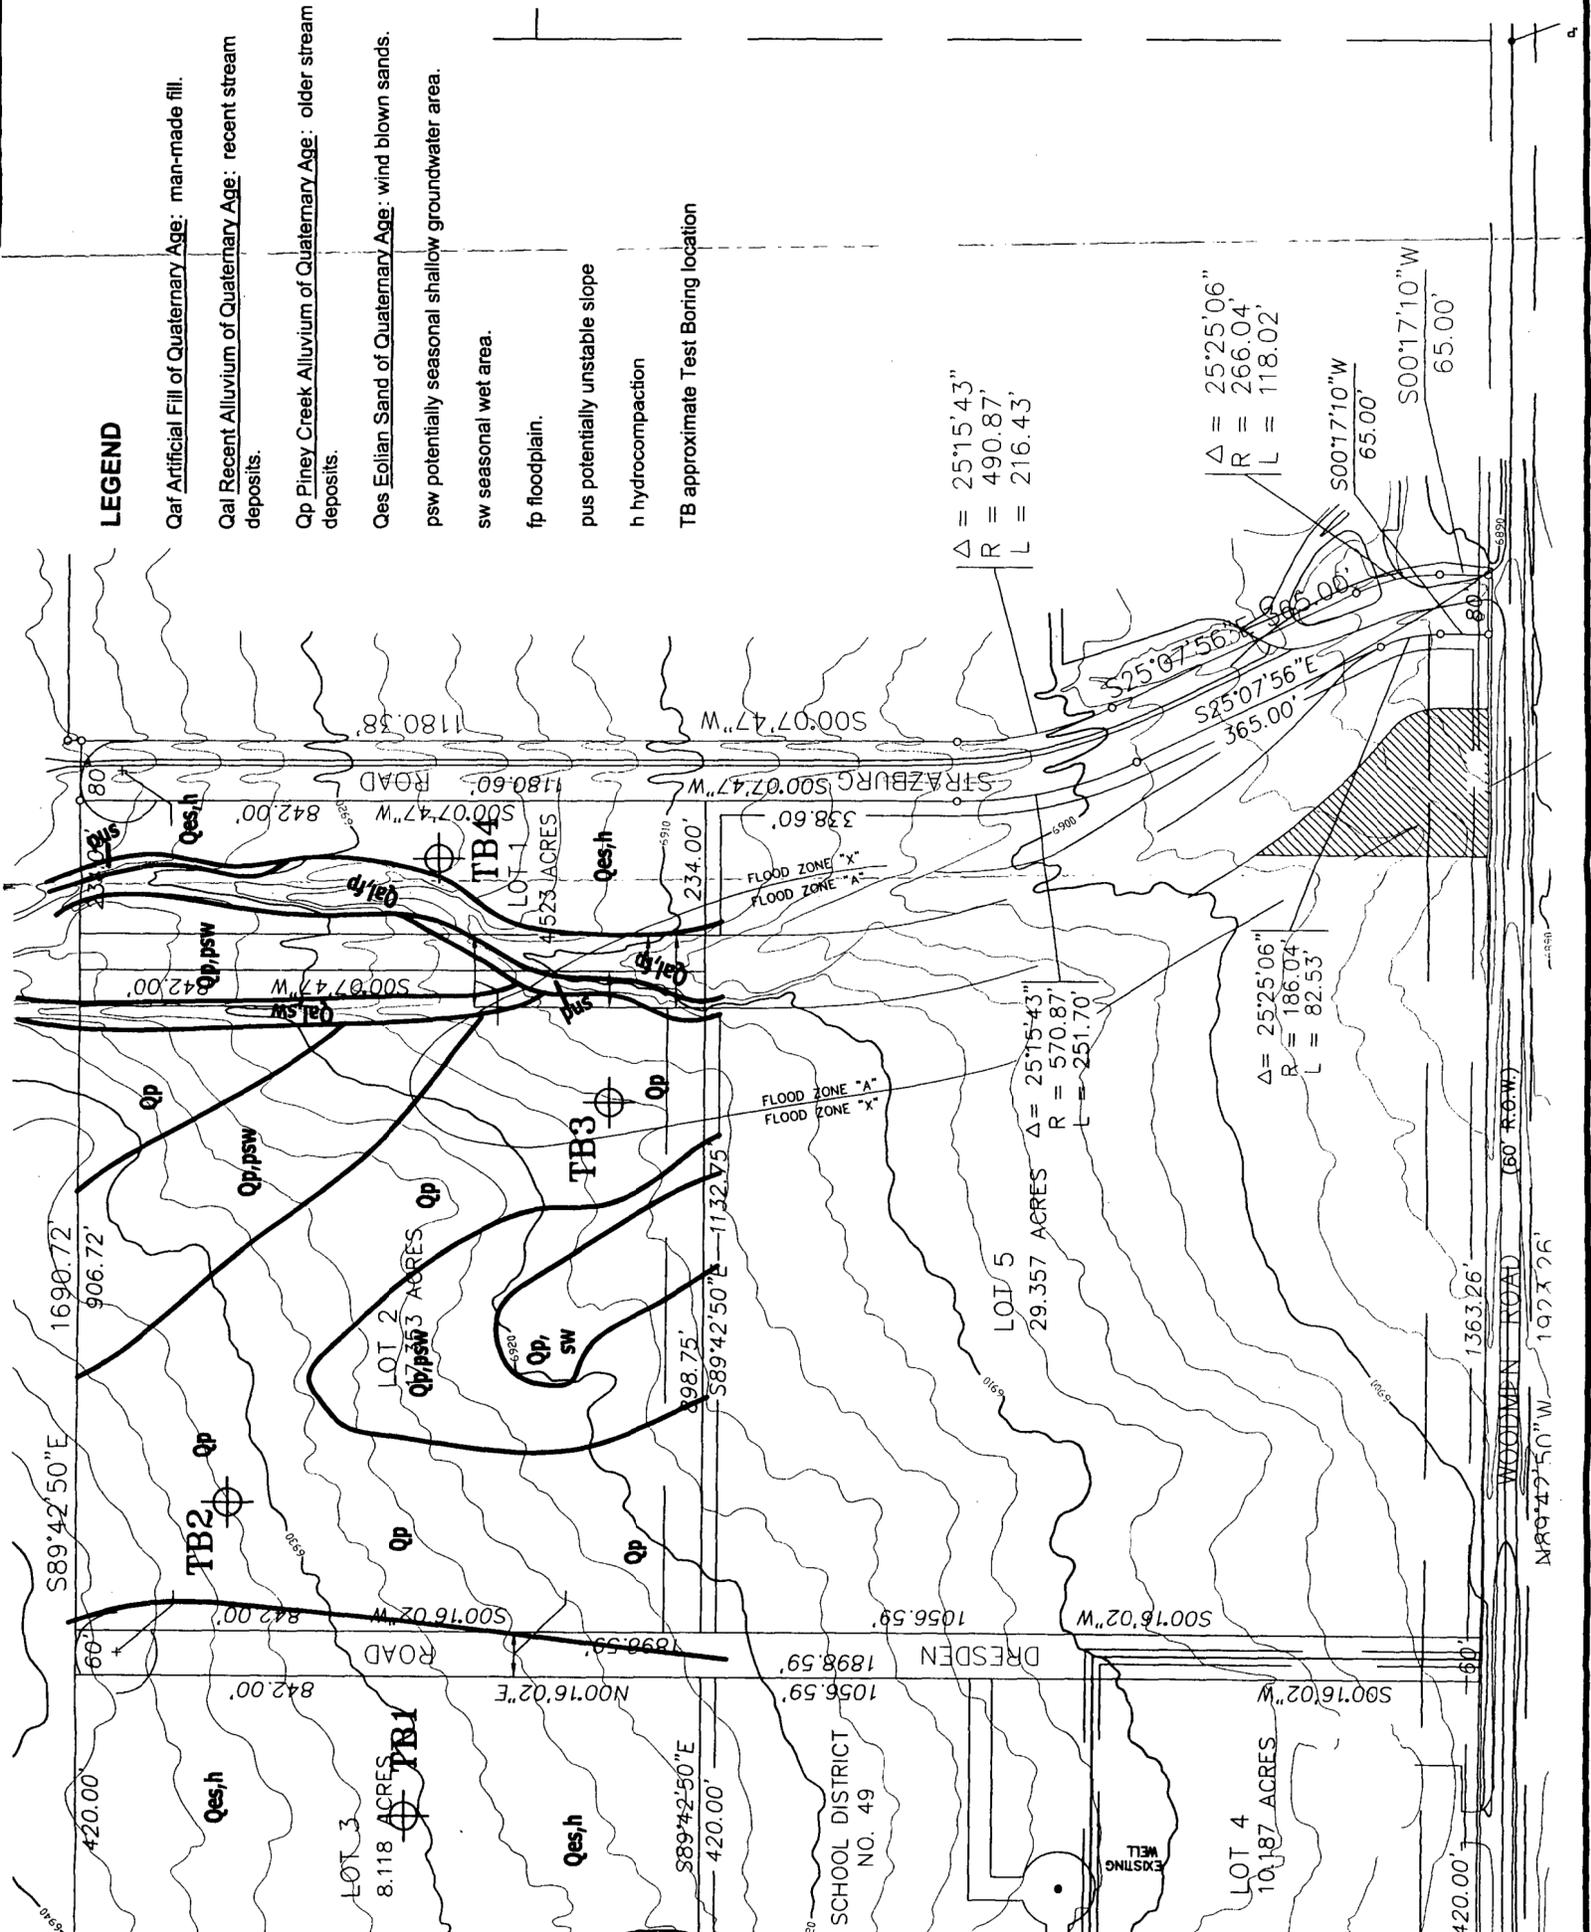
As mentioned previously, mapping has been performed on this site to produce an Engineering Geology Map (Figure 8). This map shows the location of various geologic conditions of which the developers should be cognizant during the planning, design and construction stages of the project. These geologic conditions and the recommended mitigation techniques are as follows:

Mitigation: In these locations, shallow foundations are recommended. Foundations must have a minimum 30-inch depth for frost protection. In areas where high subsurface moisture conditions are anticipated periodically, subsurface perimeter drains and underslab drains or capillary breaks may be necessary to dewater the excavation. Typical details for drains are presented in Figures 10 through 12. Basements or useable areas located below grade are not recommended in these areas. It may be desirable on some lots to build up the building area to raise the foundation further above anticipated groundwater level. Any grading in these areas should be done to direct surface flow around construction to avoid areas of ponded water. Further investigation will be necessary to determine the groundwater depth at each individual building site. Areas of perched water are also possible across much of the site due to lenses of sand overlying impermeable sandstones and claystones. Areas of perched water tables have been encountered in other developments in the area of the site. One particular area was noted on the north central portion of the site. Contractors should be cognizant of the potential for subsurface water during construction on each individual site.

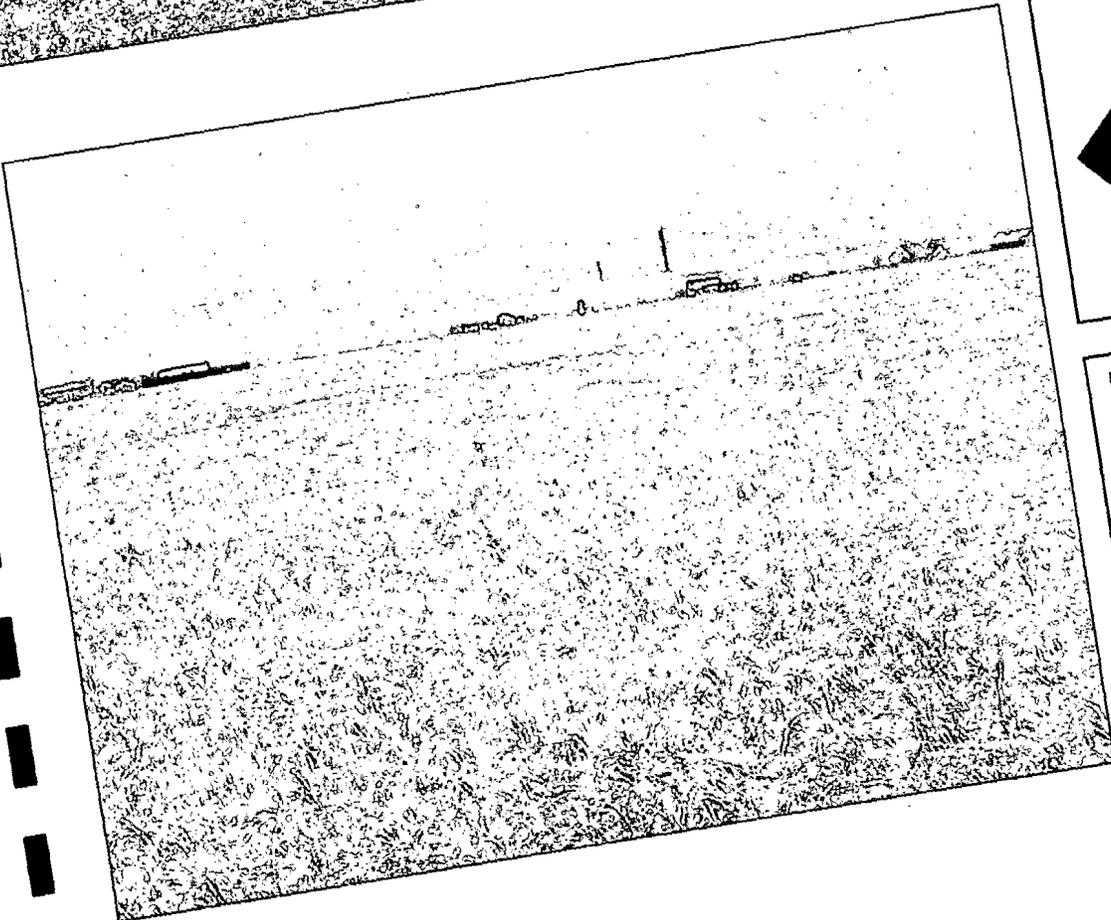
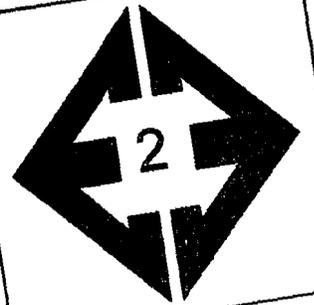
From south-central portion of site, looking west towards seasonally wet area.

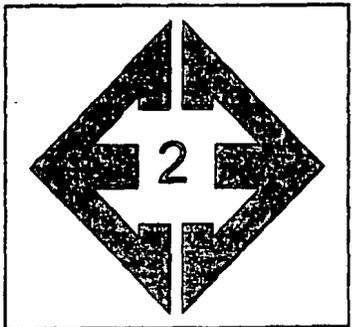
**From south-
central portion
of site, looking
west towards
seasonally wet
area.**
