Final Acceptance – Punchlist from DPW Stormwater

Project Name:	Bradley Storage
EDARP Filing Number(s):	PPR-17-011
ESQCP Number:	ESQ1917
Attendees:	DPW: Joshua Augustenborg, Ben Jones, Christina Prete, Glenn Reese, Brad Walters and David Parkerson Developer: Joshua Beggs
Date of Walk-Thru:	January 3, 2023
Walk-Thru Number:	1

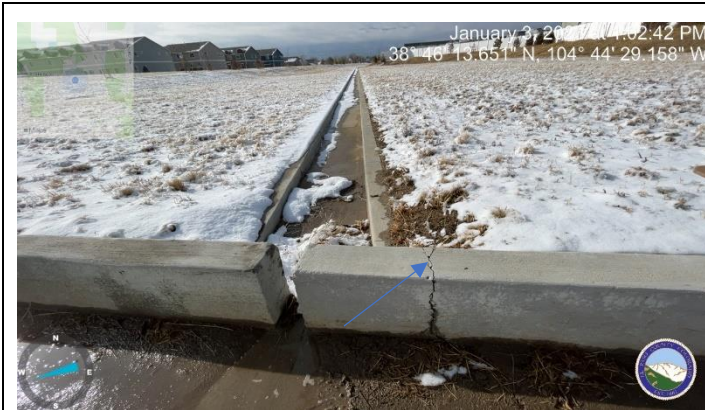
- Pond 1 Forebay B: Stress crack adjacent to weir notch needs to be repaired. Reference Photo 1.
- Pond 1 Forebay A: Sediment and debris needs to be cleaned out. Reference Photo 2.

Photo 1: Pond 1 Forebay B. Stress crack adjacent to weir notch needs to be repaired.

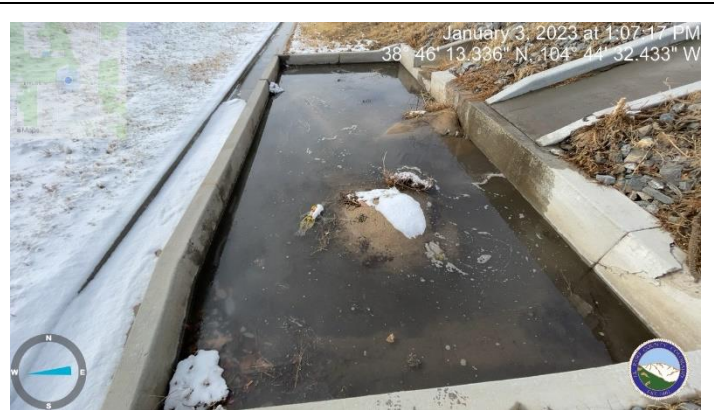
Photo 2: Pond 1 Forebay A. Sediment and debris needs to be cleaned out.

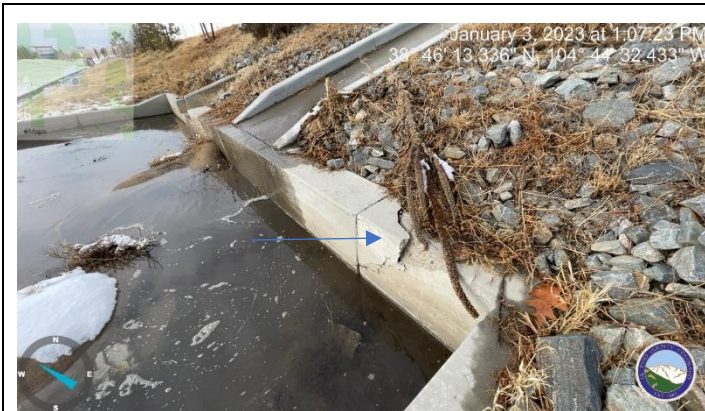
- Pond 1 Forebay A: Stress crack/broken concrete needs to be repaired. Reference Photo 3
- Pond 1 Forebay A: Concrete flume is undercut above forebay and needs to be repaired. Reference Photo 4 and Photo 5.

Photo 3: Pond 1 Forebay A. Stress crack/broken concrete needs to be repaired.

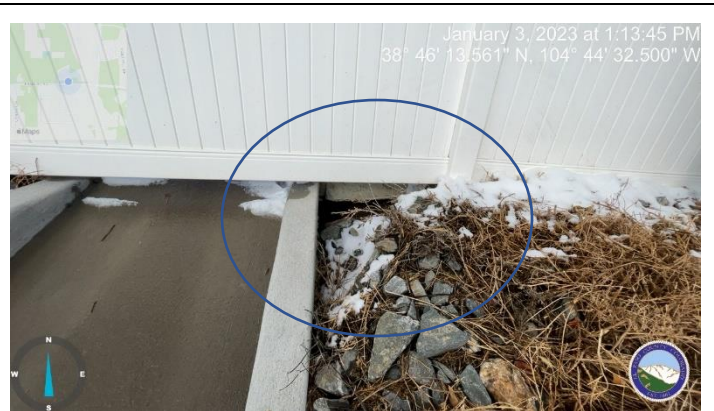
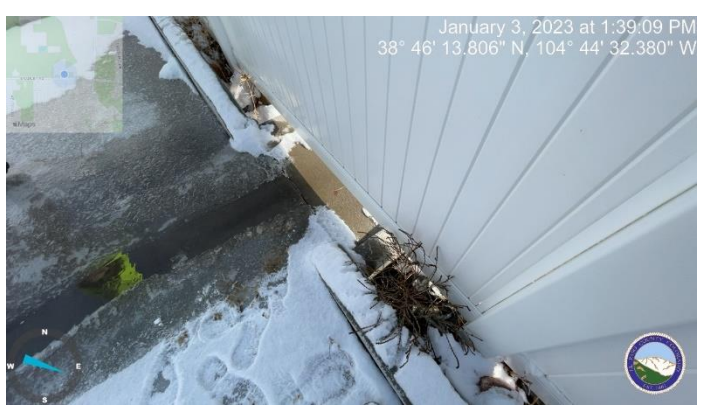
Photo 4: Pond 1 Forebay A. Concrete flume is undercut upgradient of Forebay A and needs to be repaired.

Photo 5: Pond 1 Forebay A. Concrete flume is undercut upgradient of Forebay A and needs to be repaired.

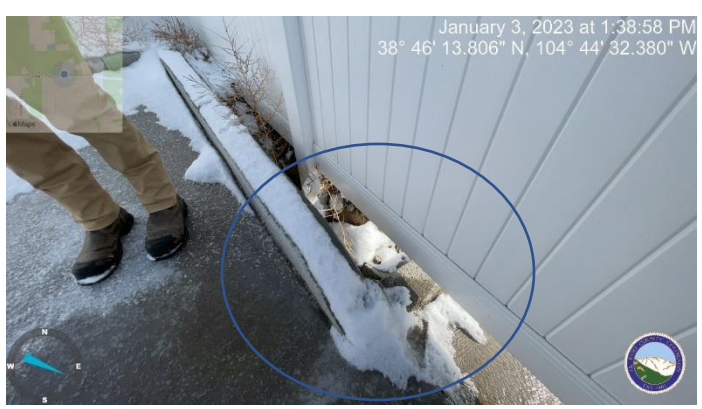
- Curb behind fence line of Pond 1 Forebay A: Suggest curb be extended to reduce/eliminate future erosion/undercutting of concrete flume. Reference Photo 6.

Photo 6: Curb behind fence line of Pond 1 Forebay A. Suggest curb be extended to help with erosion/undercutting of concrete flume.

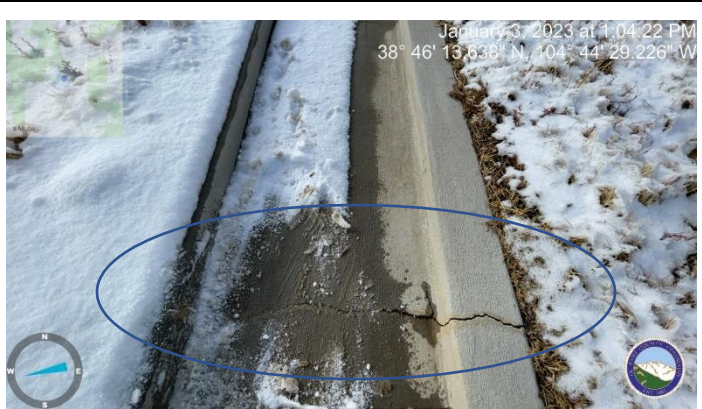
- Concrete Trickle Channel: Multiple stress cracks need to be repaired, as well as expansion joints need to be properly caulked/sealed. Reference Photo 7.

Photo 7: Concrete trickle channel. Multiple stress cracks need to be repaired, as well as expansion joints need to be properly caulked/sealed.

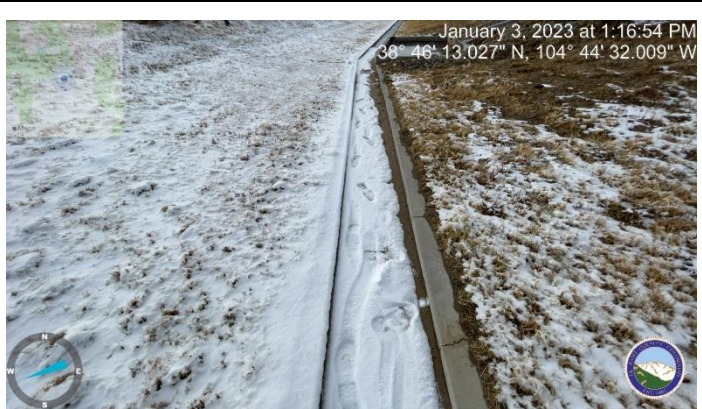
Photo 8: Concrete trickle channel. Clean out sediment and debris throughout channel.

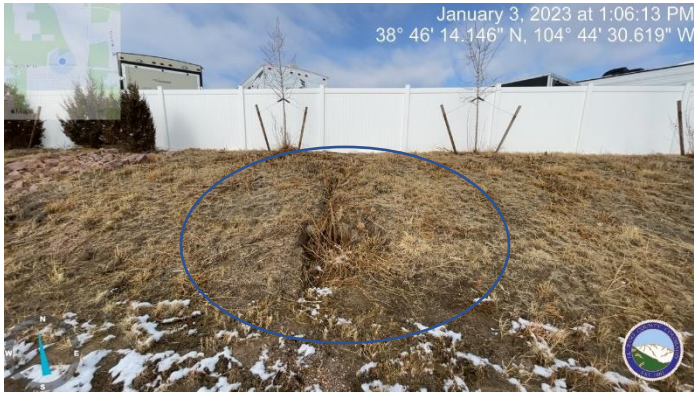
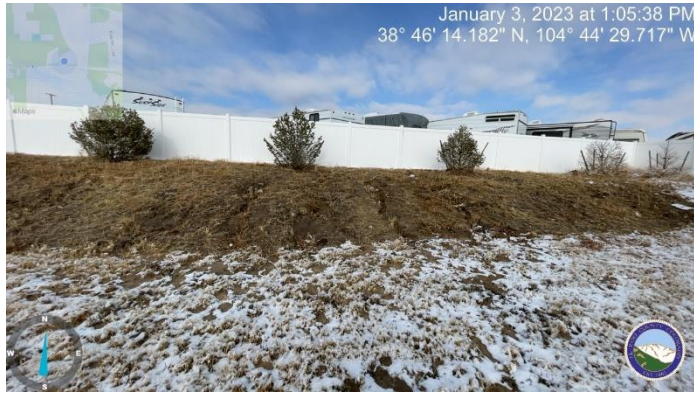
Photo 9: Pond 1 Embankment. Multiple erosion rills need to be regraded and stabilized.

Photo 10: Pond 1 Embankment. Multiple erosion rills need to be regraded and stabilized.

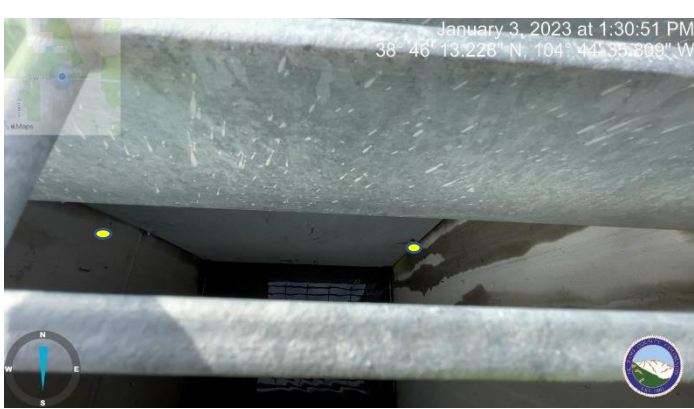
Photo 11: Pond 1 Outlet Structure. Restrictor plate is missing three bolts that need to be replaced.

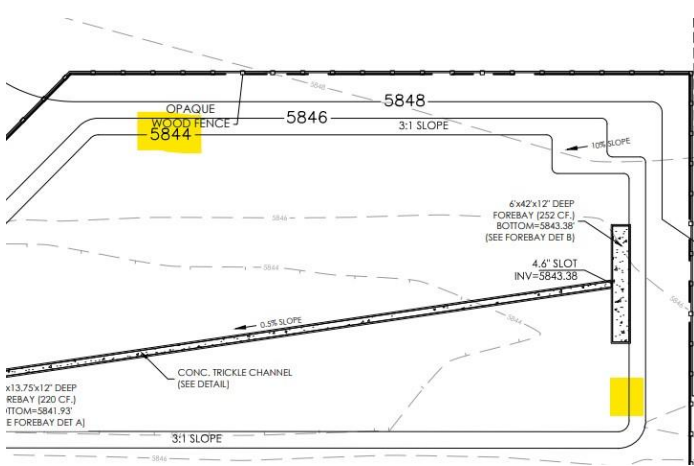
Photo 12: Pond 1 rip rap rundown locations.

- Pond 1 Outlet Structure: Restrictor plate is missing three bolts that need to be replaced. Reference Photo 11.
- Pond 1 Rip Rap Rundowns: Two rip rap rundowns were installed in the field but not shown on the approved plans. Explain field change in the Pond Certification Letter and show locations on the As-Built Drawings. Reference Photo 12 and GEC Plan Sheet 7 of 19.
