**Final Acceptance Punchlist**  
**El Paso County – Department of Public Works - Stormwater Section**

Project Name:	Redtail Ranch
EDARP Filing Number(s):	SF1821
ESQCP Number:	ESQ1932
Attendees:	DPW SW: Molly Layshock, Mikayla Hartford, Glenn Reese DPW Dev Services: Developer:
Date of Walk-Thru:	05/18/2023
Walk-Thru Number:	1 <sup>st</sup> FA walk

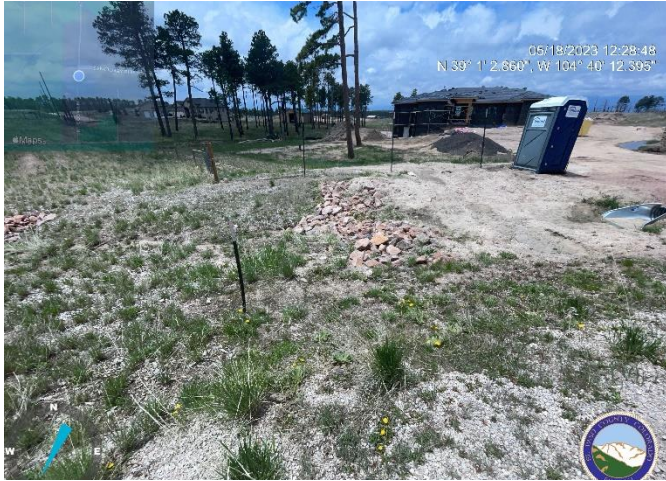
Photo 1: Sediment entering extended detention basin 1 at rock check dams at 12804 Ward Lane.

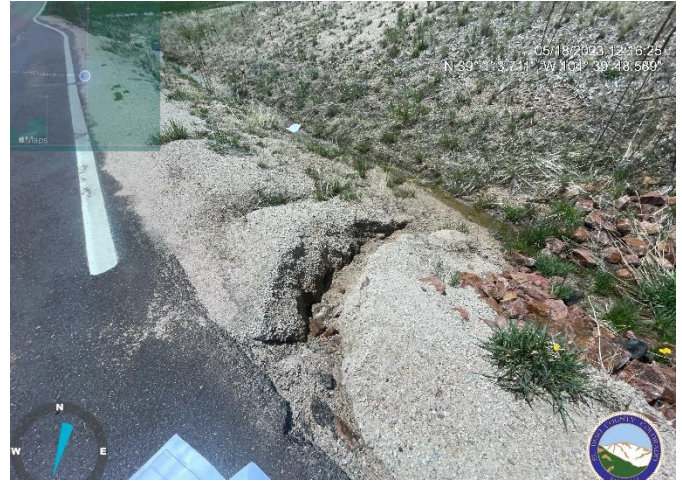
Photo 2: Fill erosion occurring along road shoulder of Sanctuary Pine Drive.

- Sitewide: Clean out sediment from all ditches along Sanctuary Pine Drive
- Sitewide: Fix erosion in ditches along Sanctuary Pine Drive (See photo 2 for example)

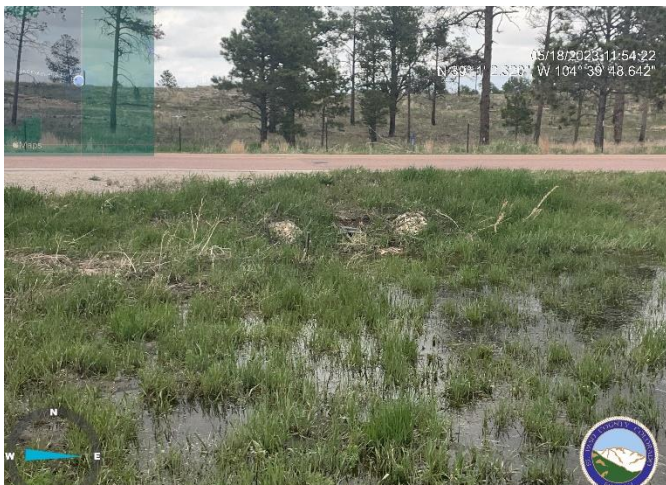
Photo 3: Remove rock socks from culvert under Vollmer Road; regrade so that no ponding occurs. All temporary control measures must be removed prior to FA.

- Update as-builts to change soil riprap called out on sheet 10 of the plans to be riprap reflecting the change observed in the field. (See comments on as-builts).
- Clean out sediment from the outfall pipe flared end section, it is holding water
- Wrong well screen is installed in the field. Install proper well screen, diamond well screen is not permitted.
- Downstream of the outlet: remove rock socks from in front of the culvert under Vollmer Road. Regrade so that no ponding occurs. All temporary control measures must be removed prior to FA. (See photo 3)

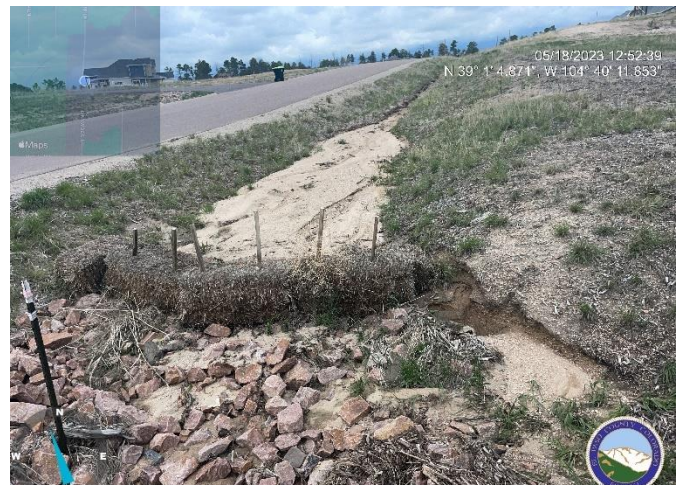
Photo 4: Regrade and stabilize ditches along Ward Lane. Remove sediment from riprap and implement as per approved plans.

- Reestablish ditches along Ward Lane and stabilize. (See photo 4)
- Remove sediment from riprap in ditches along Ward Lane and implement as per approved plans. (See photo 4)

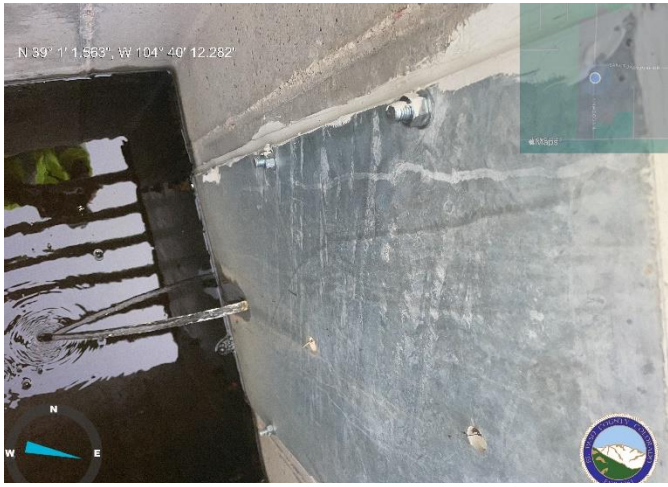
- Major comment: During the FA Walk, Basin 2 was fully drained but Basin 1 had about 18"-24" of standing water. The outlet structure was not clogged but the system was not fully draining (See photo 5). The pond bottom, trickle channel, and forebays could not be fully inspected because they were covered. The pond's drainage issues must be resolved before FA and pond bottom stabilization must be achieved.

Photo 5: Pond 1 orifice holes are draining, but Pond 1 is not.
