Final Acceptance Punchlist
El Paso County – Department of Public Works - Stormwater Section

Project Name:	Tamlin RV Boat and Storage
EDARP Filing Number(s):	PPR1945, CON213
ESQCP Number:	ESQ213
Attendees:	DPW SW: Joshua Augustenborg, Ben Jones DPW Development Services: None Developer: Ned McDonald
Date of Walk-Thru:	10/11/2023
Walk-Thru Number:	1

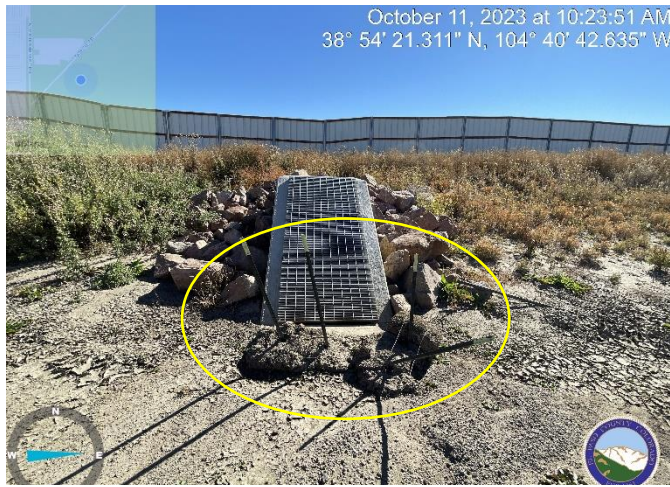
Photo 5: All temporary control measures can be removed throughout site.

- Remove noxious weeds in pond and implement final stabilization in pond and as needed throughout site.
- All temporary control measures can be removed throughout the site. Reference Photo #5.
- All temporary control measures can be removed throughout the site. Reference Photos # 9 and 10.

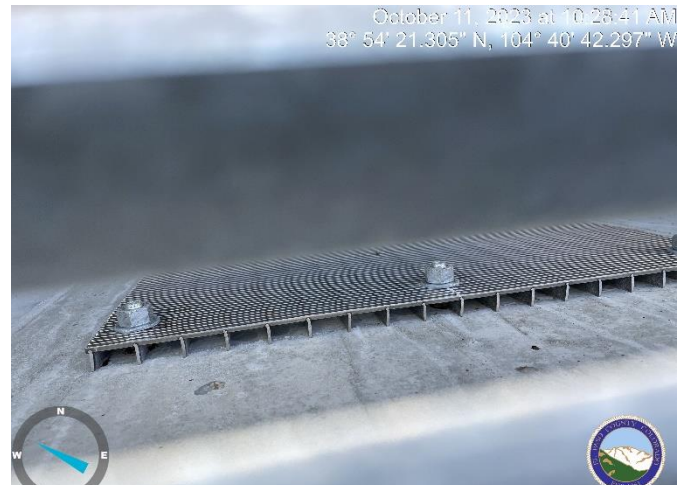
Photo 6: Microscreen at Pond A installed with improper orientation. Reference sheet 6 in the GEC plan.

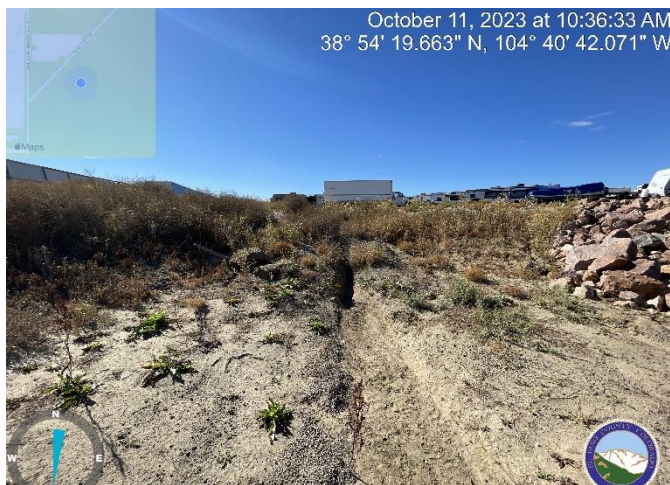
Photo 7: South riprap rundown is not on plans. Show in updated as-builts.

- Install Maintenance Access Road.
- Bottom stage of Pond A needs to have asphalt milling cleaned out. Reference Photo #2.
- North riprap rundown needs to be reestablished due to erosion blowout. Plans call for Type L, 90 feet in length, 18 inches deep. Currently all riprap rundowns do not have depth/shape to convey water from site down into pond. Reference Photo #1.
- West riprap rundown needs to be reestablished due to erosion blowout. Plans call for Type M riprap, 45 feet in length, 24" deep. Reference Photos #3 & #4.
- Microscreen at Pond A: Improper orientation. Vee wire bars should be vertical. Reference sheet 6 in the GEC plan. Reference Photo #6. If there is justification for the existing orientation of the micro-screen, please send.
- South riprap rundown is not on plans. Show on updated as-builts. Reference Photos #7 and 8.

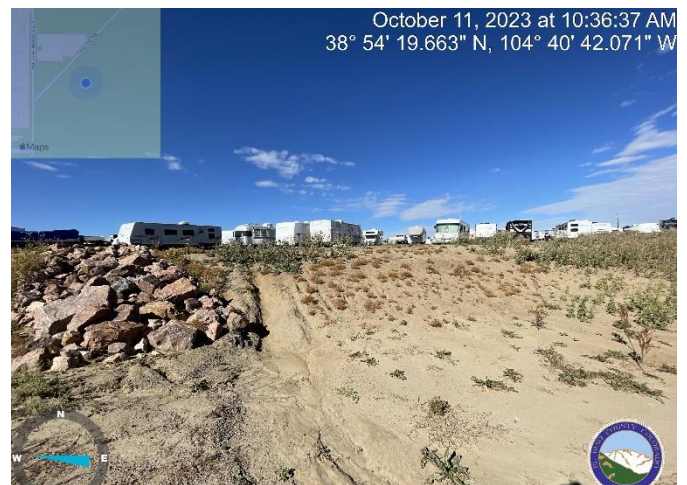
Photo 8: South riprap rundown is not on plans. Show in updated as-builts.

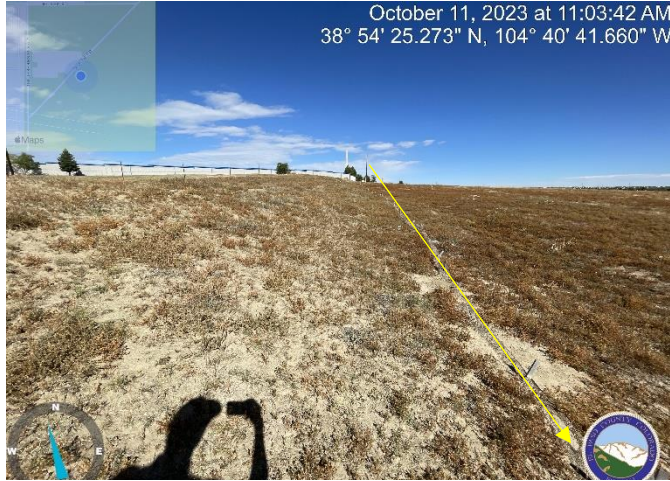
Photo 9: All temporary control measures can be removed throughout site.

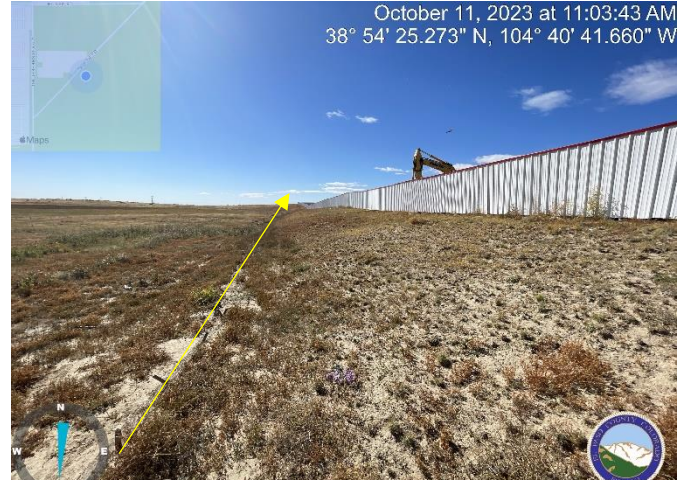
Photo 10: All temporary control measures can be removed throughout site.

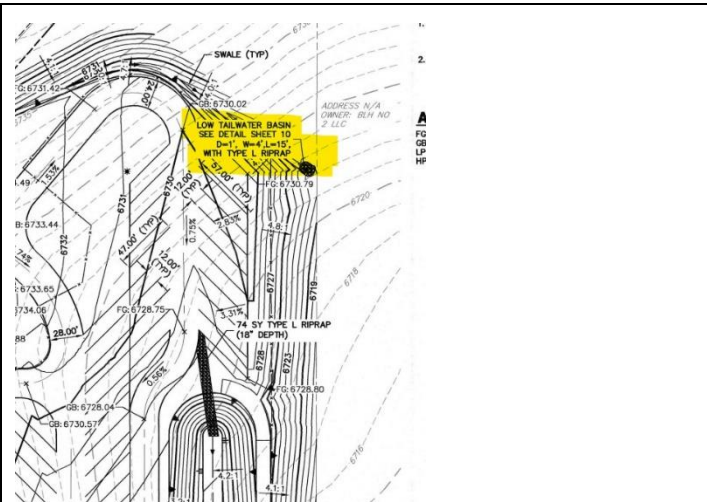
- Tailwater basin is not installed per plan detail. Reference sheet 4 of 10 on the GEC. Reference Photo #12.

Photo 11: Tailwater basin is not installed per plan detail. Reference sheet 4 of 10 on the GEC.
