**ENTECH**  
ENGINEERING, INC.

October 4, 2023

Re: Soils and Geology Study  
Parcel No. 53320-02-015  
2725 Akers Drive  
Lot 7, Akers Acers Subdivision 1  
El Paso County, Colorado  
Entech Job No. 231480

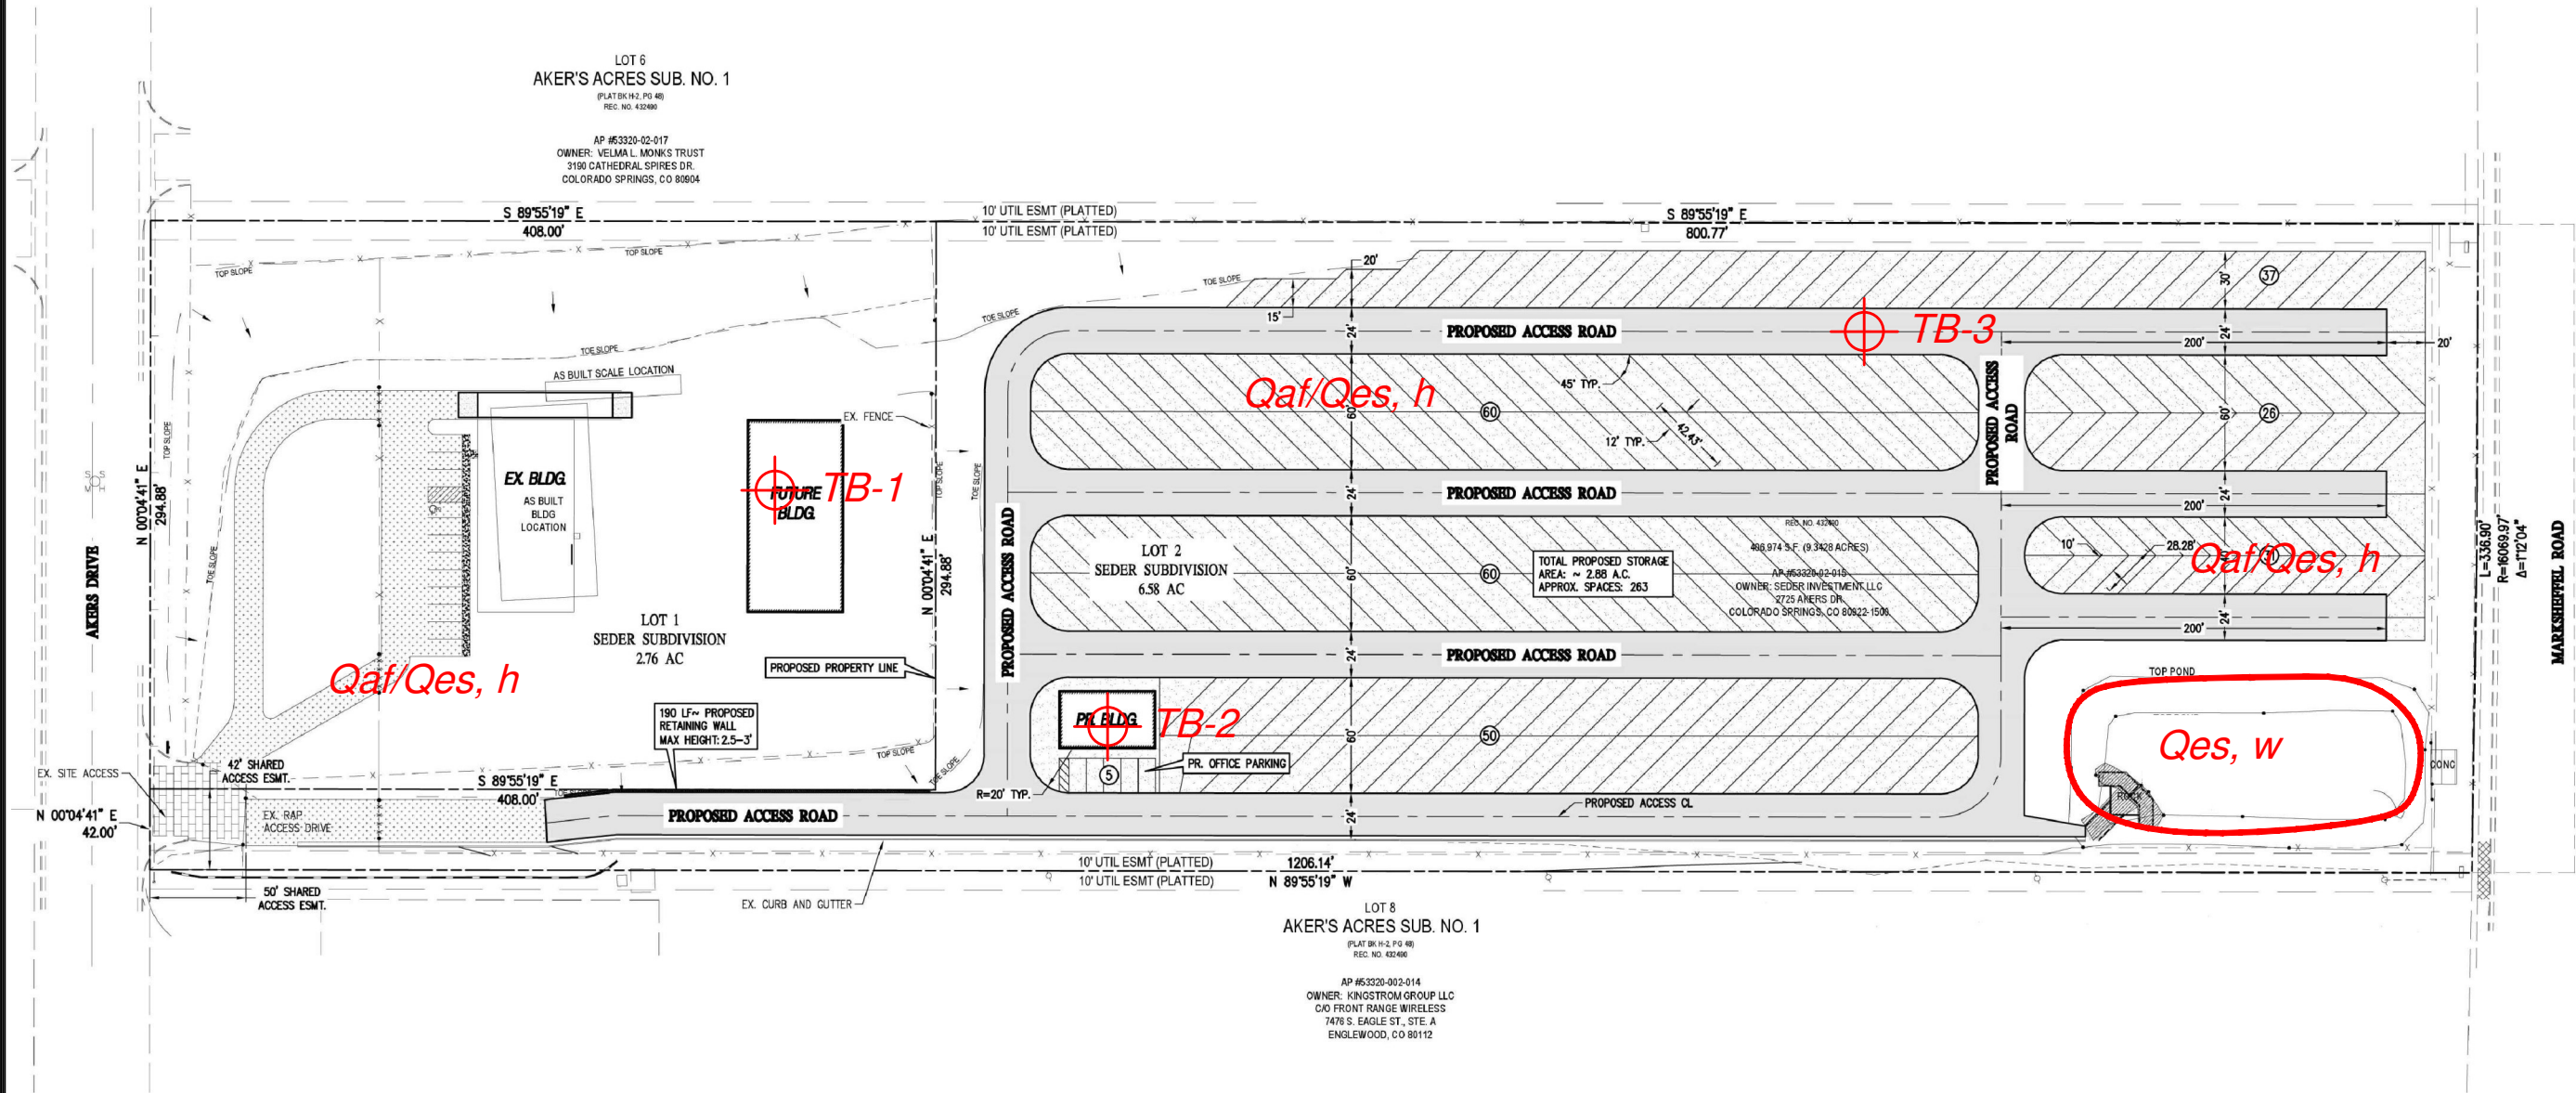
FIG. 6

Legend:  
Qaf/Qes - Artificial Fill of Holocene Age overlying Eolian Sands of late Pleistocene Age:  
man-placed fill deposits and stockpiles overlying windblown sediment deposits

h - hydrocompaction  
w - ponded water

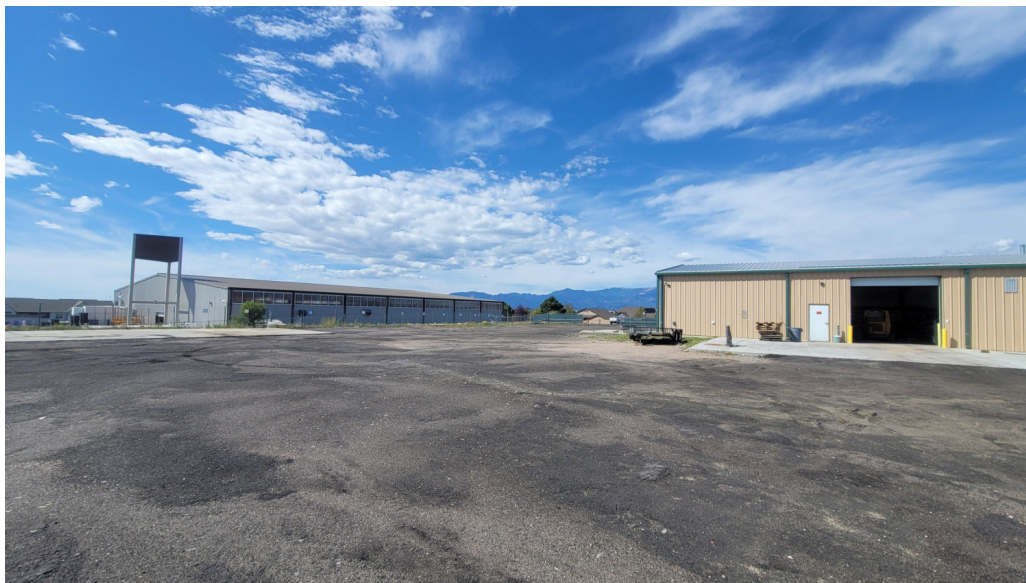
**Looking southwest  
from the west-central  
portion of the site.**

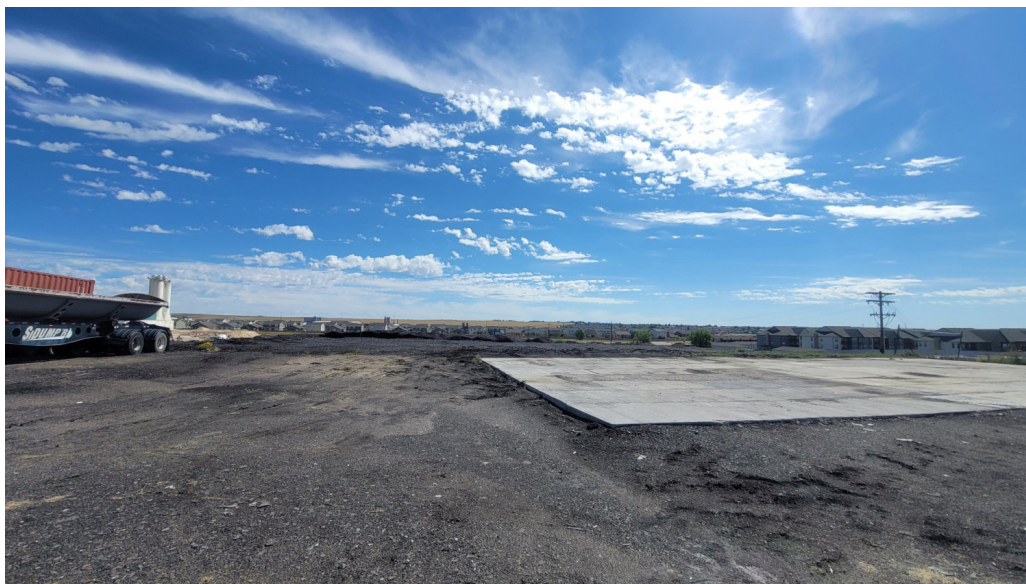
**Looking east from the  
west-central portion of  
the site.**

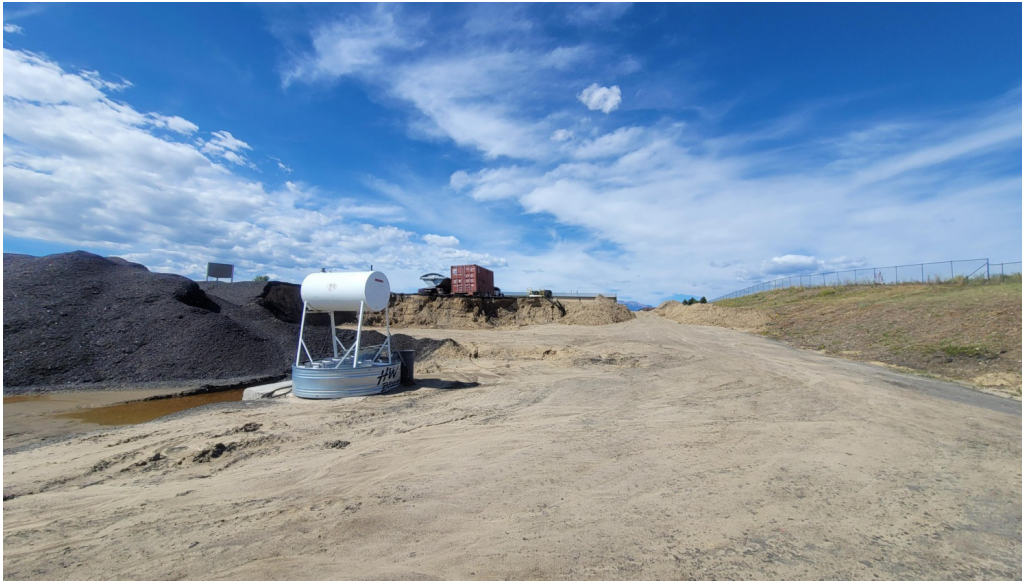
**Looking west from the  
northeastern portion of  
the site.**

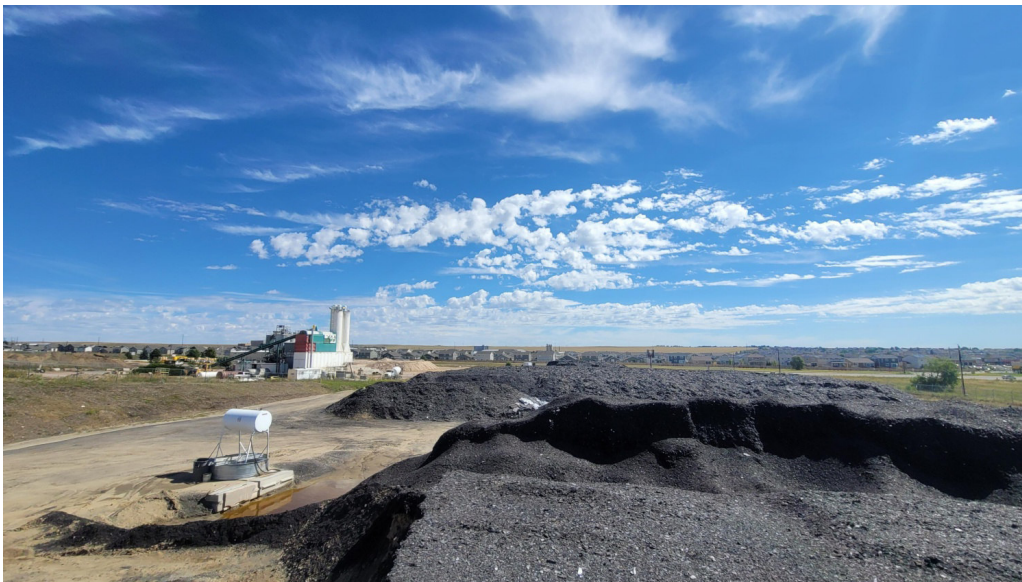
**Looking east from the  
central portion of the  
site.**

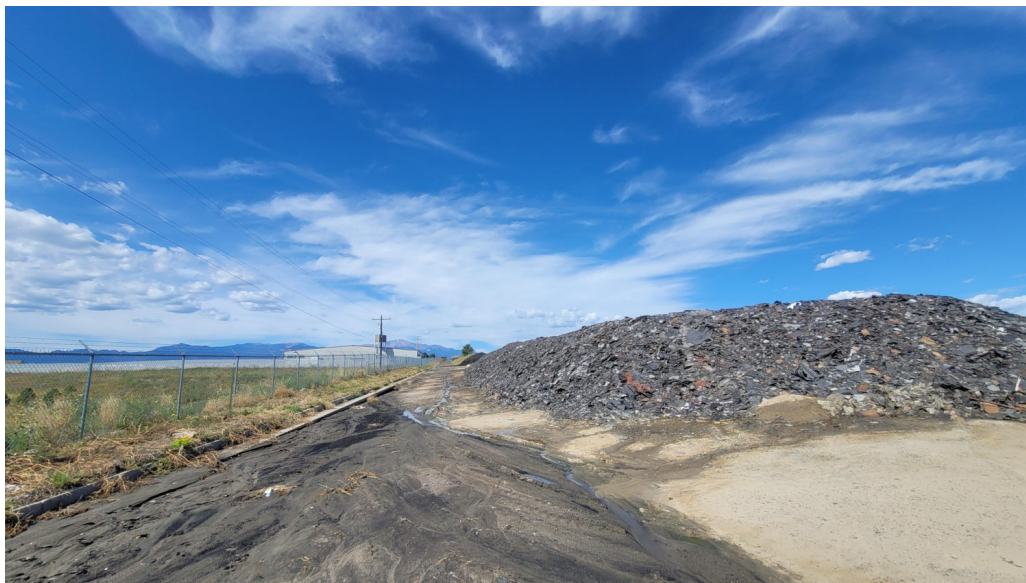
**Looking west from the  
southeastern side of  
the site.**

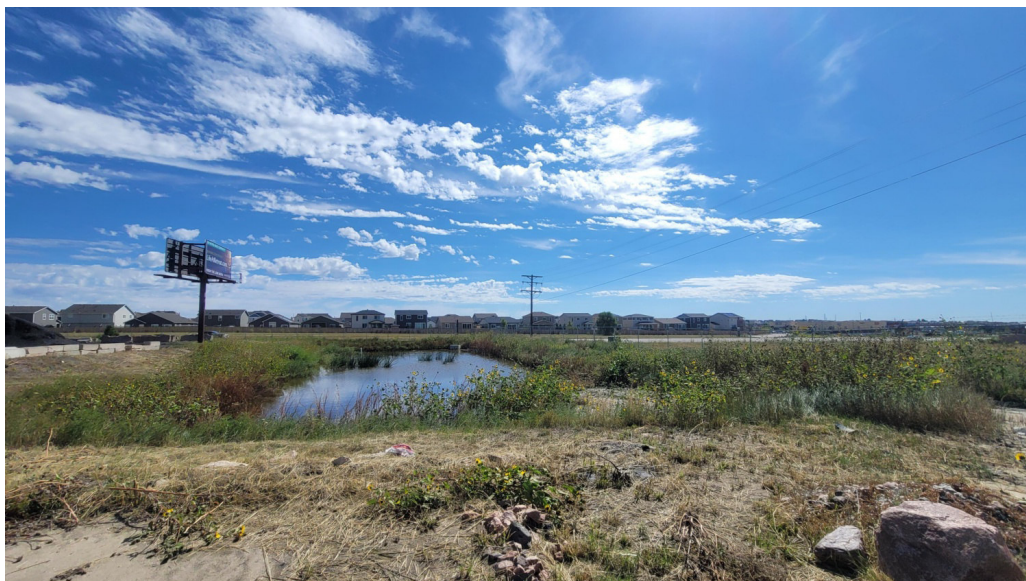
**Looking east towards  
detention pond in the  
southeastern corner of  
the site.**
