GEOLOGIC HAZARD EVALUATION  
STERLING RANCH RESIDENTIAL  
EL PASO COUNTY, COLORADO

**GEOLOGIC HAZARD EVALUATION  
STERLING RANCH RESIDENTIAL  
EL PASO COUNTY, COLORADO**

**Morley-Bentley Investments, LLC**  
20 Boulder Crescent Street, Suite 200  
Colorado Springs, Colorado 80903

January 20, 2009

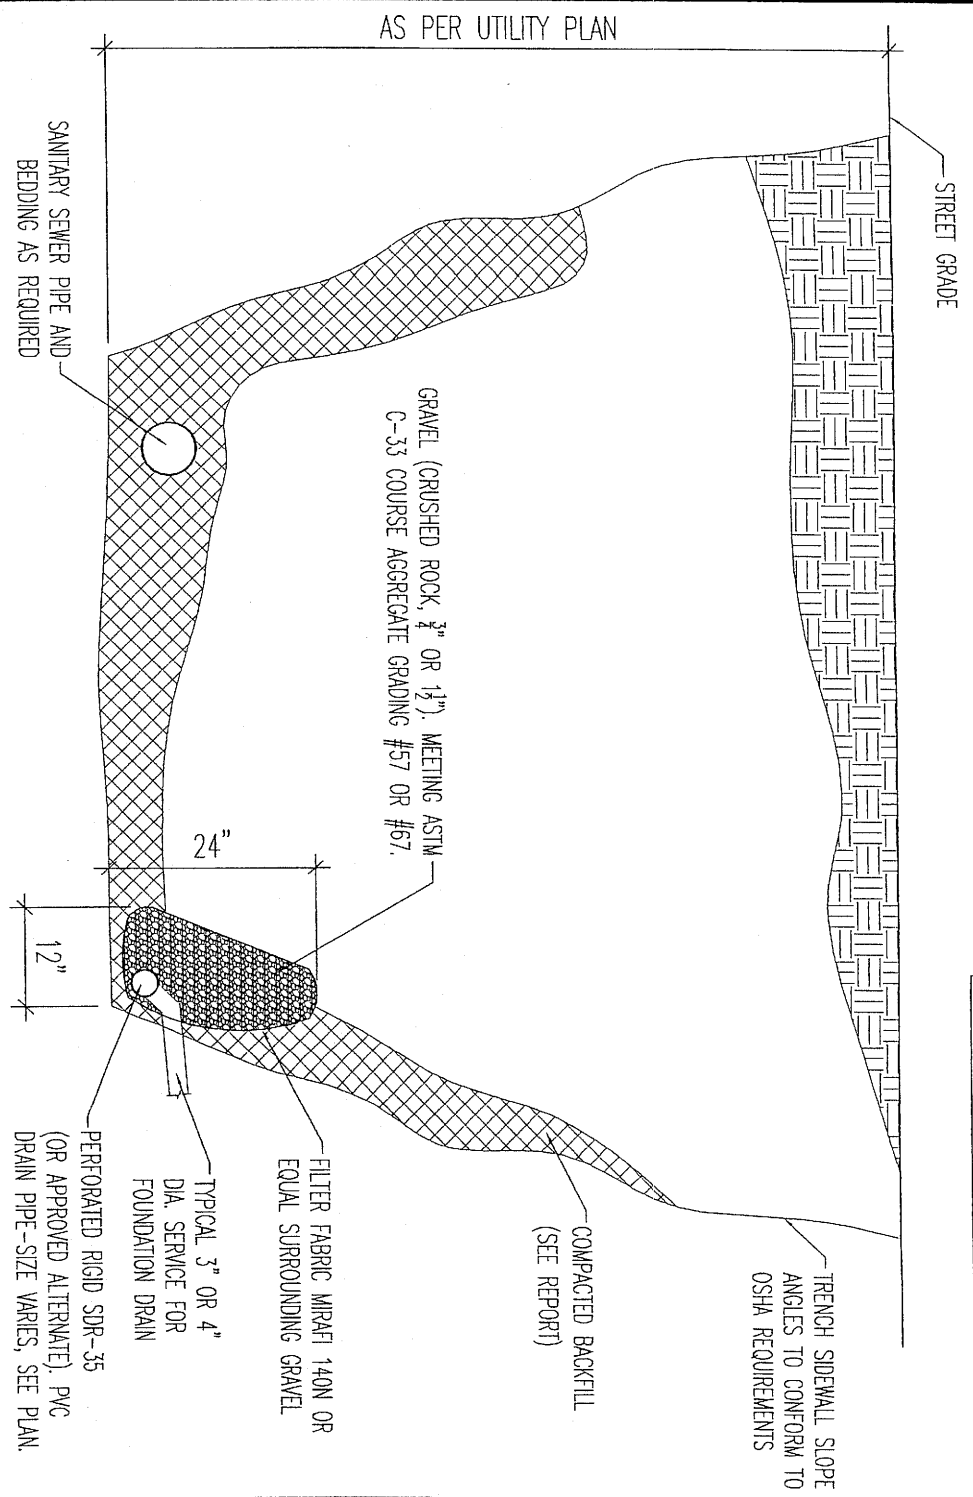
**ACTIVE DRAIN BESIDE SEWER**

Shallow groundwater: These are areas where shallow groundwater was encountered in the test borings or site conditions and vegetation indicate the potential for shallow groundwater. The same mitigation as discussed for seasonal shallow groundwater is recommended for areas of shallow groundwater. Basement construction is not recommended in these areas unless the area is regraded and raised with the placement of fill. Unstable soils should be anticipated where excavations approach the groundwater level. Geo-grids or shotrock may be necessary to stabilize excavations in these areas. Utility trenches will be affected by shallow groundwater in these areas. A typical sewer underdrain detail is presented in Figure 13.

NOTE:  
 TO BE USED IN CASES WHERE GROUNDWATER IS  
 FOUND DURING TRENCHING OR WHERE SHALLOW  
 GROUNDWATER IS KNOWN TO EXIST.
