Geology and Soils Reports  
Performed For  
A VACATION AND REPLAT OF LOT 1,  
V I L FILING No. 1  
PORTION OF THE NORTHWEST QUARTER OF  
SECTION 30, TOWNSHIP 13 SOUTH,  
RANGE 63 WEST OF THE 6TH M.M., EL PASO  
COUNTY, COLORADO

Allison Engineering  
(719) 331-6538

July 11, 2022

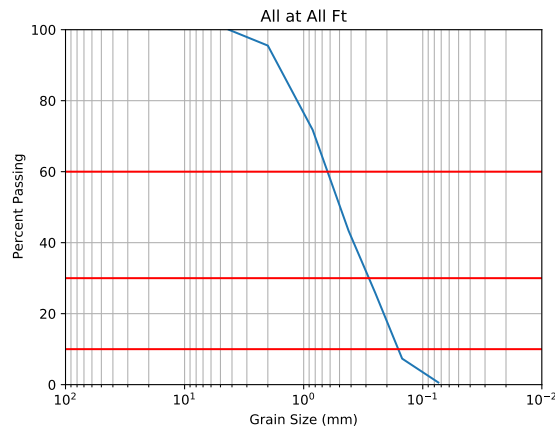
While the native soil is low in fines as seen in Figure 2 and thus the soil has low cohesion, ample area is available for homesites on level ground. Even so, the grade on less level areas is uniformly in those areas less than 9%.

No deposit of clay was found in the field survey and test excavations. Sieve analysis further substantiated low content of fines and hence a low expansion potential for this site making construction easier and lower cost as soil remediation of special engineering will not be required. Of course these conclusions are to be born out with site specific testing.

Figure 2: Composite sieve analysis. All sieves for all holes when plotted appear near identical.

The material found in each of the six test excavations across the four lots was consistent as noted in the description of Figure 2. The stability of excavations in such material should be a concern to future excavation contractors. Safe management of those excavations would be accomplished by terracing or shoring.

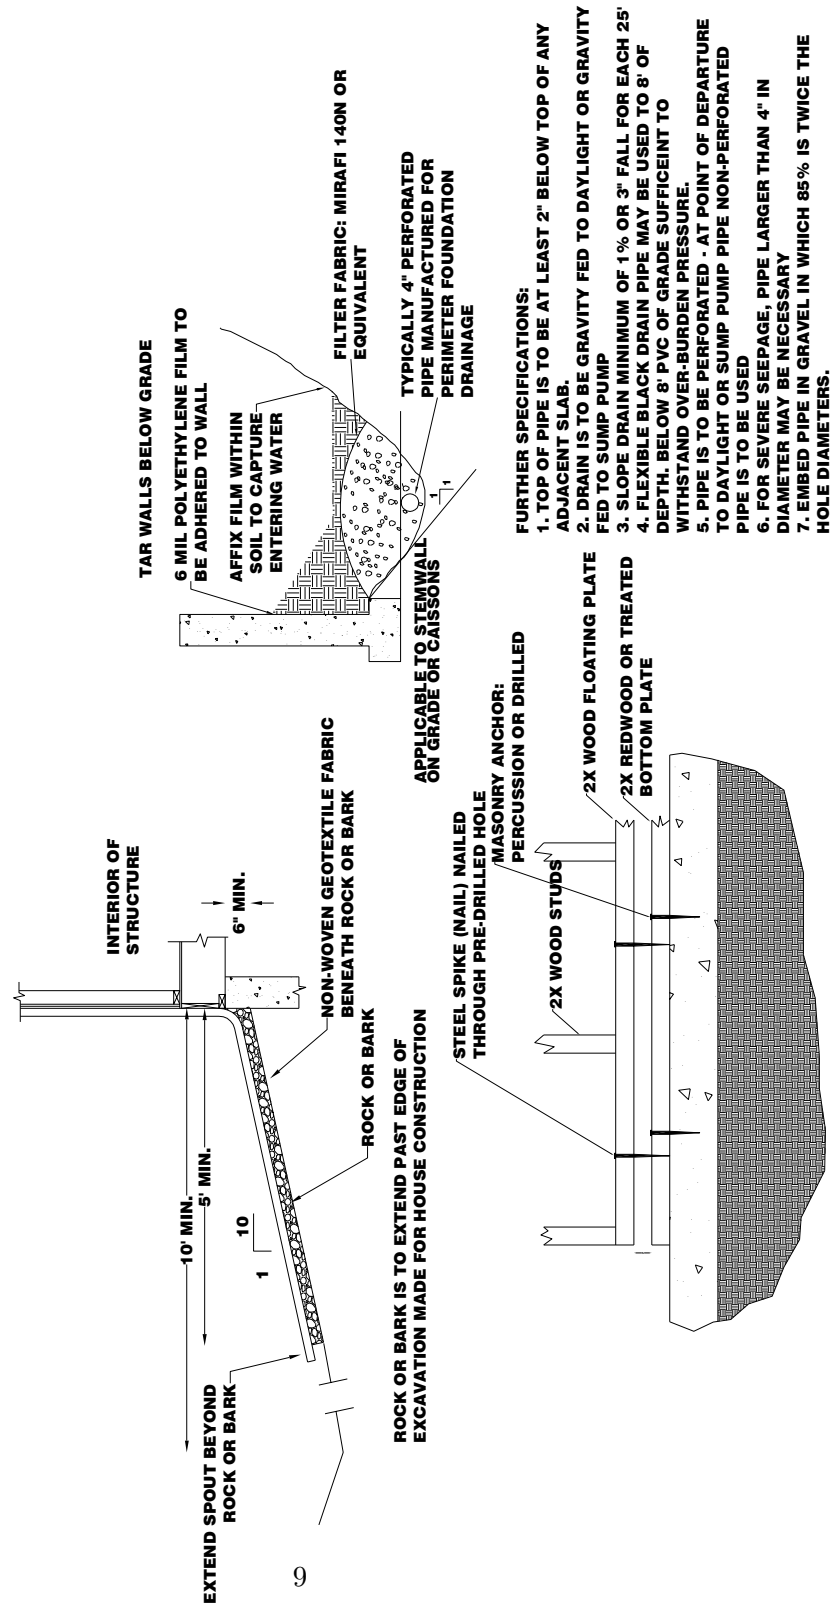
Figure 3: Engineering Details.

precaution where the area to be protected is high-cost finished living areas. If an area is not protected there is always opportunity for poorly maintained surface management to result in moisture infiltration. The type of management alluded to is that pertaining to downspouts from rain gutters and maintenance of grade against the house. Prudent is the structure where the grade drops uniformly one foot for the first 10 feet perpendicular to the home and that water not be retained but conveyed further from the structure. Figure 3 depicts proper downspout maintenance and perimeter drain details.

The soil within the zone of influence is not of a character of which significant expansion is expected and the soil is too granular for a reliable swell-consolidation test. Nonetheless, sufficient fines are contained in the native soil that slabs should have sufficient control joints with approximate limits of 120 square-feet and with limited horizontal extents of 12 feet. Also, non-load-bearing partition walls should be floating per the detail provided in Figure 3.
