**ENTECH**  
ENGINEERING, INC.

Re: Soils and Geology Study - Review  
Waterview East Commercial – Filing No. 1  
Parcel Nos. 55092-00-004, 55093-00-001, 55093-00-002, 55093-00-004, 55093-00-005,  
and 55090-00-006  
El Paso, Colorado  
Entech Job No. 220689  
PCD File No. SF-269

**SLOPE STABILITY ANALYSIS**  
WATERVIEW EAST DEVELOPMENT  
WATERVIEW COMMERCIAL

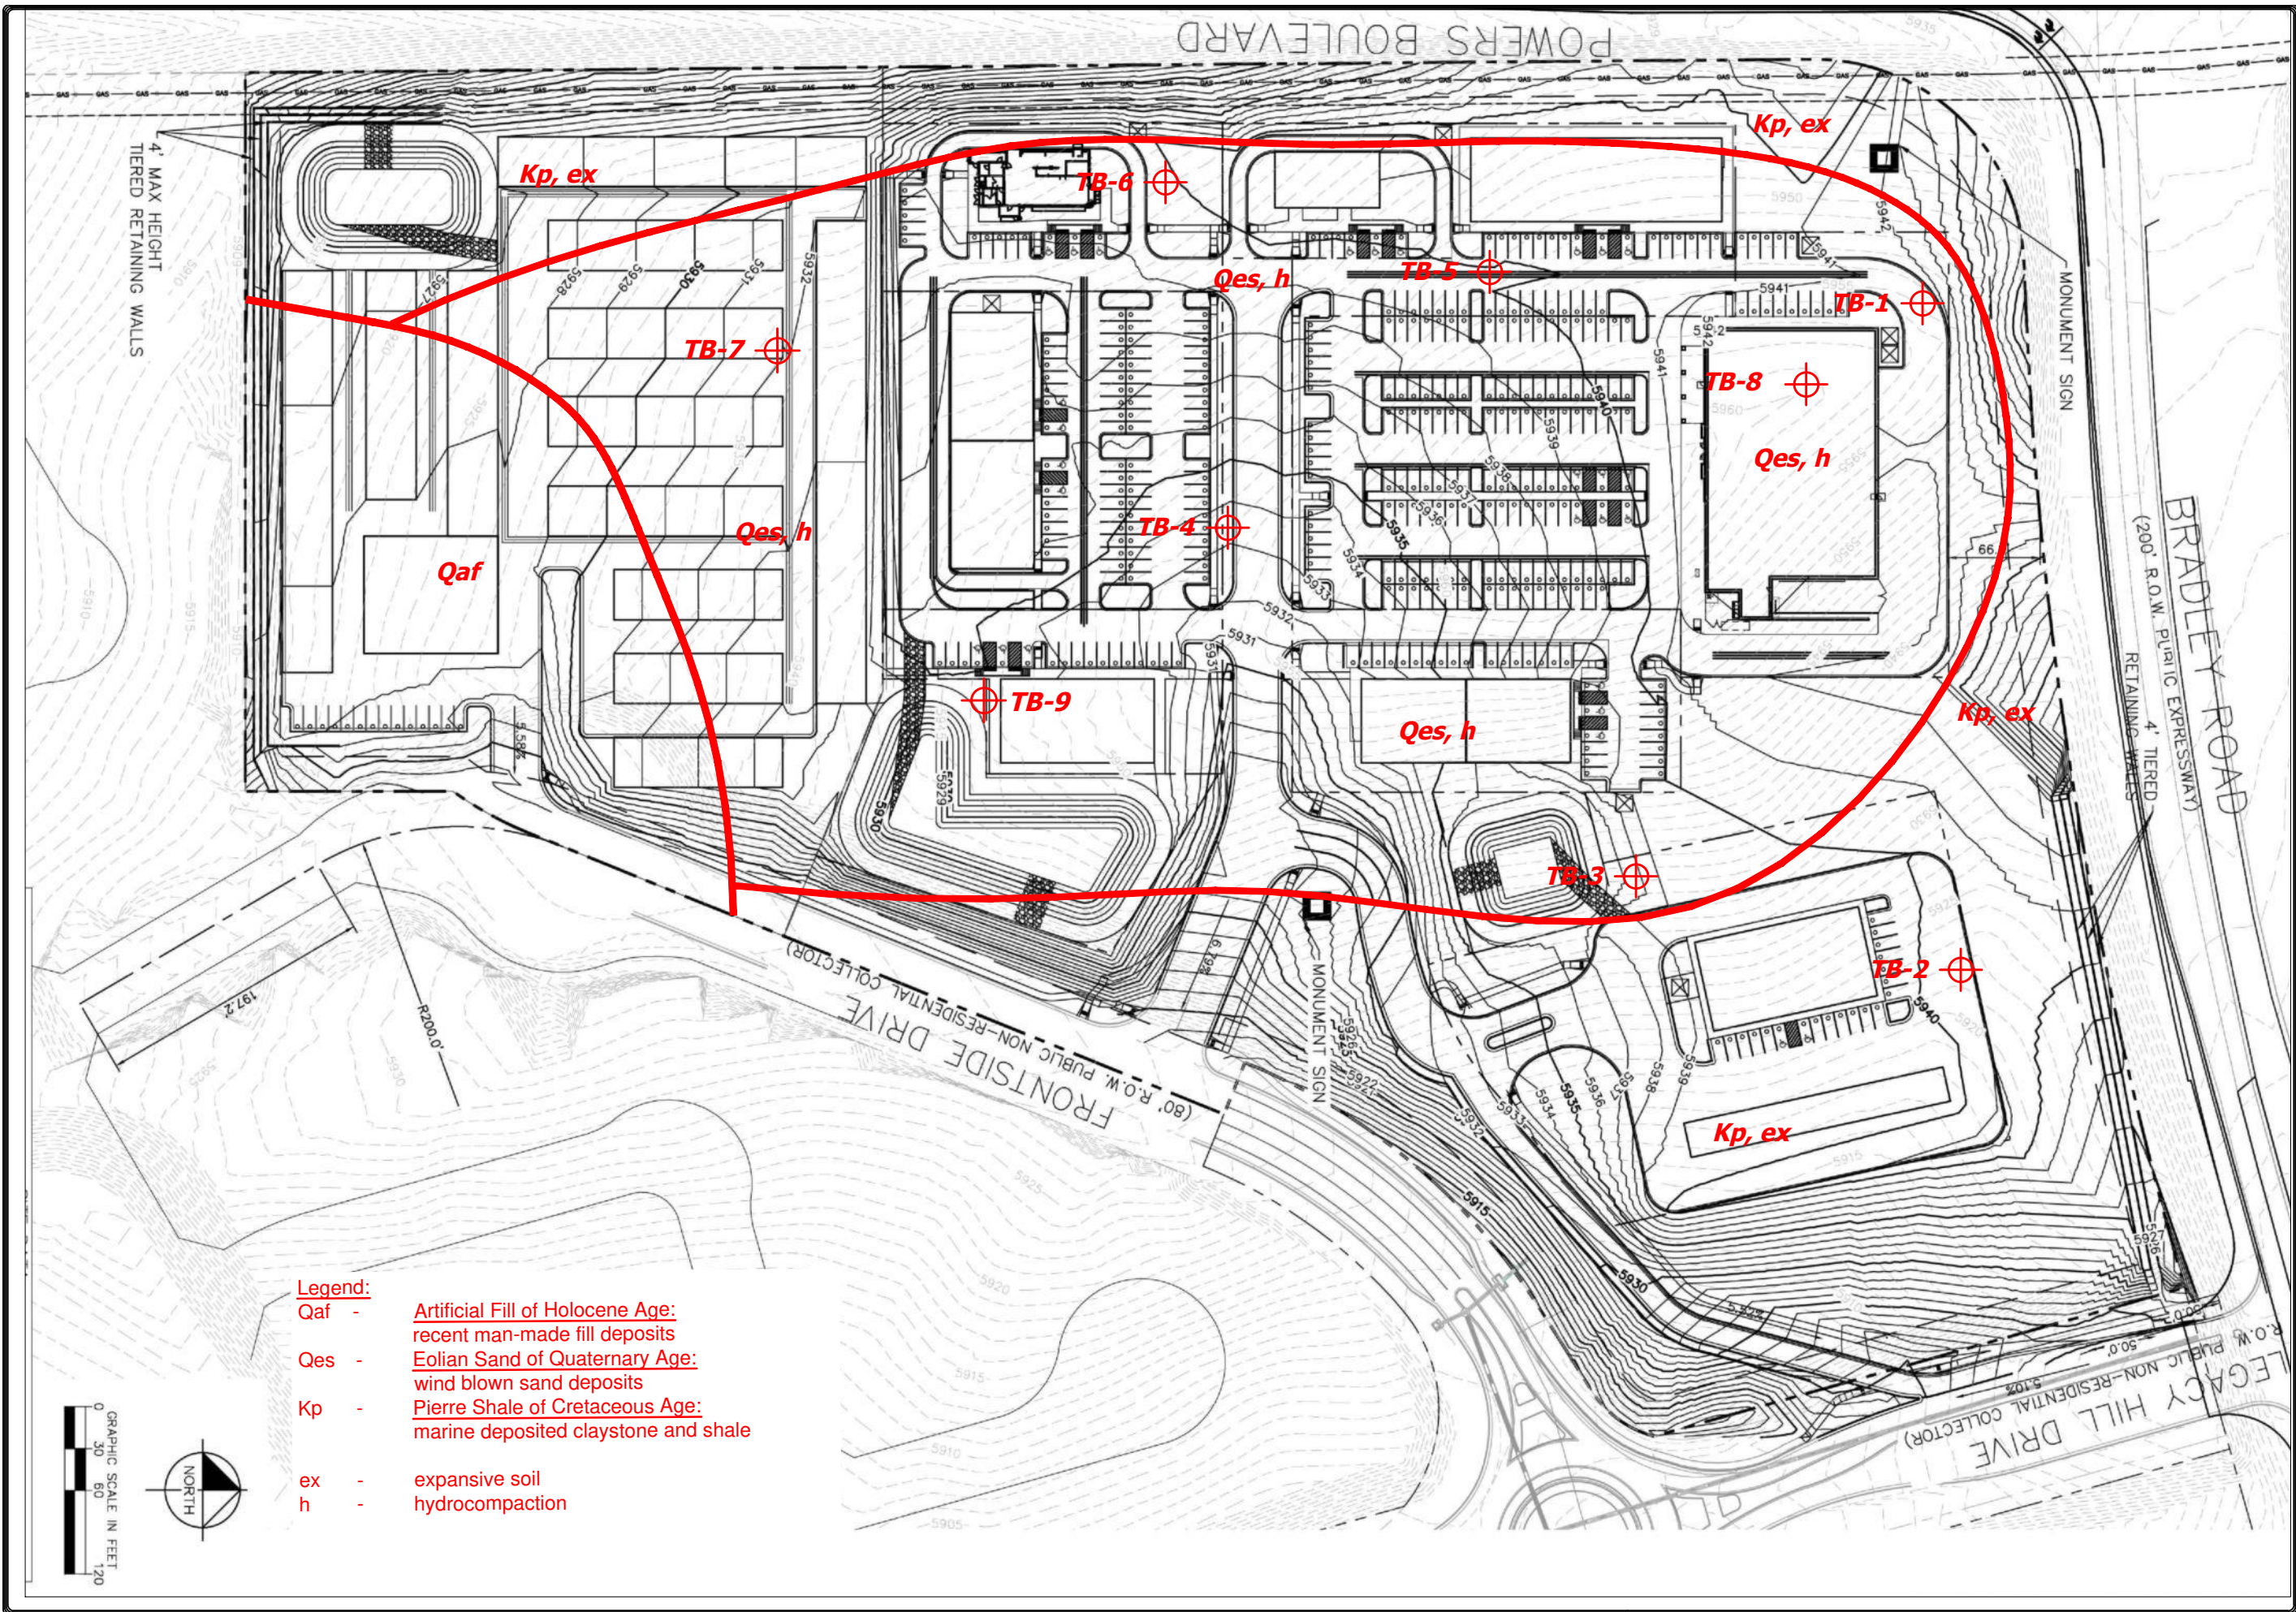
| FIGURE No.<br>6 |

Detailed mapping has been performed on this site to produce an Engineering Geology Map Figure 6. This map shows the location of various geologic conditions of which the developers should be cognizant during the planning, design and construction stages of the project. Hazards include areas of artificial fill, expansive soils, and hydrocompaction. These hazards and the recommended mitigation techniques are as follows:

Expansive soils are common in the area, and were encountered in the test borings drilled on site. Swells ranged from low to moderate in the soils tested. The clay and claystone, if encountered beneath foundations, can cause differential movement in the structure foundation. These occurrences should be identified and dealt with on an individual basis or possibly mitigated during site grading.

Areas in which hydrocompaction have been identified are acceptable as building sites. In areas identified for this hazard classification, however, we anticipate a potential for settlement movements upon saturation of these surficial soils. The low density, uniform grain sized, windblown sand deposits are particularly susceptible to this type of phenomenon. Additionally, loose or collapsible soils may be encountered on this site.

Mitigation Should expansive soils be encountered beneath the foundation; mitigation will be necessary. Mitigation of expansive soils will require special foundation design. Overexcavation and replacement with non-expansive soils at a minimum of 95 percent of its maximum Modified Proctor Dry Density, ASTM D-1557 is a suitable mitigation, which is common in the area. Floor slabs on expansive soils should be expected to experience movement. Overexcavation and replacement has been successful in minimizing slab movements. Overexcavation depths of 4 to 6 feet are anticipated for the site. Mitigation may also include moisture conditioning and recompaction of the clay soils.

Mitigation: The potential for settlement movement is directly related to saturation of the soils below the foundation areas. Therefore, good surface and subsurface drainage is extremely critical in these areas in order to minimize the potential for saturation of these soils. The ground

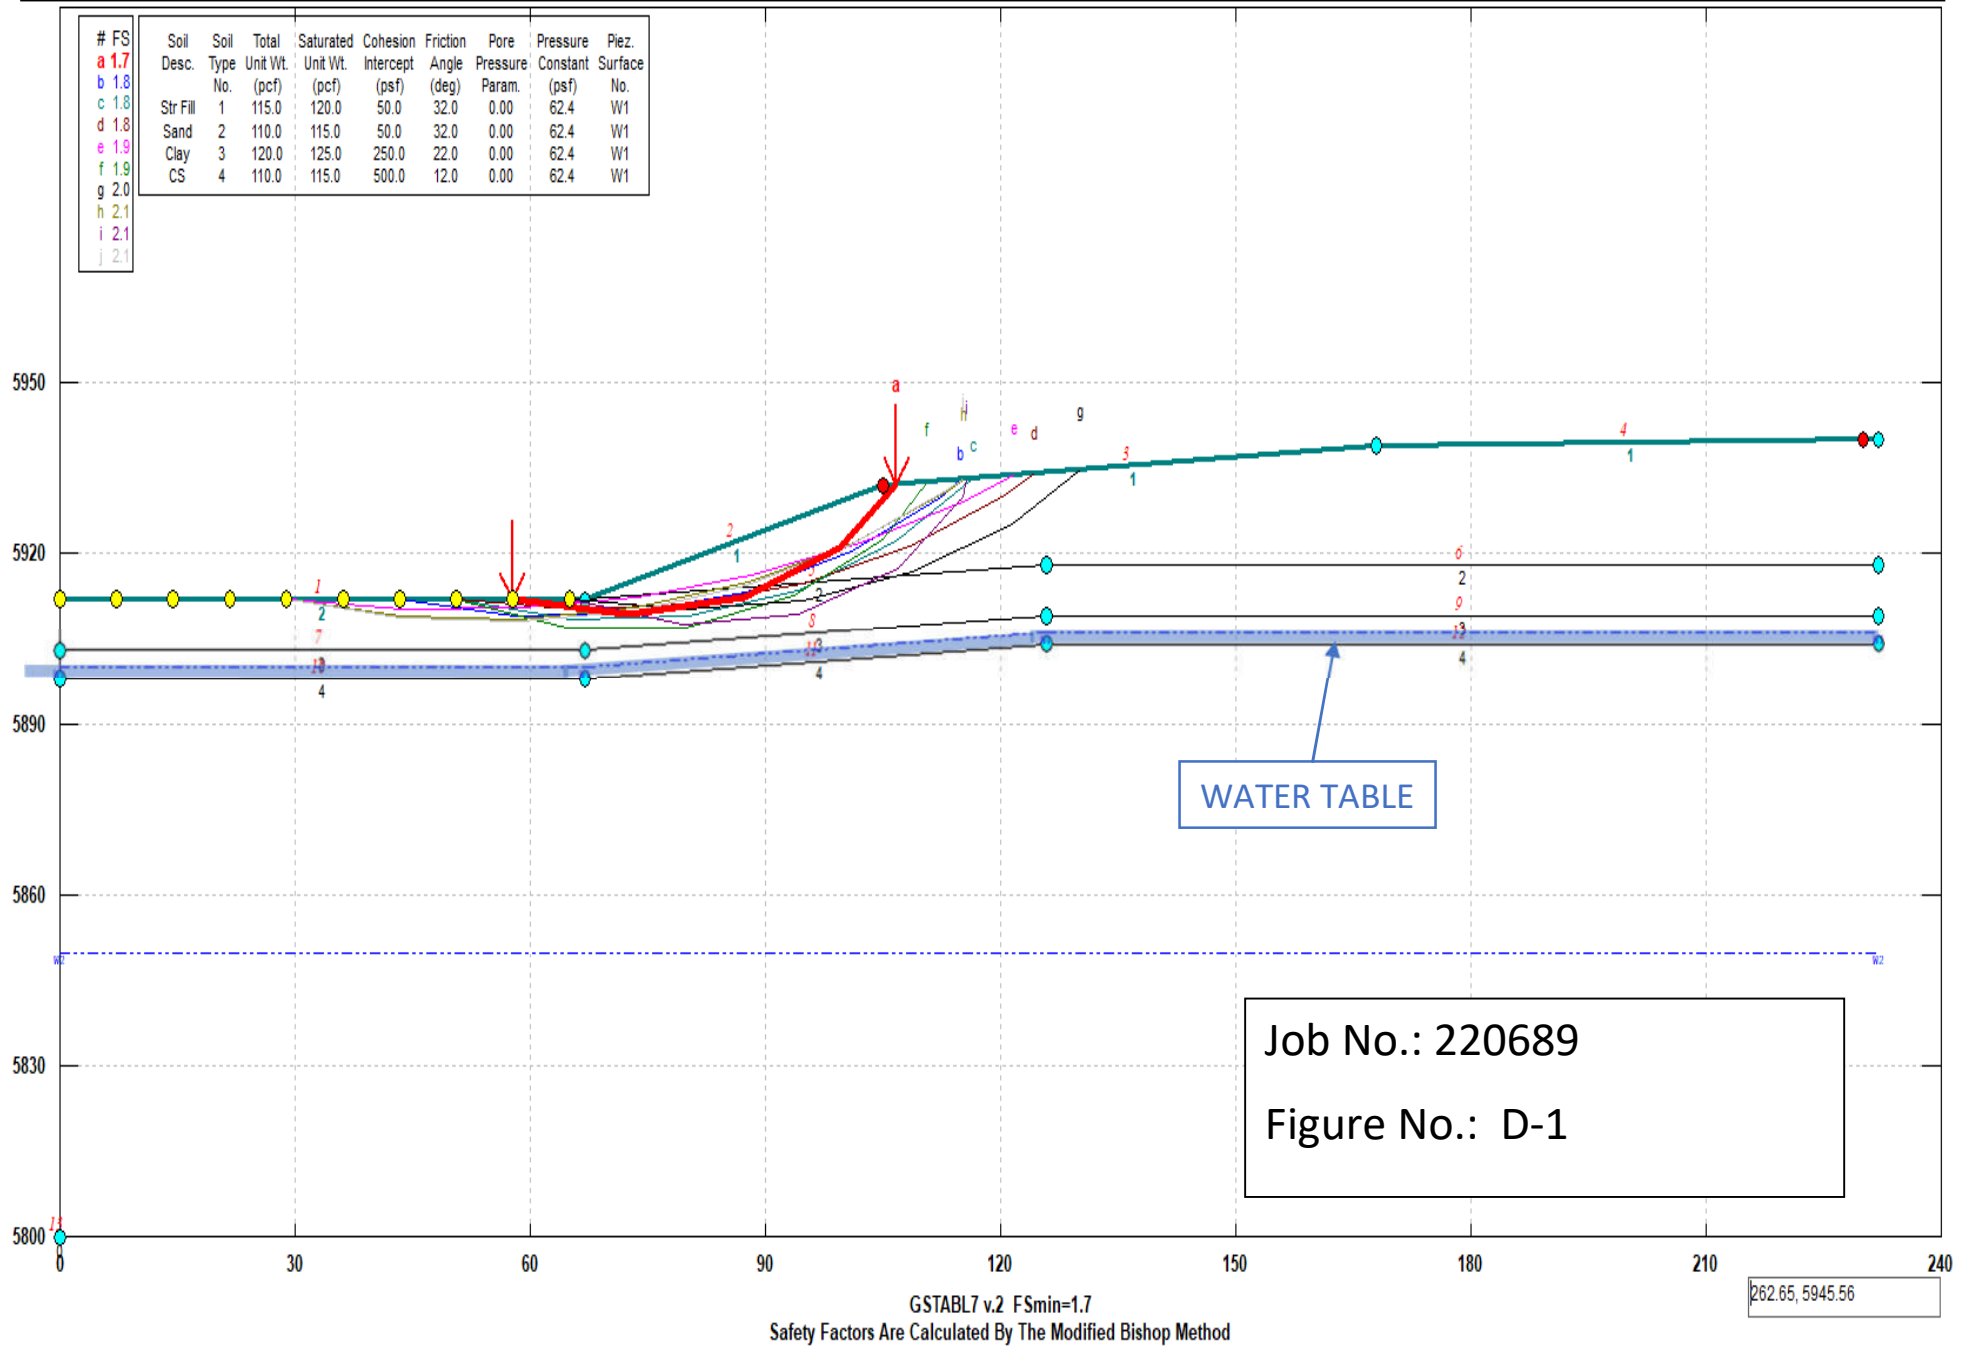
# WATERVIEW COMMERCIAL – WATERVIEW EAST – A-A PROPOSED

Factors of safety of 1.7 to 2.7 were obtained for the proposed fill slopes in the northeastern portion of the site. A factor of safety of 1.3 was obtained for the proposed detention pond with tiered retaining wall in the southwestern portion of the site. **Retaining walls should be designed for global slope stability. All slopes should be evaluated for local and global stability for final designs.** Results of the slope stability analysis are presented in Appendix D. A factor of safety of 1.5 is recommended for areas of critical structures such as buildings, and factor of safety of 1.3 for not critical structures such as roadways and parking areas. Preliminary analysis of the proposed development show that adequate factors of safety can be achieved.

Proper control of drainage at both the surface and in the subsurface is extremely important to slope performance. Areas of ponded water at the surface should be avoided. We recommend surface drainage be directed away from the slopes to prevent saturation of the slopes that could create unstable conditions. Utility trenches, basement excavations and other subsurface features should not be permitted to become water traps which may promote saturation of the subsurface materials. Additional moisture may create unstable conditions on the slopes. Drainage should be directed away from these slopes to avoid saturation of the materials. Downspouts and other concentrated flows should be piped down the slopes. Discharges and flows onto the slopes should not be permitted.
