Phase I Environmental Site Assessment

Two Adjacent 5 Acre Parcels of Vacant Land

Beacon Lite Road

Monument, Colorado 80132

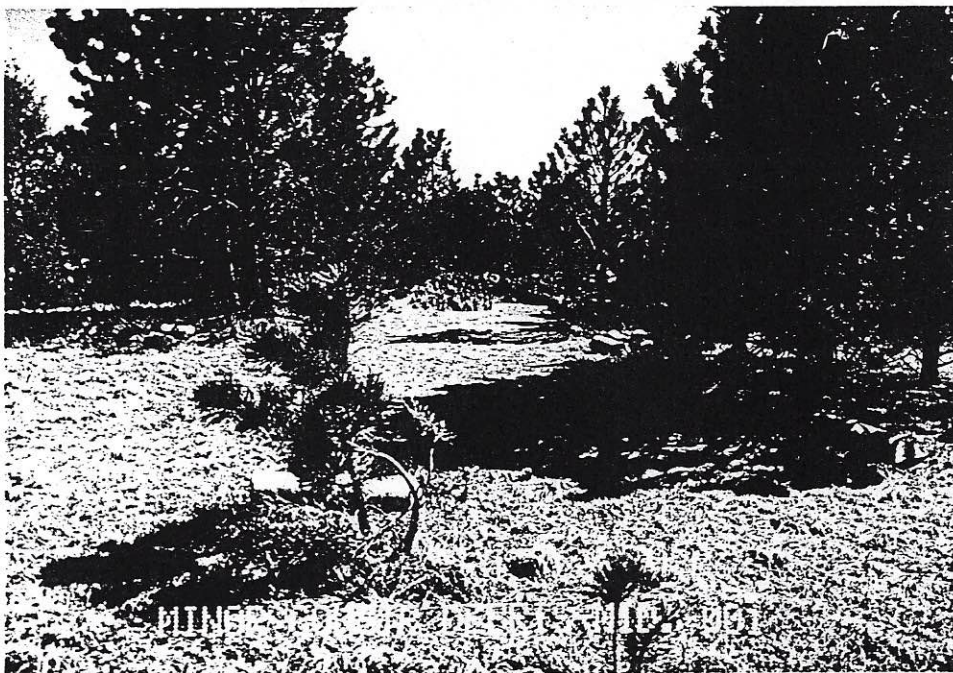
No construction debris was observed on parcel 002 of the property. Minor construction debris, consisting primarily of concrete forms, was found on the middle of parcel 001. All construction debris should be removed from the subject property and properly disposed.

11. Minor construction debris found in the middle of 001 of the subject.

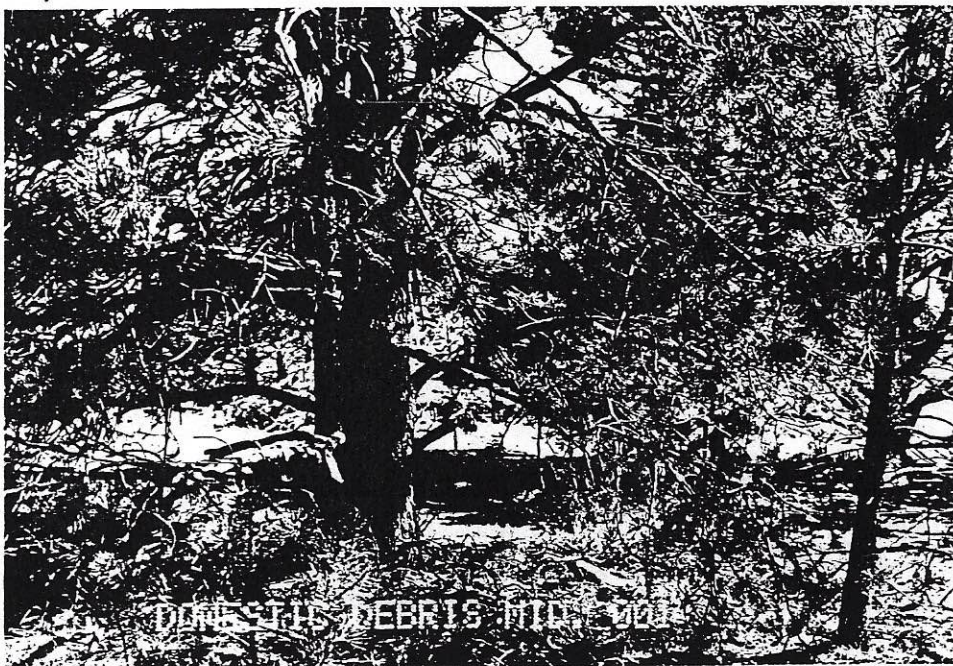
No significant domestic debris, trash, industrial waste or debris was observed on the subject property. Minor domestic debris was found in the evergreen trees on the middle of parcel 001. All domestic debris should be removed from the subject property and properly disposed.

12. Domestic debris found in the middle of 001 of the subject.
