505 ELKTON DRIVE
COLORADO SPRINGS, CO 80907
PHONE (719) 531-5599
FAX (719) 531-5238

Attn: Chuck Crum

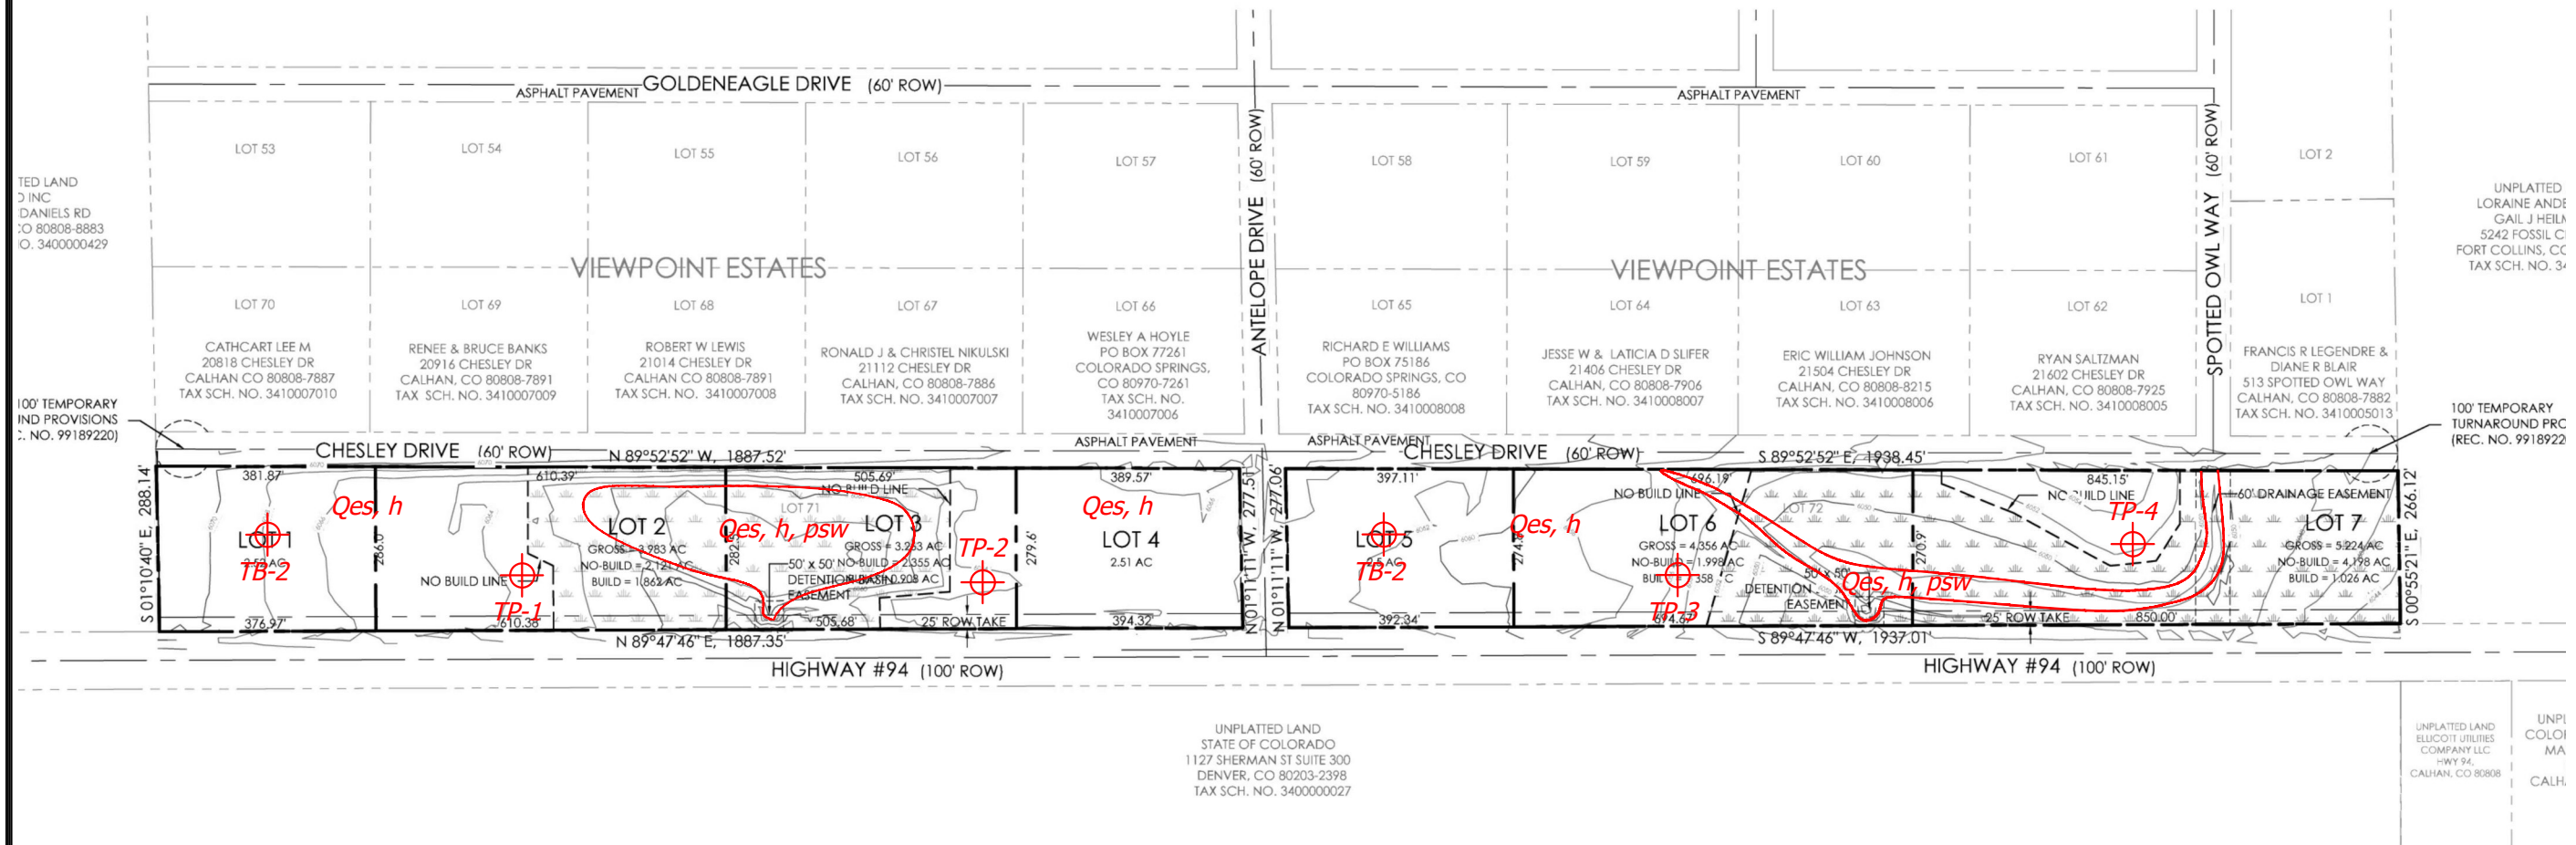
6

The soils listed above were mapped from site-specific mapping, the *Geologic map of the Pueblo 1-degree x 2-degrees' quadrangle, south-central Colorado* published by the U.S. Geologic Survey in 1976 (Reference 4). The test borings and test pits were used in evaluating the site and are included in Appendix B. The Geology Map prepared for the site is presented in Figure 6.

Areas in which hydrocompaction have been mapped across the site mapped as Eolian Sands of Quaternary Age (Qes). In areas identified for this hazard classification, however, we anticipate a potential for settlement movements upon saturation of these surficial soils. The low density, uniform grain sized, windblown sand deposits are particularly susceptible to this type of phenomenon. Additionally, loose or collapsible soils may be encountered in other areas on this site.

Mitigation: The potential for settlement movement is directly related to saturation of the soils below the foundation areas. Therefore, good surface and subsurface drainage is extremely critical in these areas in order to minimize the potential for saturation of these soils. The ground surface around all permanent structures should be positively sloped away from the structure to all points, and water must not be allowed to stand or pond anywhere on the site. We recommend that the ground surface within 10 feet of the structures be sloped away with a minimum gradient of five percent. If this is not possible on the upslope side of the structures, then a well-defined swale should be created to intercept the surface water and carry it quickly and safely around and away from the structures. Roof drains should be made to discharge well away from the structures and into areas of positive drainage. Where several structures are involved, the overall drainage design should be such that water directed away from one structure is not directed against an adjacent building. Planting and watering in the immediate vicinity of the structures, as well as general lawn irrigation, should be minimized.

Should loose or collapsible soils be encountered beneath foundations, removal and recompaction of the upper 2 feet with thorough moisture conditioning and recompaction at 95% of Modified Proctor Dry Density, ASTM D-1557 will be necessary. **Specific recommendations should be made after additional investigation of each building site.**

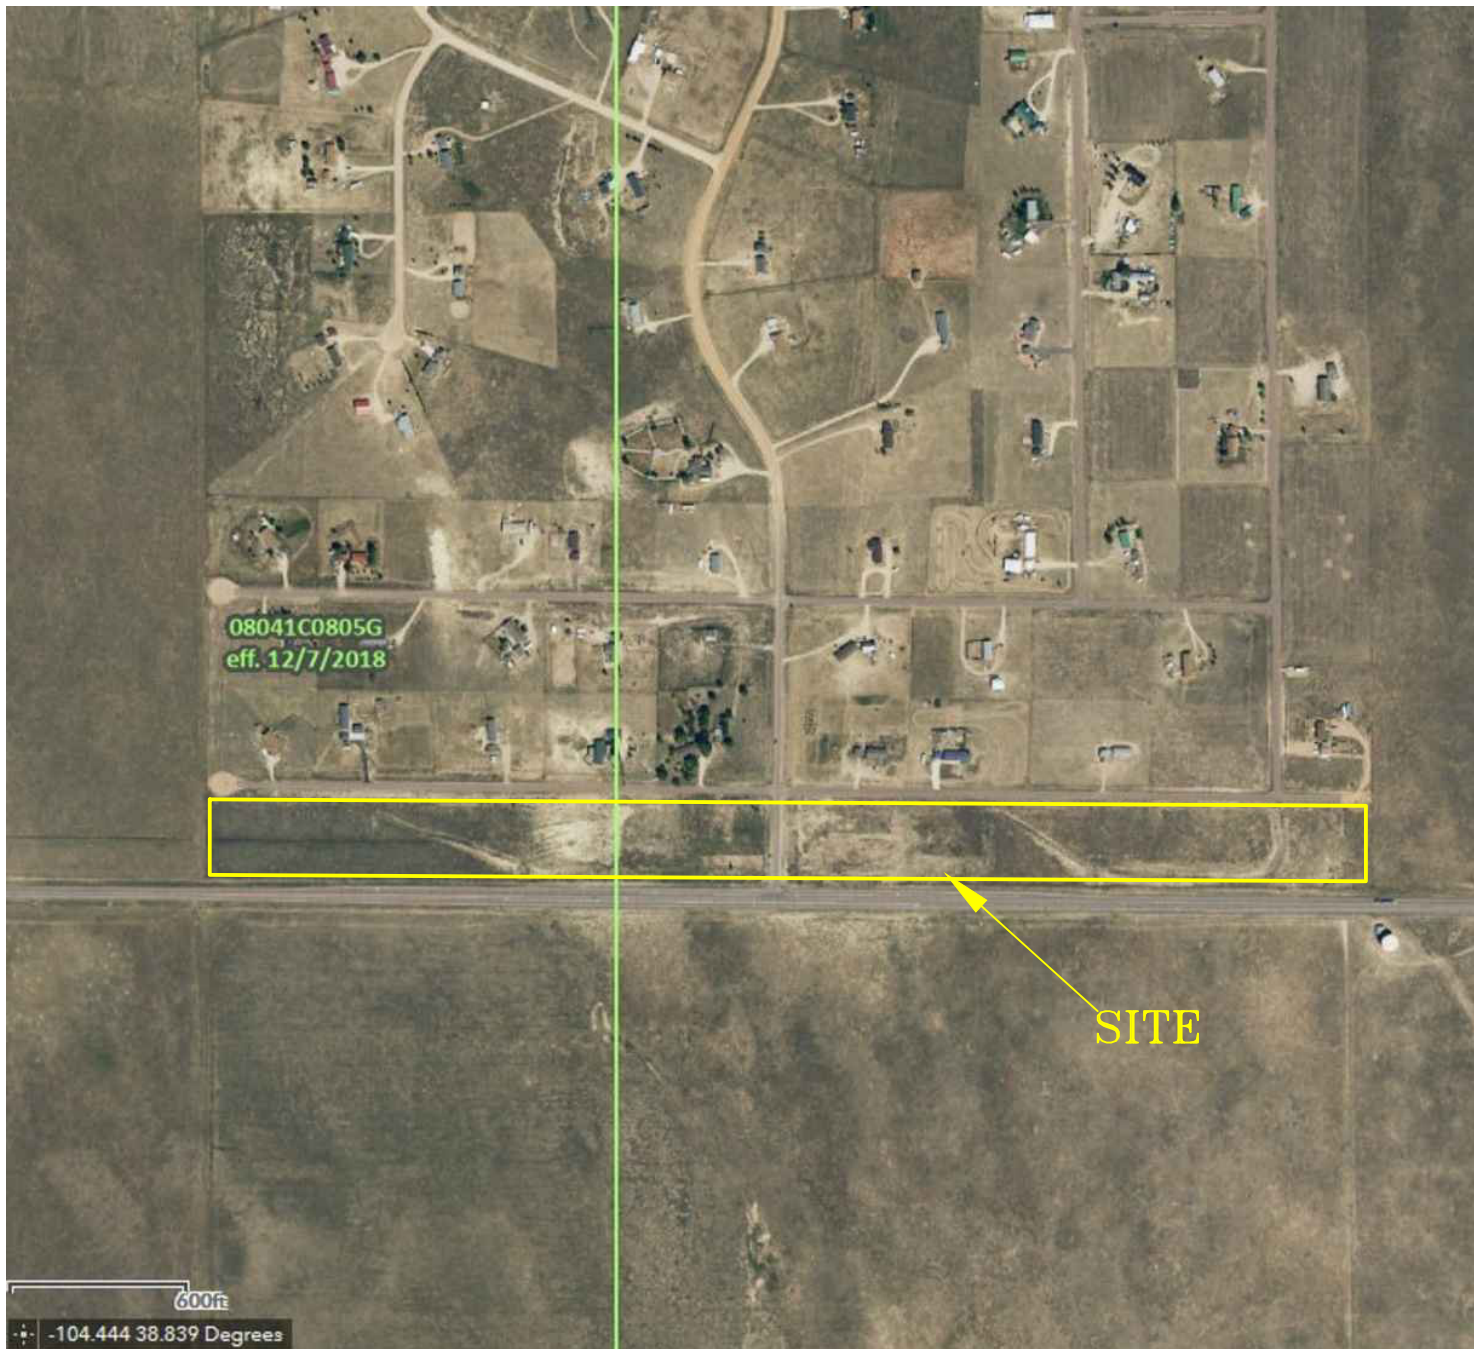
FEMA FLOODPLAIN MAP
VIEWPOINT ESTATES FILING NO. 2
HWY 94 & ANTELOPE DRIVE
EL PASO COUNTY, CO.
FOR: MVE, INC.

The site does not lie within a mapped floodplain zone according to the FEMA Map Nos. 08041CO805G and 08041CO810G dated December 7, 2018 (Figure 7, Reference 6). Finished floor levels must be a minimum of one foot above the floodplain level. Exact locations of floodplain and specific drainage studies are beyond the scope of this report.

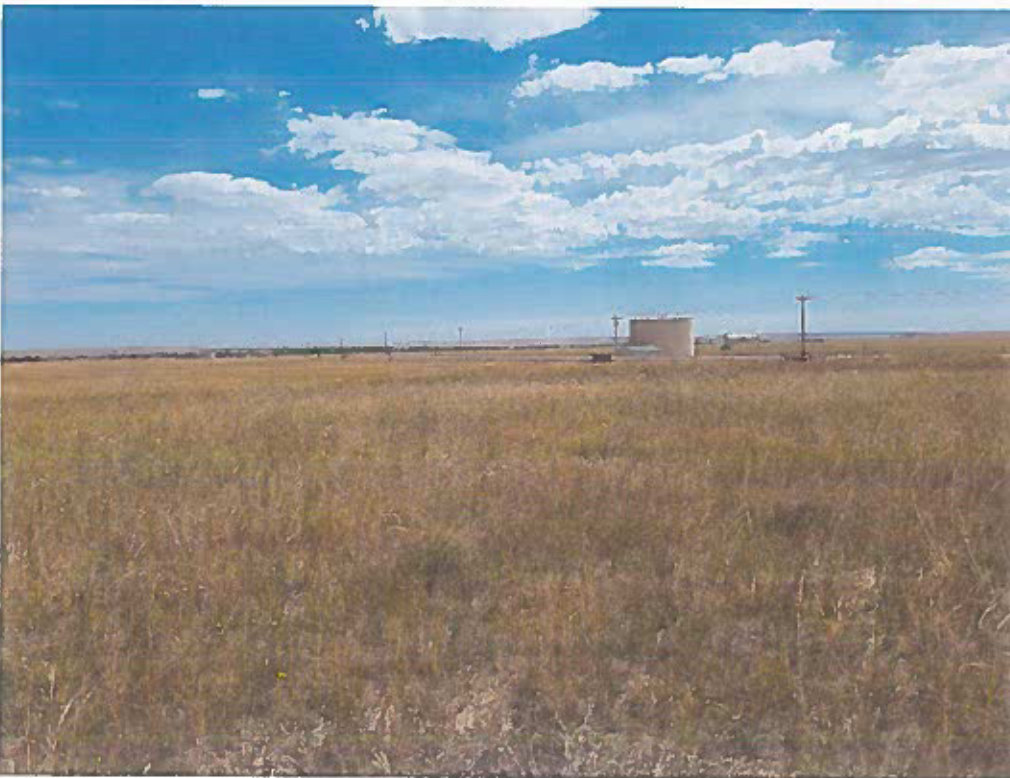
Drainage areas located in portions of Lots 2 and 3 and Lots 6 and 7, and located within drainage easements/no-build areas. The drainages flow in a southerly direction, and water was not observed in the drainages at the time of this investigation. Portions of the drainage easement area have been mapped as potentially seasonal shallow groundwater areas. These areas are indicated in the Geology/Engineering Geology Map (Figure 6) and are discussed below. These areas are located within the no-build area and will be avoided. The proposed building areas are not affected by these areas.

Drainage easements are located on Lots 2 and 3, and Lots 6 and 7. The drainages flow in a southerly direction. Water was not observed in the drainages at the time of this investigation. Portions of the drainage easements have been mapped as potentially seasonal shallow groundwater areas. These areas are indicated in the Geology/Engineering Geology Map (Figure 6). These areas are located within no-build areas and will not affect proposed building areas.

**Looking southeast
towards minor
drainage easement in
the eastern portion of
Lot 7.**
