POND 1  
FINAL ASBUILT  
FIELD DATA COMPLETED 5-17-23

POND 4  
FINAL ASBUILT  
FIELD DATA COMPLETED 5-17-23

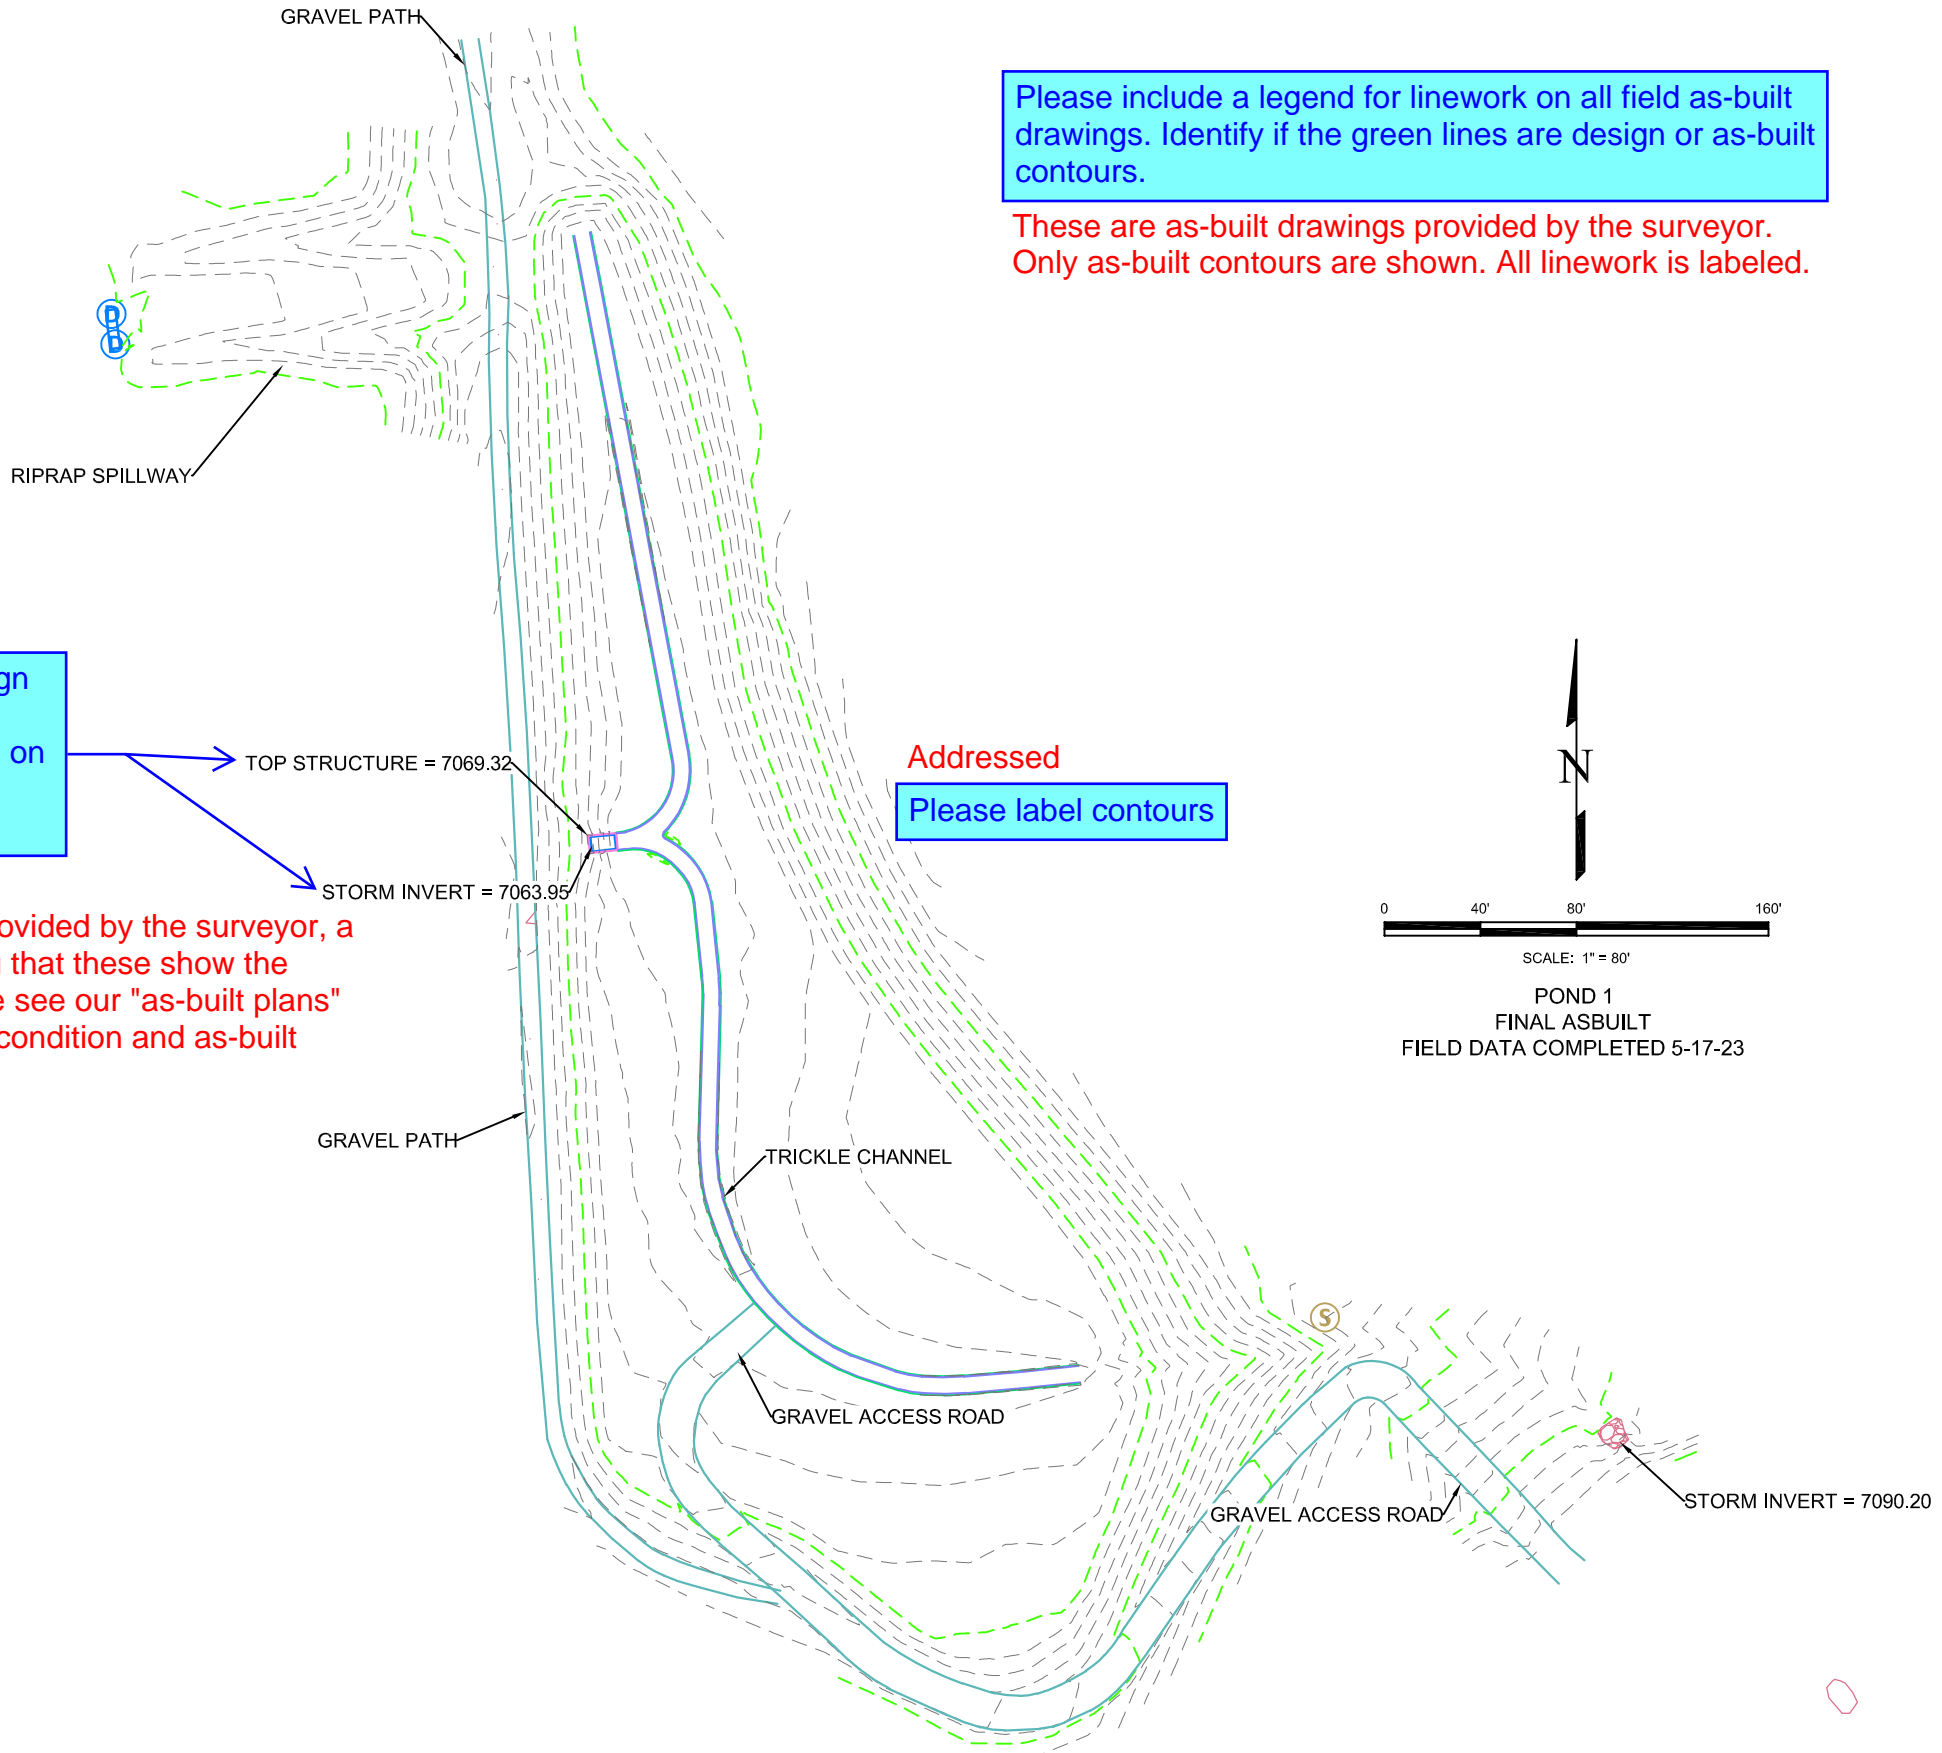
Please include a legend for linework on all field as-built drawings. Identify if the green lines are design or as-built contours.

Please show design elevations and as-built elevations on all field as-built drawings.

These are as-built drawings provided by the surveyor. Only as-built contours are shown. All linework is labeled.

Addressed  
Please label contours

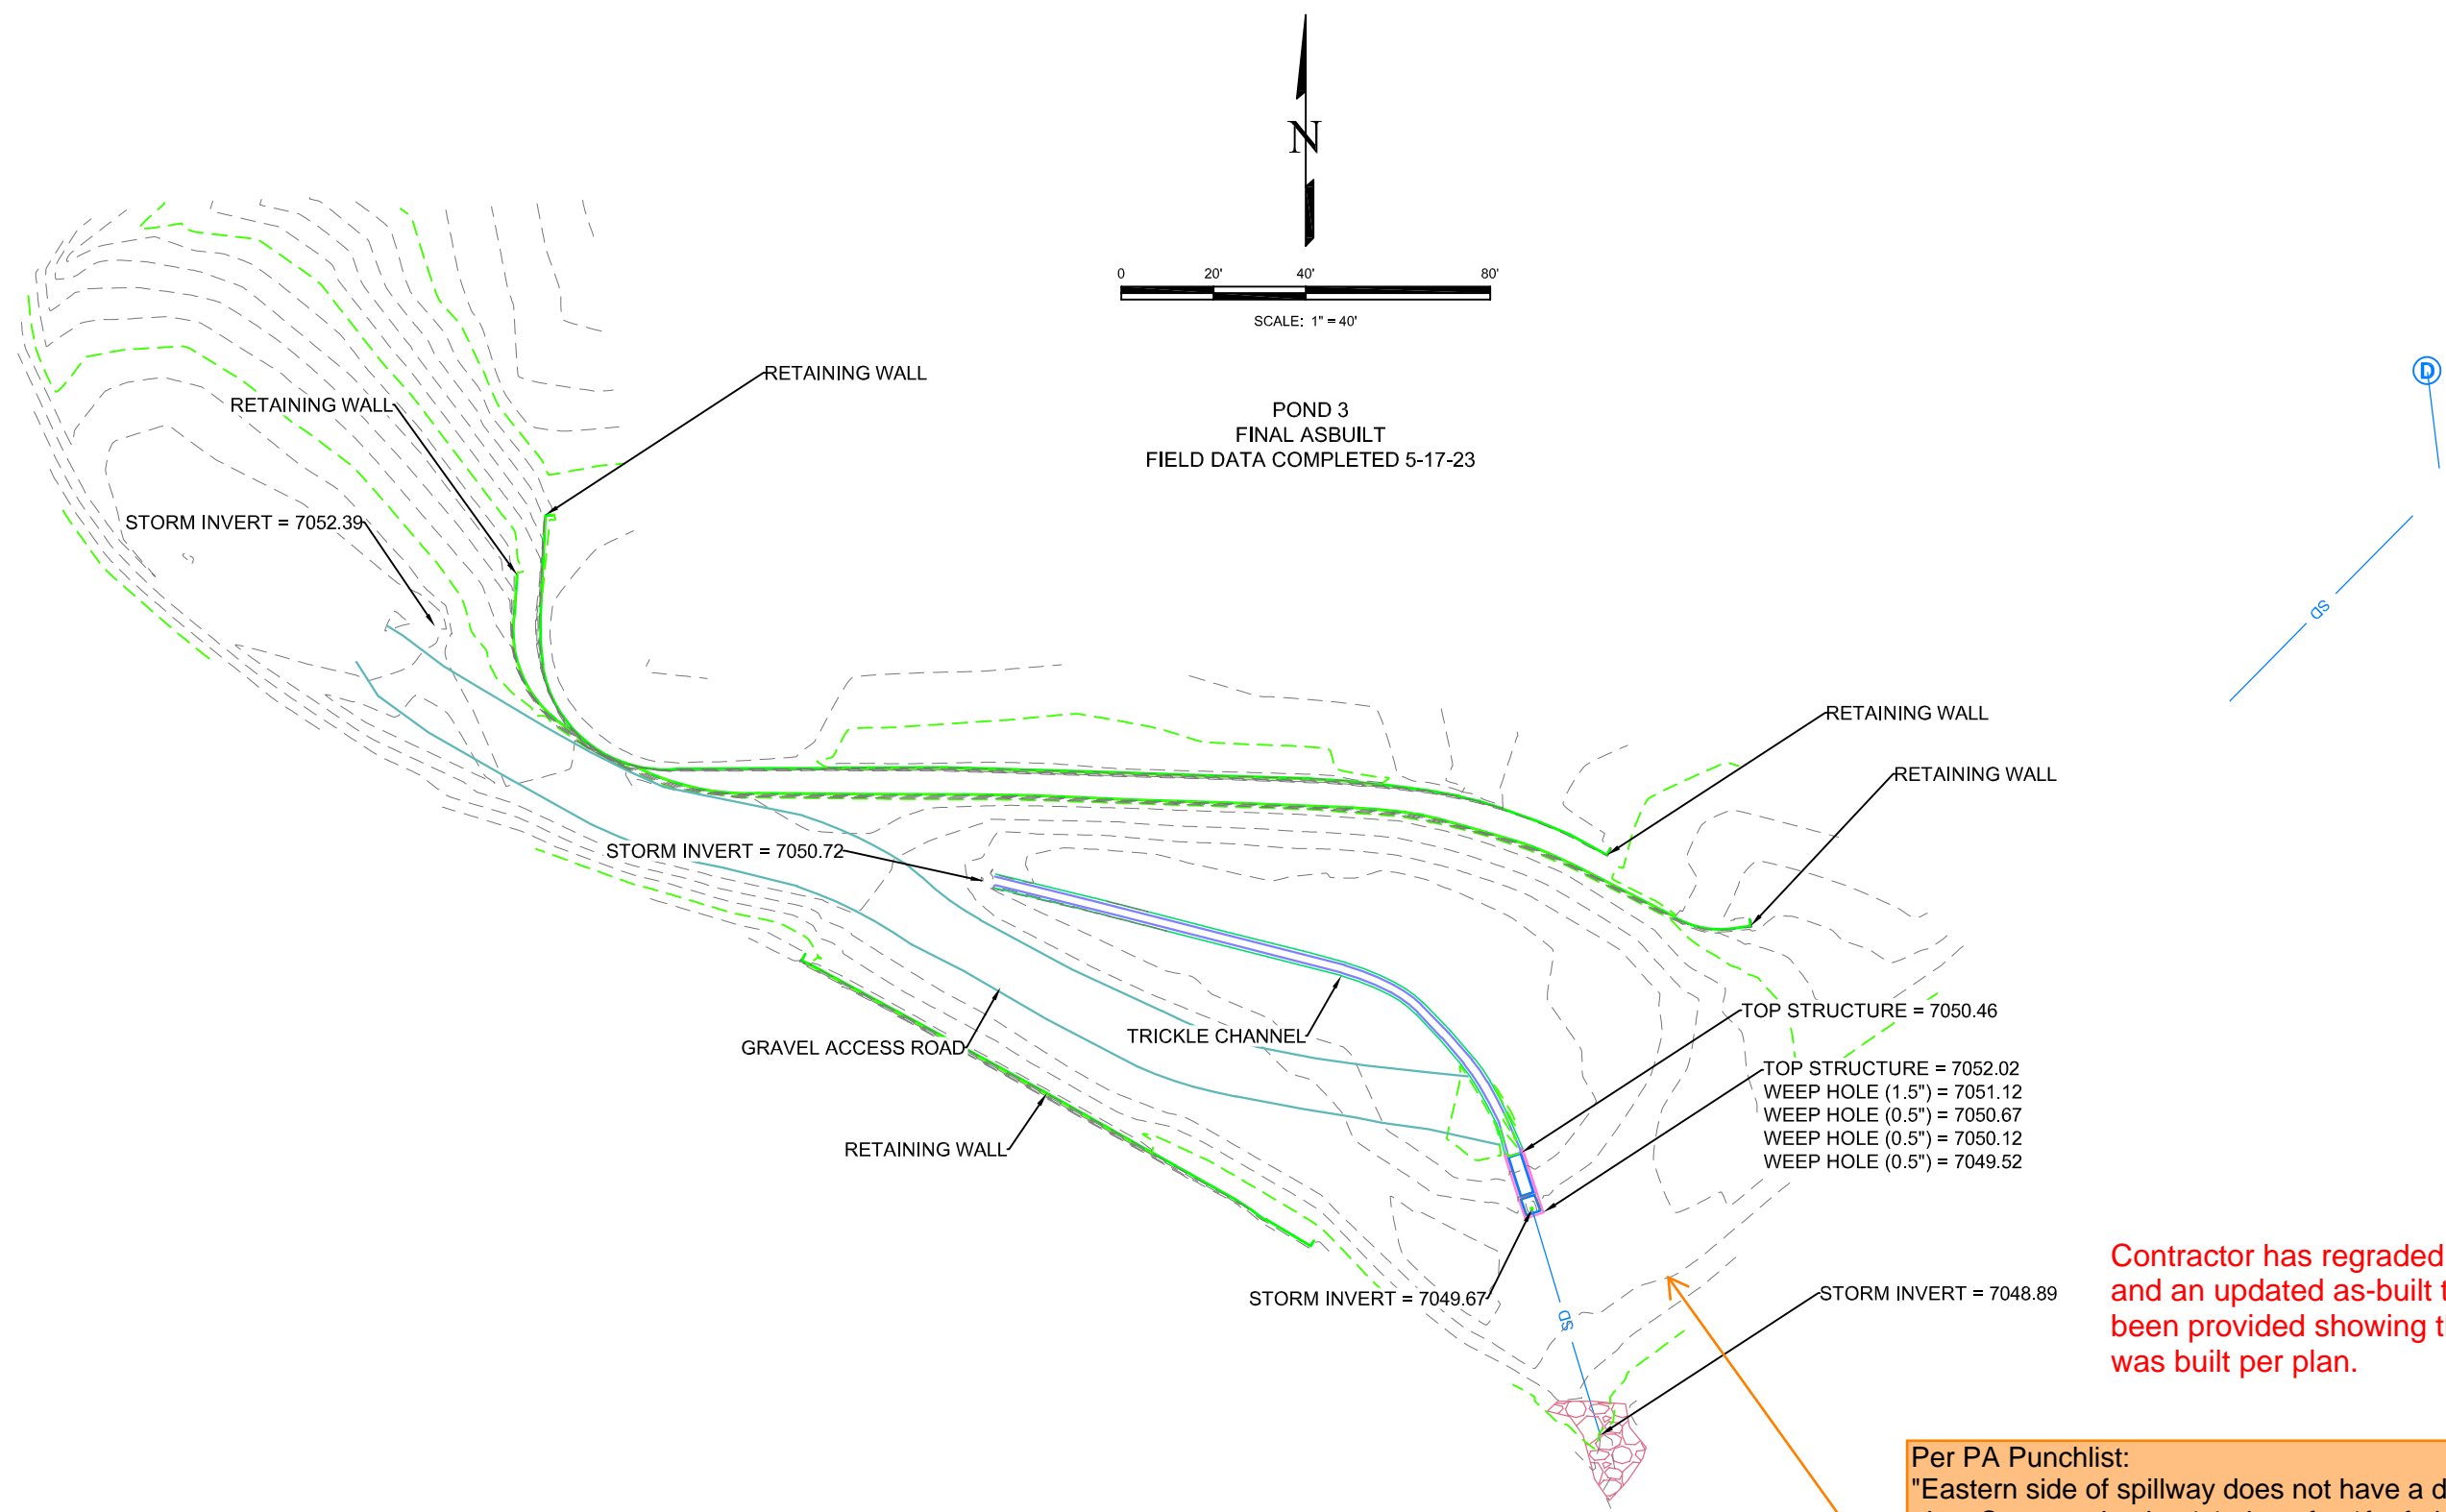
Per PA Punchlist:  
"Eastern side of spillway does not have a discernible embankment per plan. Supposed to be 4:1 slope for 1ft of elevation. Elevations of spillway crest or embankment likely not built per plan. Construct per plan."  
Or come up with a suitable alternative spillway design that is at an acceptable depth and properly armored.

Contractor has regraded this area, and an updated as-built topo file has been provided showing the spillway was built per plan.

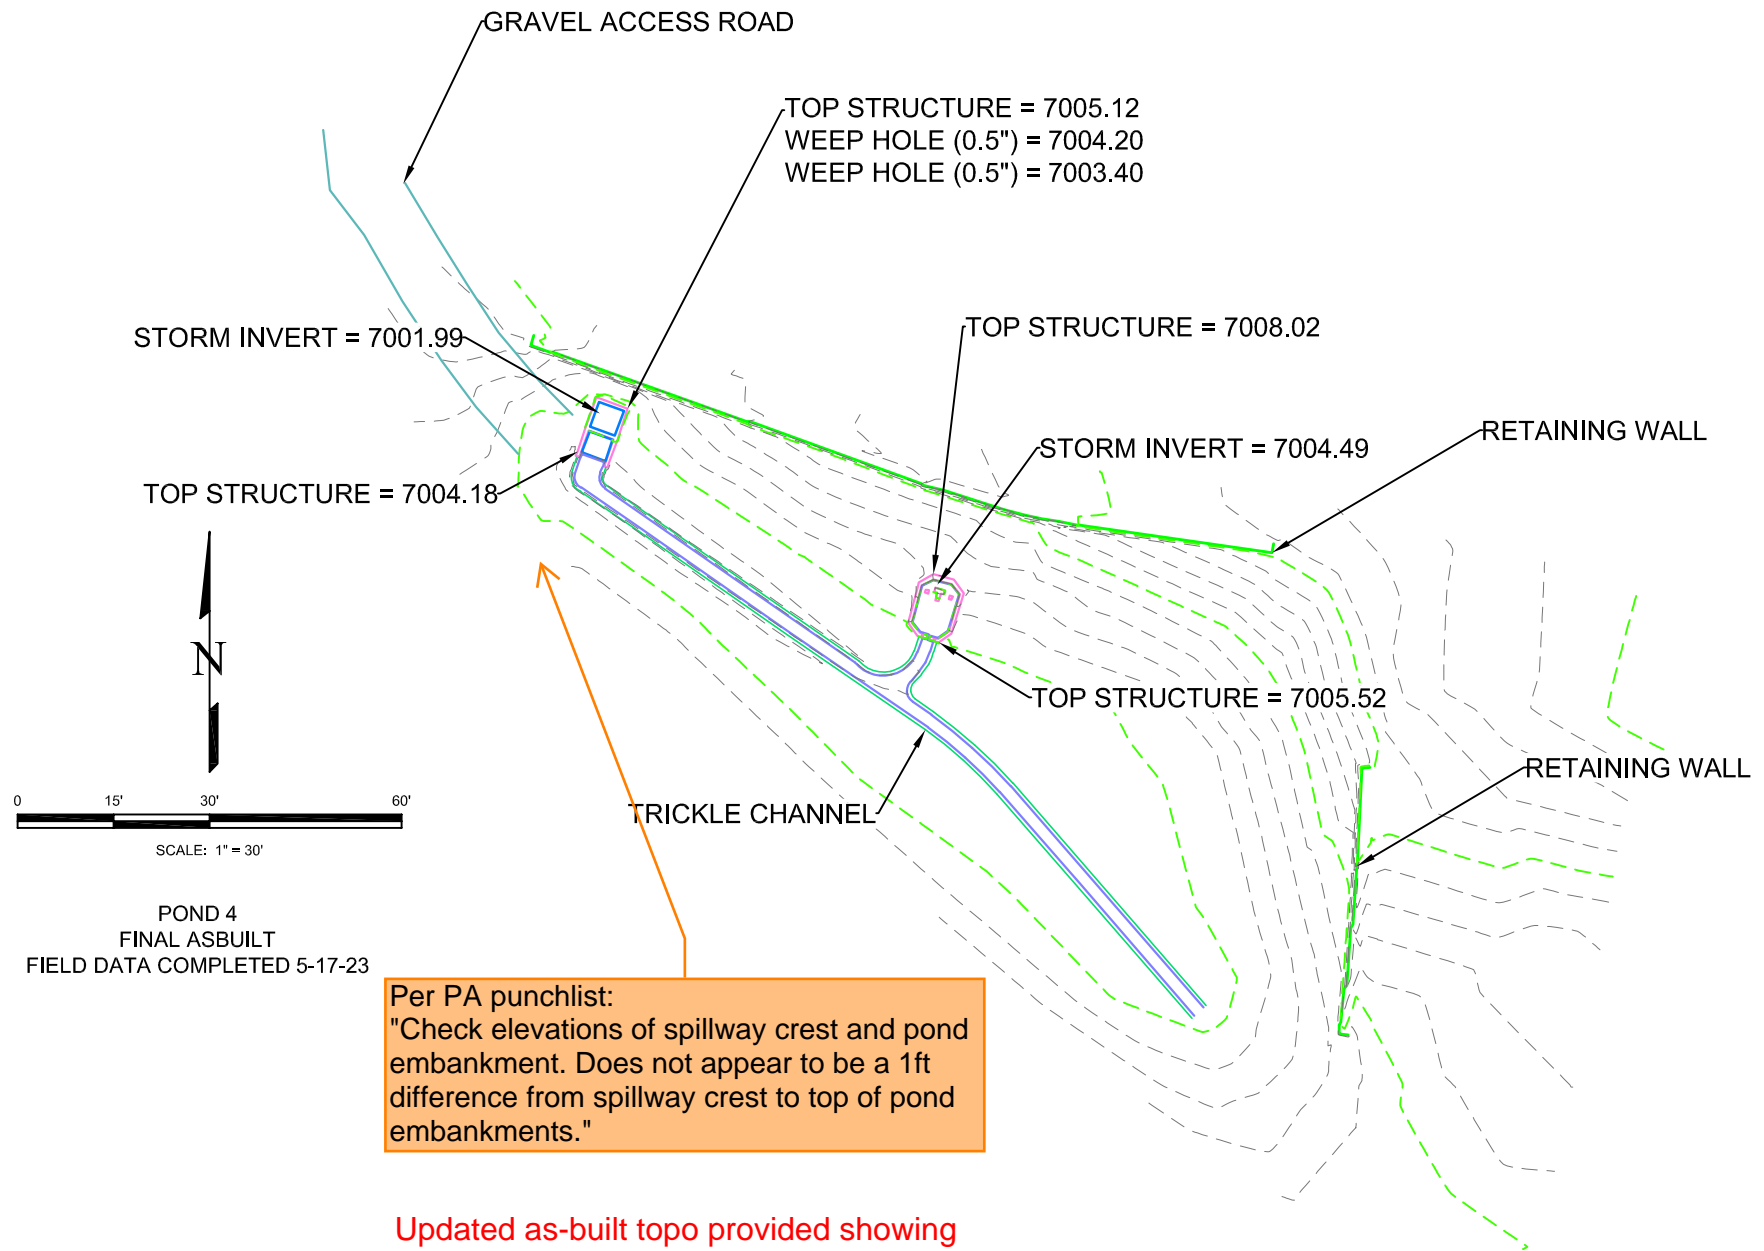
Per PA punchlist:  
"Check elevations of spillway crest and pond embankment. Does not appear to be a 1ft difference from spillway crest to top of pond embankments."

Updated as-built topo provided showing more than a foot between top of pond and spillway crest after contractor regraded this area to plan.
