March 5, 2021

La Plata Communities
1755 Telstar Drive, Suite 211
Colorado Springs, Colorado

Subject: Preliminary Geologic Hazards Evaluation
The Ranch, Phase 2
Northeast of Link Road and Squirrel Creek Road
El Paso County, Colorado
Project No. CS19053.001-115 L2

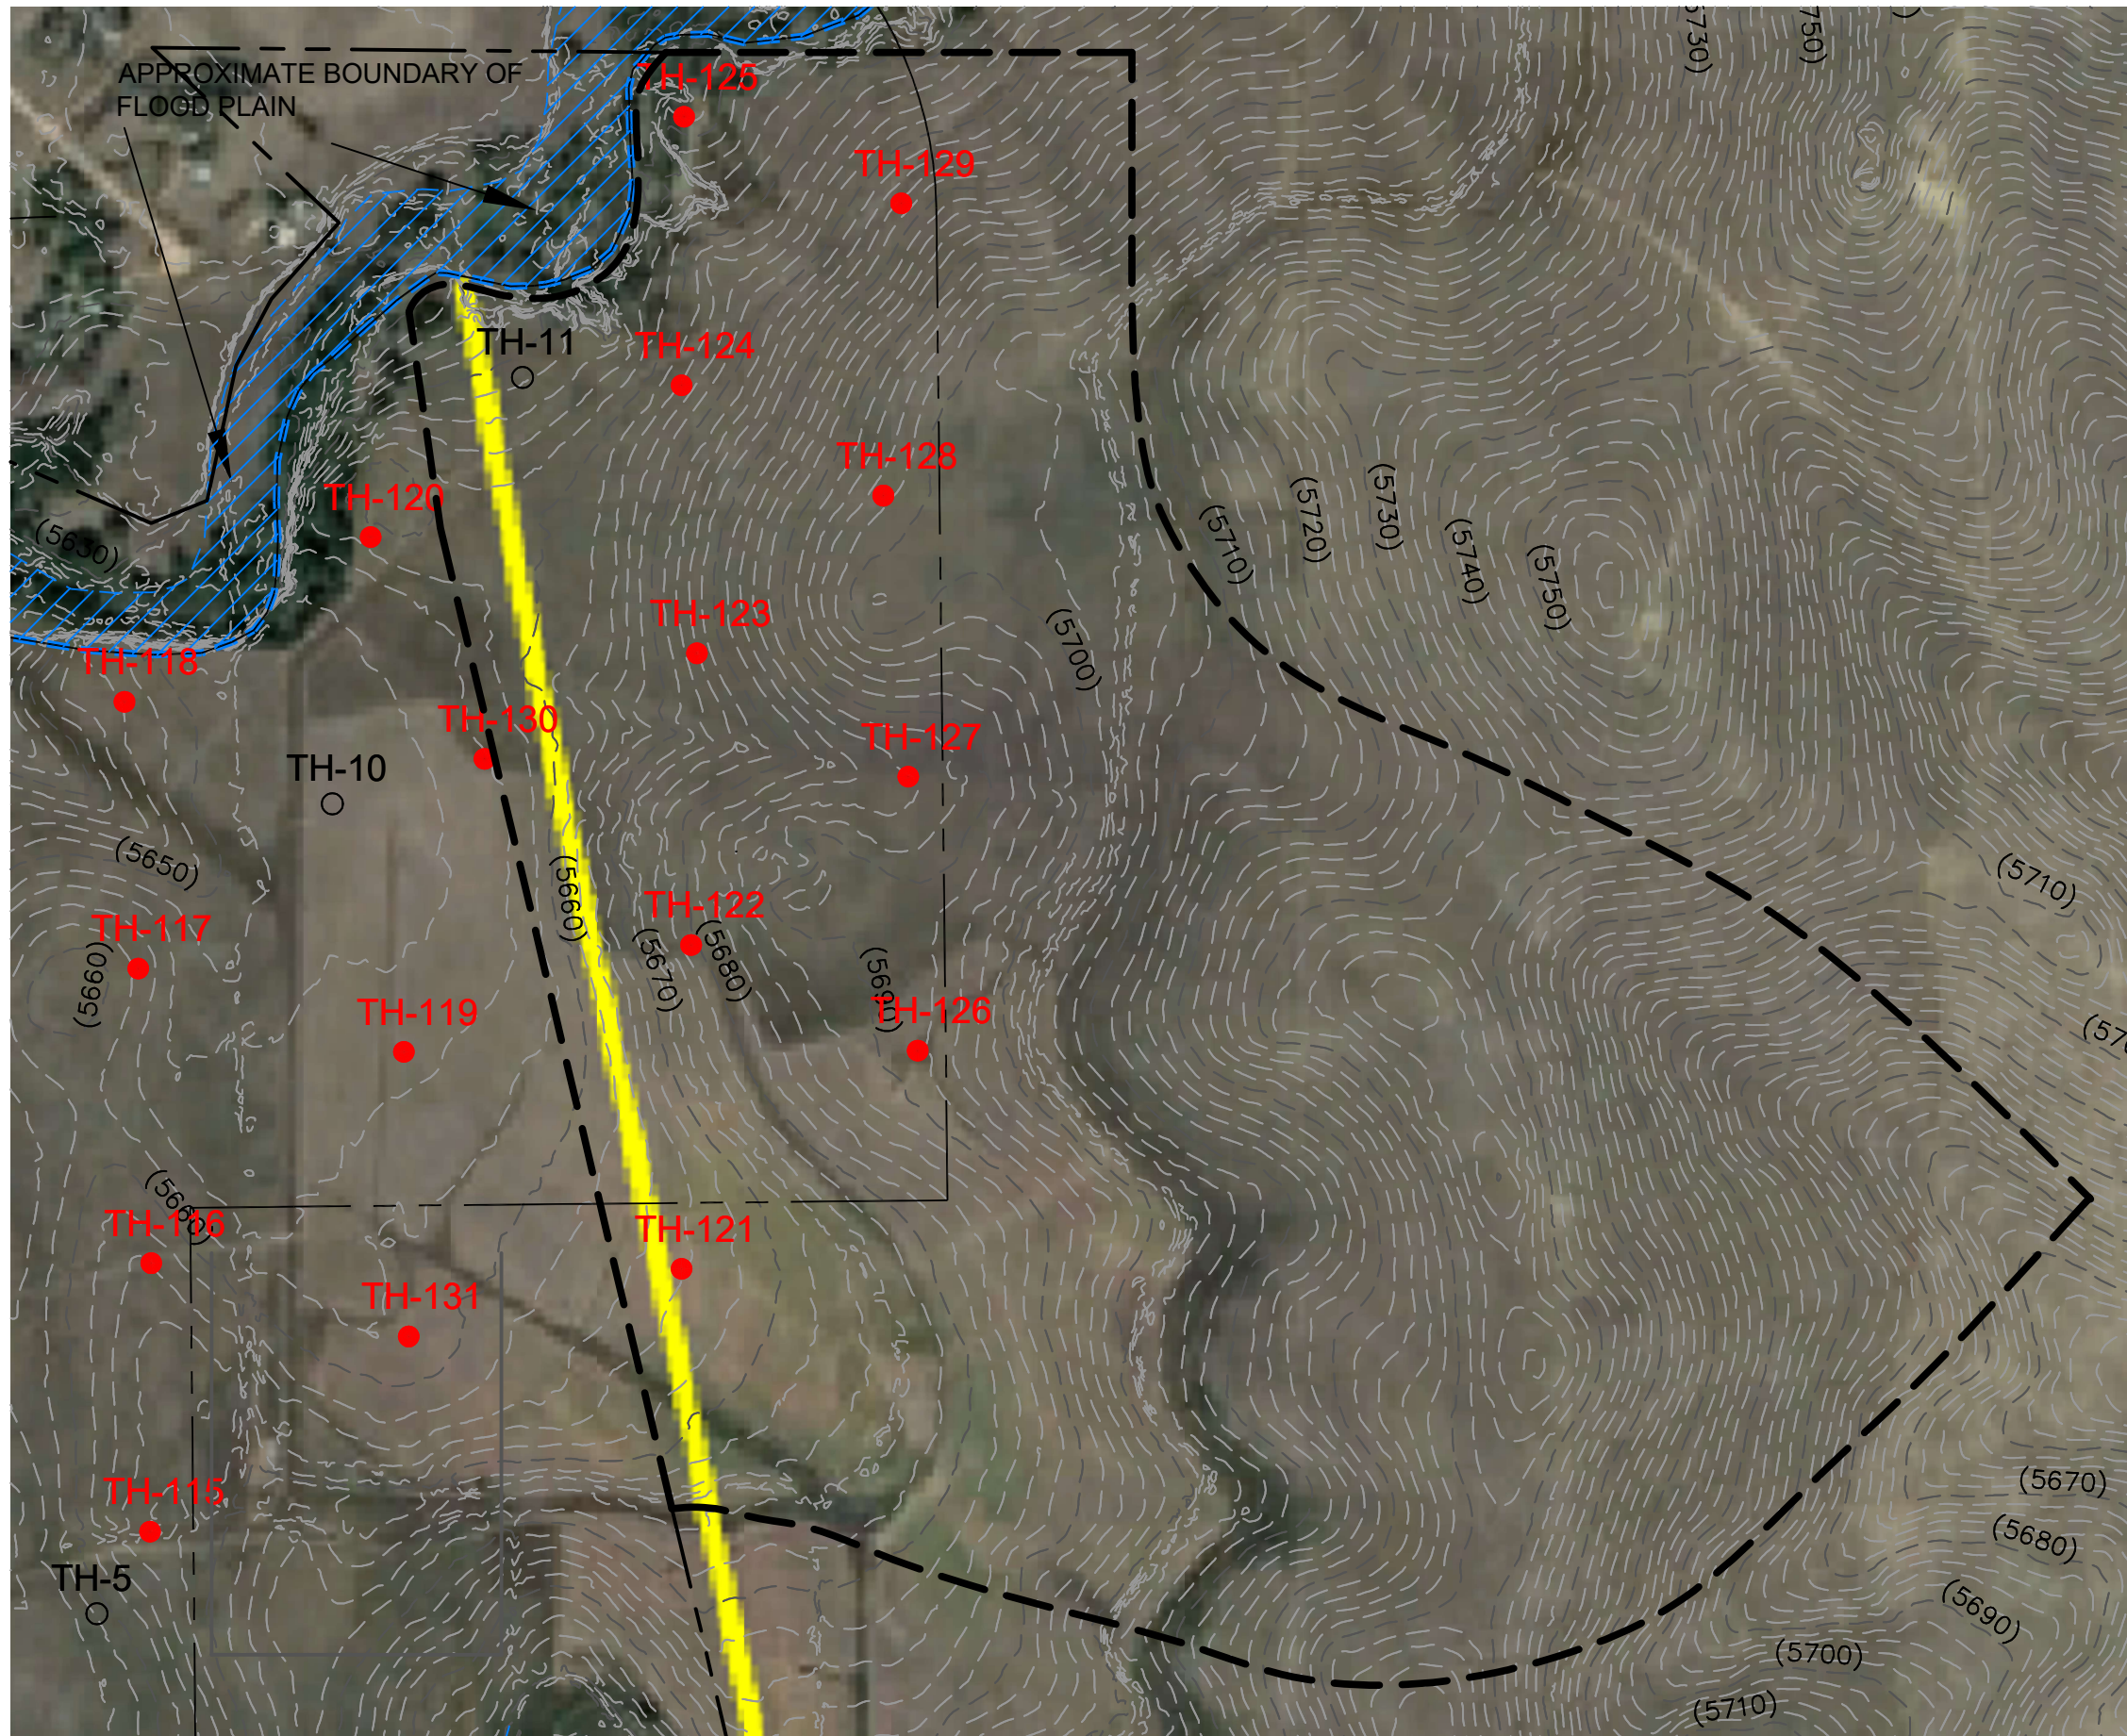
Location of Exploratory Borings

Subsurface conditions were previously investigated by drilling a total of forty-three (43) widely spaced borings across the overall Ranch site. A total of 10 borings are located in Phase 2 of the Ranch development, generally in the western half of the phase. Locations of the previous borings are presented in Fig. 1. Our interpretation of mapping of geological and engineering conditions by Charles S. Robinson and Associates, Inc are presented on Figs. 2 and 3, respectively. Exploratory boring logs from our previous investigations and laboratory test results can be found in Appendix A.

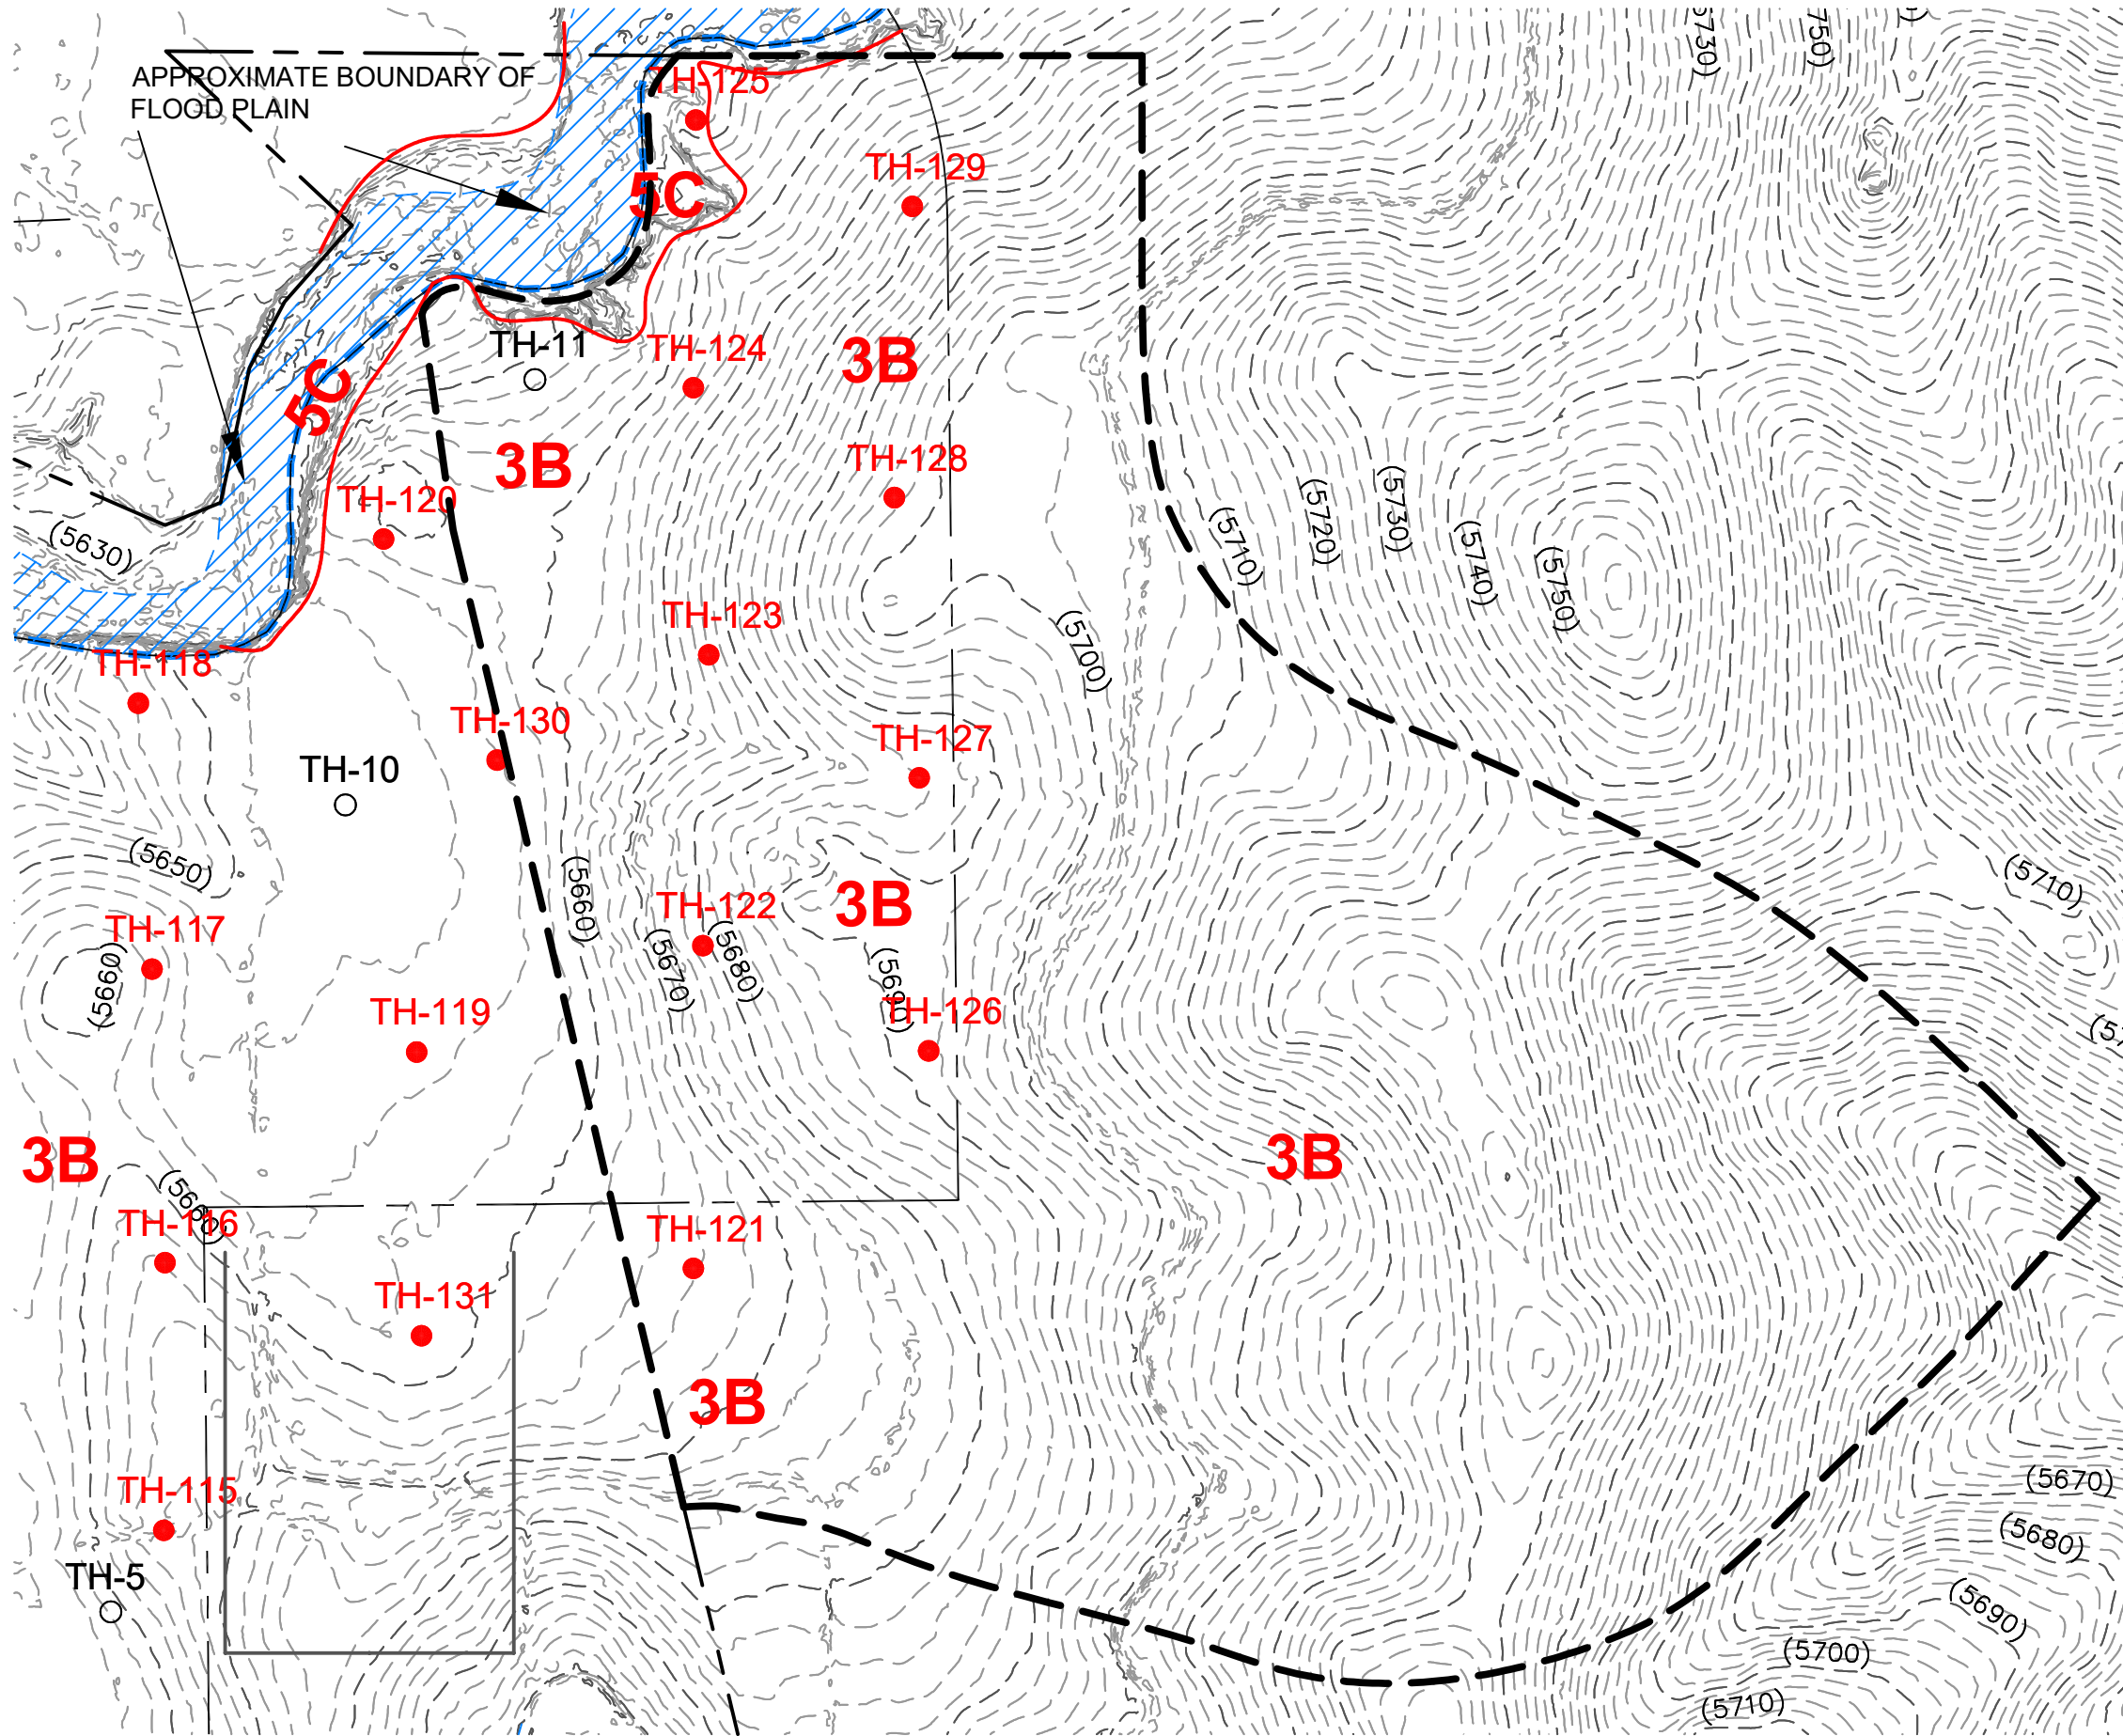
The Engineering Geology classification developed by Charles Robinson (1977) was considered for evaluation of the parcel of Silver Cross Ranch currently named The Ranch and is mapped as described below. Portions with steep, unstable and potentially unstable slopes are shown in Fig. 3, map unit 5C. These areas are typically adjacent to physiographic flood plains that are undergoing active bank

erosion. The civil engineer should determine the flood potential and inundation areas for site design. The other issues are site-wide concerns and are not depicted in Fig. 3.

Map Unit “3B” depicts expansive and potentially expansive alluvium, colluvium and bedrock on flat to moderate slopes (0-12%).

Map Unit “5C” depicts unstable or potentially unstable colluvium or bedrock on steep slopes (12-30%).

Areas with unstable or potentially unstable slopes were observed in and adjacent to Jimmy Camp Creek. Down-cutting erosion has over-steepened slopes. Over-steepened slopes are subject to creep and slump failure. A method to reduce risk is to avoid the slopes. A reasonable rule of thumb is to limit development to areas outside of a 3:1 (horizontal to vertical) line from the base of the steep slope. Grading to flatten slopes is an alternative, along with erosion protection.
