**Preliminary Acceptance Punchlist**  
**El Paso County – Department of Public Works - Stormwater Section**

Project Name:	Mountain View Academy
EDARP Filing Number(s):	CON2041, PPR208
ESQCP Number:	ESQ2017
Attendees:	DPW SW: Joshua Augustenborg, Ben Jones, Mikayla Hartford and Steve Jacobsen DPW Development Services: N/A Developer: Jon Lien
Date of Walk-Thru:	10/09/2023
Walk-Thru Number:	2

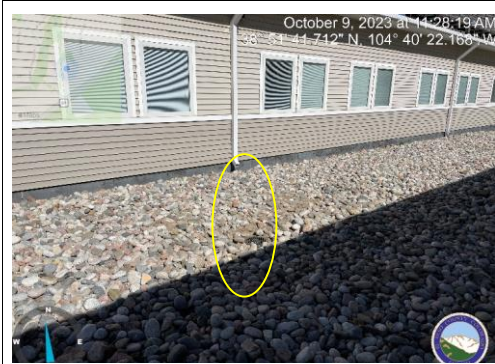
- Please verify the area drain on east side of building is installed and the system is functioning.
- The underdrain system where area drain is present on the west side of the building is holding water. Ensure the system is not clogged/broken. Reference Construction Drawing sheet C3.10 of the CDs.

Photo 1: The underdrain system where area drain is present is holding water. Ensure the system is not clogged/broken.

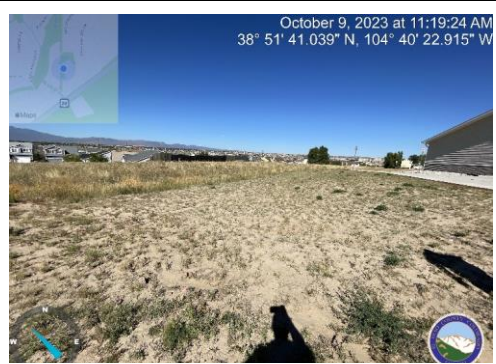
- Sparse vegetation west of building. Reference Construction Drawing sheet C3.7 of the GEC.
- South side of access road/detention pond embankment 4:1 slope is highly eroded/undercut in multiple locations. Reference Construction Drawing sheet C3.5 Sections A-A, B-B and C-C of the CDs.

Photo 2: Sparse vegetation on Tract A west of area drain location.

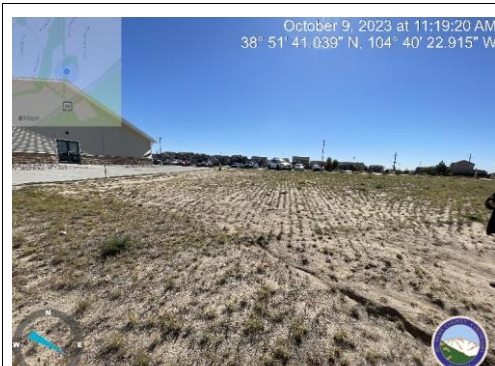
Photo 3: Sparse vegetation on Tract A west of area drain location.

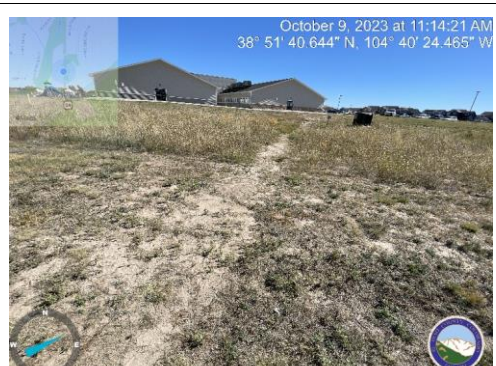
Photo 4: Sparse vegetation on Tract A west of area drain location.

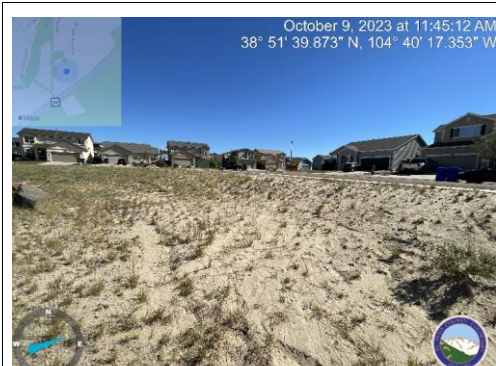
- The 20-foot sidewalk at the west side of the school drains to the west towards properties and the existing cul-de-sac. There has been significant erosion and flooding at a property to the south of the cul-de-sac. The approximately 200-foot long and 20-foot-wide sidewalk creates imperviousness on the property where there previously was not and may be contributing to the erosion by increasing concentrated flows. This increased imperviousness needs to be accounted for and managed. See photos 5 and 6 to see some erosion downstream of the sidewalk.

Photo 5: Sparse vegetation on the east banks of Trickle channel is causing erosion. Sediment from slopes needs to be cleaned out of channel.

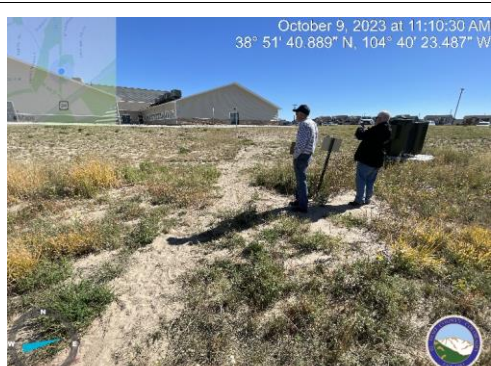
Photo 6: Sparse vegetation, sedimentation, and erosion on Tract A west of the 20' sidewalk location.

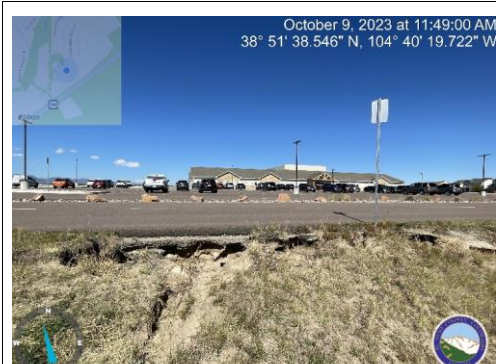
Photo 7: South side of parking/detention pond embankment lot is highly eroded/undercut in multiple locations.

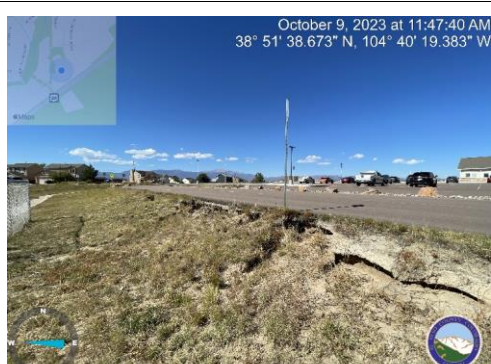
Photo .8: South side of parking/detention pond embankment lot is highly eroded/undercut in multiple locations.

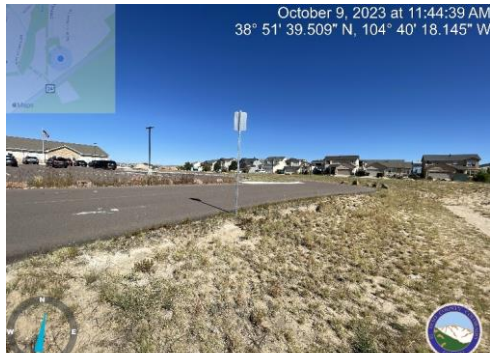
Photo 9: South side of parking/detention pond embankment lot is highly eroded/undercut in multiple locations.

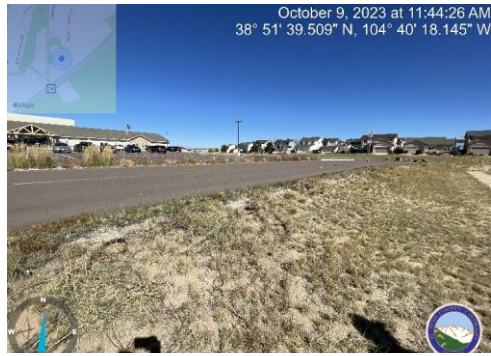
Photo 10: South side of parking/detention pond embankment lot is highly eroded/undercut in multiple locations.

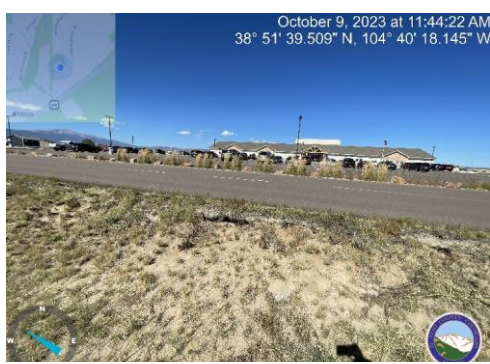
Photo 11: South side of parking/detention pond embankment lot is highly eroded/undercut in multiple locations.

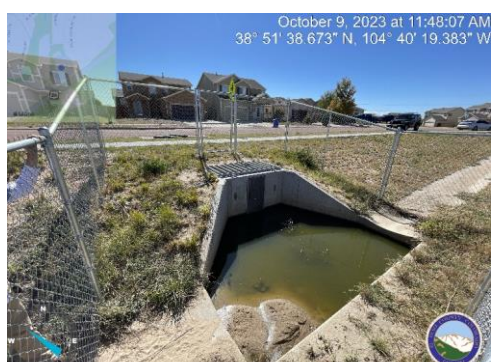
- Sediment build-up in micro pool of outlet structure needs to be cleaned out.
- Sparse vegetation on the east banks of Trickle channel is causing erosion. Sediment from slopes needs to be cleaned out of trickle channel and slopes stabilized

Photo 12: Sediment build up in micro pool of outlet structure needs to be cleaned out.
