**Preliminary Acceptance Punchlist**  
**El Paso County – Department of Public Works - Stormwater Section**

Project Name:	Security Fire Station #4
EDARP Filing Number(s):	PPR2029 CON2228
ESQCP Number:	ESQ2223
Attendees:	DPW SW: Glenn Reese, Dylan Finley DPW Dev Services: David Parkerson Developer: Neil Parker
Date of Walk-Thru:	05/23/2023
Walk-Thru Number:	1

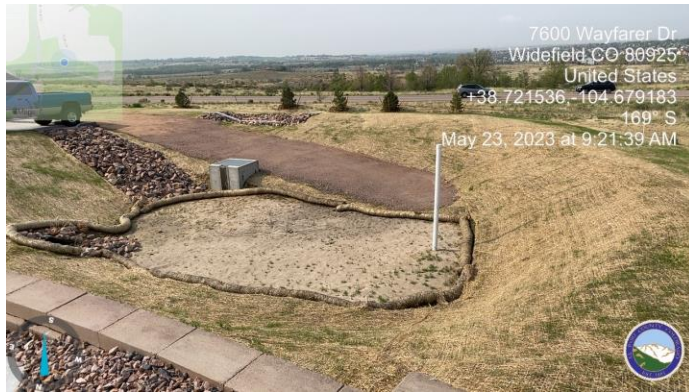
- Riser pipe for underdrain needs to be cut to an appropriate height.
- Gasket/caulking missing from orifice plate.
- Restrictor plate missing two bolts.

Photo 1: Riser pipe needs to be cut to an appropriate height.

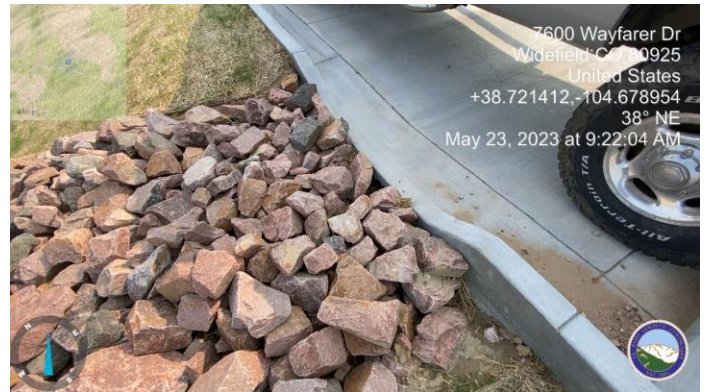
- Undercutting occurring at riprap rundown at southeast corner of pond
- Area drain at north east corner requires re-grading to promote positive drainage.

Photo 2: Undercutting occurring at riprap rundown

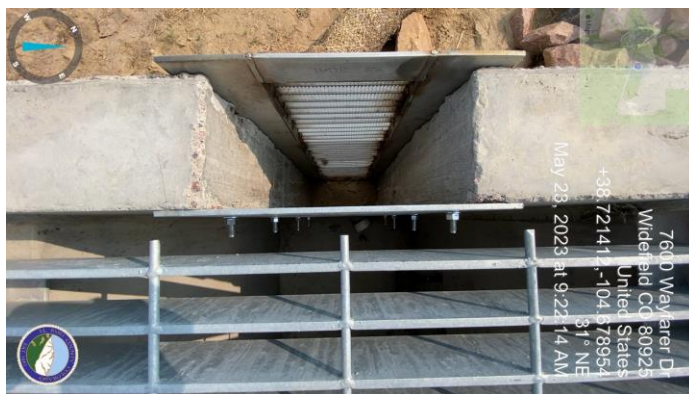
Photo 3: Gasket missing from orifice plate

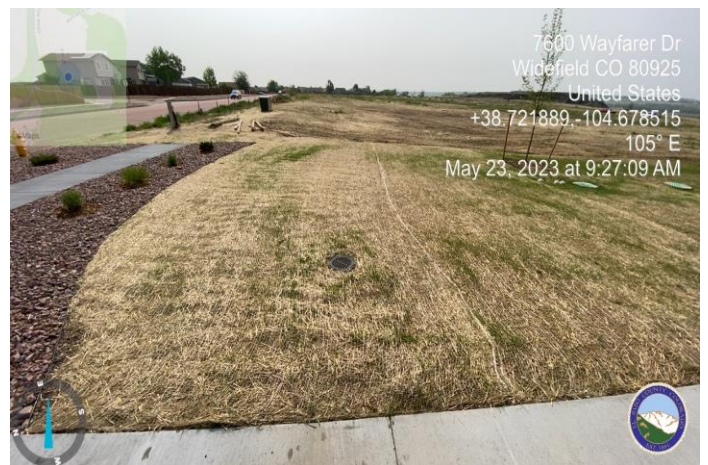
Photo 4: Grade to promote positive drainage to area drain
