## PAVEMENT EVALUATION

**The Ridge at Lorson Ranch, Filing No. 2  
El Paso County, Colorado**

**JOB NO. 196427**

**May 20, 2024  
REV: June 4, 2024**

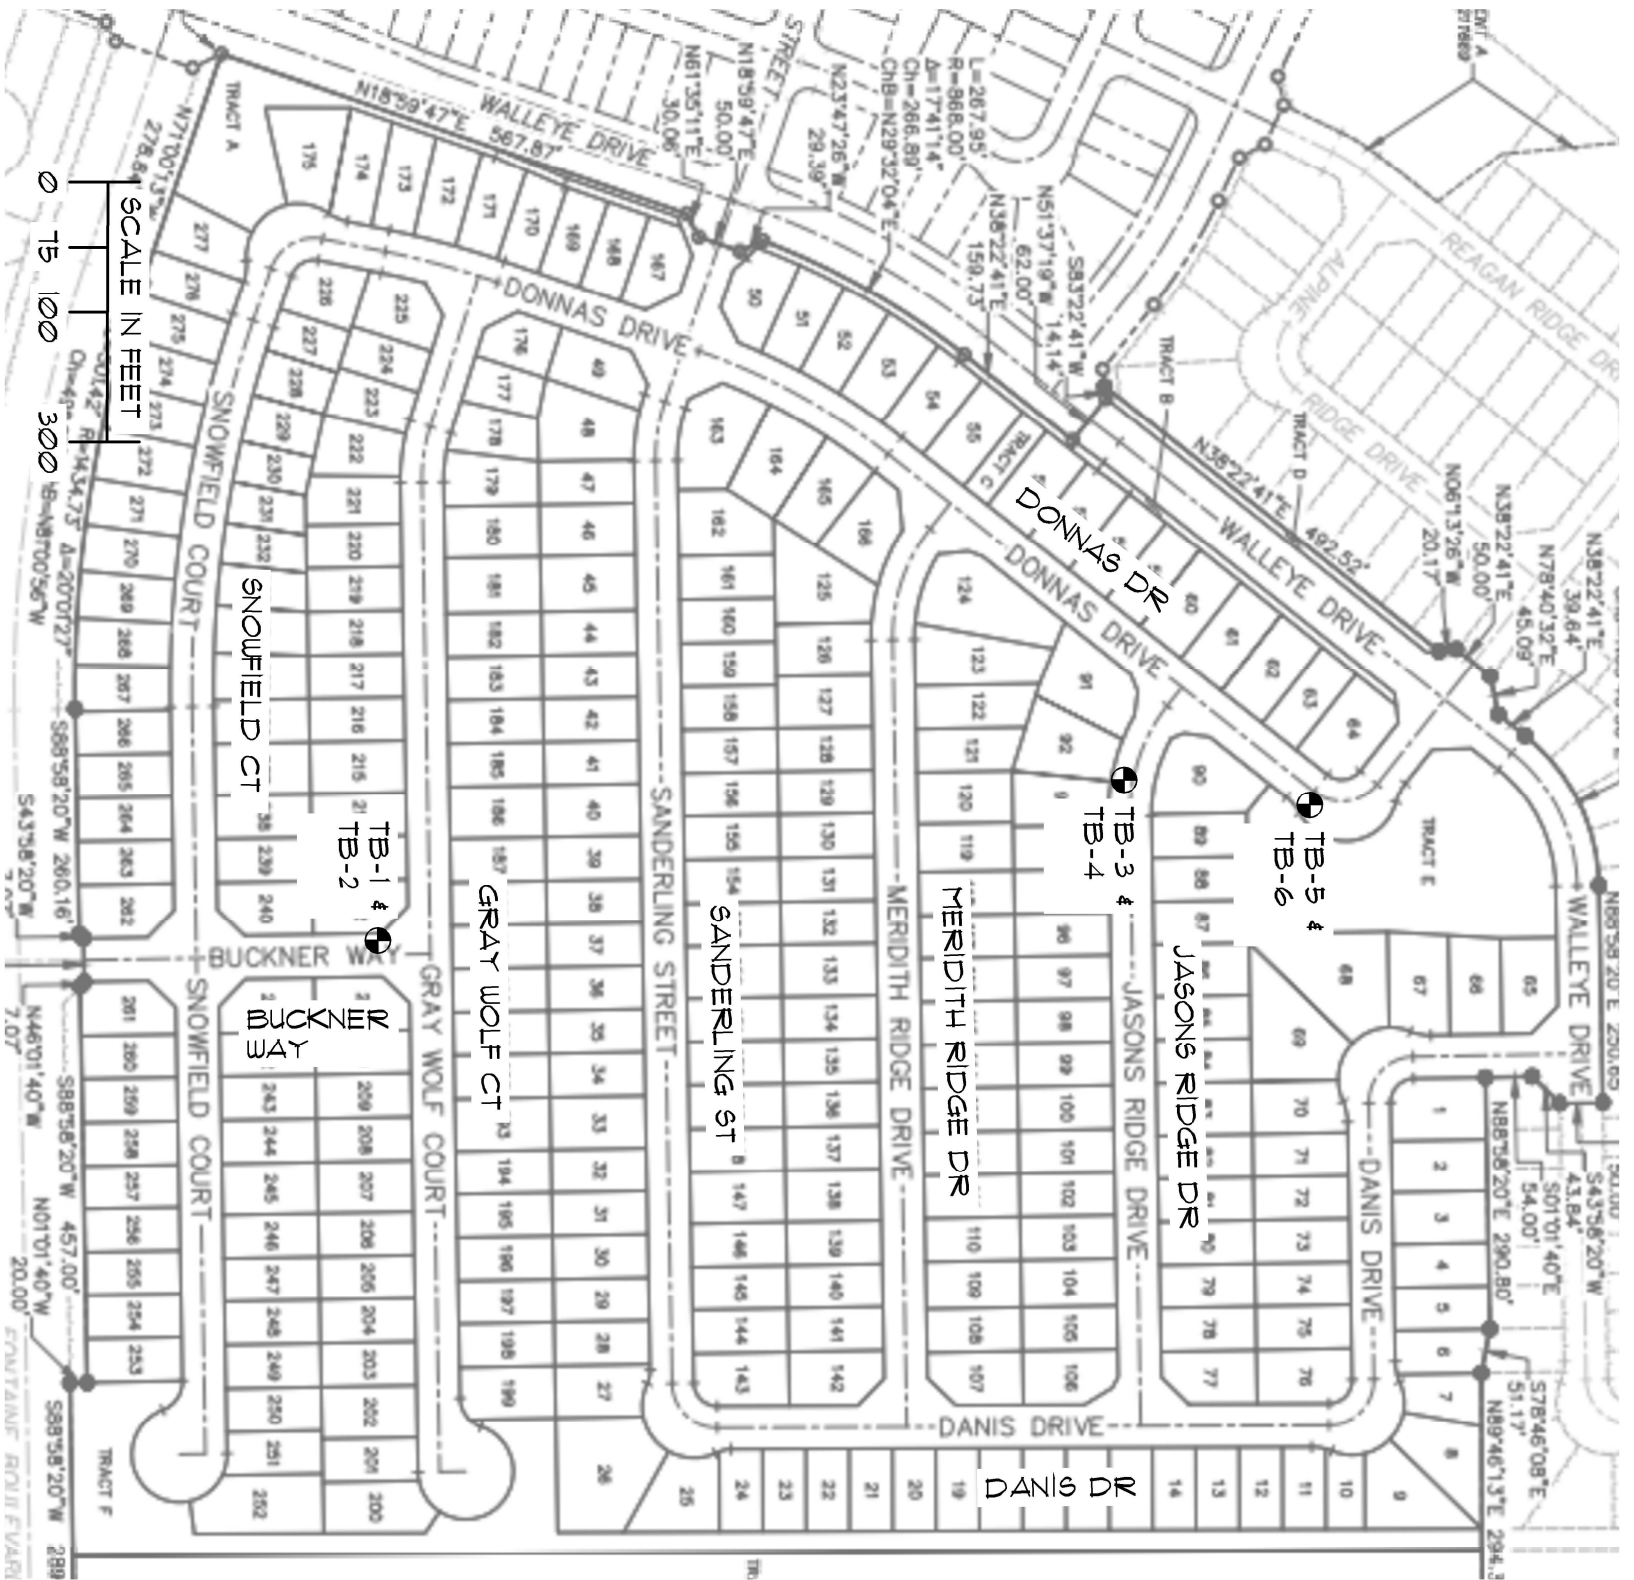
TEST BORING LAYOUT PLAN  
 SHEET No. **FIG-2**

The apparent heave observed by RMG was primarily located along the edges of the pavement, adjacent to the curb and gutter, or at the pavement penetrations (manholes, shutoff valves, etc.). The test borings and sampling performed by RMG consisted of three groups of two test borings, with each group including one boring in the portion of pavement exhibiting signs of heave (typically adjacent to the gutter), and one boring near the middle of the roadway where heaving was not observed. RMG did not perform test borings near the pavement penetrations due to the risk of damaging the utilities below. The subsurface materials encountered in the test borings generally consisted of overlot fill composed of silt to clay extending to the 4-foot termination depths of the test borings.
