Subject: Drive Area Geotechnical Evaluation
Existing Commercial Property
2675 Akers Drive
Colorado Springs, Colorado
Project No. 16-173339.2

PAVEMENT EVALUATION REPORT

2675 AKERS DRIVE
COLORADO SPRINGS, COLORADO

PROJECT NO: 0305-CS16

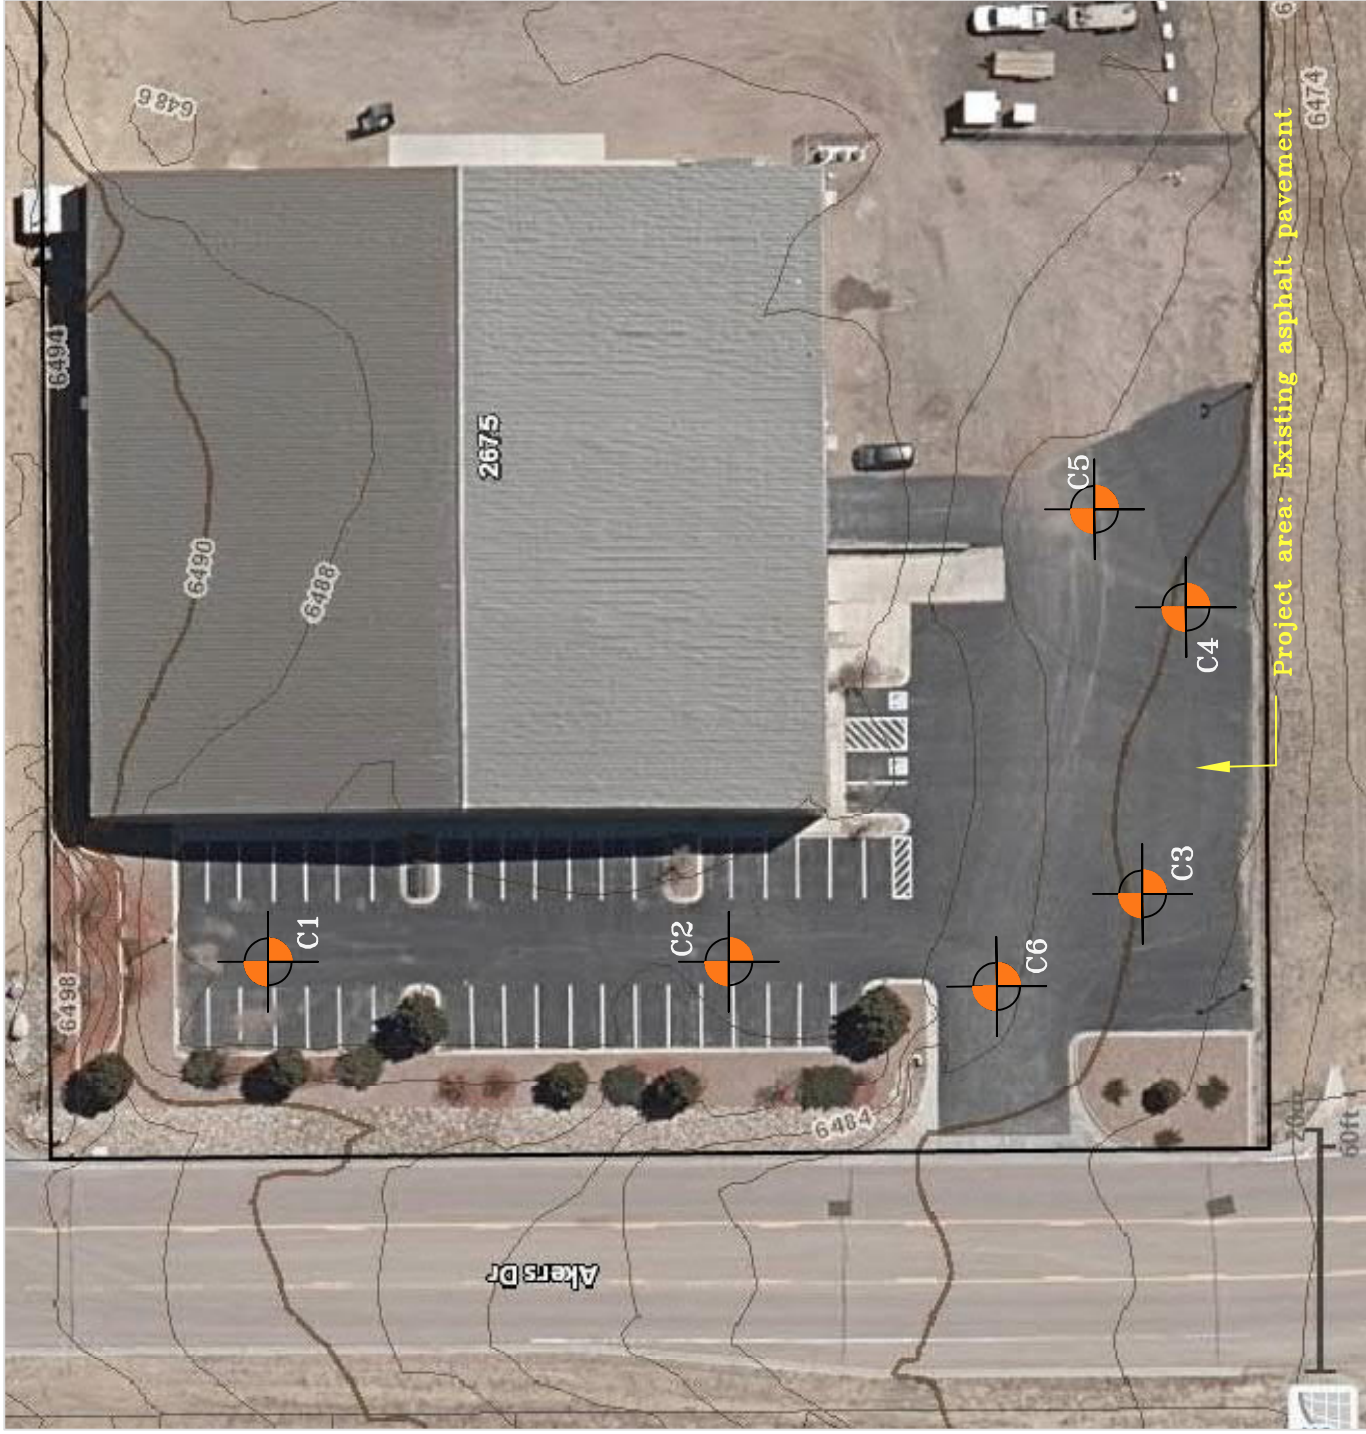
SCHEMATIC SITE PLAN

Six 8-inch diameter asphaltic concrete cores were taken at locations C1 through C6 as shown in Figure 2. Photographic documentation of asphaltic concrete cores is included in Appendix B.

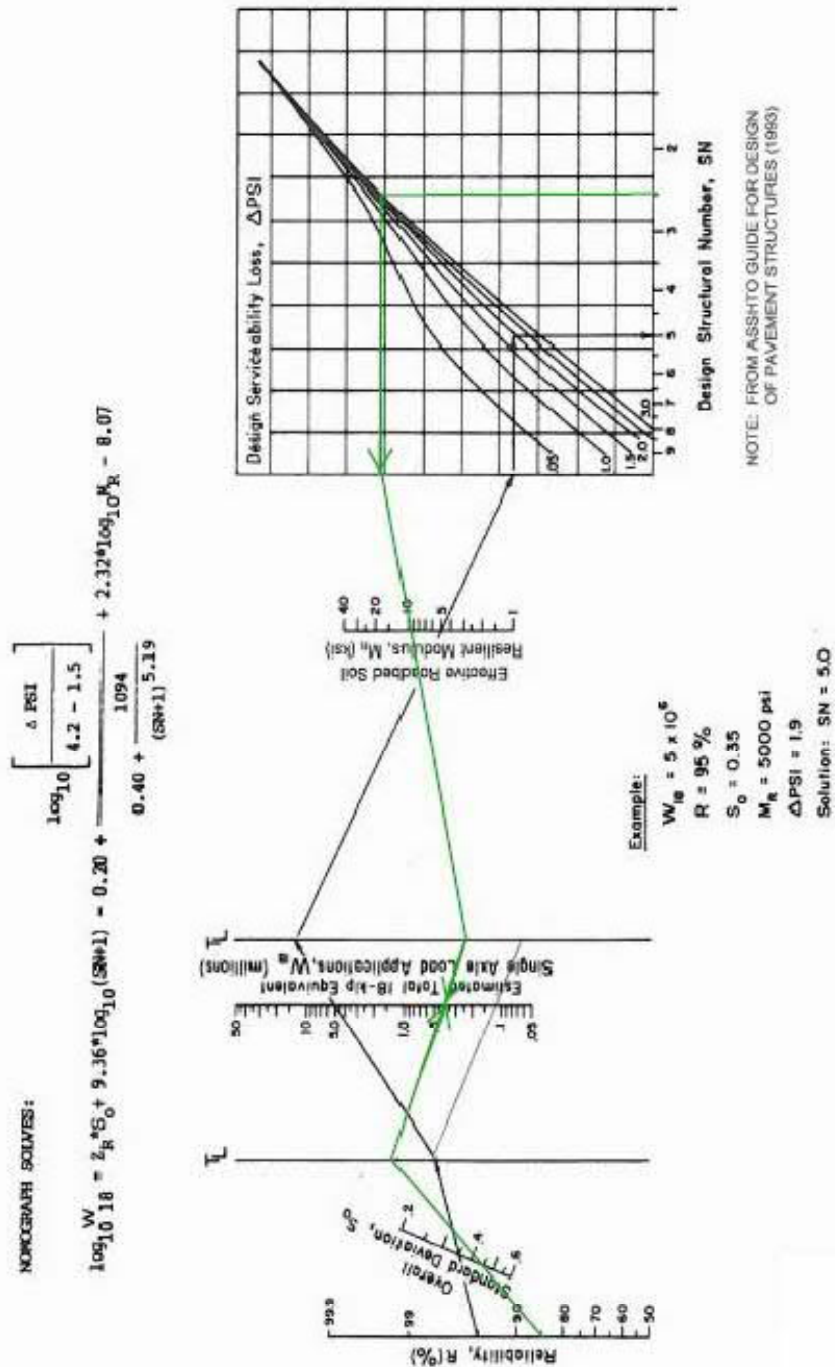
PAVEMENT DESIGN

Based on the results of our subsurface exploration, we anticipate sandy soil subgrades for pavements throughout the site, which is equivalent to soil classification between A-3 and A-2-4 in accordance with American Association of State Highway and Transportation Officials (AASHTO). We used the modified AASHTO pavement design method for the evaluation of the capacity of existing pavement. Results of our analyses and design are summarized below and illustrated in Figure 3.

- Existing average/design pavement thickness: Average 4.5-inch
- Baserock average/design thickness: Average 14-inch
- Future overlays within 20 years of design life: 1.5-inch
- Calculated existing Structural Number based on above data: 2.5

- AASHTO Subgrade Soil Classification: A-3 / A-2-4 (Sands to clayey sands; medium dense)
- Visual Distress Conditions: Less than 10% of pavement areas with linear and transverse cracking, some ponding, minimal rutting; no potholes; no evidence of subgrade failure.
- Estimated Subgrade Resilient Modulus = 10,000 psi

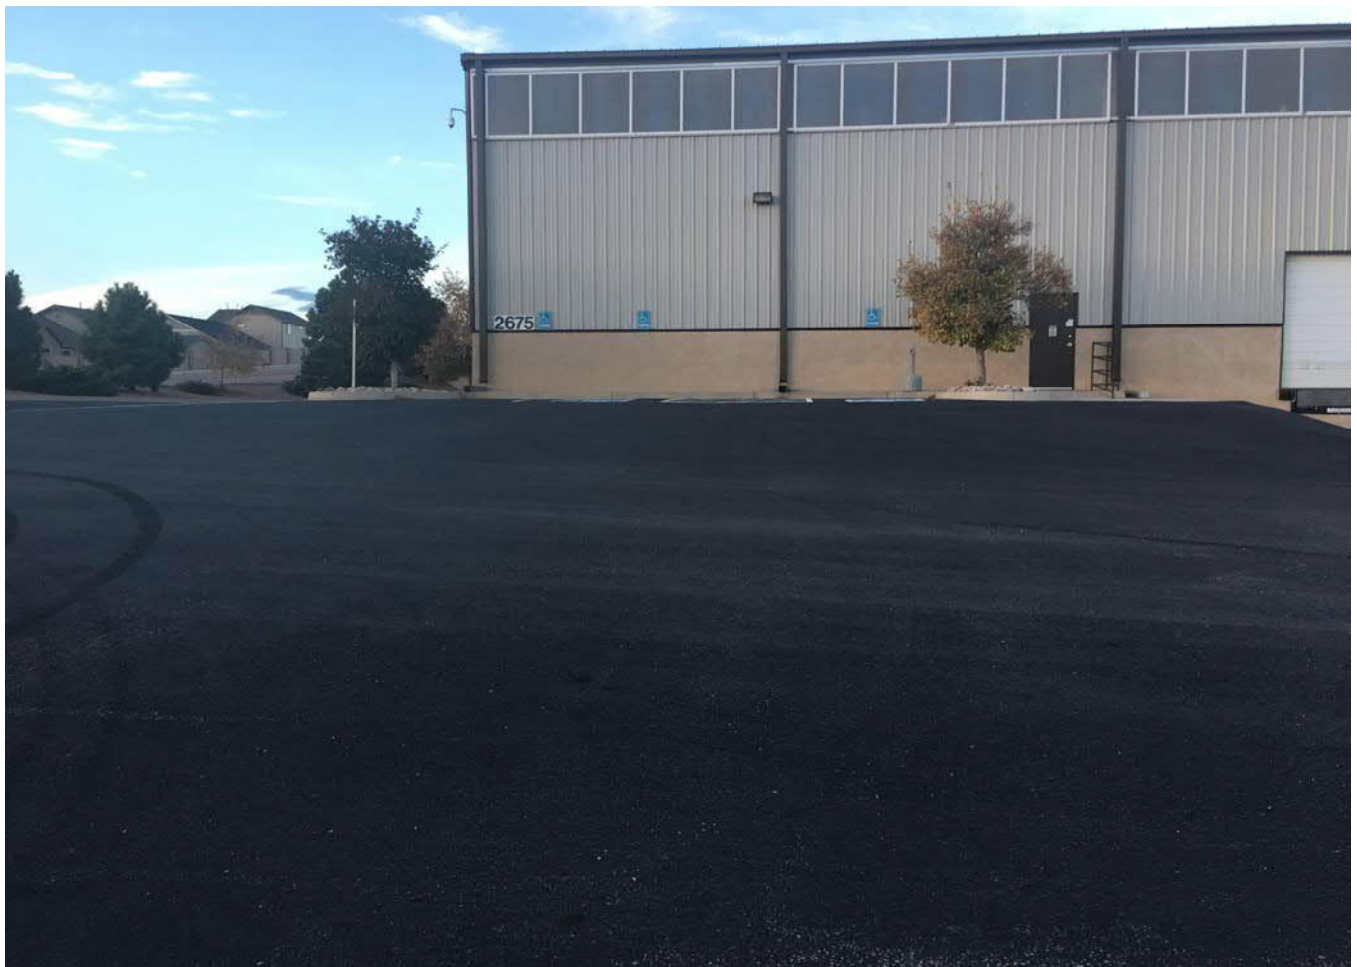
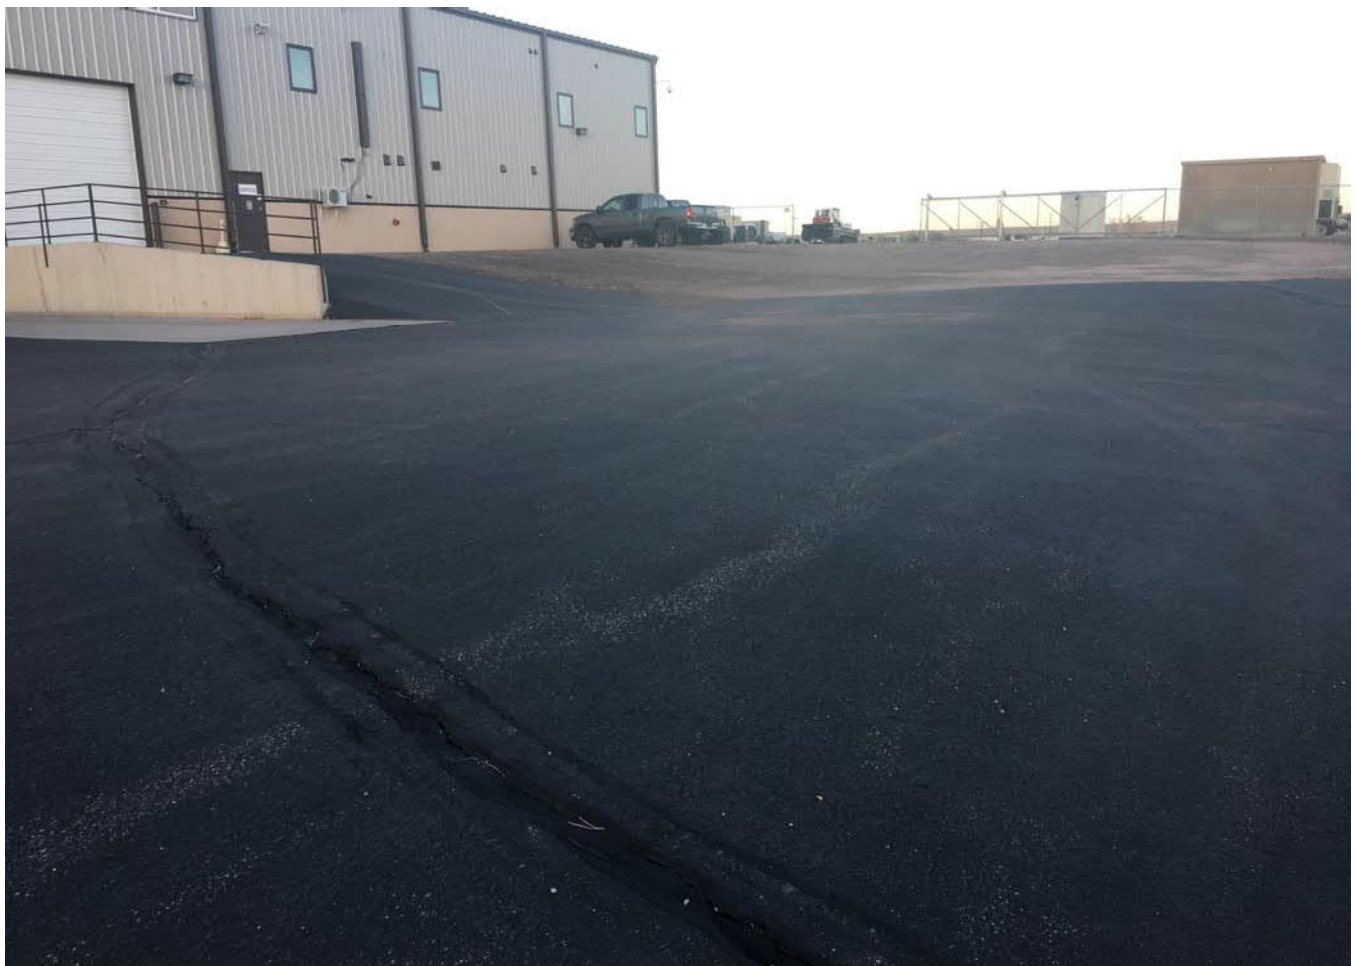
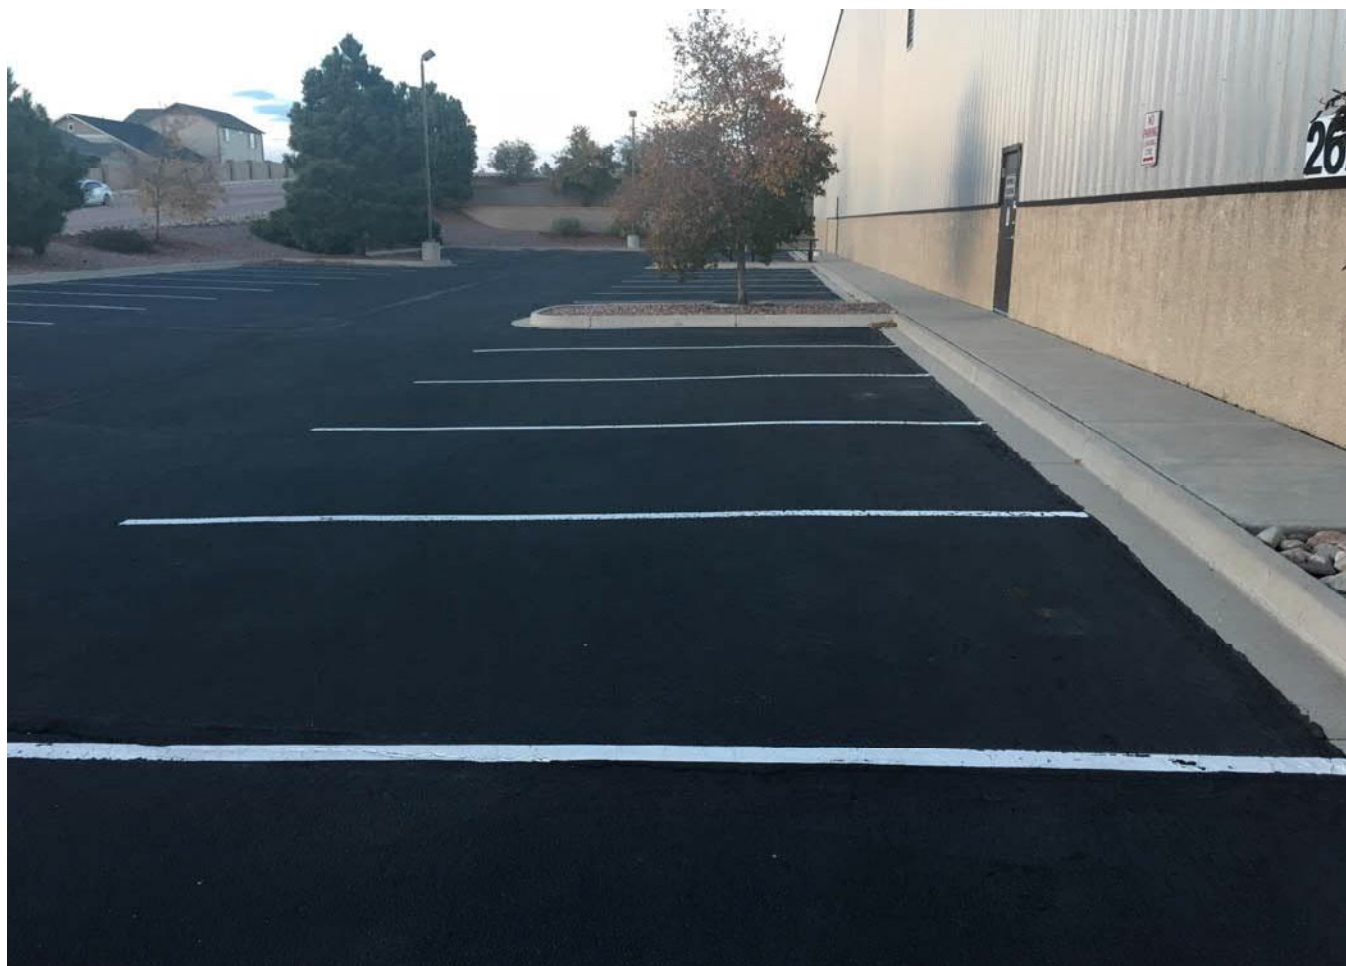
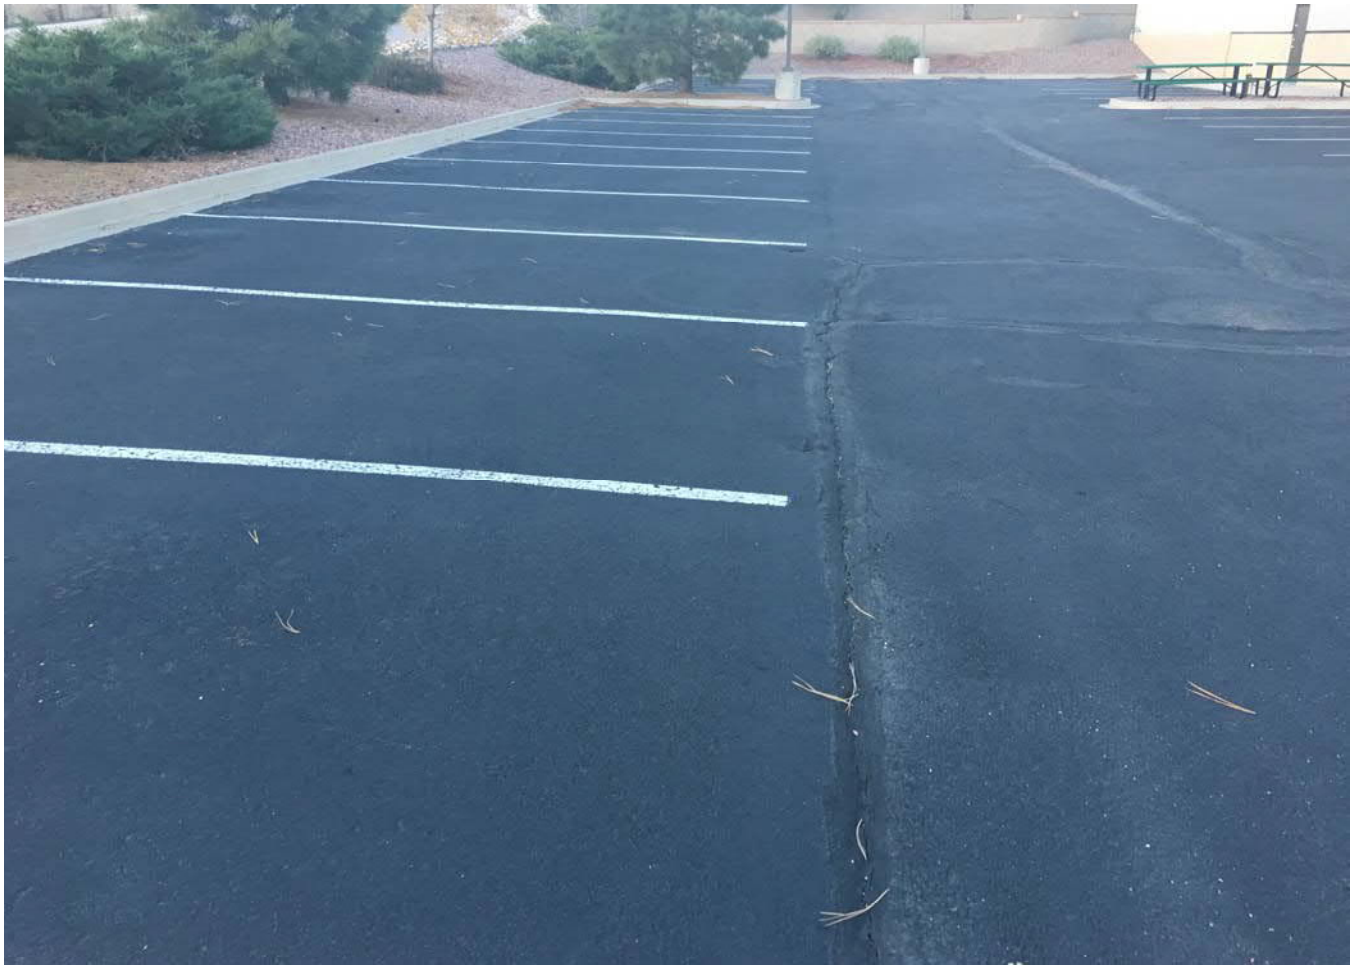
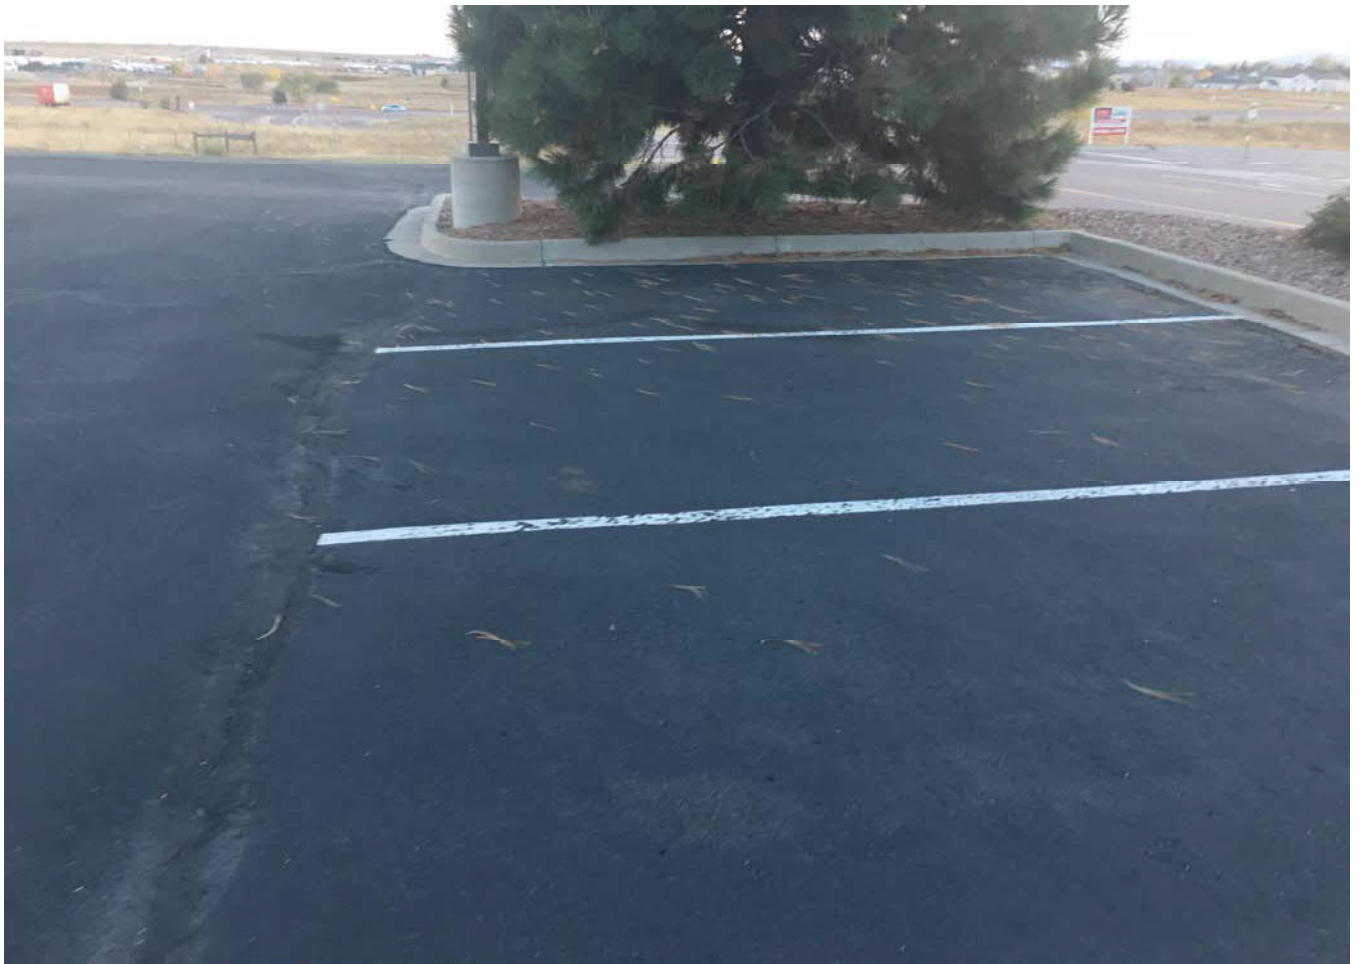
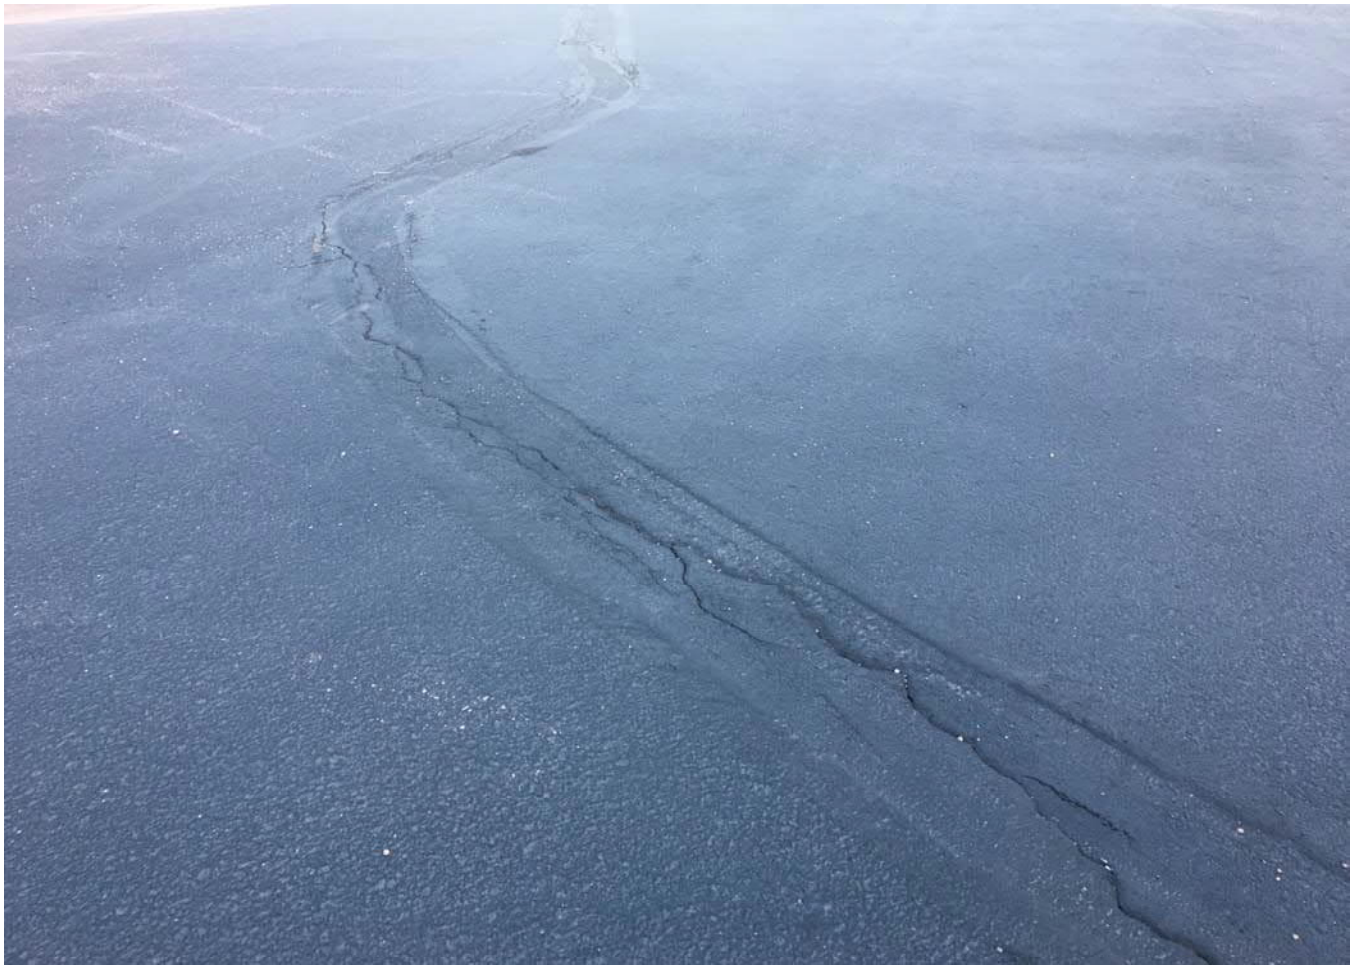
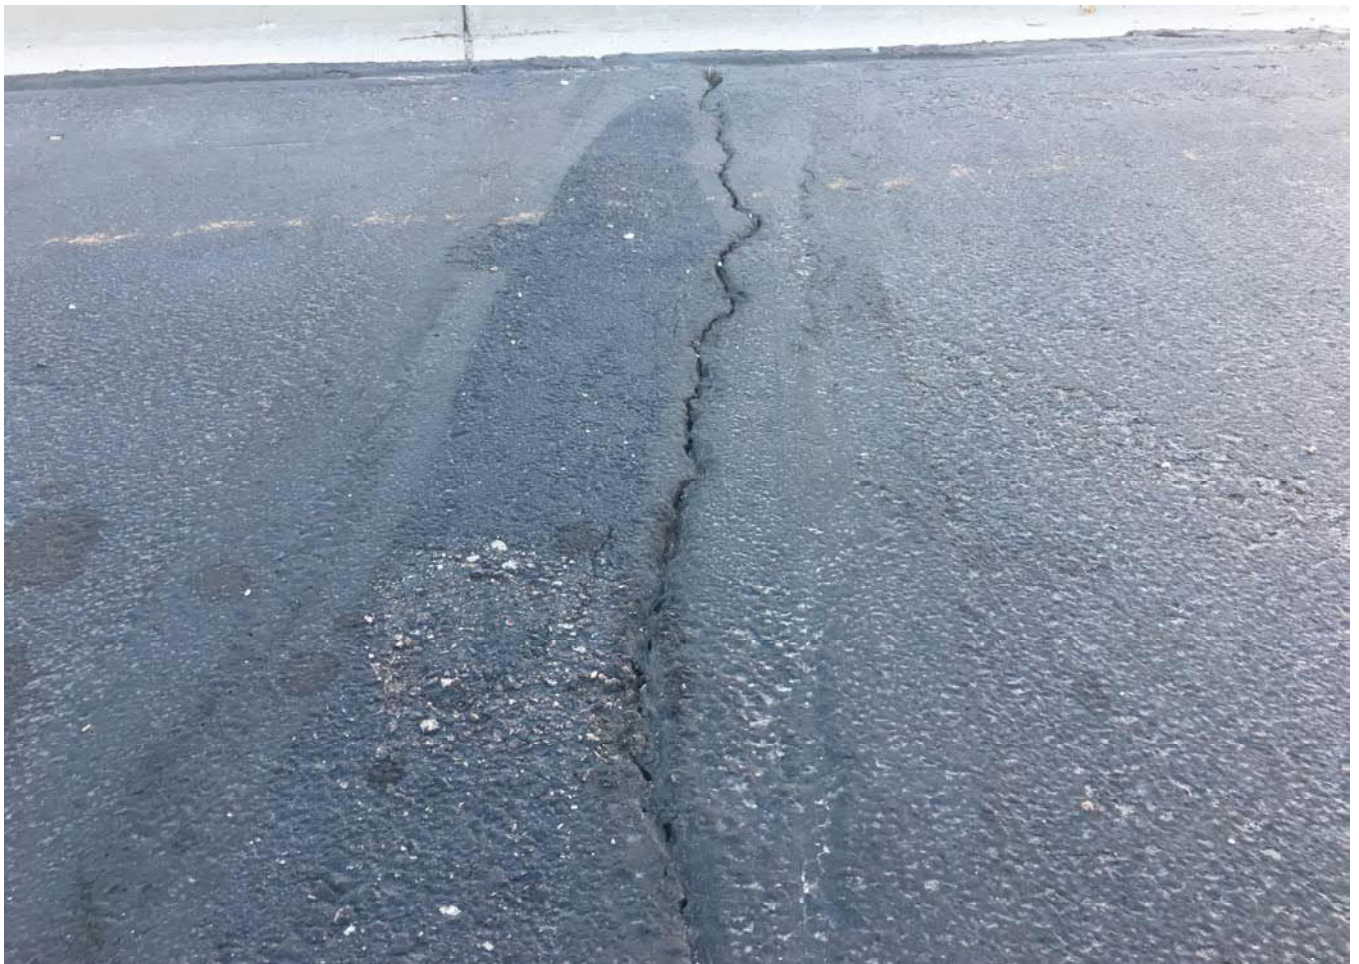
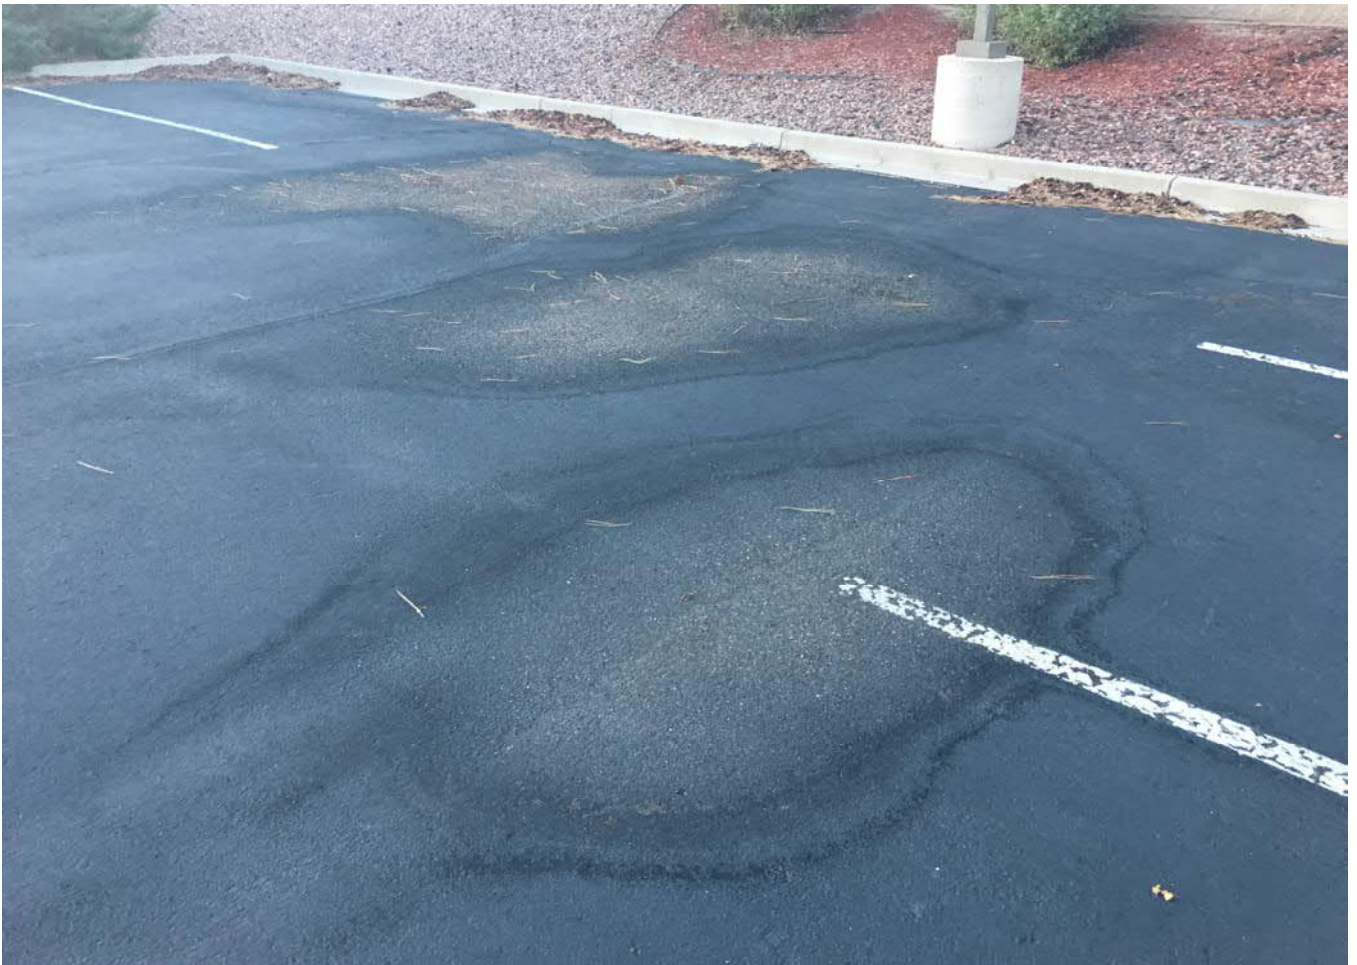
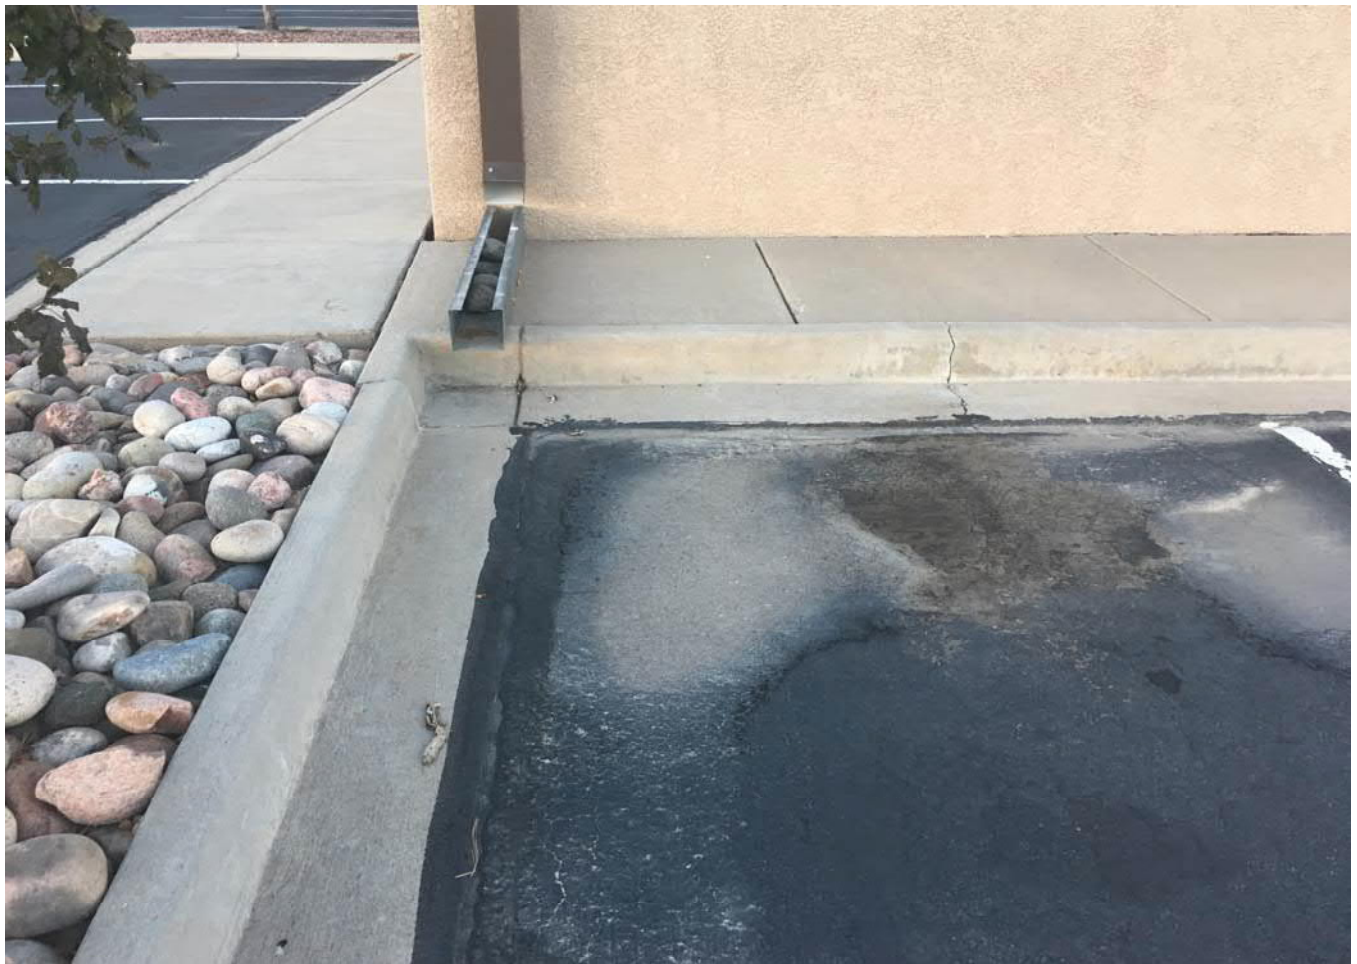
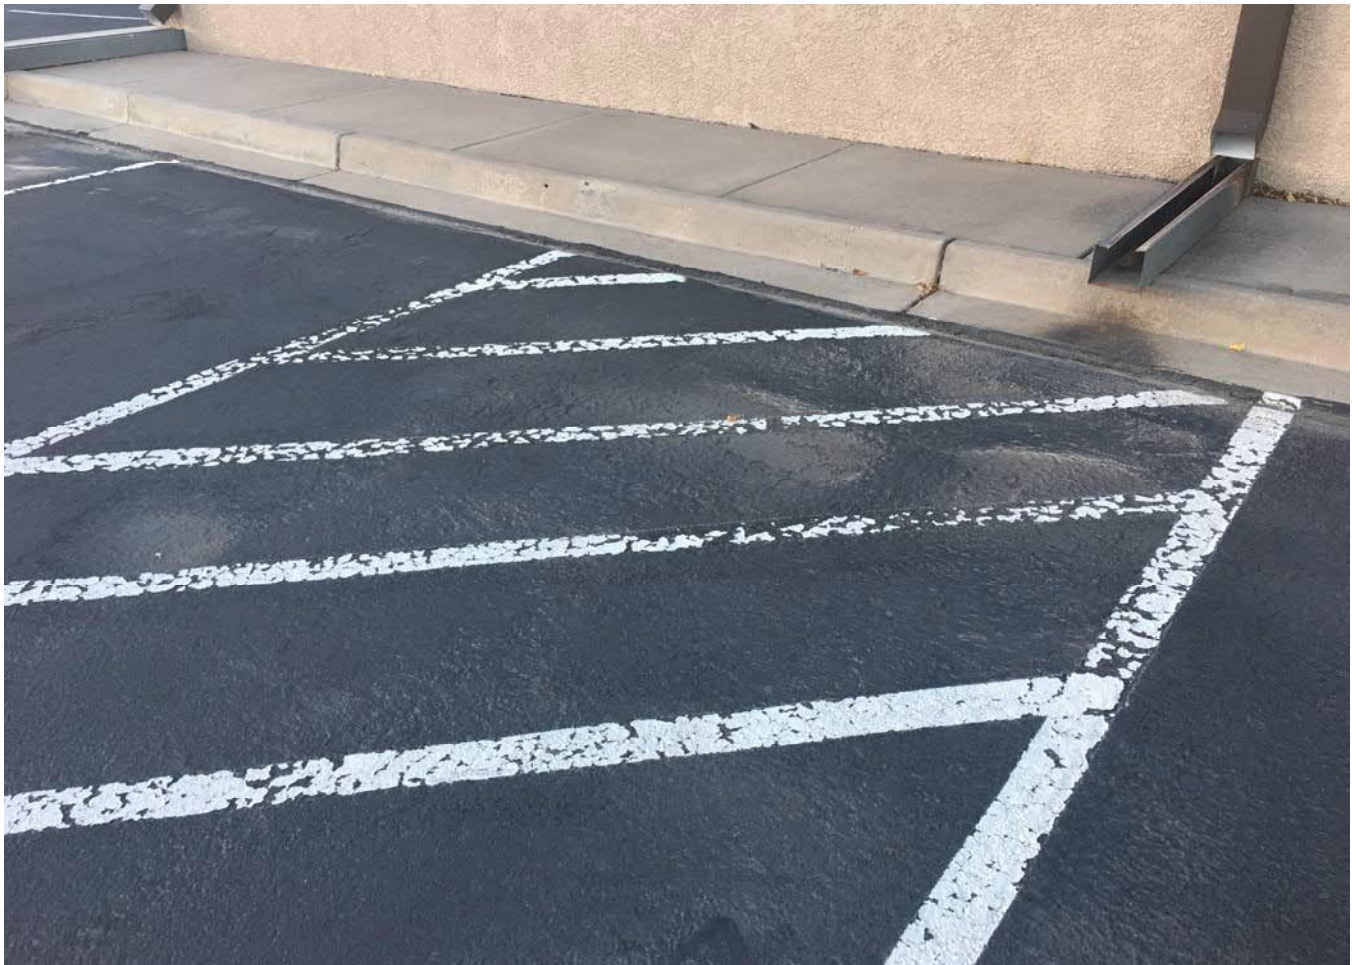
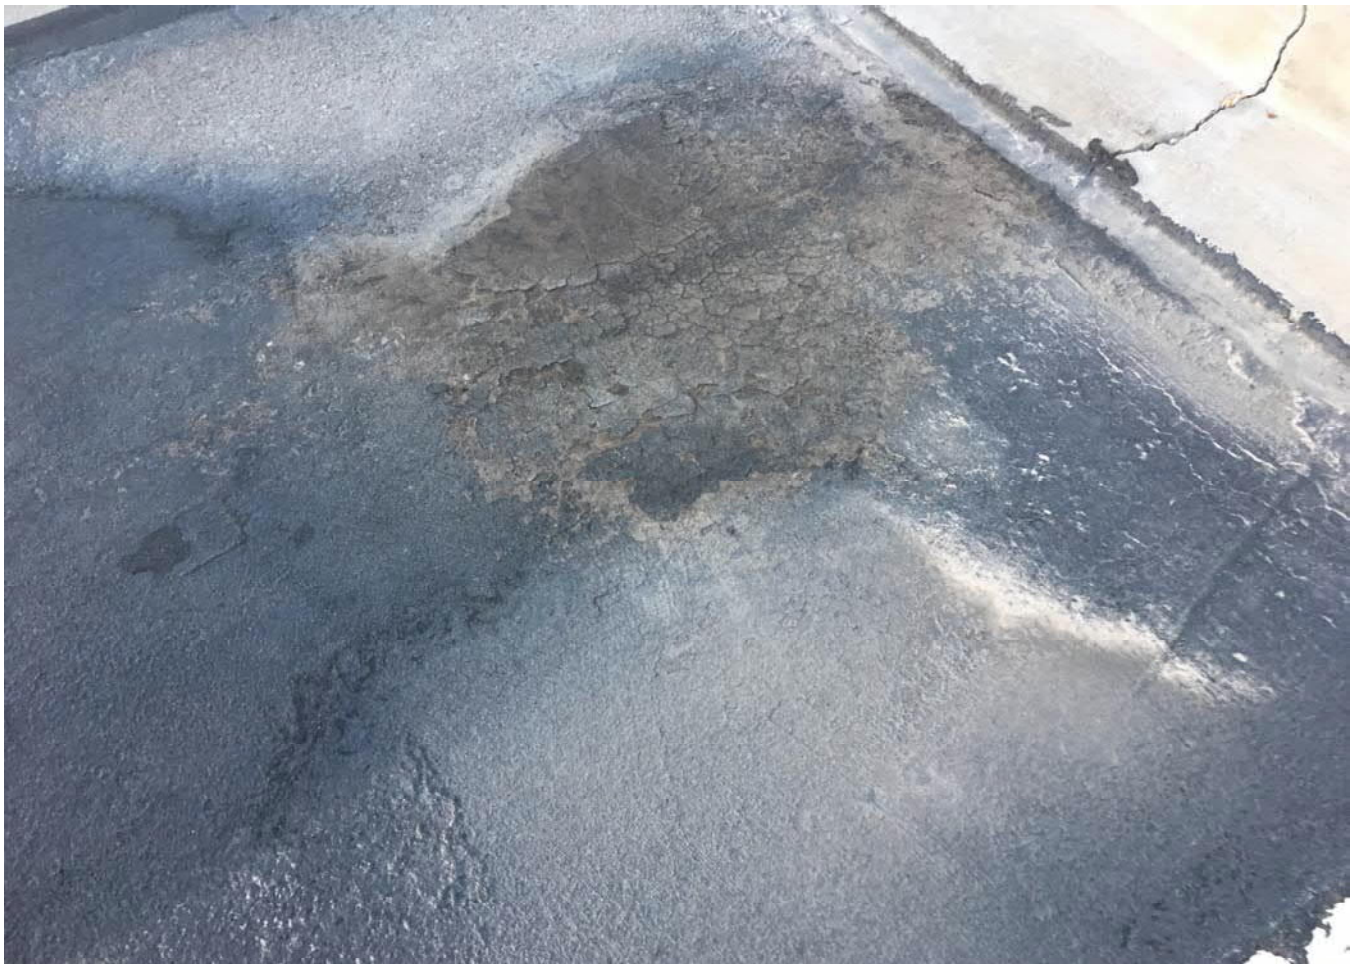
SITE CONDITIONS (ASPHALTIC CONCRETE PAVEMENT)

In October 2016, we visited the site (Figure 1 and Figure 2) and performed a visual reconnaissance of the pavement areas. We noted visual evidence of significant ponding and inadequate drainage related damage, and some pavement cracking. Photographic documentation of site conditions is included in Appendix A.

The site is currently developed and has existing utilities in place. The surface parking area is paved with asphaltic concrete and varied in thickness from 4-6 inches. The underlying base layer was averaging approximately 12 inches in thickness of processed aggregate material. Subgrade materials were identified as poorly graded sands and clayey sands, though non-expansive. The asphalt pavement appears to be in relatively good condition, however it did exhibit pavement cracking with widths on the order of ½ to 1 inch. These are indicative of the mature pavement age, and result from seasonal temperature fluctuations. In addition, there were some areas where ponding of surface water was observed. This results from a poor surface water drainage condition.

- a. Improve site drainage by connecting all road downspouts to discharge pipes and not allowing discharge directly onto the pavements.
- b. Install an interceptor drain between the paved and unpaved areas in the southeastern portion and minimizing surface water run-off towards the paved areas.
- c. Seal longitudinal (linear) and transverse cracking with elastomeric sealant and/or fill cracks with asphalt emulsion slurry or light grade of asphalt mixed with fine sand.
- d. Place thin overlay (1.5-inch thick) or surface treatment (seal coat) in the pavement areas impacted by ponding and weathering.
- e. All repair or treatment areas must be cleaned of dirt and debris before sealer or surface treatment is applied.

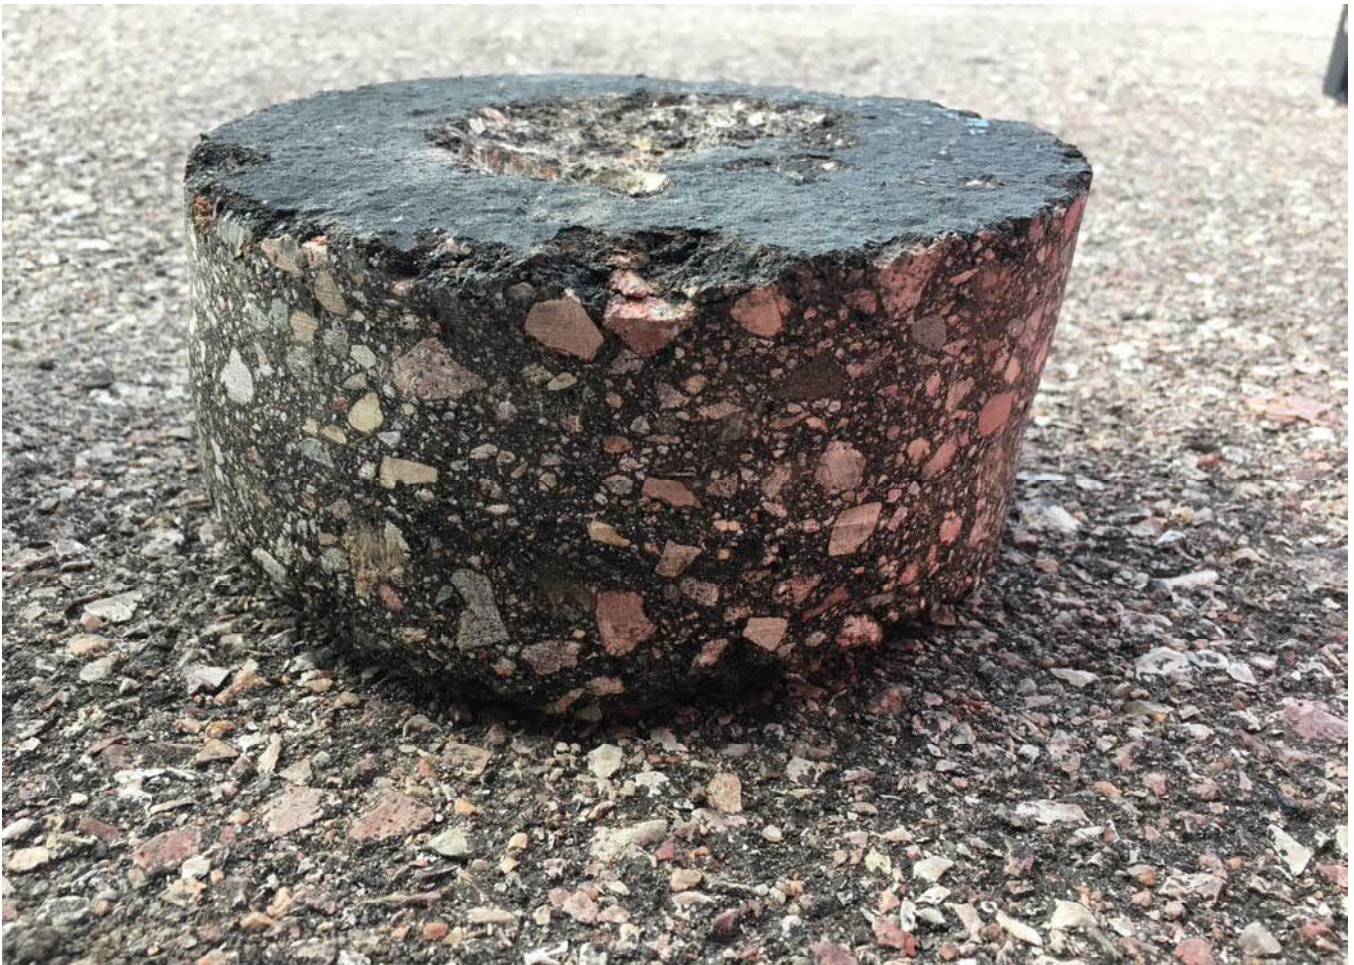
CORE C1: SIDE VIEW

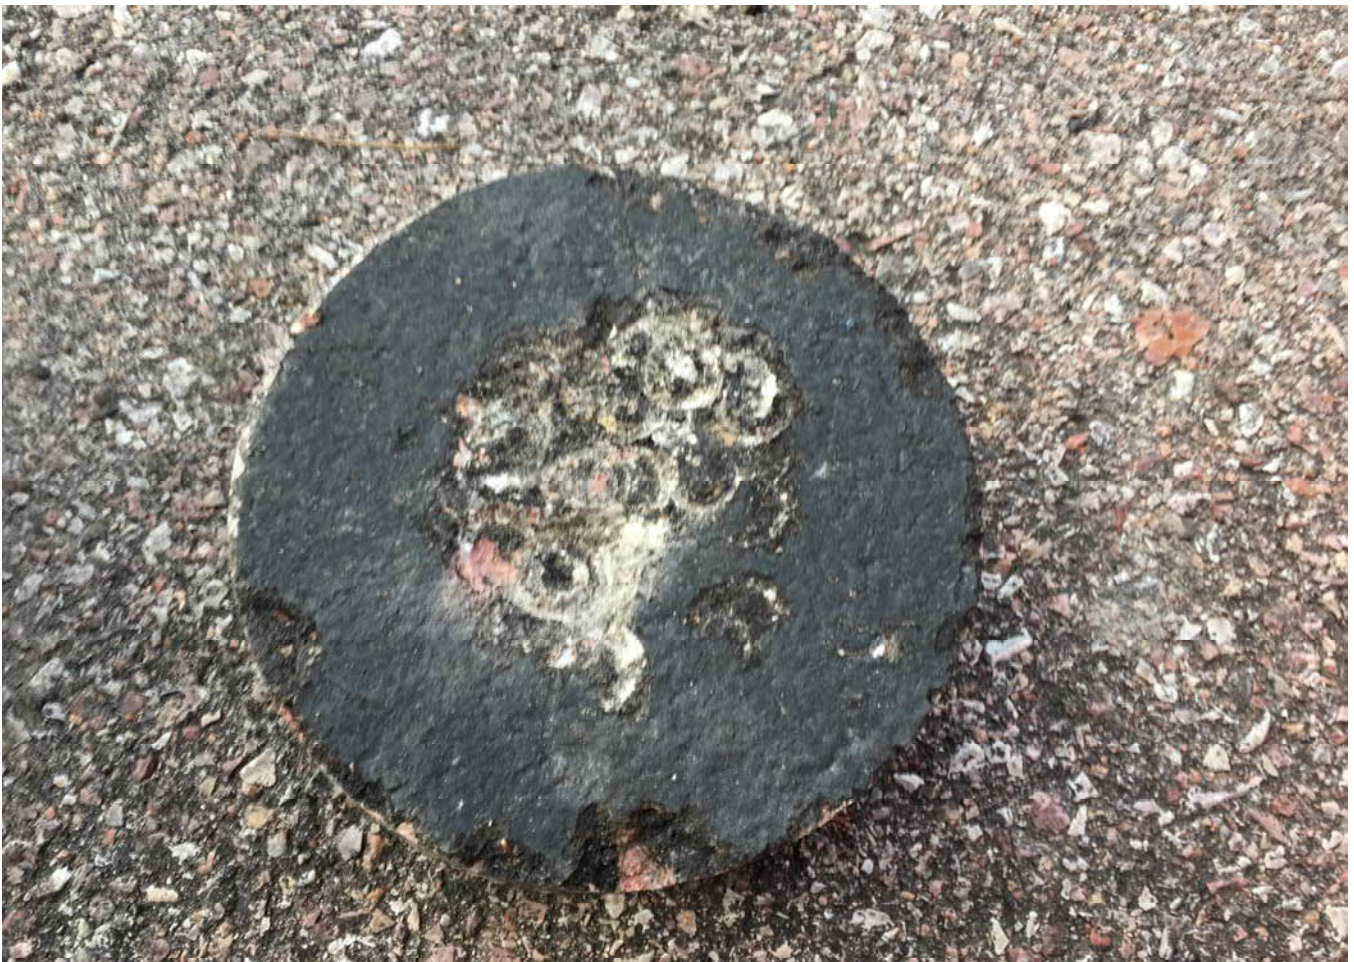
CORE C1: TOP VIEW

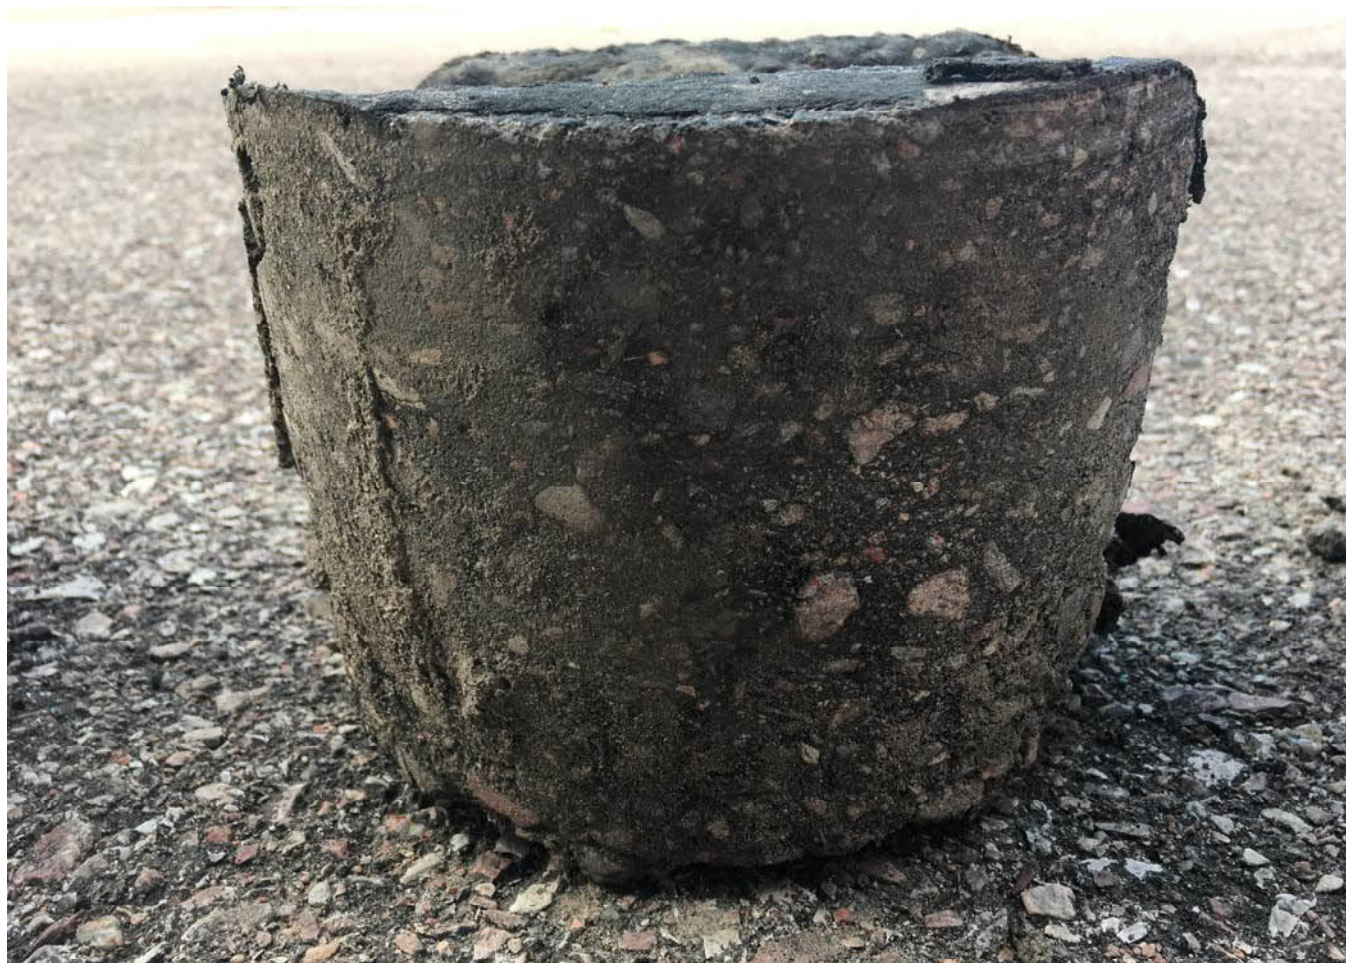
CORE C3: SIDE VIEW
