Subject: Drive Area Geotechnical Evaluation
Existing Commercial Property
2675 Akers Drive
Colorado Springs, Colorado
Project No. 16-173339.2

PAVEMENT EVALUATION REPORT

2675 AKERS DRIVE
COLORADO SPRINGS, COLORADO

PROJECT NO: 0305-CS16

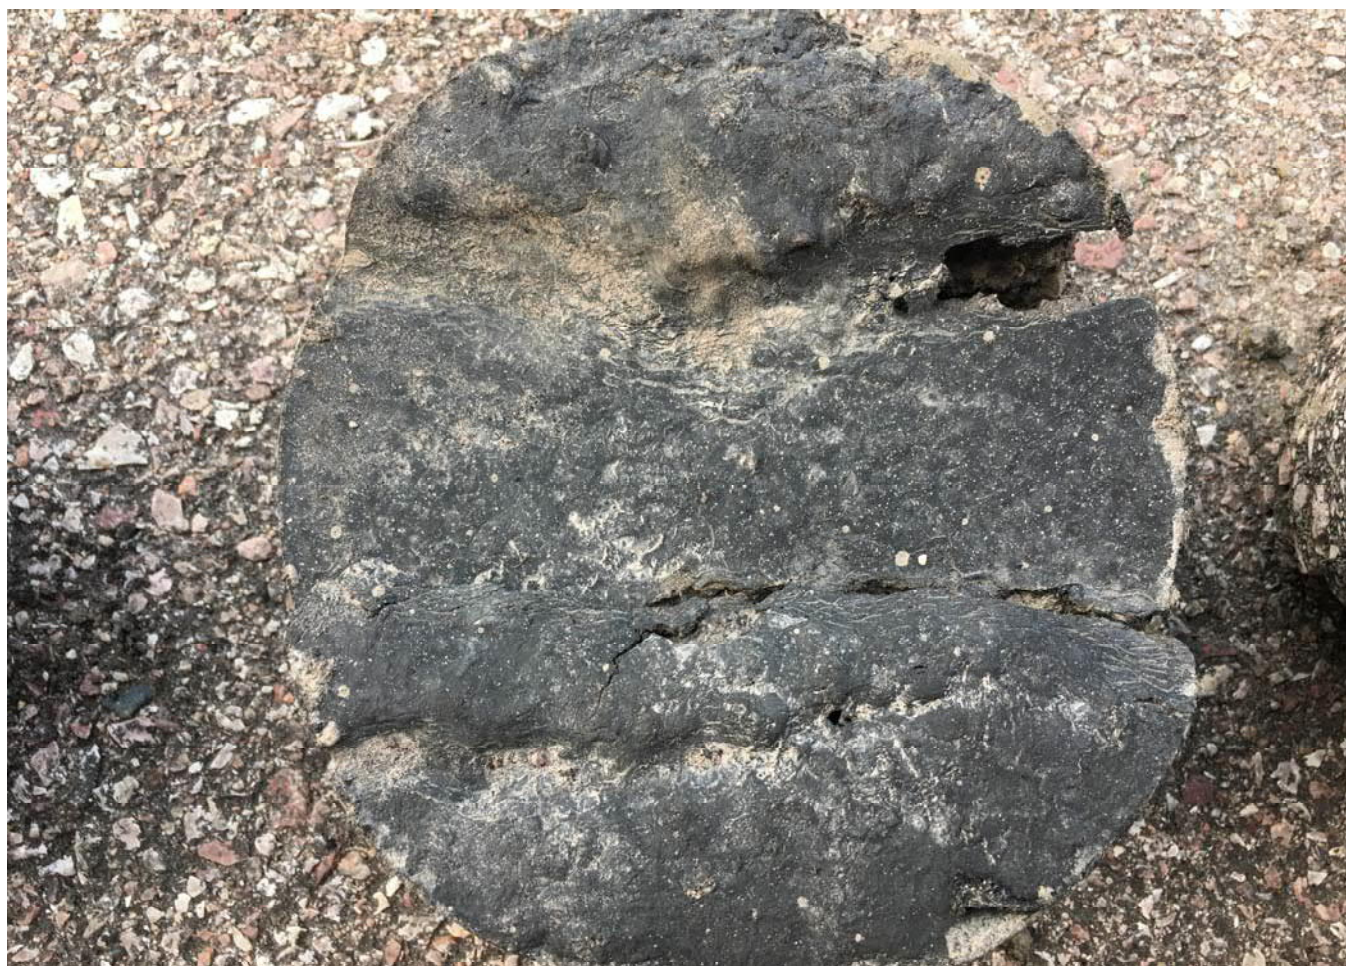
CORE C3: TOP VIEW

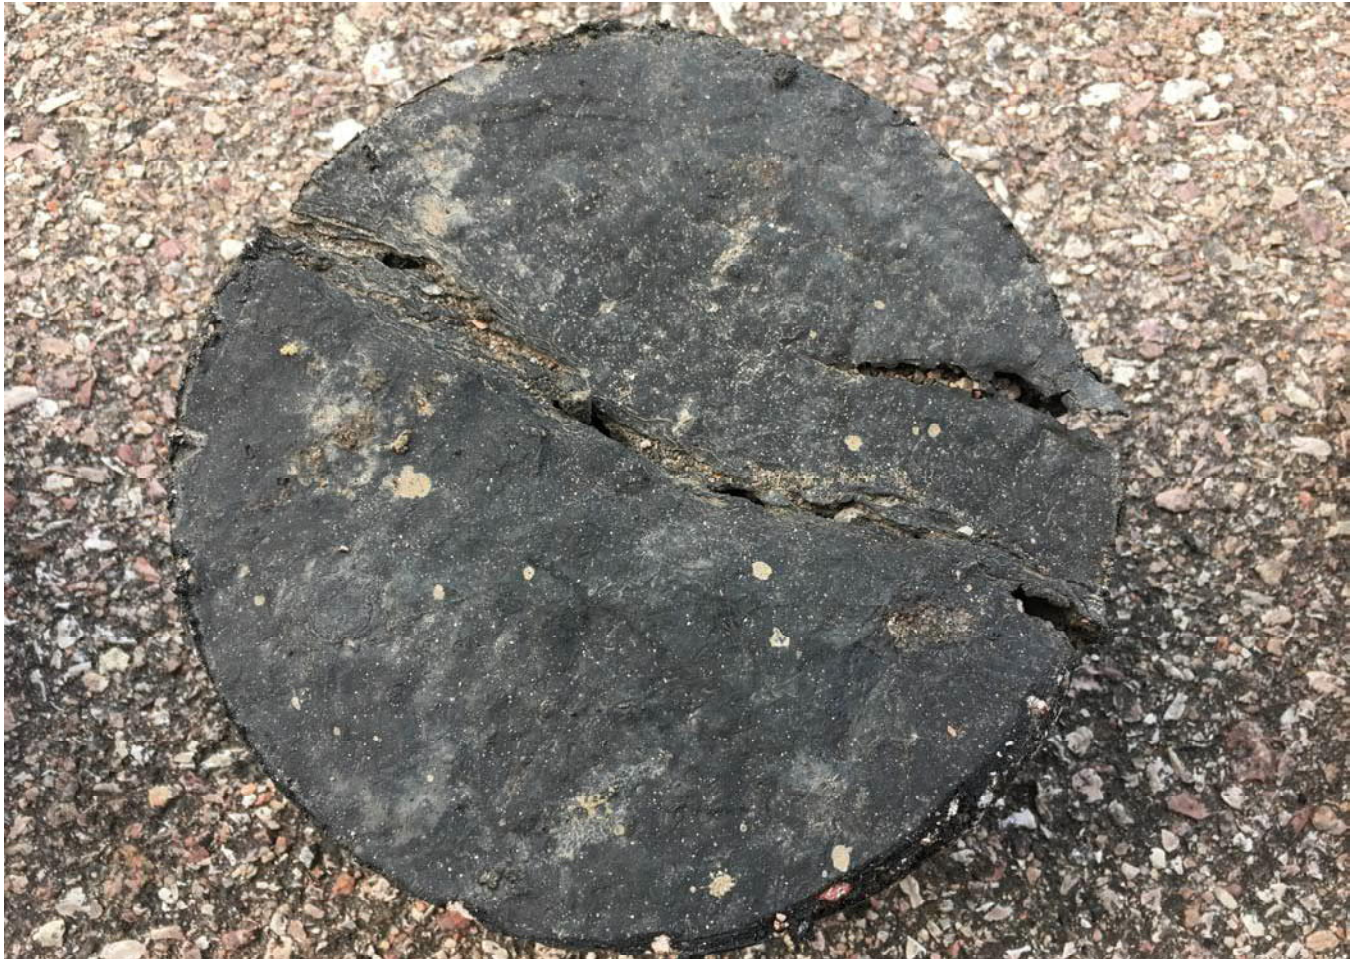
CORE C4: TOP VIEW

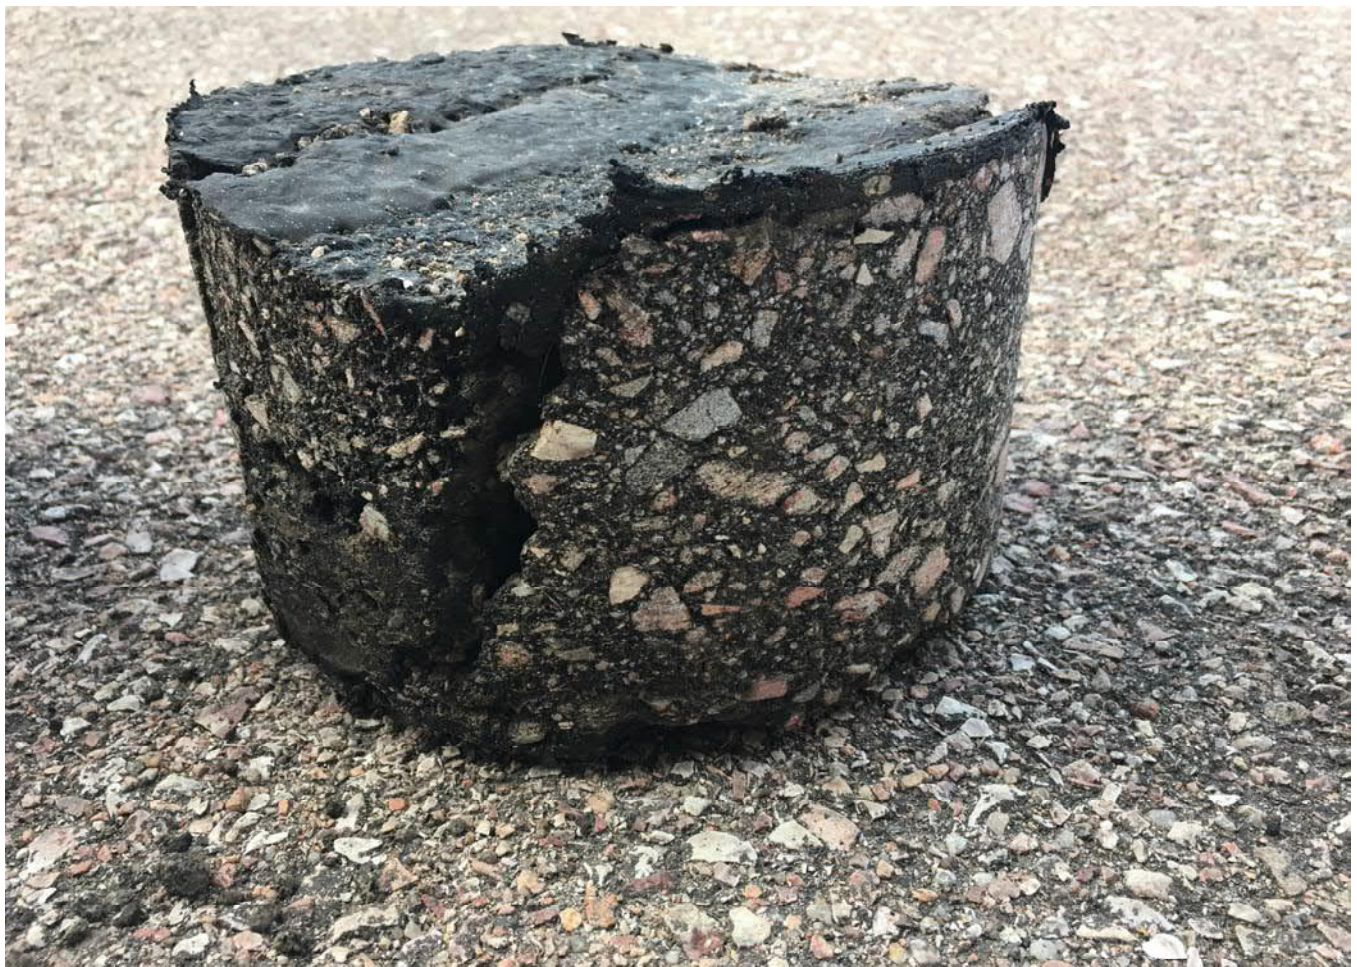
CORE C5: SIDE VIEW

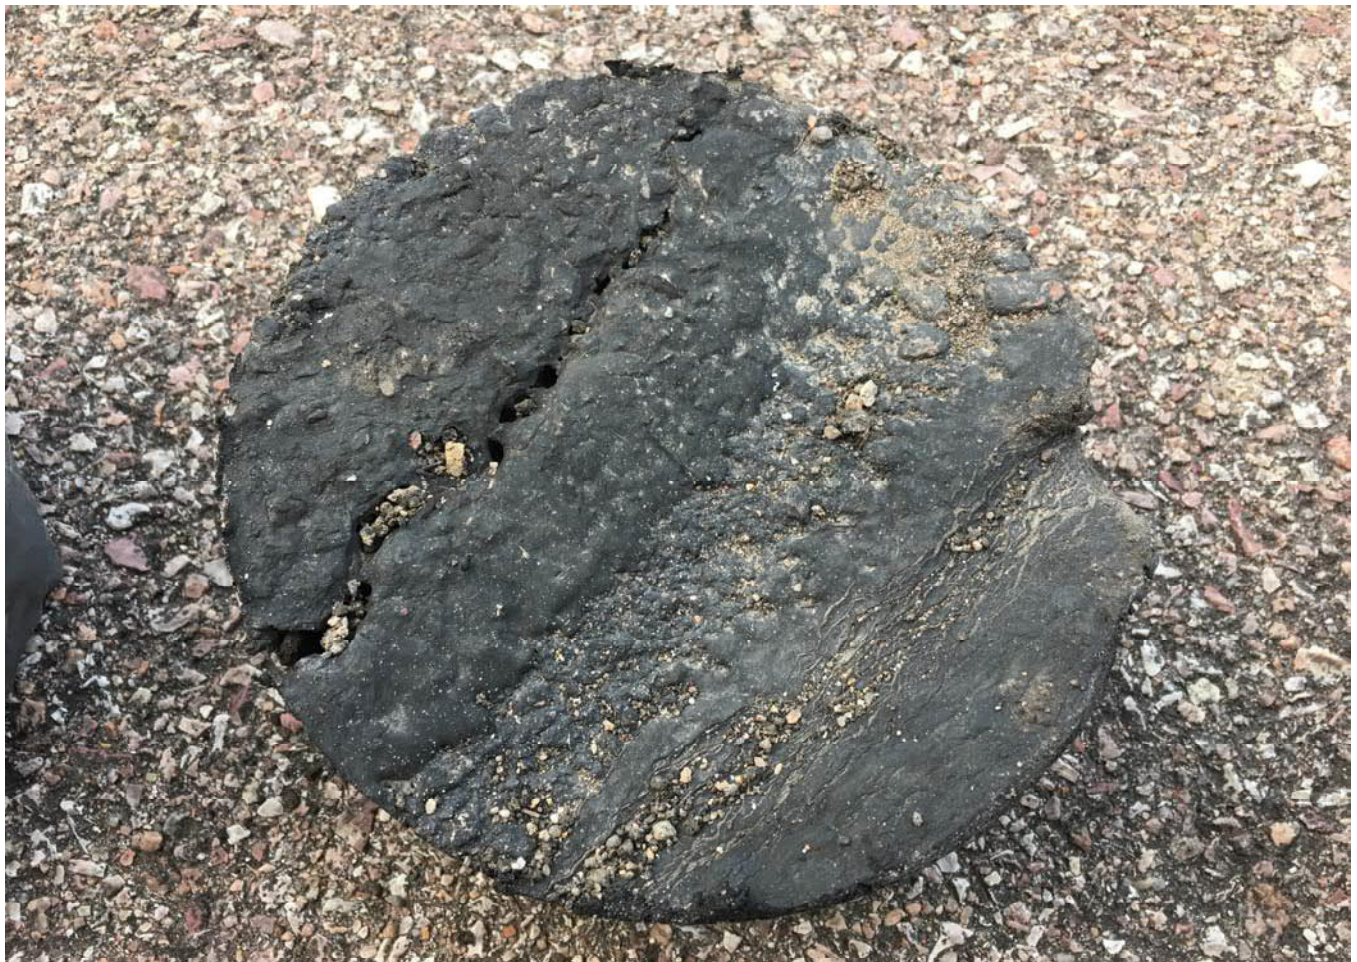
CORE C5: TOP VIEW
