**Subject: Drive Area Geotechnical Evaluation**  
Existing Commercial Property  
2675 Akers Drive  
Colorado Springs, Colorado  
Project No. 16-173339.2

## PAVEMENT EVALUATION REPORT

2675 AKERS DRIVE  
COLORADO SPRINGS, COLORADO

PROJECT NO: 0305-CS16

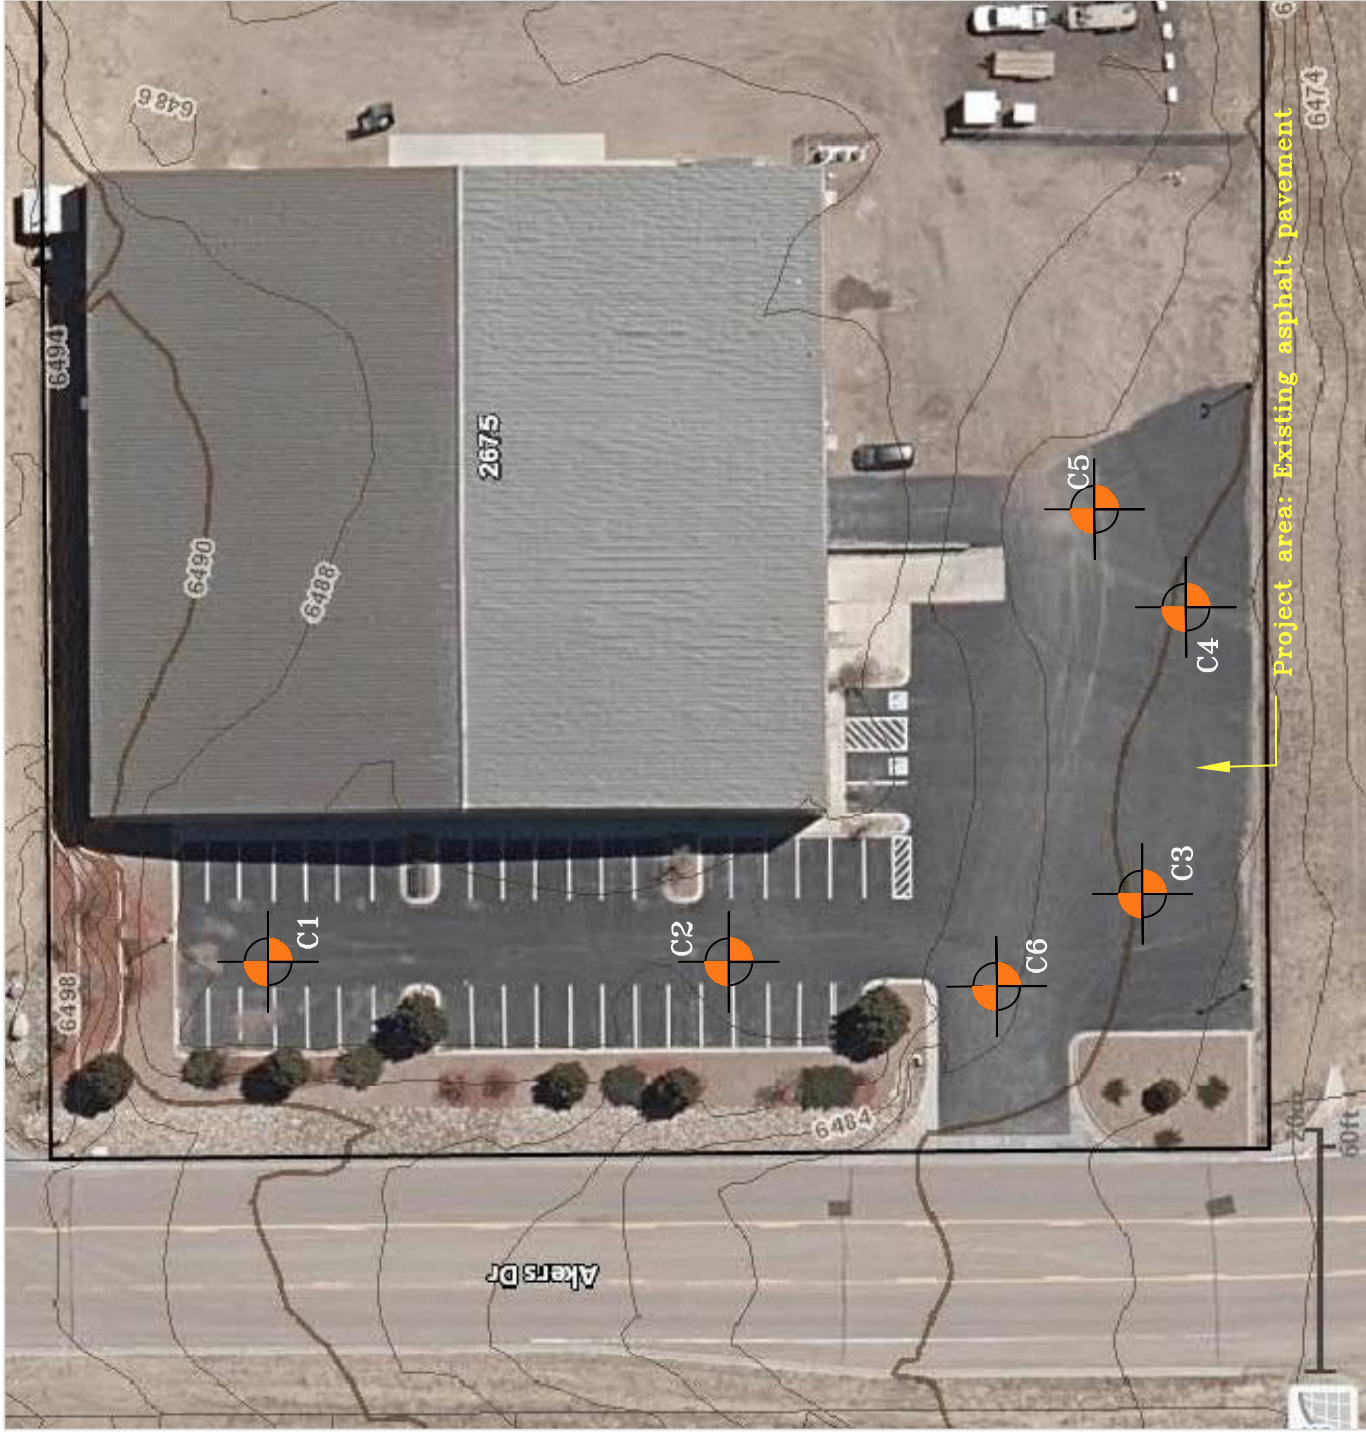
**SCHEMATIC SITE PLAN**

The site is a presently developed property with an asphalt parking lot and a roughly 30,000 metal industrial/warehouse building. The property was developed between 1999 and 2003 based on historic aerial photographs on Google earth. In addition, repairs were made to the asphalt in the high traffic areas on the southern portion of the lot between 2011 and 2015. The repairs consisted of mill and overlay in the vicinity of location C4, and a slurry seal or ½ inch seal coat in the locations of C3, C5, and C6, as noted in Figure 2.

Six 8-inch diameter asphaltic concrete cores were taken at locations C1 through C6 as shown in Figure 2. Photographic documentation of asphaltic concrete cores is included in Appendix B.

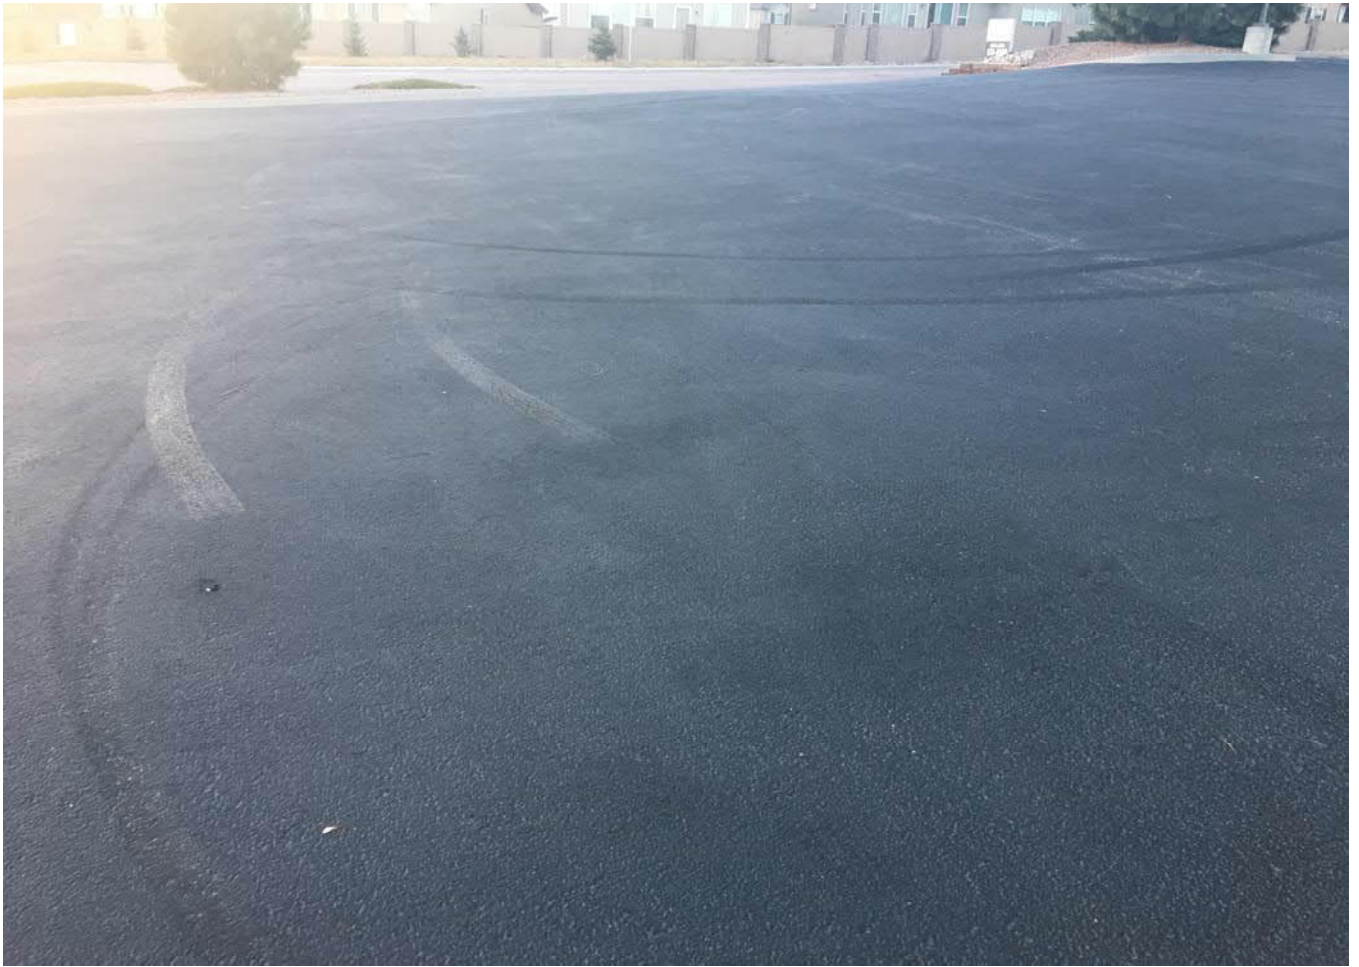
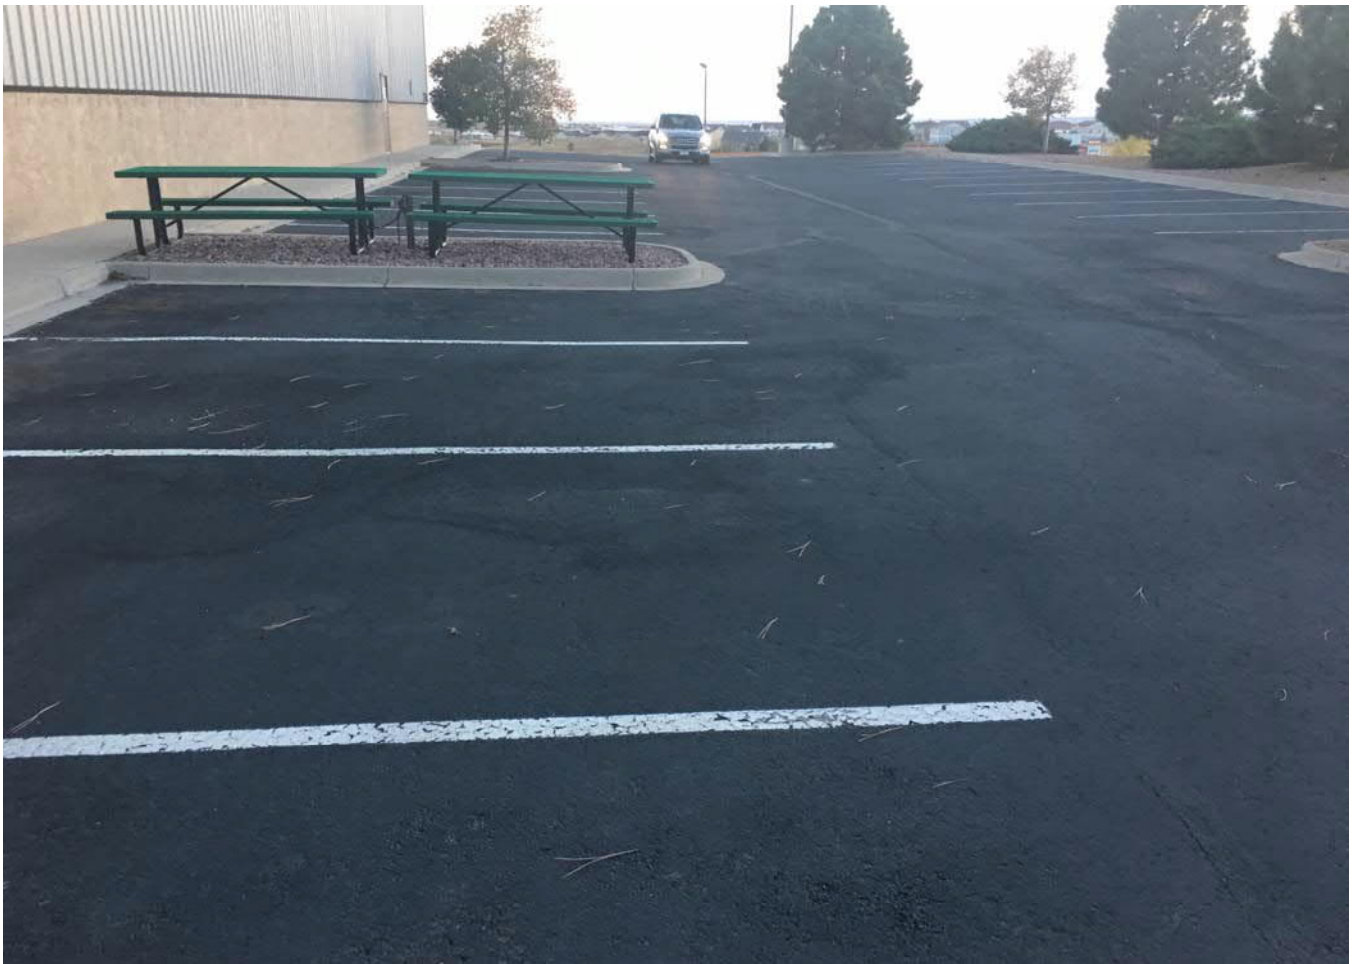
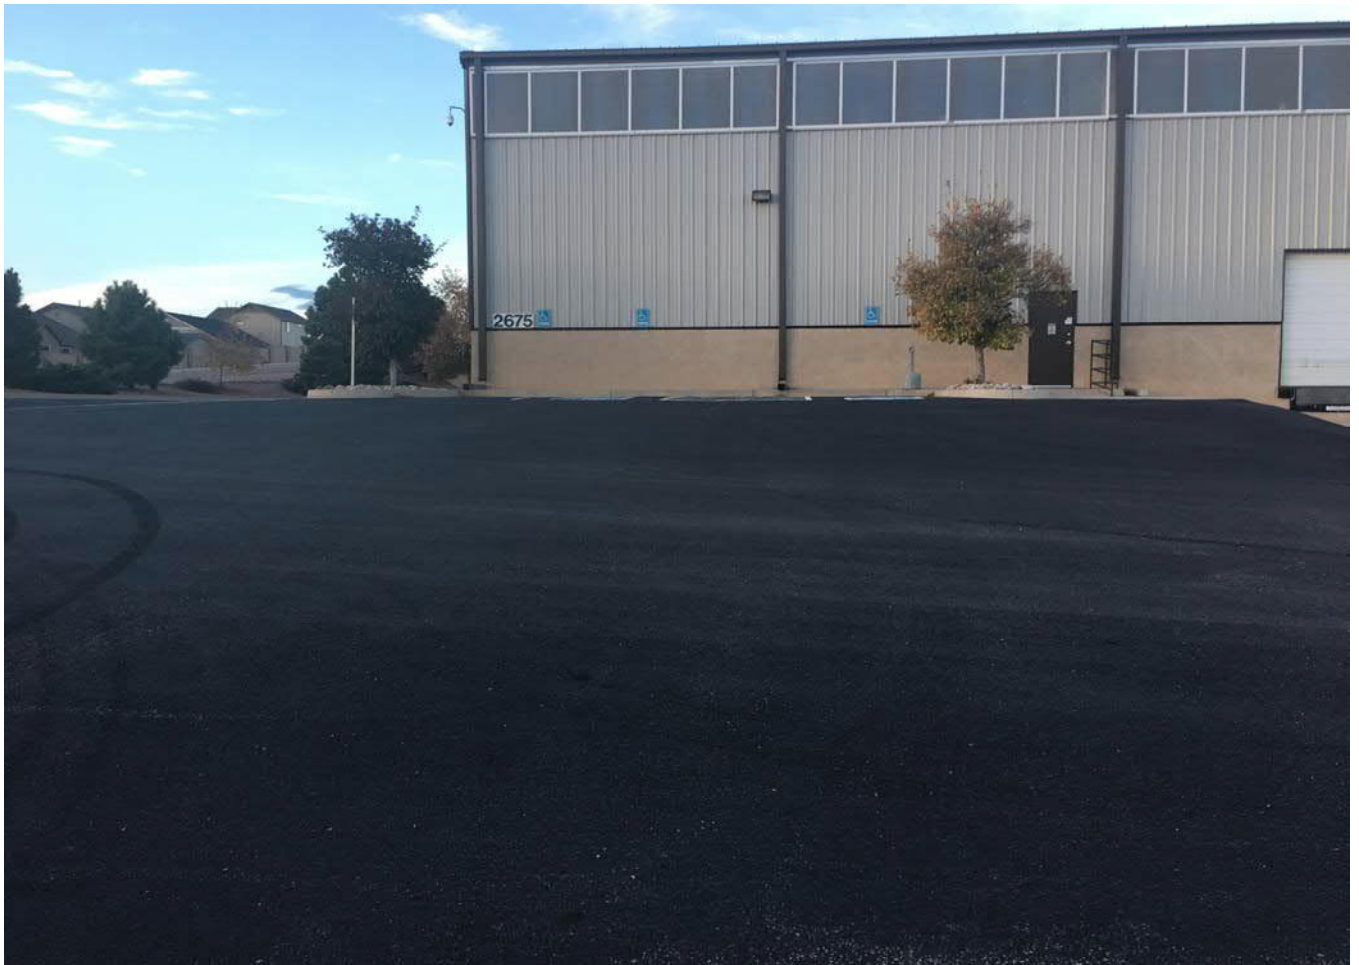
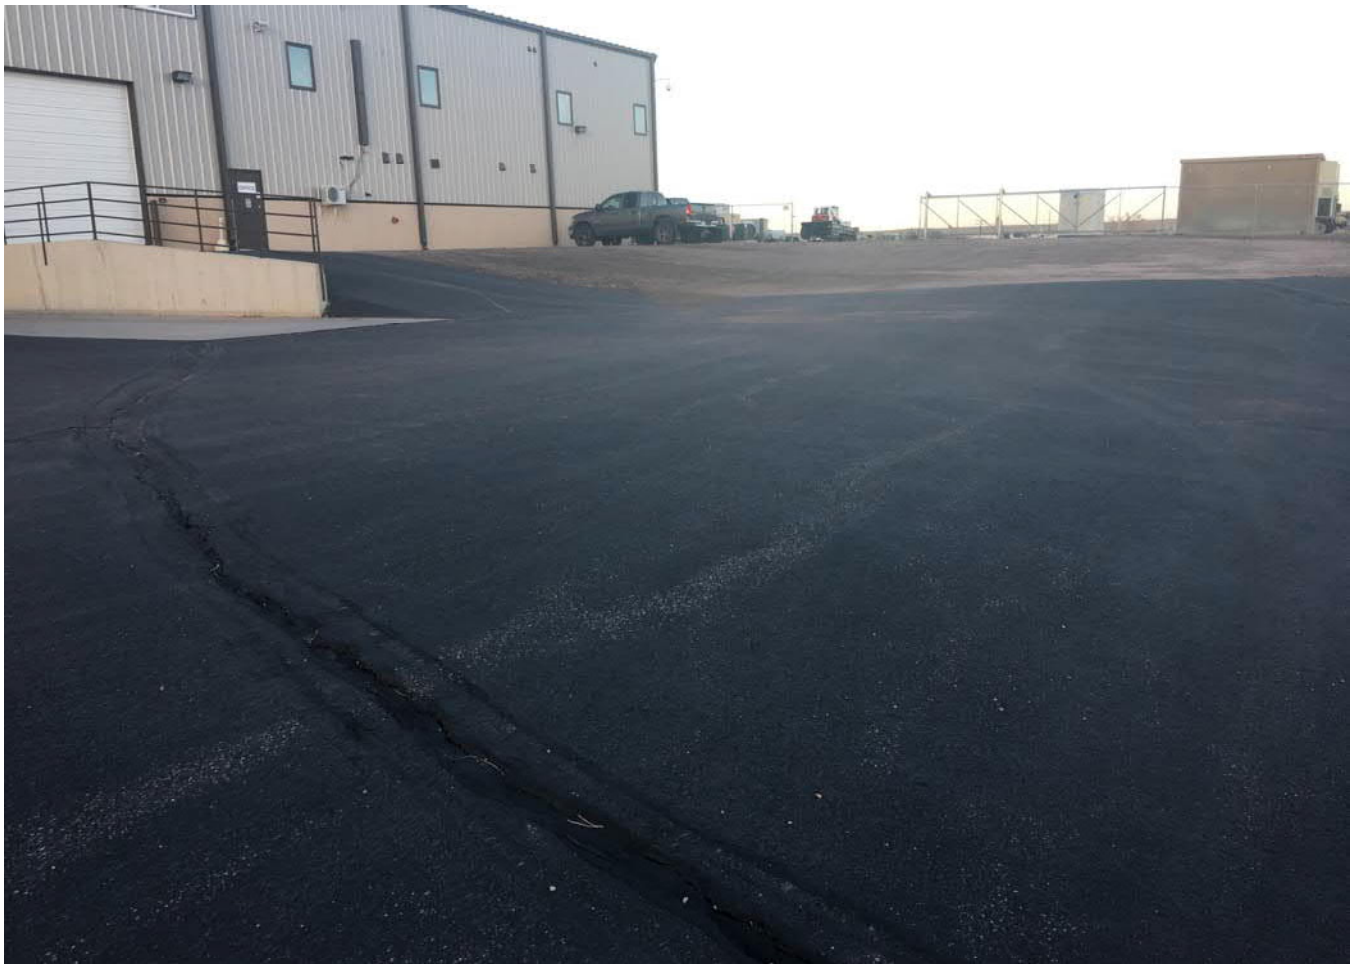
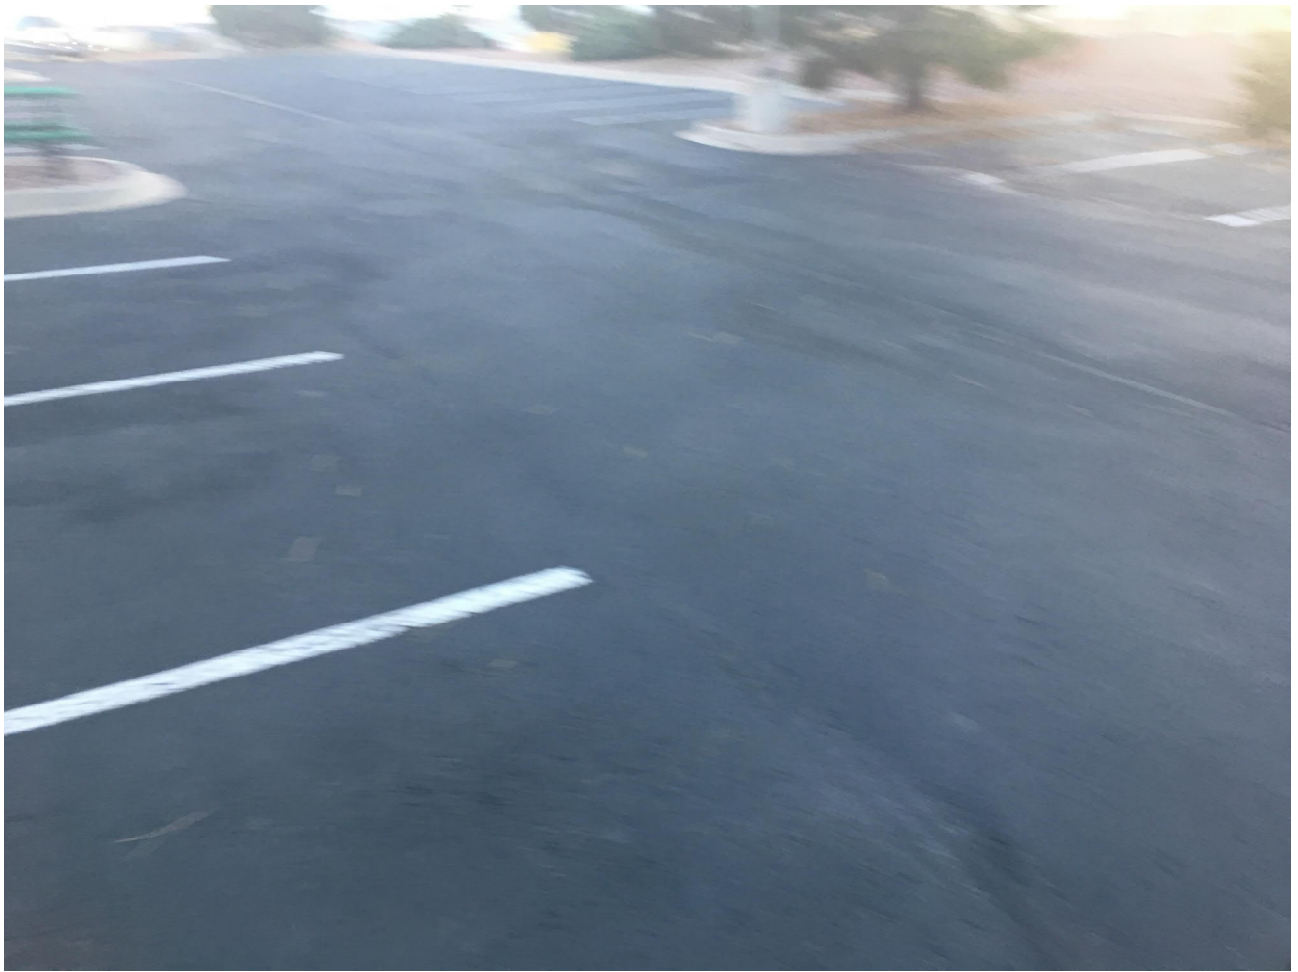
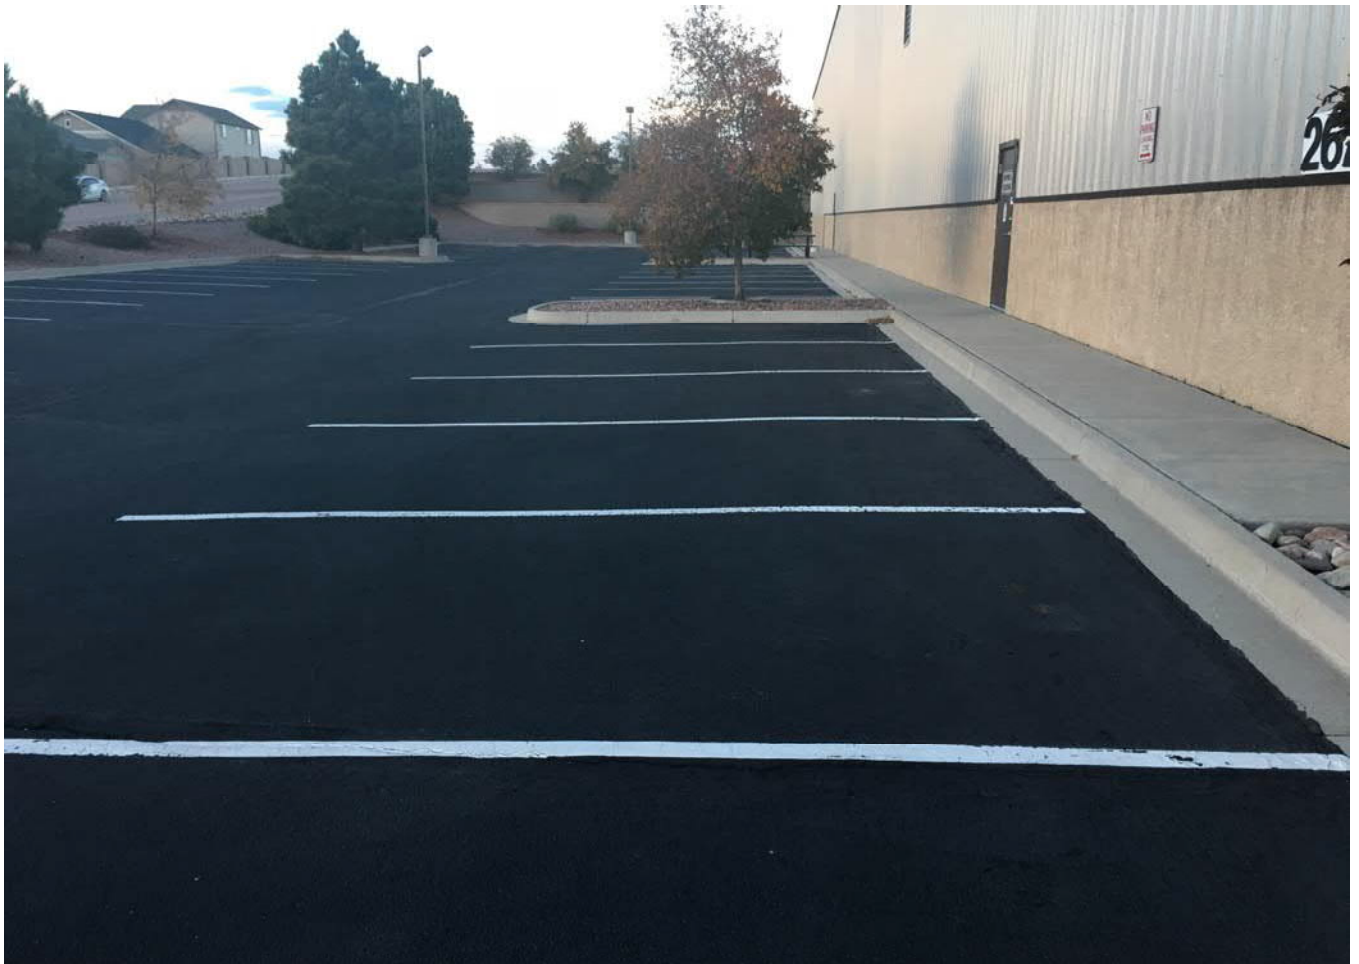
## SITE CONDITIONS (ASPHALTIC CONCRETE PAVEMENT)

In October 2016, we visited the site (Figure 1 and Figure 2) and performed a visual reconnaissance of the pavement areas. We noted visual evidence of significant ponding and inadequate drainage related damage, and some pavement cracking. Photographic documentation of site conditions is included in Appendix A.

The site is currently developed and has existing utilities in place. The surface parking area is paved with asphaltic concrete and varied in thickness from 4-6 inches. The underlying base layer was averaging approximately 12 inches in thickness of processed aggregate material. Subgrade materials were identified as poorly graded sands and clayey sands, though non-expansive. The asphalt pavement appears to be in relatively good condition, however it did exhibit pavement cracking with widths on the order of ½ to 1 inch. These are indicative of the mature pavement age, and result from seasonal temperature fluctuations. In addition, there were some areas where ponding of surface water was observed. This results from a poor surface water drainage condition.

- a. Improve site drainage by connecting all road downspouts to discharge pipes and not allowing discharge directly onto the pavements.
- b. Install an interceptor drain between the paved and unpaved areas in the southeastern portion and minimizing surface water run-off towards the paved areas.
- c. Seal longitudinal (linear) and transverse cracking with elastomeric sealant and/or fill cracks with asphalt emulsion slurry or light grade of asphalt mixed with fine sand.
- d. Place thin overlay (1.5-inch thick) or surface treatment (seal coat) in the pavement areas impacted by ponding and weathering.
- e. All repair or treatment areas must be cleaned of dirt and debris before sealer or surface treatment is applied.

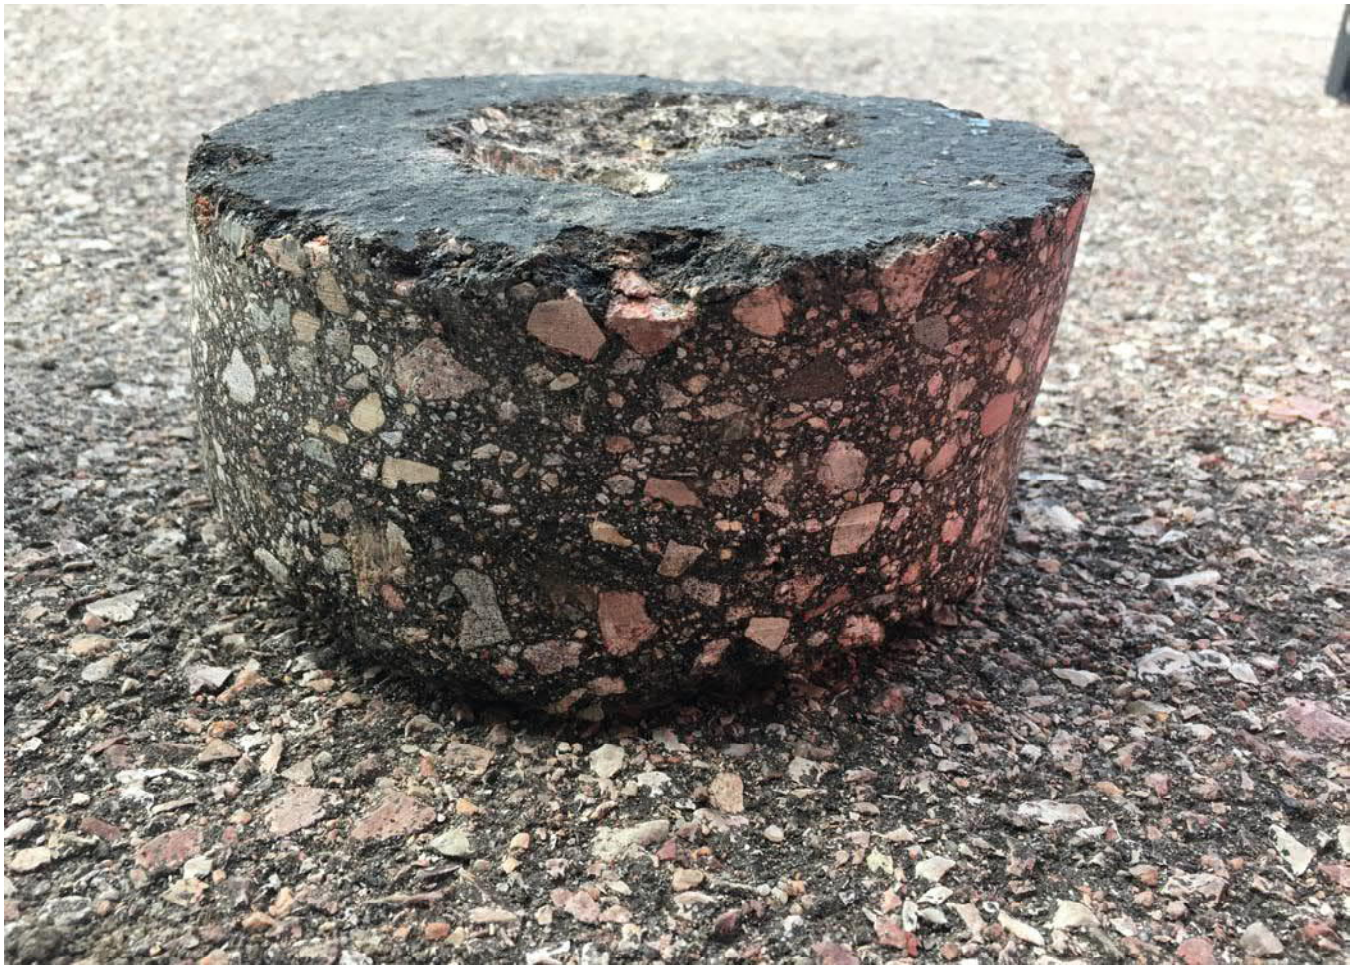
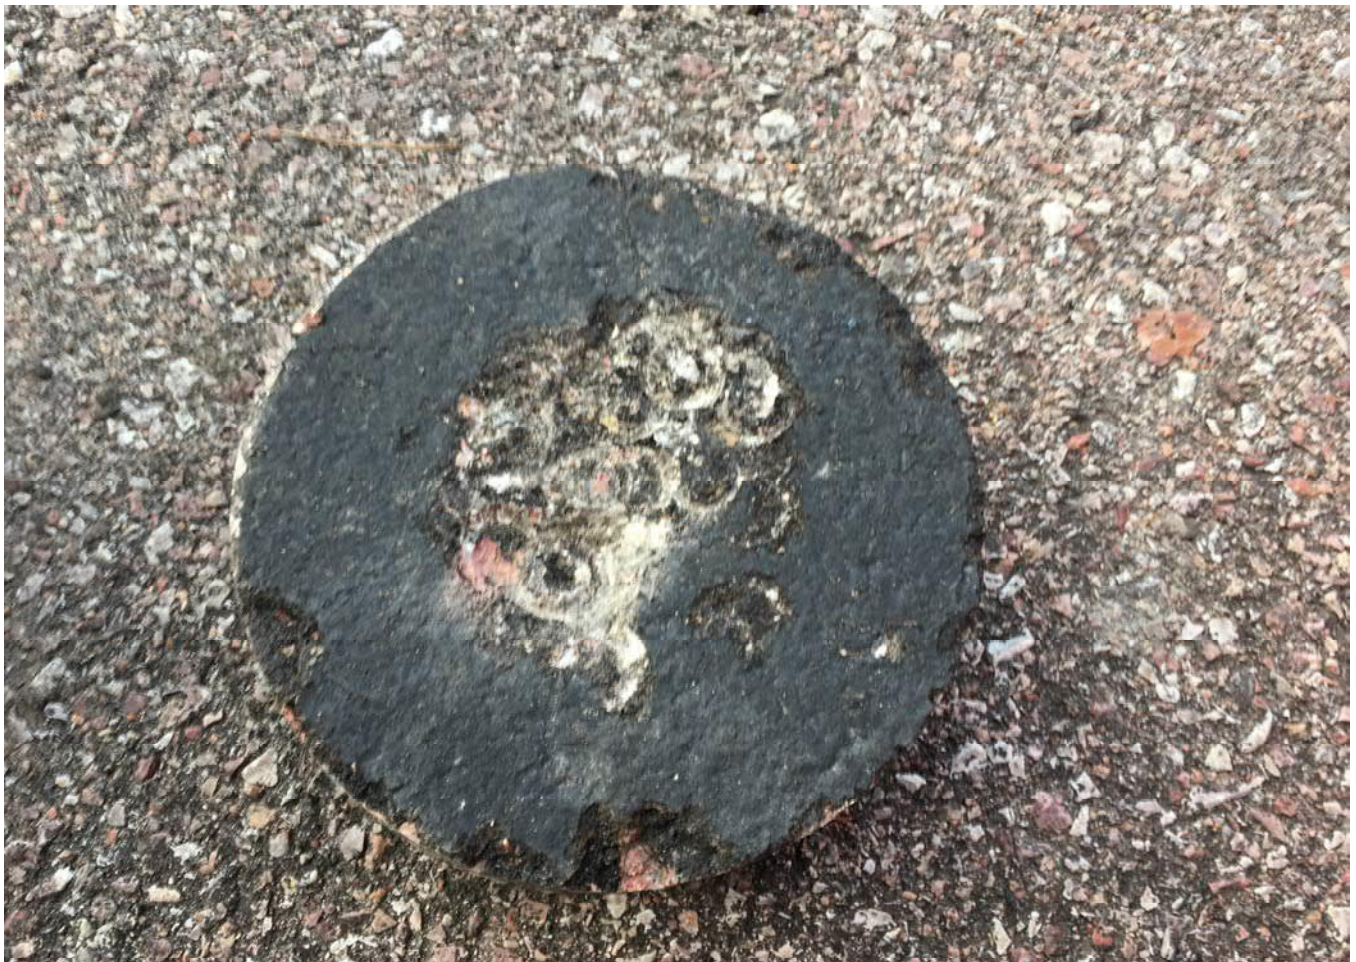
CORE C1: SIDE VIEW

CORE C1: TOP VIEW

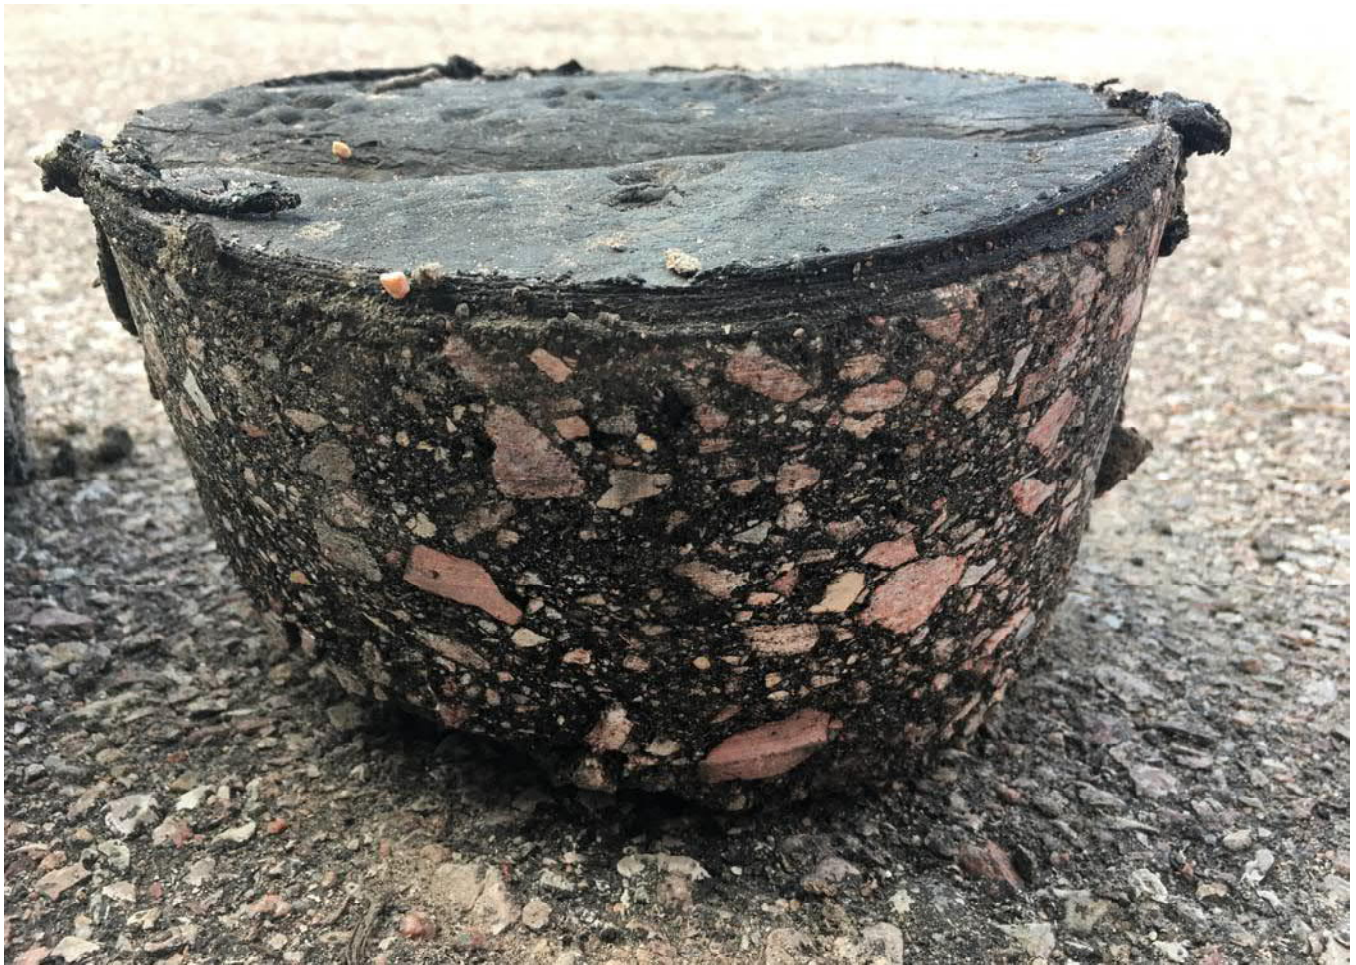
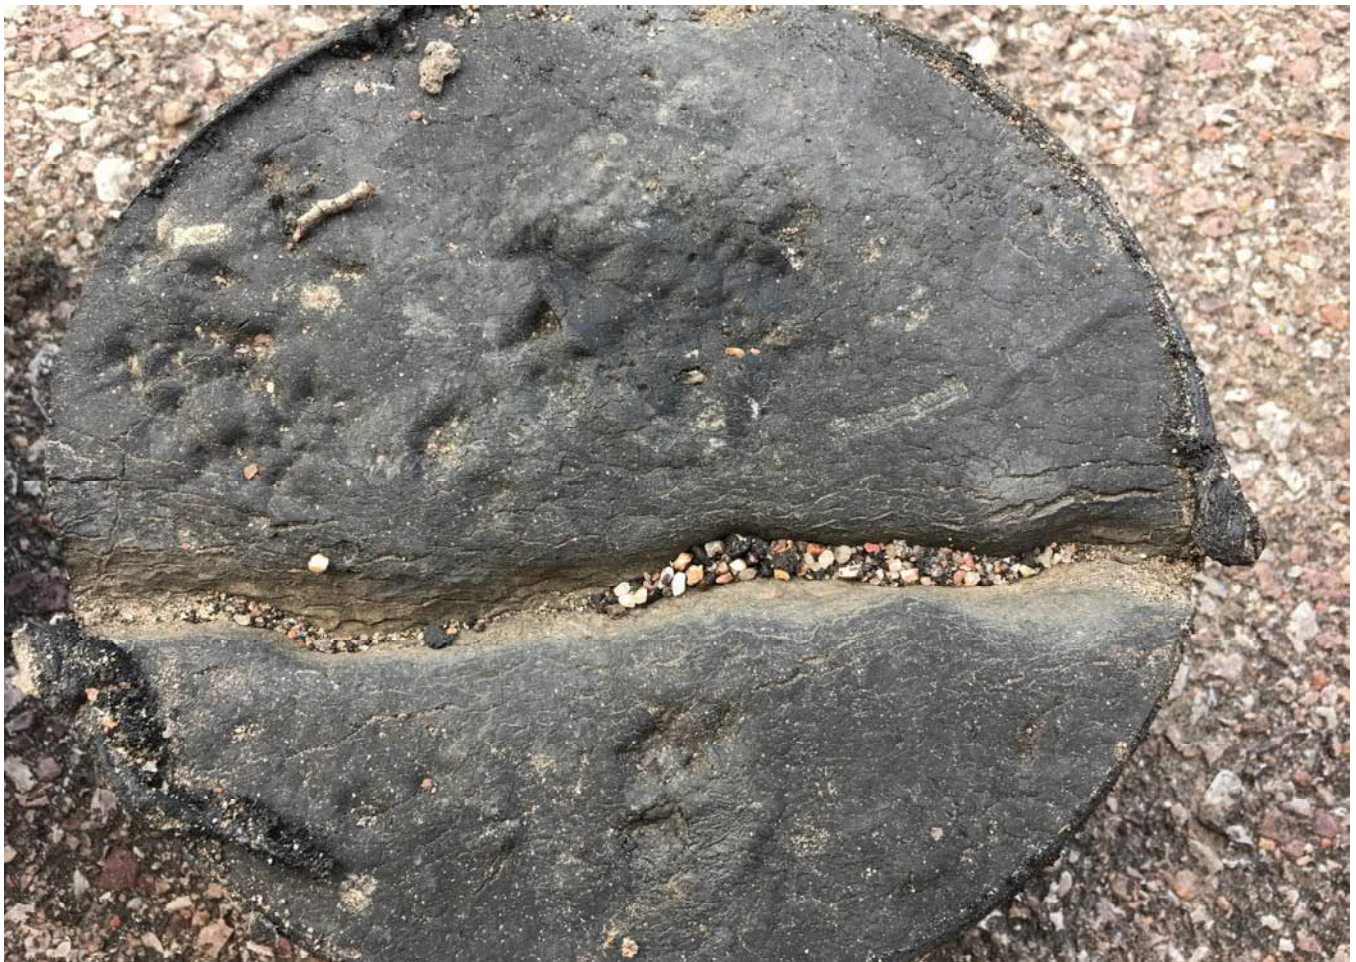
CORE C2: SIDE VIEW

CORE C2: TOP VIEW

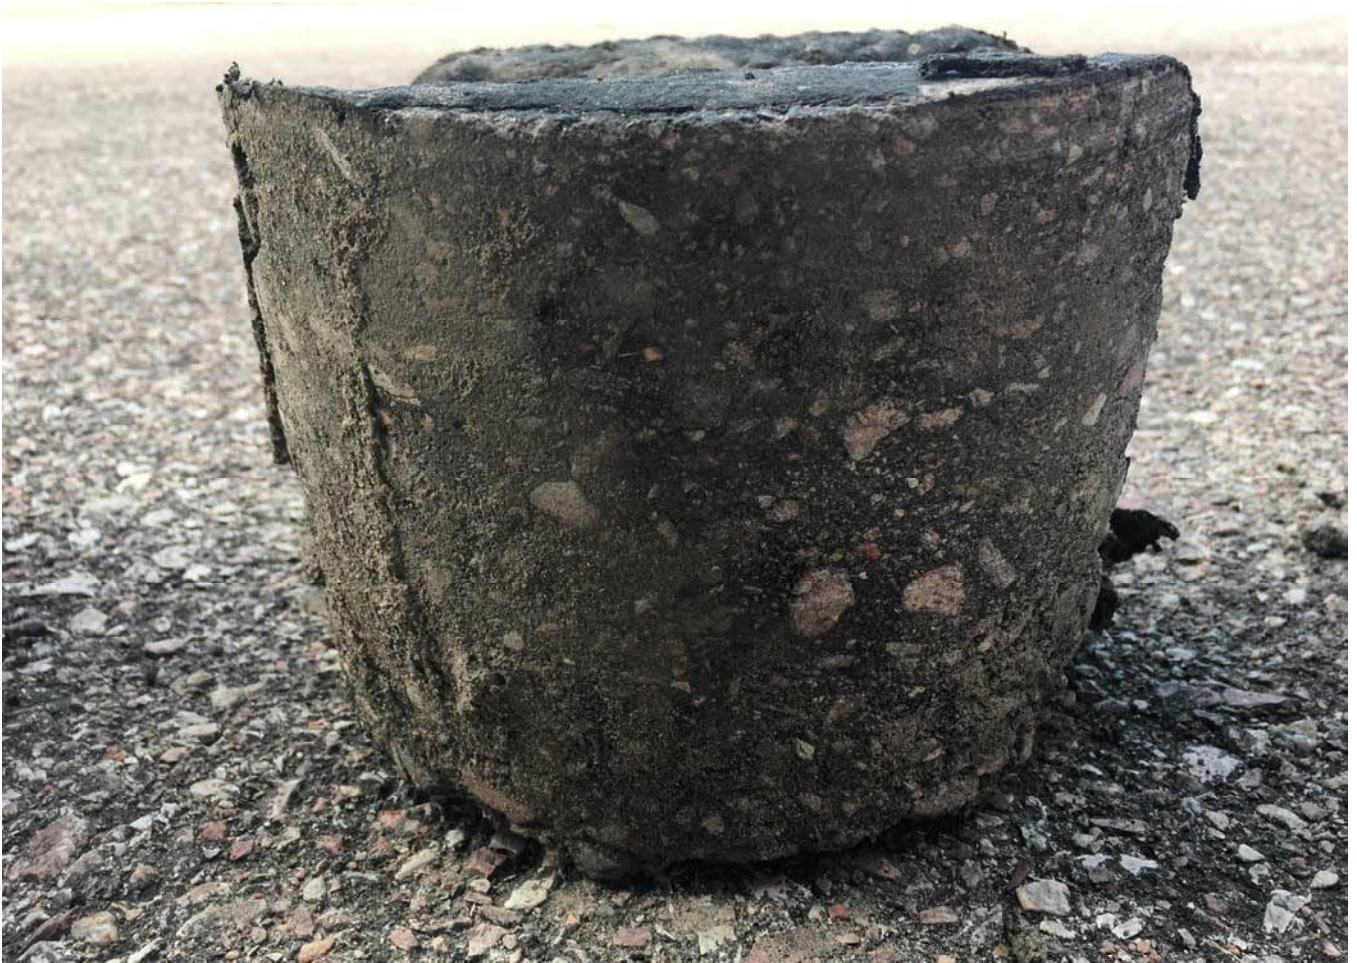
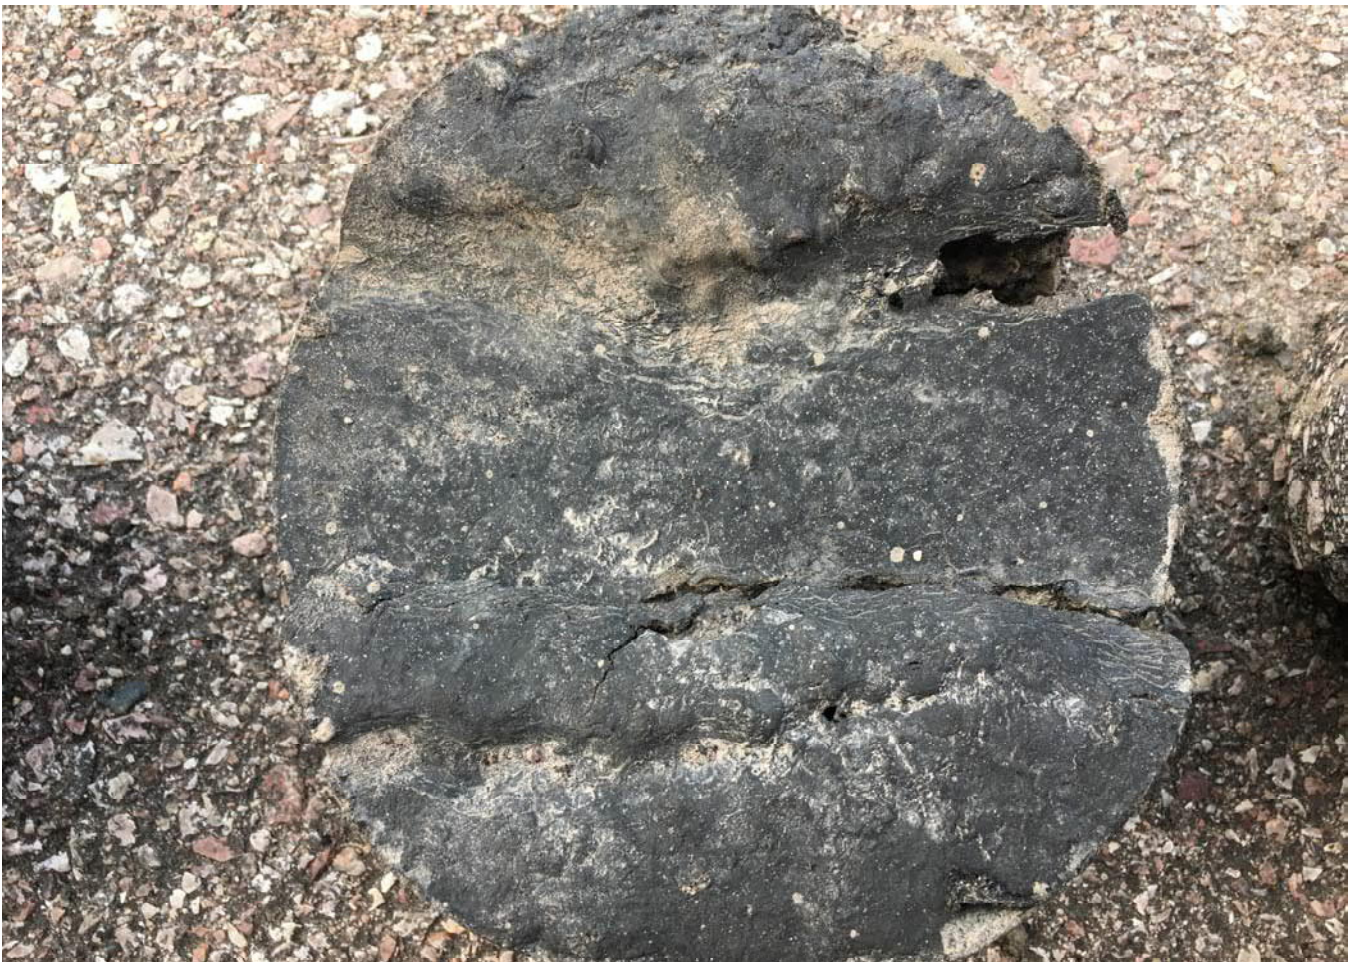
CORE C3: SIDE VIEW

CORE C3: TOP VIEW

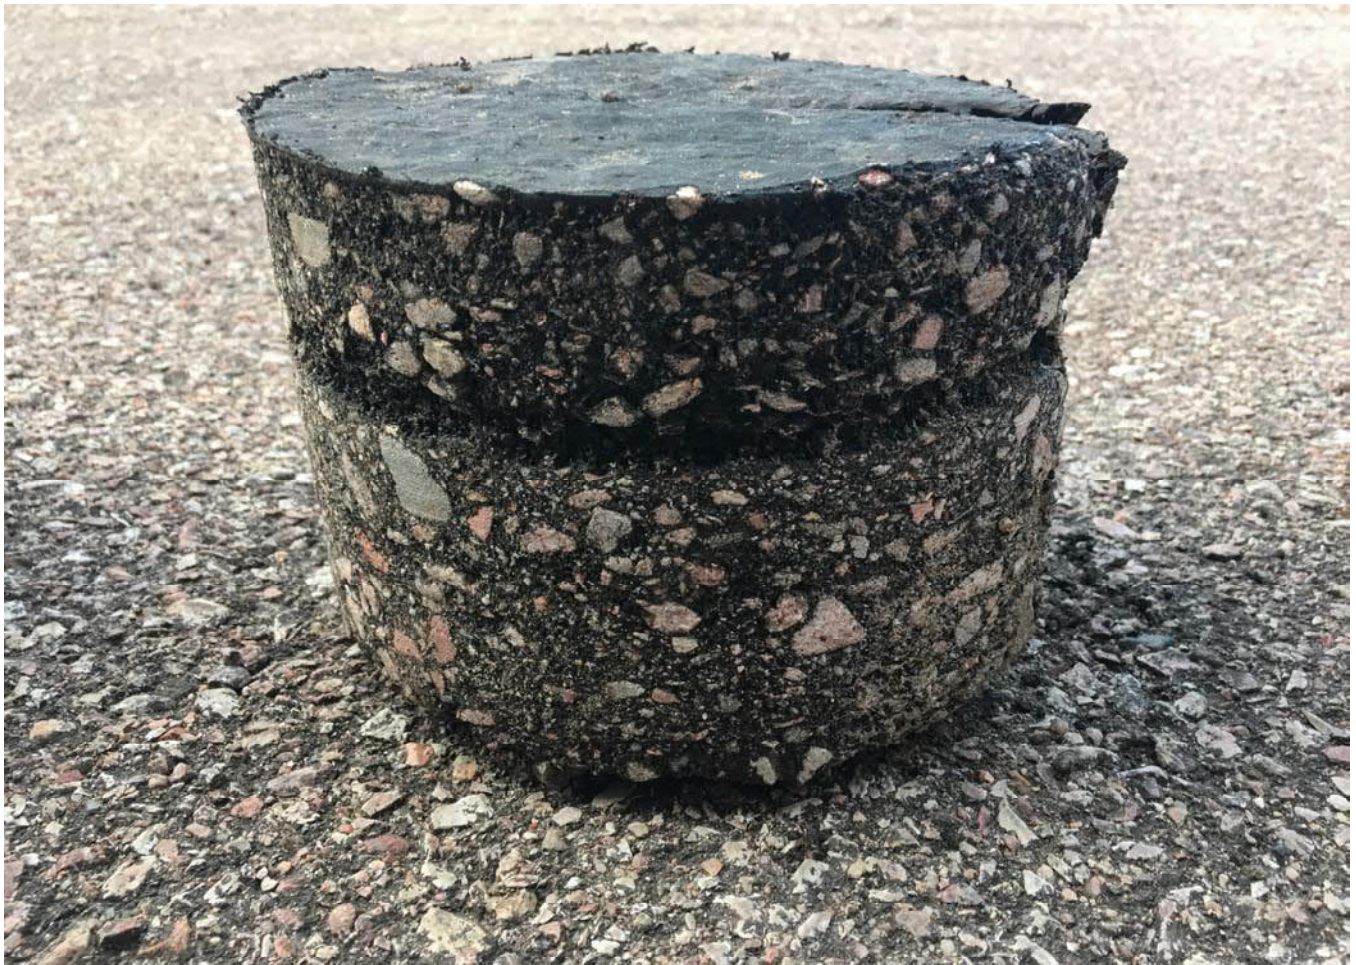
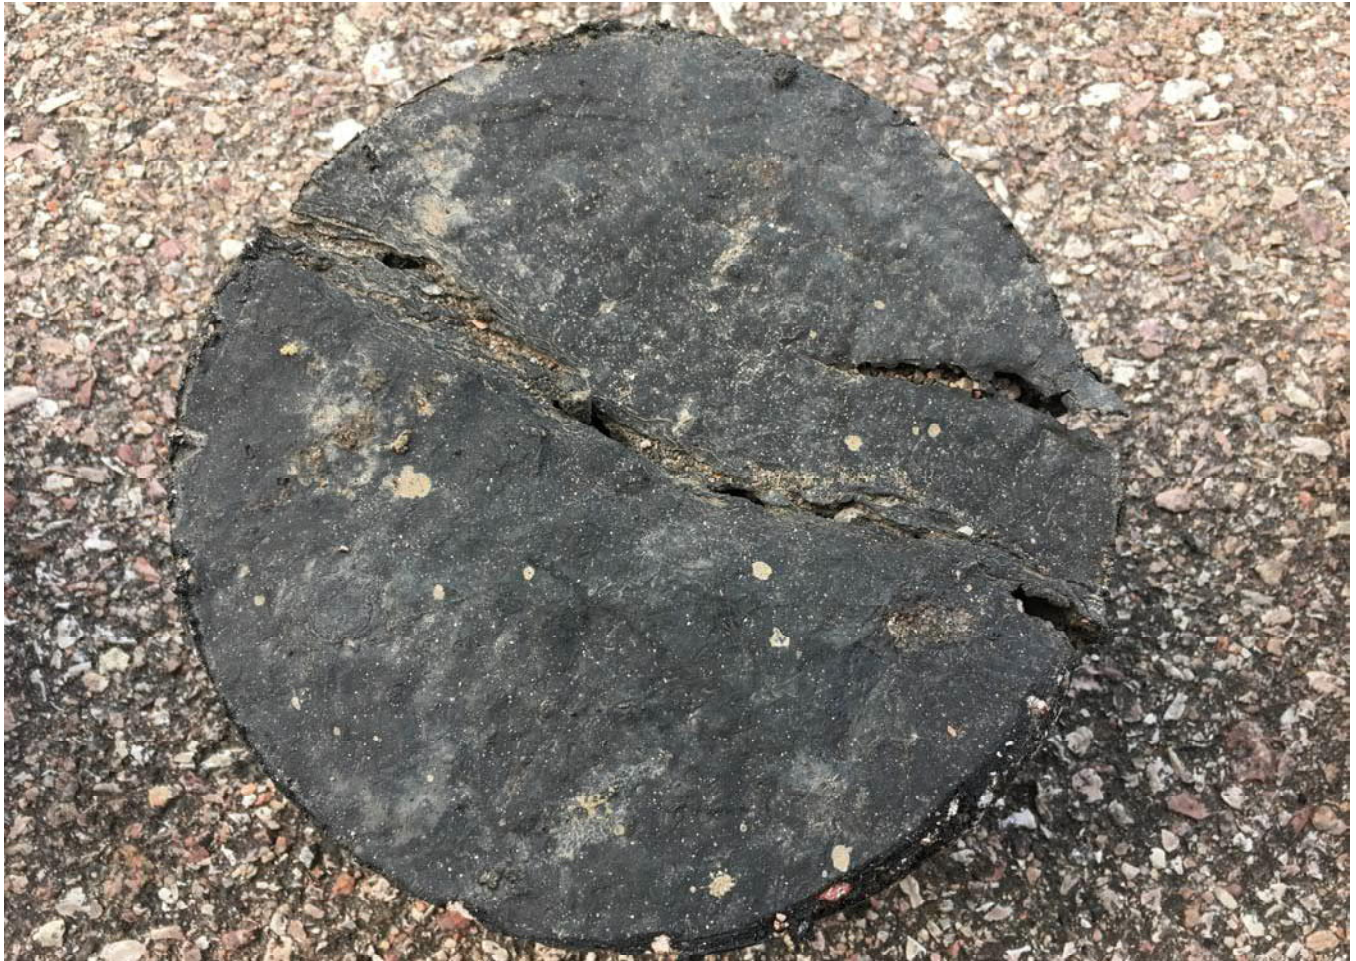
CORE C4: SIDE VIEW

CORE C4: TOP VIEW
