**Subject: Drive Area Geotechnical Evaluation**  
Existing Commercial Property  
2675 Akers Drive  
Colorado Springs, Colorado  
Project No. 16-173339.2

## PAVEMENT EVALUATION REPORT

2675 AKERS DRIVE  
COLORADO SPRINGS, COLORADO

PROJECT NO: 0305-CS16

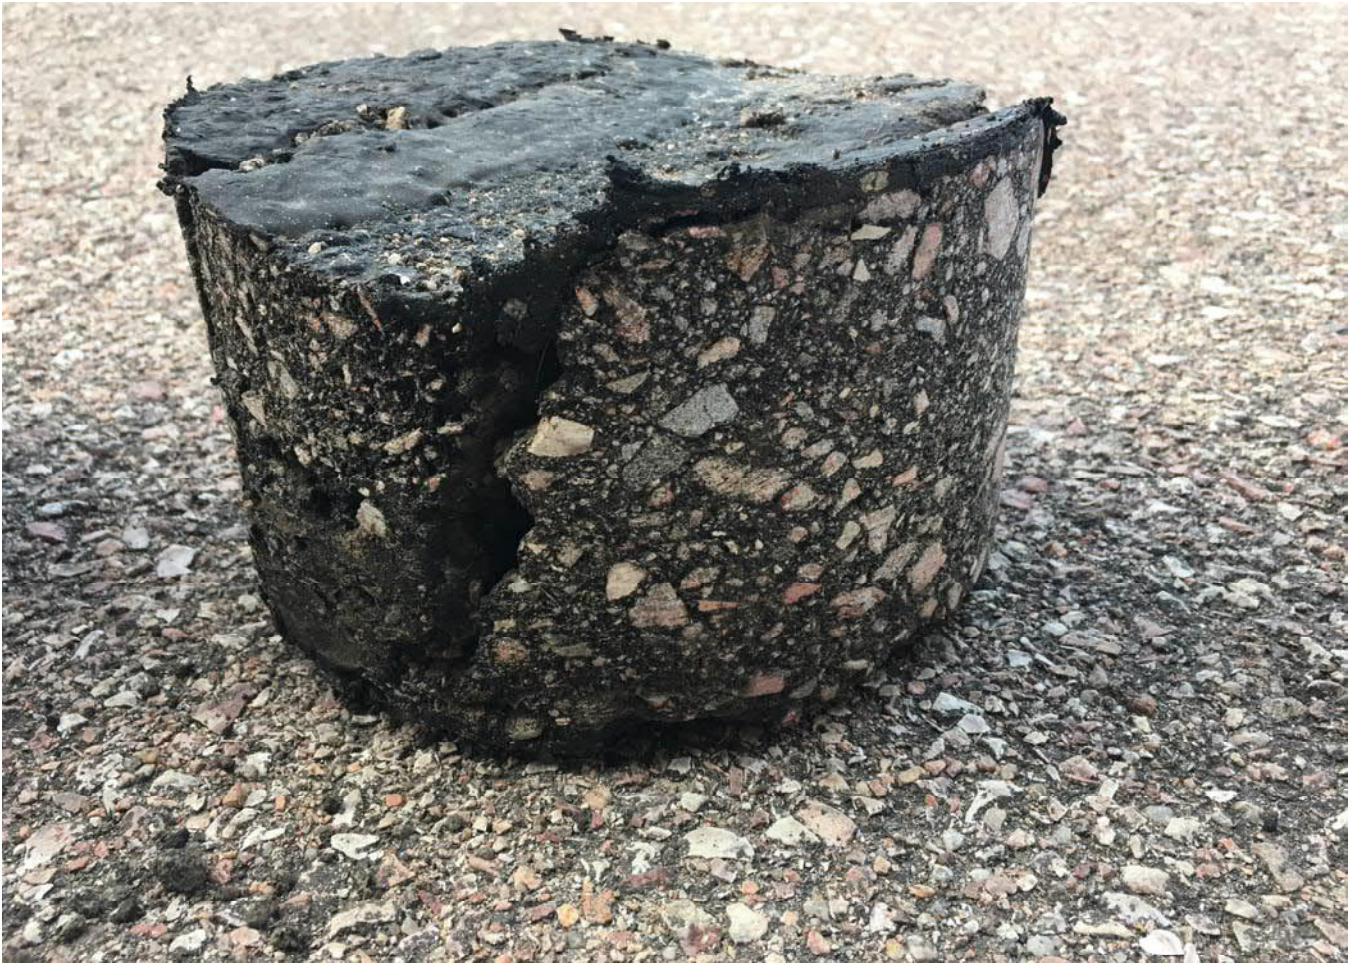
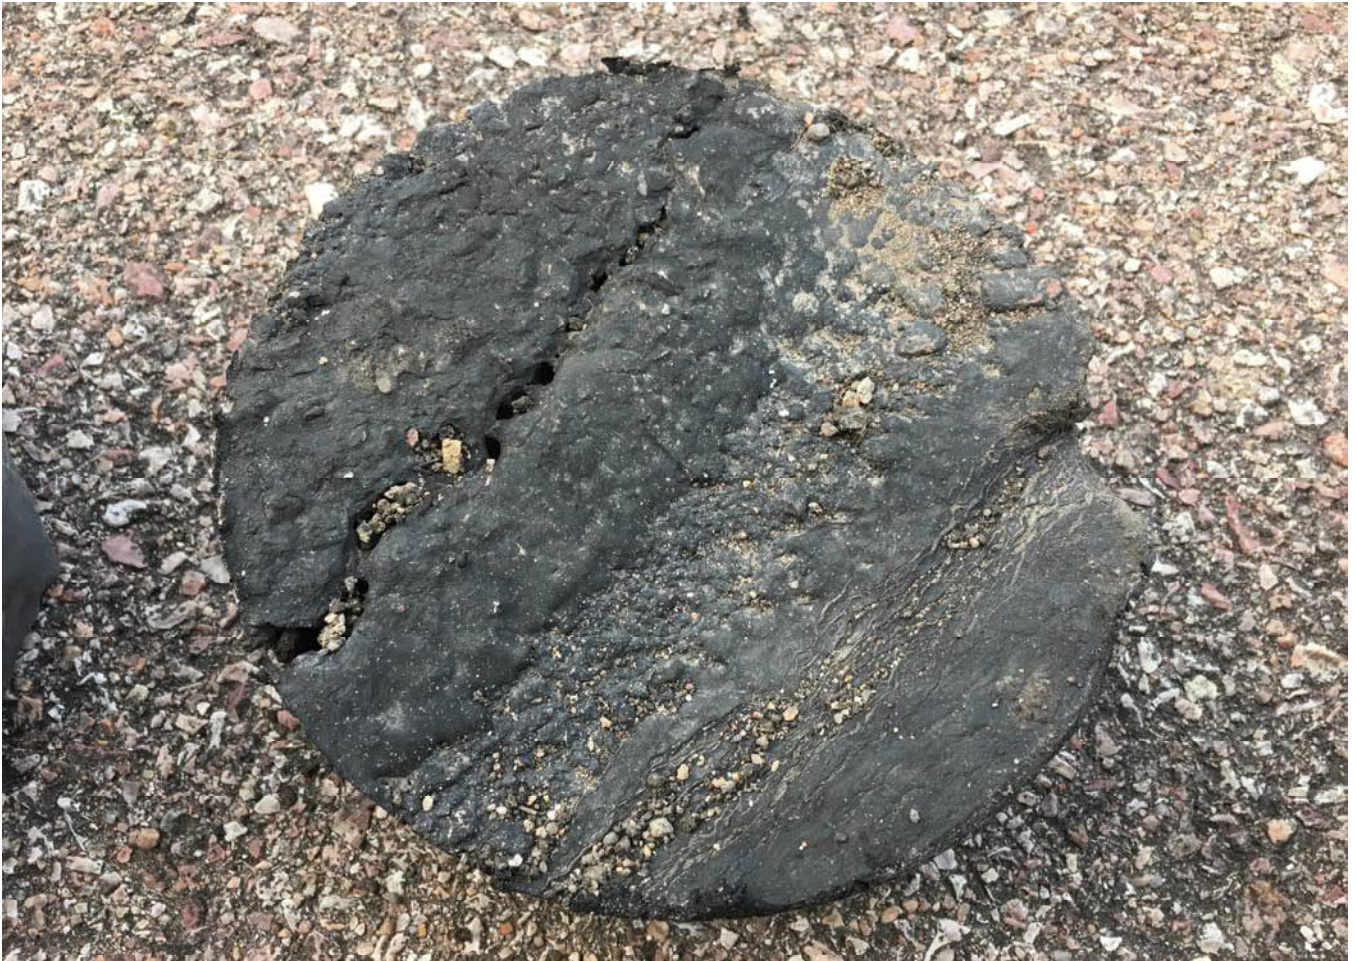
CORE C5: SIDE VIEW

CORE C5: TOP VIEW

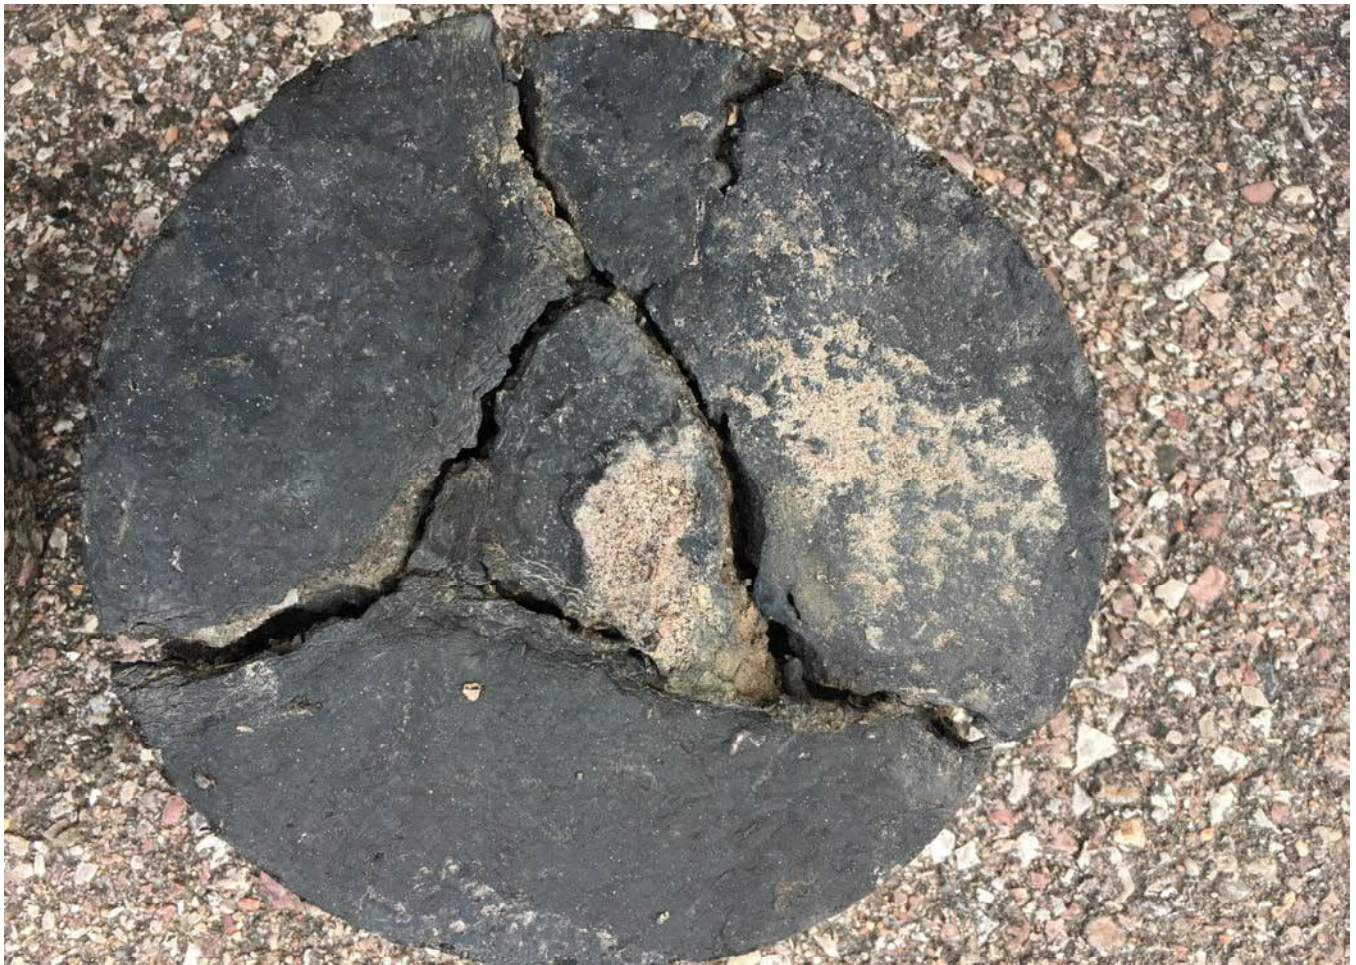
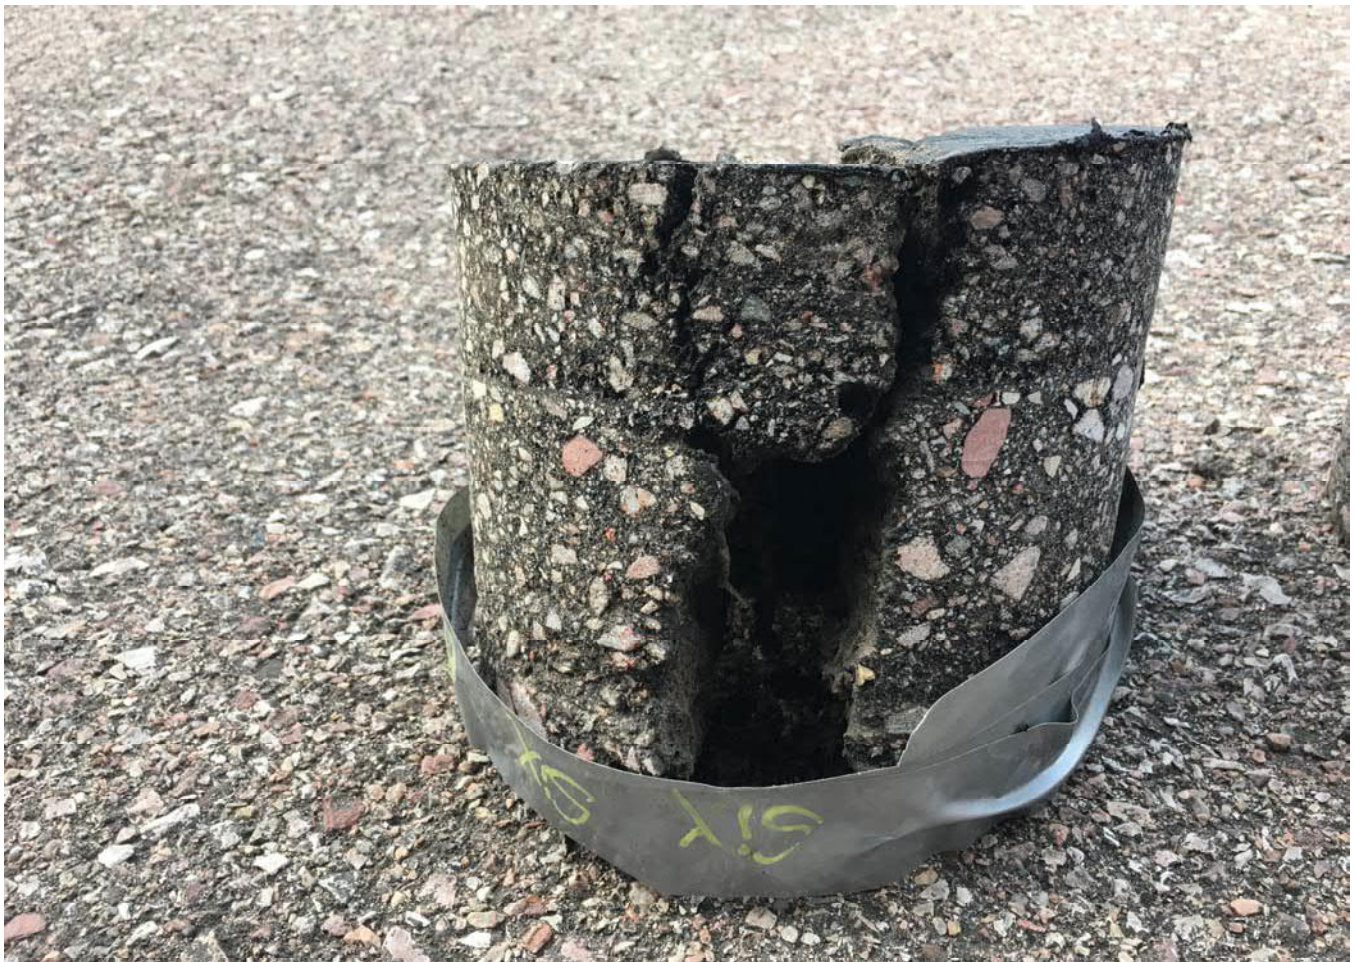
CORE C6: TOP VIEW

CORE C6: SIDE VIEW
