ENTECH
ENGINEERING, INC.

**SOILS AND GEOLOGY STUDY
THE COMMONS AT FALCON FIELD
PARCEL NOS. 43070-00-001 AND 430720-00-015
WOODMEN ROAD AND HIGHWAY 24
EL PASO COUNTY, COLORADO**

January 20, 2021
Revised July 21, 2023

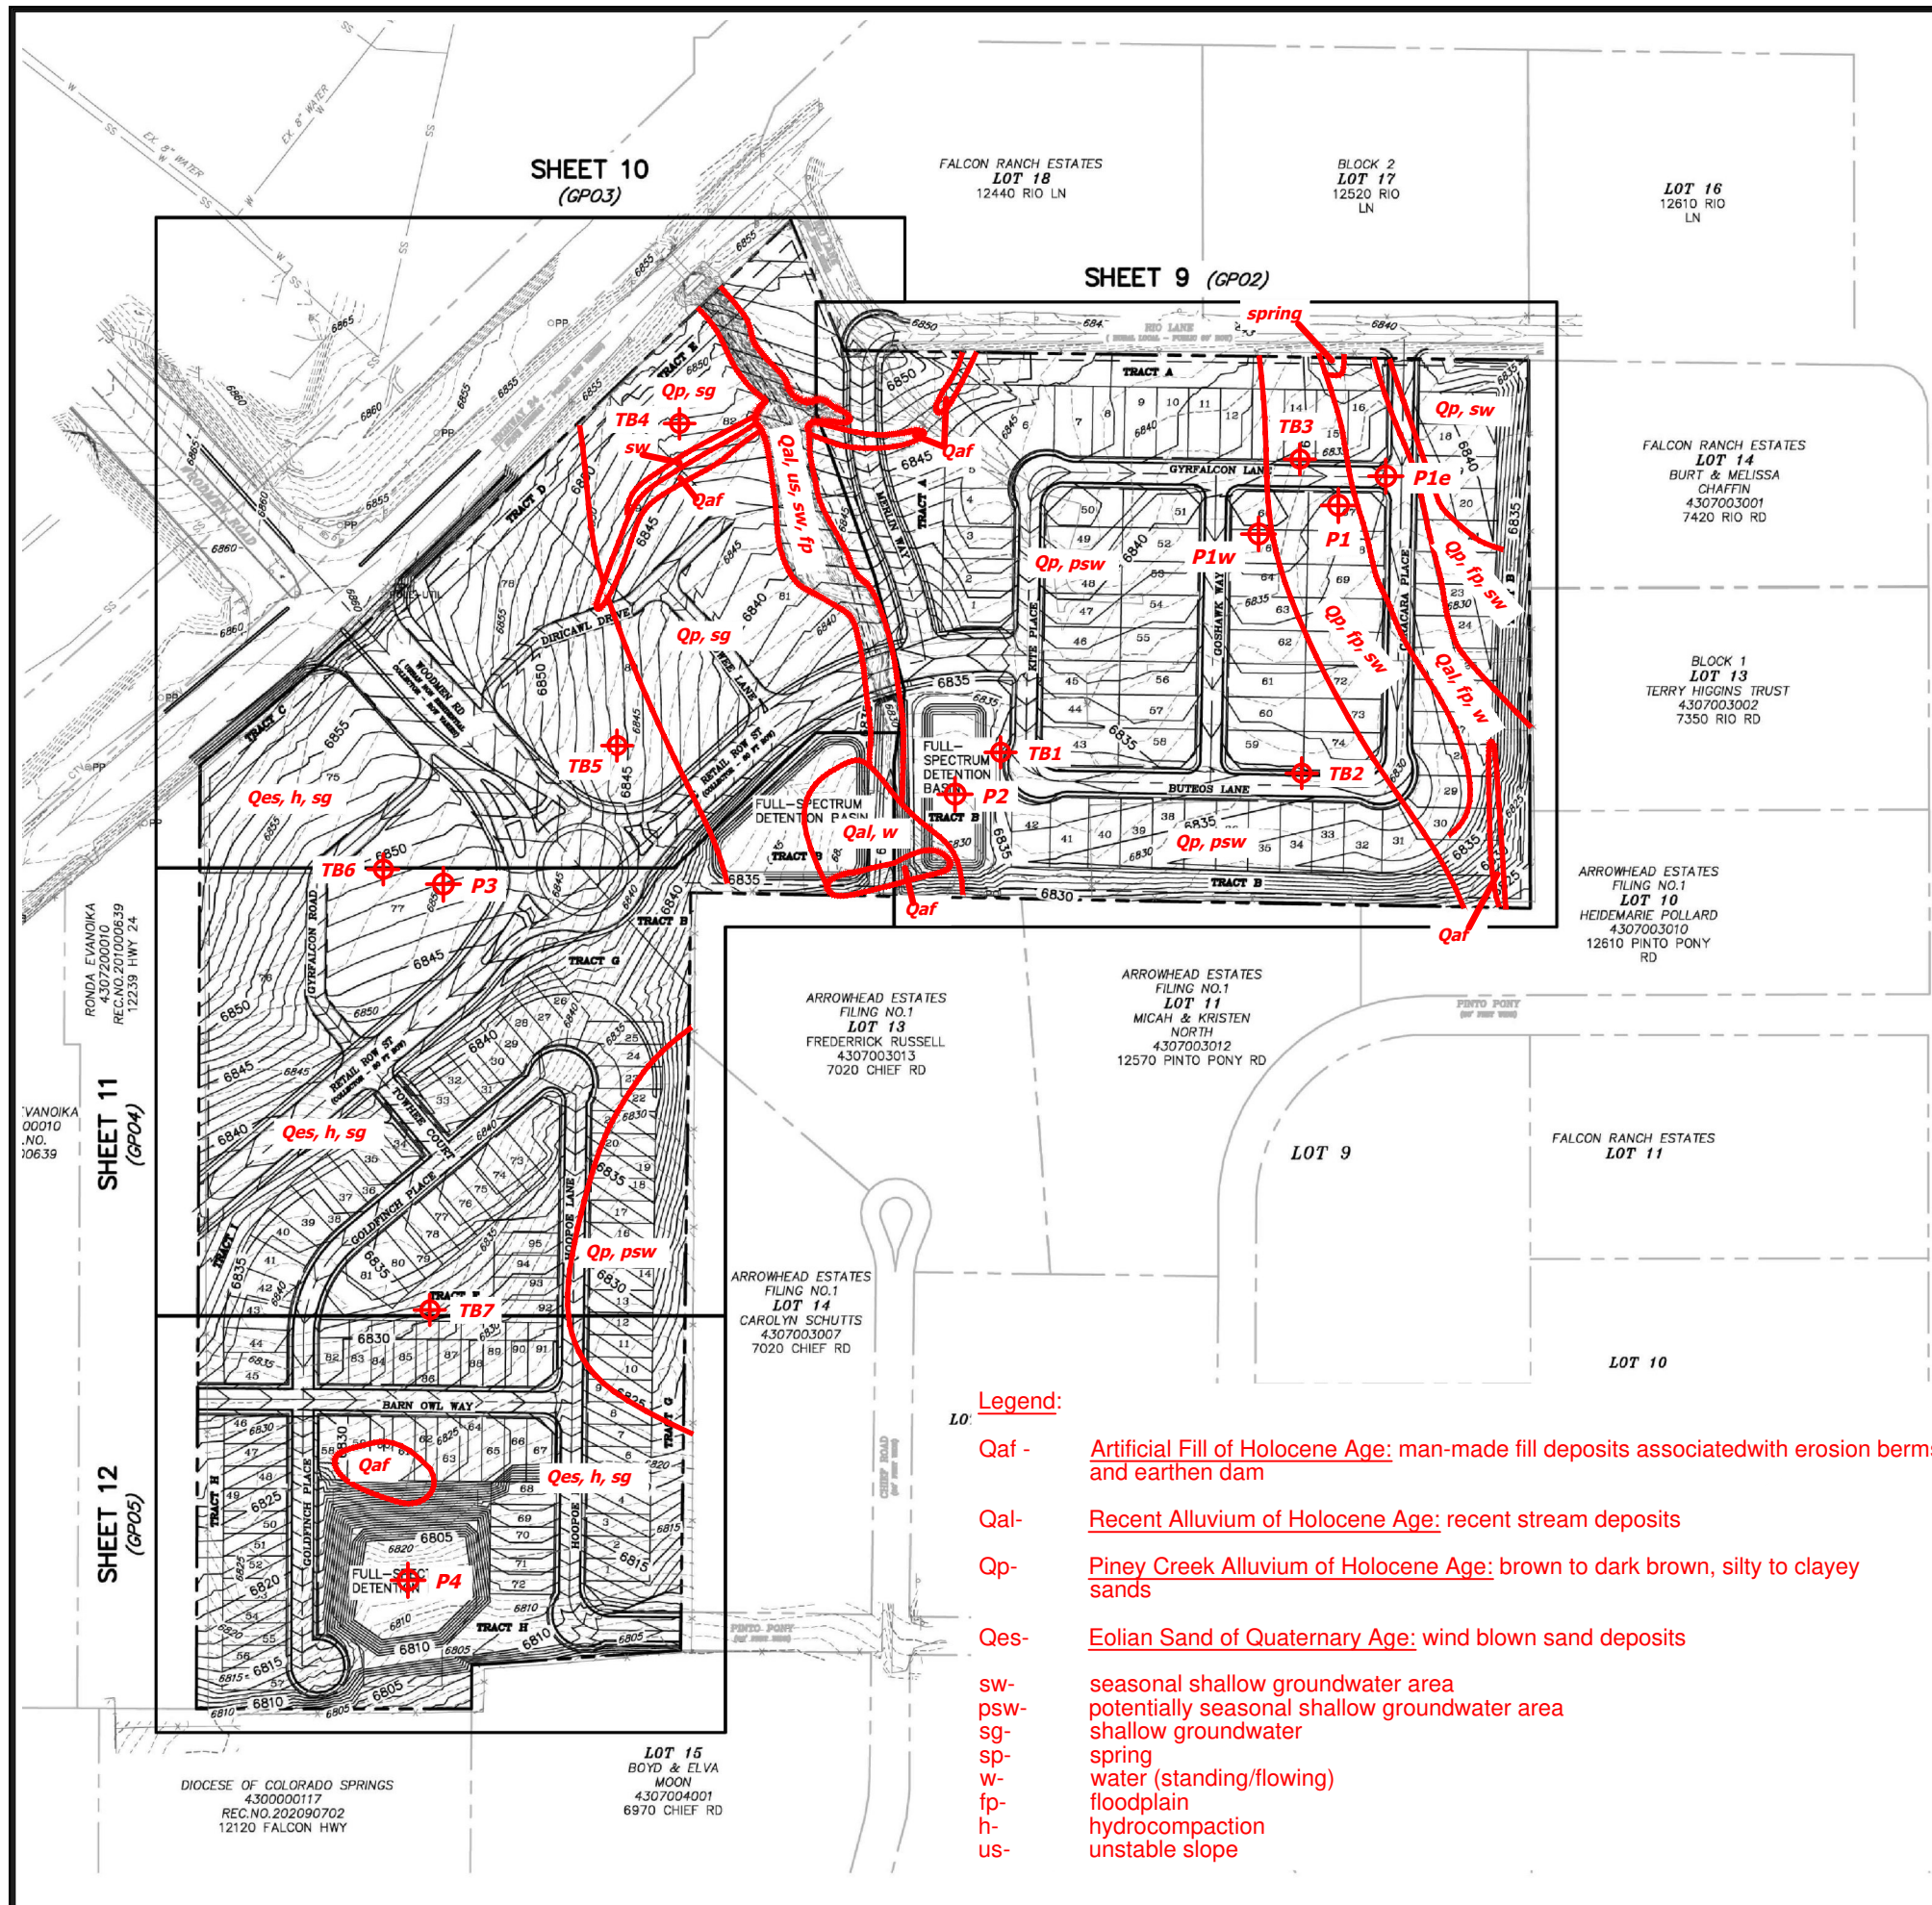
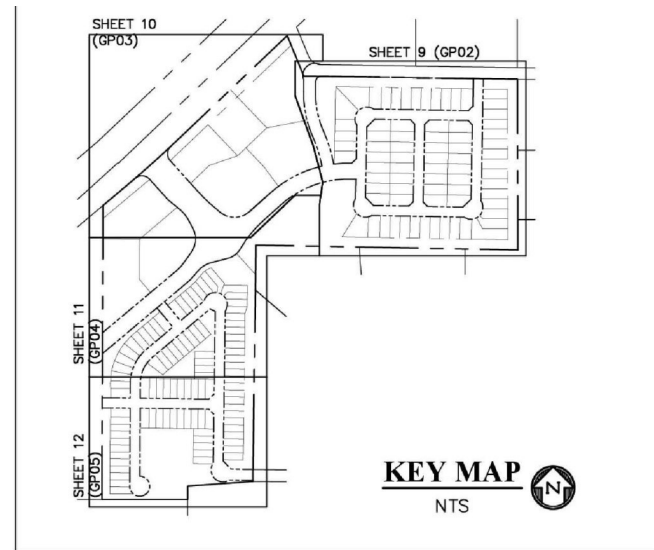
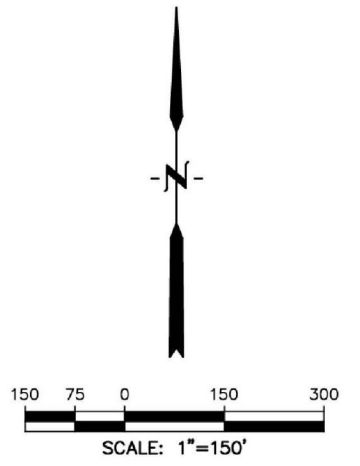
GEOLOGY/ENGINEERING GEOLOGY MAP
 THE COMMONS AT FALCON FIELD
 EL PASO COUNTY, COLORADO
 FALCON FIELD, LLC

Detailed mapping has been performed on this site to produce an Engineering Geology Map (Figure 6). This map shows the location of various geologic conditions of which the developers and planners should be cognizant during the planning, design and construction stages of the project. The constraints/hazards identified on this site include artificial fill, hydrocompaction, potentially expansive soils, seasonal and potentially seasonal shallow groundwater areas, areas of ponded water, springs, unstable slopes, and floodplains. These geologic conditions and the recommended mitigation techniques are as follows.

The majority of the slopes on-site are gently sloping and do not exhibit any past or potential unstable slopes or landslides. Some of the steeper slopes along the drainage in the central portion of the site have been identified as unstable slopes. The mitigation recommendation for these areas is as follows:

Areas of the site have been identified as seasonal and potentially seasonal shallow groundwater areas. Additionally, shallow groundwater was encountered in some of the borings (less than 5 feet) and is identified as areas of shallow groundwater. A spring is located in the northeastern portion of the property along Rio Lane. Water was observed flowing in this area at the time of our recent site observations, and along the drainage. The drainage in the central portion of the site west of the existing house and has been mapped as a floodplain zone according to the FEMA Map Nos. 08041CO553G and 08041CO561G, (Figure 7, Reference 8). The minor drainage in to the east of the house is not a mapped FEMA floodplain, however, it is a physiographic floodplain. These areas are indicated on the Geology/Engineering Geology Map Figure 6. The existing drainages will be routed through a pipe or box culvert. These areas are further discussed as follows:

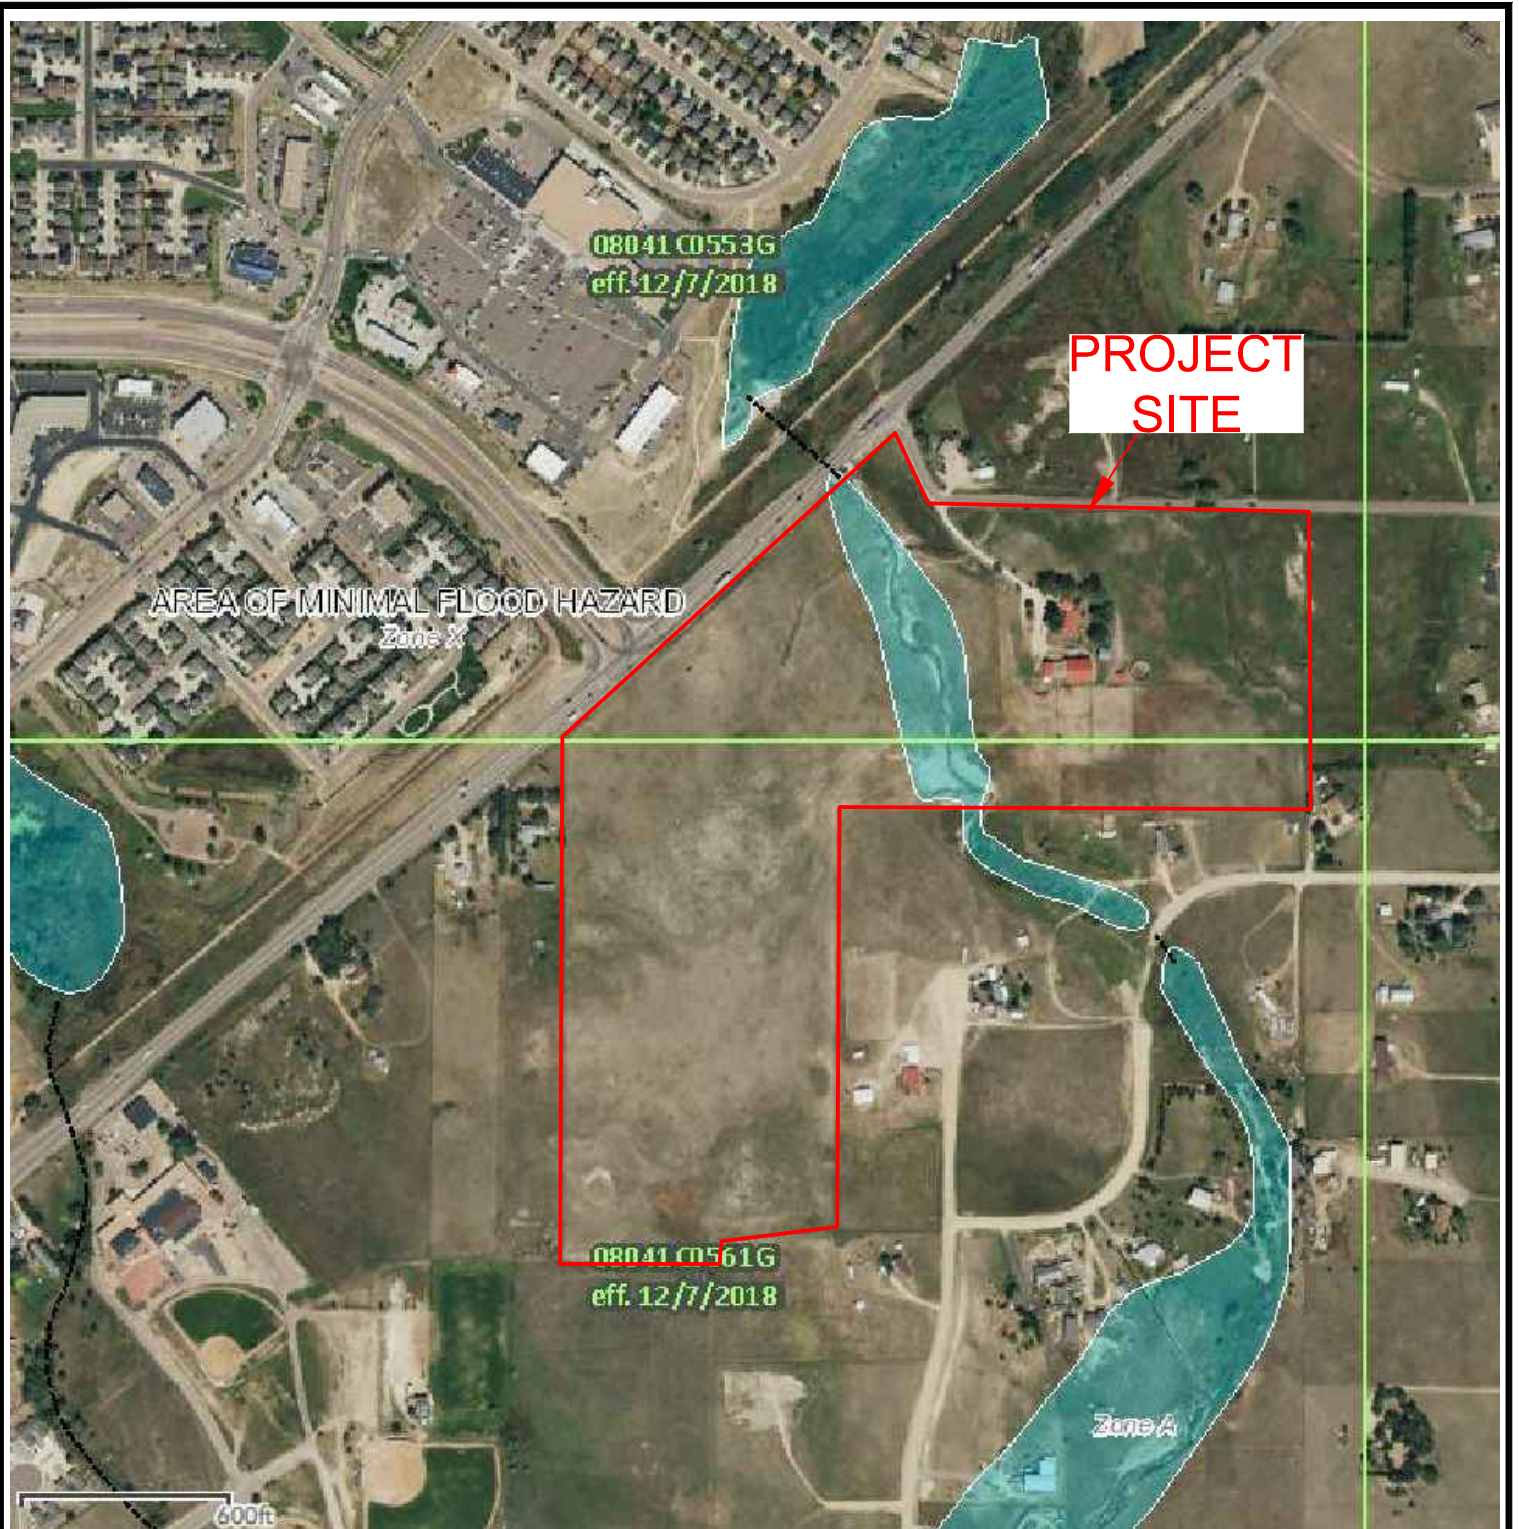
FEMA FLOODPLAIN MAP
THE COMMONS AT FALCON FIELD
EL PASO COUNTY, COLORADO
FALCON FIELD, LLC

Floodplain – Constraint: The drainage in the central portion of the site and has been mapped as a floodplain zone according to the FEMA Map Nos. 08041CO553G and 08041CO561G, (Figure 8, Reference 8). There is also an unmapped physiographic floodplain in the eastern portion of the site. Any construction considered in a floodplain area will require approval of the drainage plan. Lots immediately adjacent to the floodplain may experience higher groundwater levels during peak flows. Subsurface perimeter drains are recommended for structures adjacent to the floodplain to help prevent the intrusion of water into areas below grade. Typical drain details are presented in Figure 8. Finished floor levels must be a minimum of one floor above the floodplain level. Exact floodplain locations by drainage studies are beyond the scope of this report.

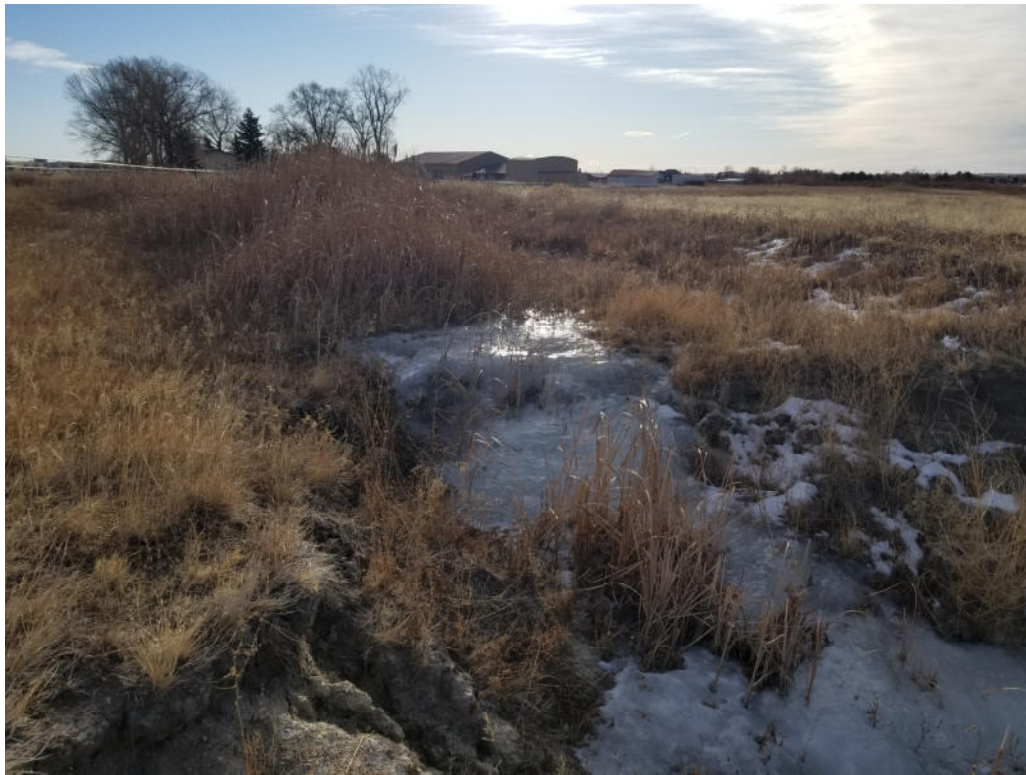
Spring: This area lies within the floodplain area on the eastern portion of the site, therefore, recommendations for the floodplain should be followed for the spring area. Additionally, should development be considered in this area, interceptor drains will be necessary to capture water and transport them safely around structures. It is anticipated dewatering and drainage systems will be necessary for this site, particularly in the drainage area below the spring in the northeastern portion of the site.

**Looking northeast
towards spring in the
northern portion of the
site.**

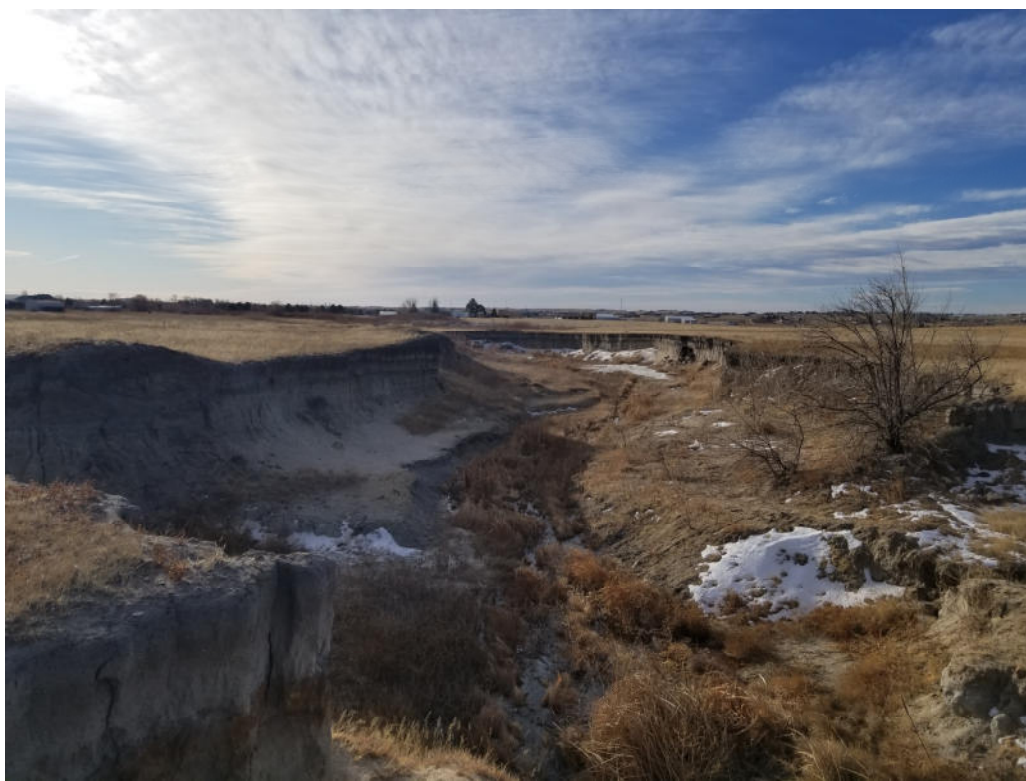
Areas of seasonal shallow groundwater have been mapped in the drainage area in the central area of the site. This area will be regraded and the drainage will be routed through a pipe or box culvert. The potential exists for seasonally high subsurface moisture conditions across most of the site. Areas of perched groundwater areas on the site may require drainage systems in order to dewater the area. Filling the site as indicated on preliminary plans will further raise foundations above the groundwater level. A sanitary sewer underdrain should be considered to assist with controlling groundwater. All soft or organic soils should be removed prior to fill placement. Proposed floor levels should be a minimum of 3 feet above the highest anticipated groundwater levels.

**Looking southeast
along drainage in the
central portion of the
site.**

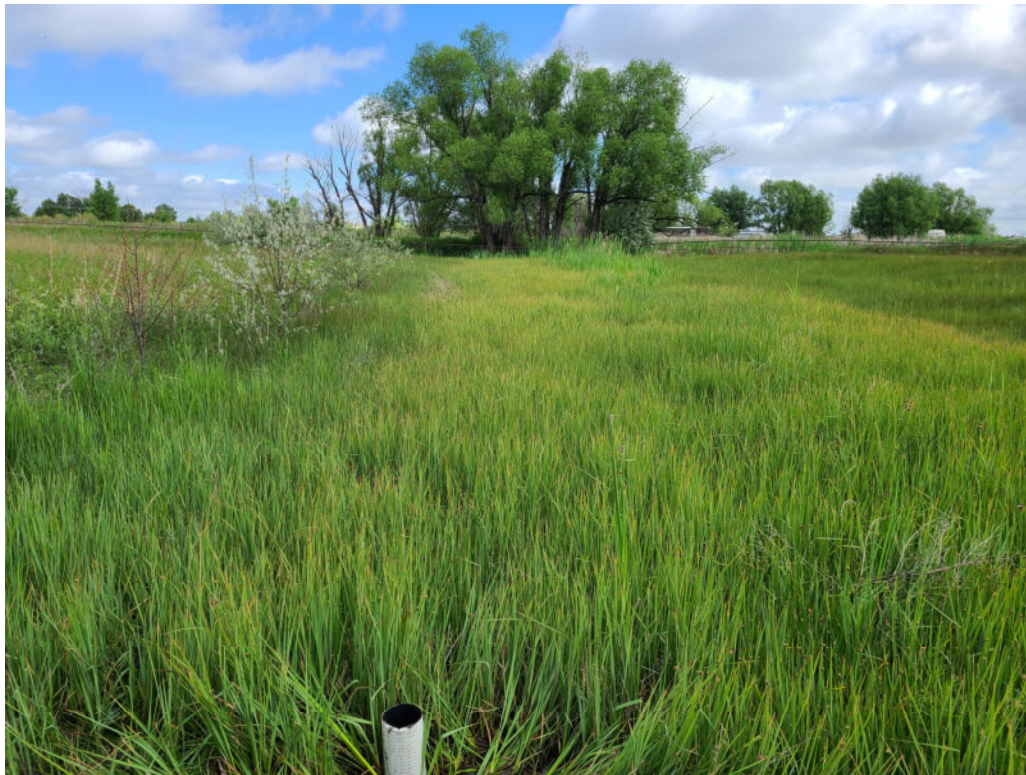
According to the preliminary overall grading plan the unstable slopes along the central drainage will be filled and regraded mitigating the unstable slope hazard. The eastern portion of the site where standing water was observed will be filled. Fill should be placed on native soils or bedrock and properly benched into the slopes. Dewatering of the area may be required during site grading prior to placing fill. The drainage is to be routed through a pipe or box culvert. Piezometer Nos. 2 and 4 are located within proposed full-spectrum detention ponds. The highest groundwater elevations from our initial readings in these areas resulted in groundwater at 4.1 feet in Piezometer No. 2 (7/20/2023), and at 6.1 in Piezometer No. 4 (7/14/2023). Based on the current grading plans the proposed cuts in the ponds will extend into the current groundwater levels potentially limiting the capacity of the full-spectrum detention ponds.

**Looking north from the
physiographic
floodplain in the
eastern portion of the
site.**

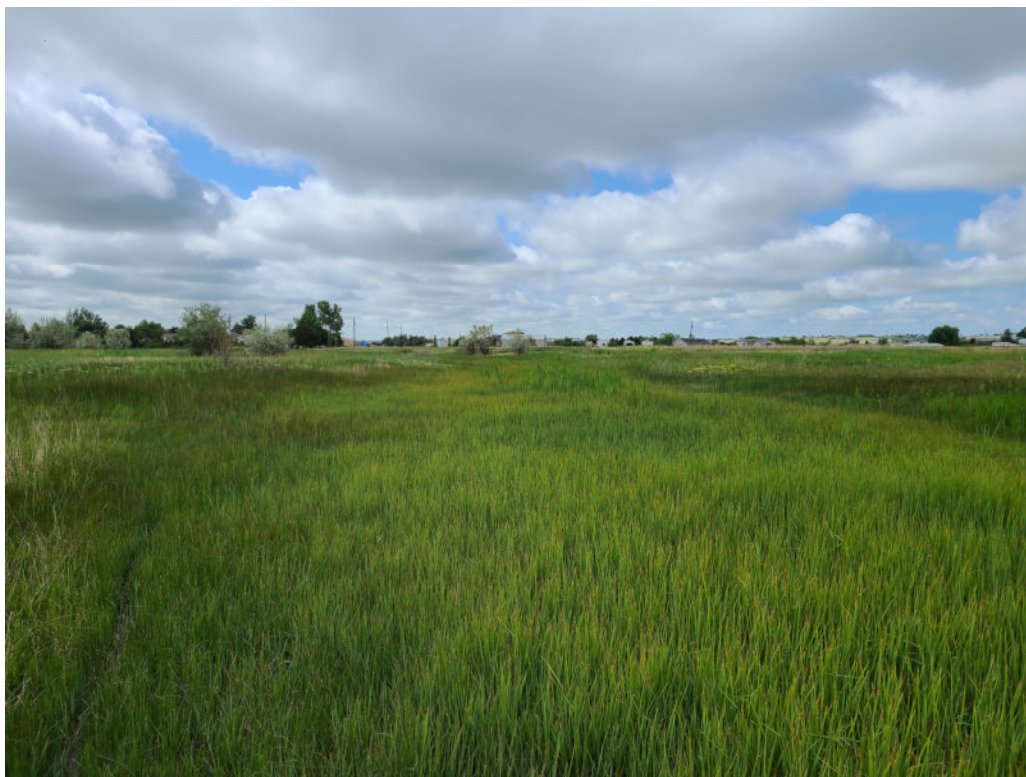
**Looking south from
the physiographic
floodplain in the
eastern portion of the
site.**
