**Re: Gulf Eagle Supply Site Development Plan – 1455 Selix Grove ((PPR1911, CON203)  
Stormwater Permanent Control Measure – Rain Garden Infiltration Letter  
M.V.E. Project No. 61078**

Re: Infiltration Rate Testing (Percolation Test Method)  
Gulf Eagle Supply  
1455 Selix Grove  
Colorado Springs, Colorado  
Entech Job No. 240644

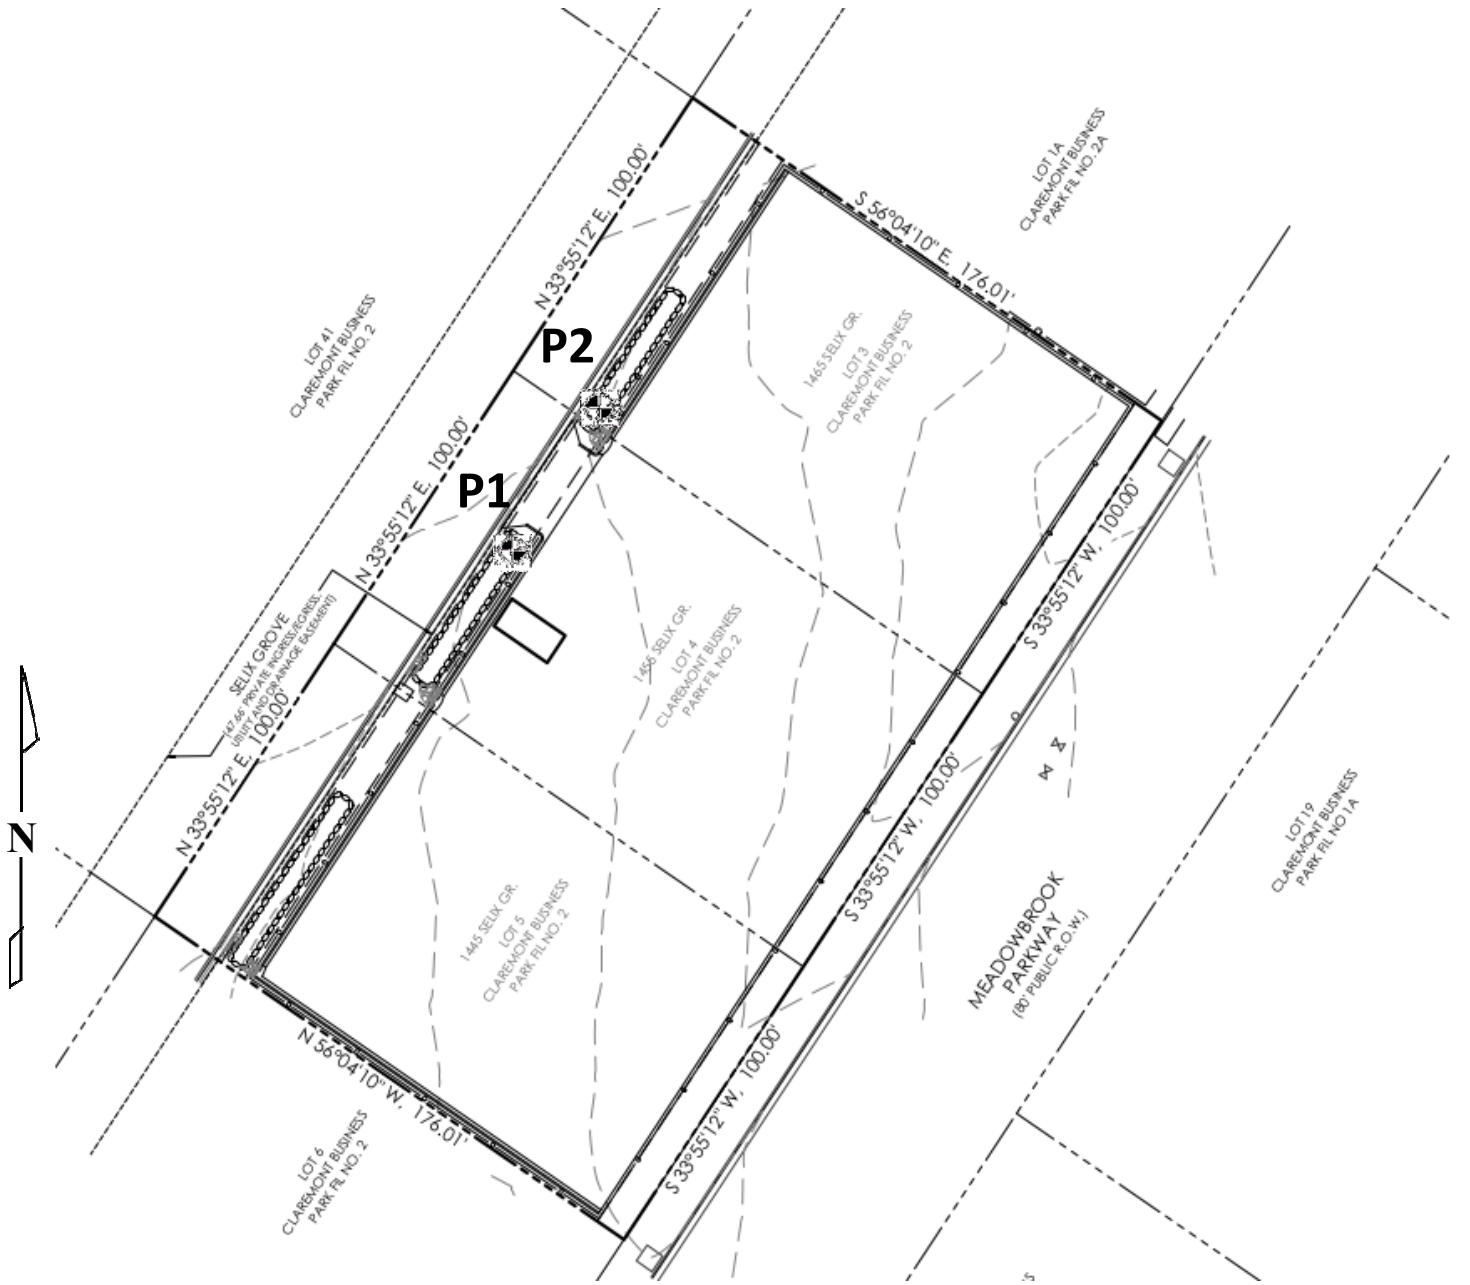
**FIG. 1**

The testing was performed on May 9, 2024. The test locations are shown on Figure 1. The southern infiltration garden (PH-1) and the northern infiltration garden (PH-2). Percolation test results, infiltration rates, and laboratory test results are shown in Figures 2 through 5. Soils encountered in the profile and percolation holes consisted of sand with silt. Bedrock was not encountered in PH-1 or PH-2. Groundwater was not encountered in the percolation holes which were drilled to approximately 3 feet.

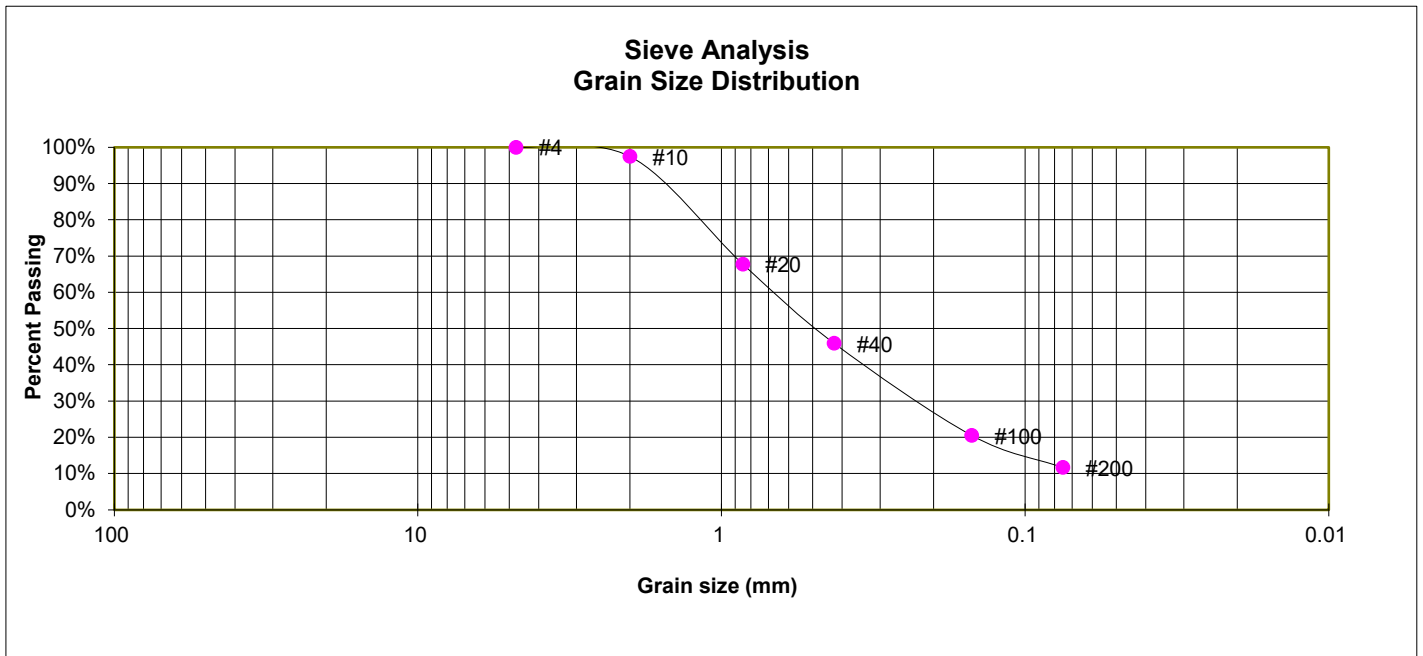
**FIG. 2**

TEST BORING P1  
DEPTH (FT) 2

SOIL DESCRIPTION SAND, WITH SILT

U.S. Sieve #	Percent Finer	
3"		
1 1/2"		
3/4"		
1/2"		
3/8"		
4	100.0%	
10	97.5%	
20	67.8%	
40	45.9%	SW-SM
100	20.5%	
200	11.7%

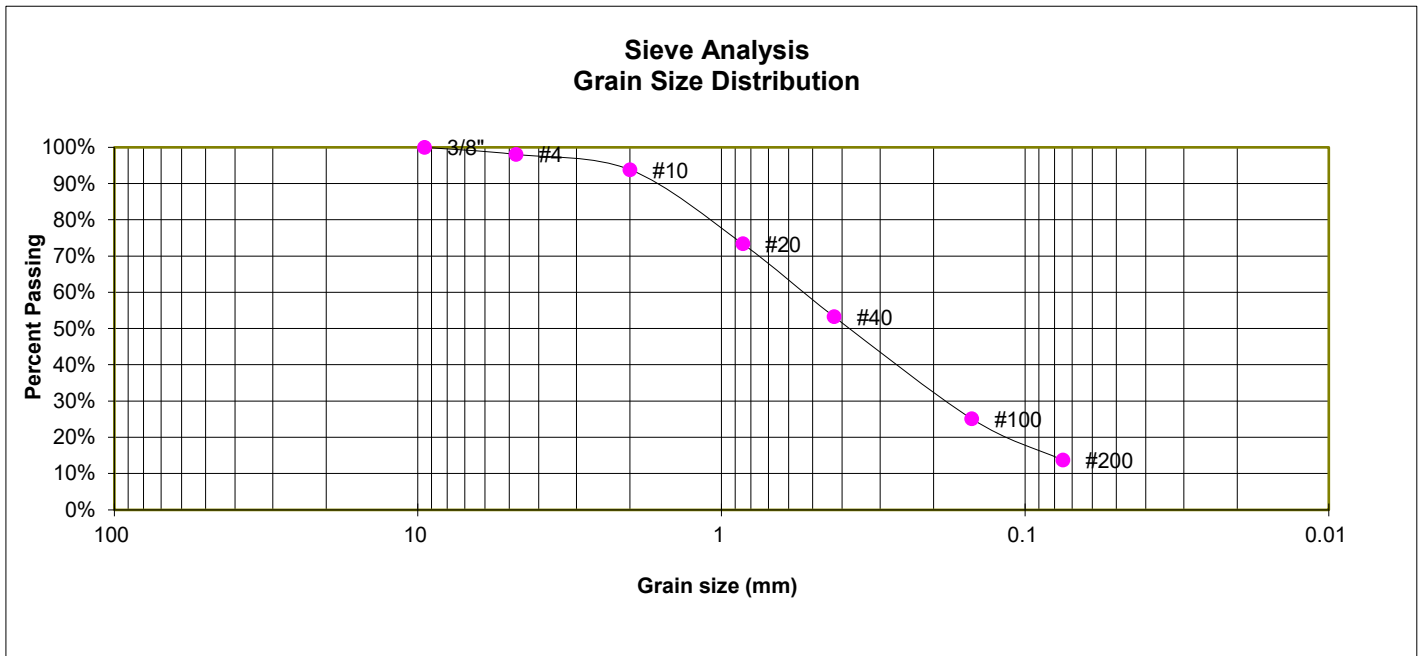
**FIG. 3**

TEST BORING P2  
DEPTH (FT) 1

SOIL DESCRIPTION SAND, SILTY

U.S. Sieve #	Percent Finer	
3"		
1 1/2"		
3/4"		
1/2"		
3/8"	100.0%	
4	98.1%	
10	93.8%	
20	73.4%	
40	53.2%	SM
100	25.2%	
200	13.7%
