January 28, 2025

**Re: Gulf Eagle Supply Site Development Plan – 1455 Selix Grove ((PPR1911, CON203)
Stormwater Permanent Control Measure – Rain Garden Infiltration Letter
M.V.E. Project No. 61078**

Re: Infiltration Rate Testing (Percolation Test Method)
Gulf Eagle Supply
1455 Selix Grove
Colorado Springs, Colorado
Entech Job No. 240644

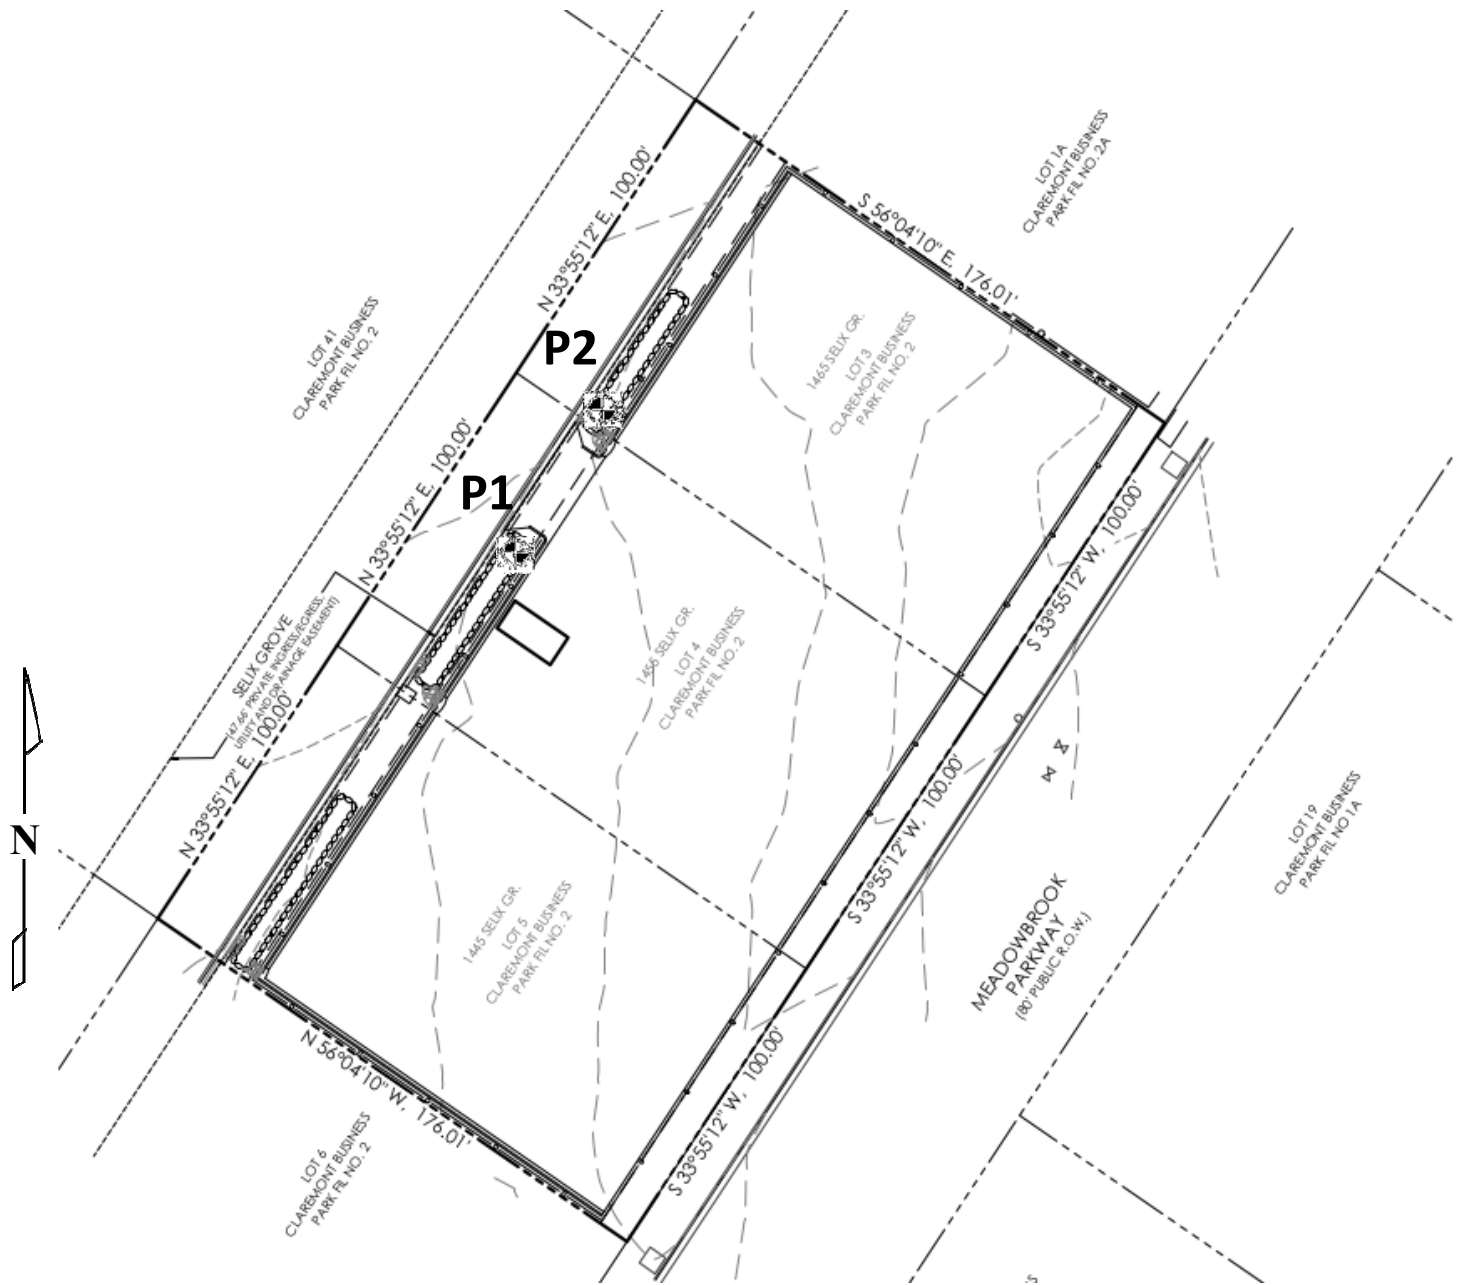
The testing was performed on May 9, 2024. The test locations are shown on Figure 1. The southern infiltration garden (PH-1) and the northern infiltration garden (PH-2). Percolation test results, infiltration rates, and laboratory test results are shown in Figures 2 through 5. Soils encountered in the profile and percolation holes consisted of sand with silt. Bedrock was not encountered in PH-1 or PH-2. Groundwater was not encountered in the percolation holes which were drilled to approximately 3 feet.

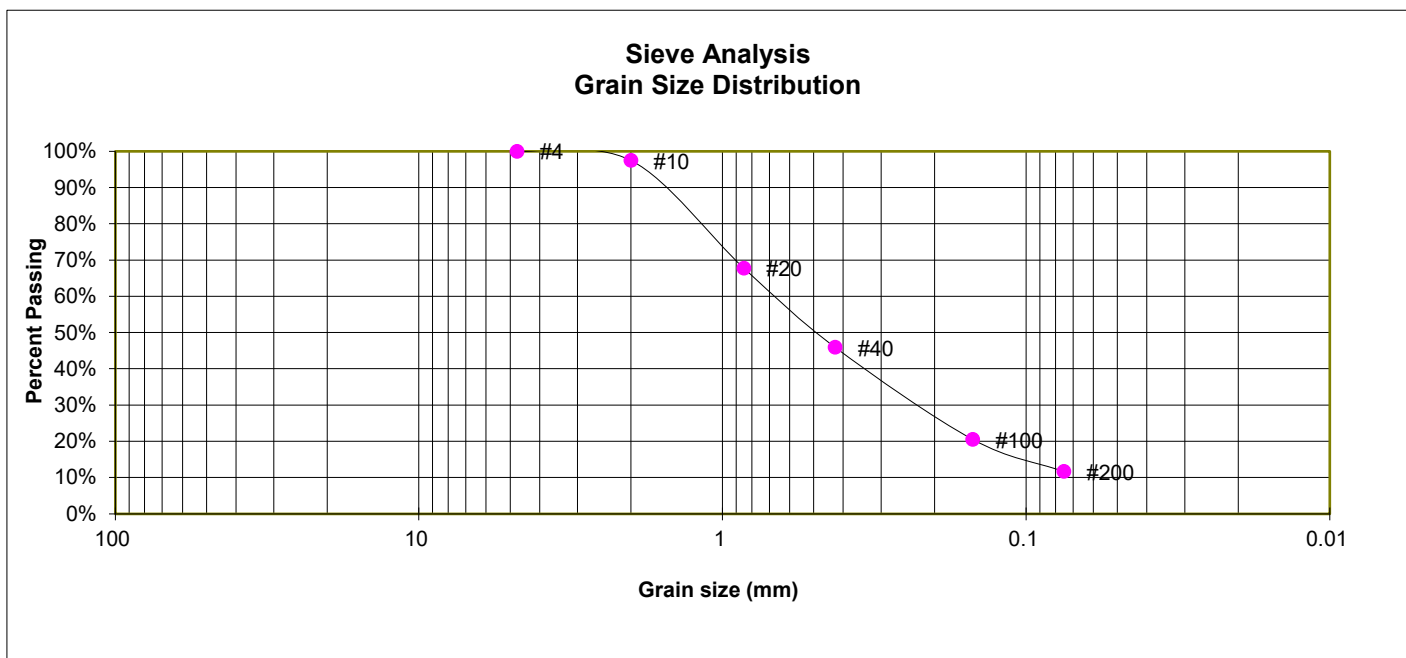
FIG. 2

TEST BORING P1
DEPTH (FT) 2

SOIL DESCRIPTION SAND, WITH SILT

U.S. Sieve #	Percent Finer	
3"		
1 1/2"		
3/4"		
1/2"		
3/8"		
4	100.0%	
10	97.5%	
20	67.8%	
40	45.9%	SW-SM
100	20.5%	
200	11.7%

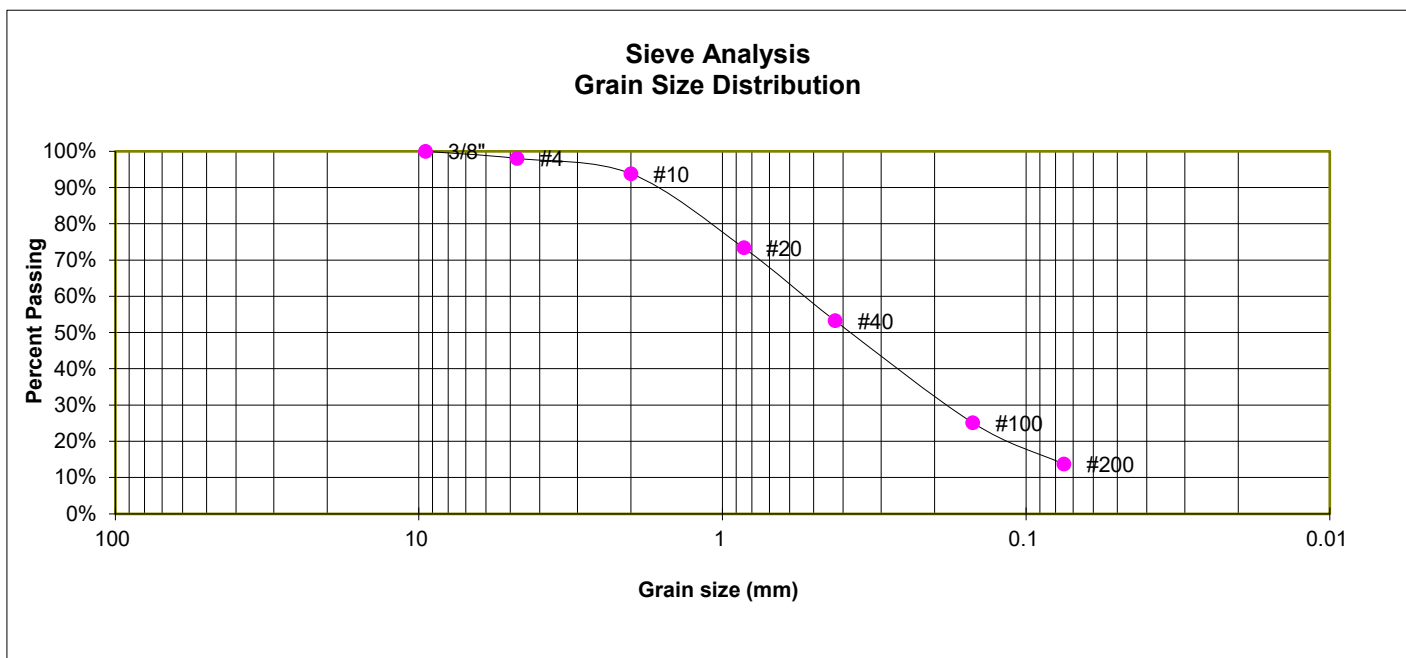
FIG. 3

TEST BORING P2
DEPTH (FT) 1

SOIL DESCRIPTION SAND, SILTY

U.S. Sieve #	Percent Finer	
3"		
1 1/2"		
3/4"		
1/2"		
3/8"	100.0%	
4	98.1%	
10	93.8%	
20	73.4%	
40	53.2%	SM
100	25.2%	
200	13.7%
