**ENTECH**  
ENGINEERING, INC.

**SOILS AND GEOLOGY STUDY  
HODGEN ROAD 7-LOT SUBDIVISION  
PARCEL NO. 61250-01-003  
EL PASO COUNTY, COLORADO**

March 20, 2025

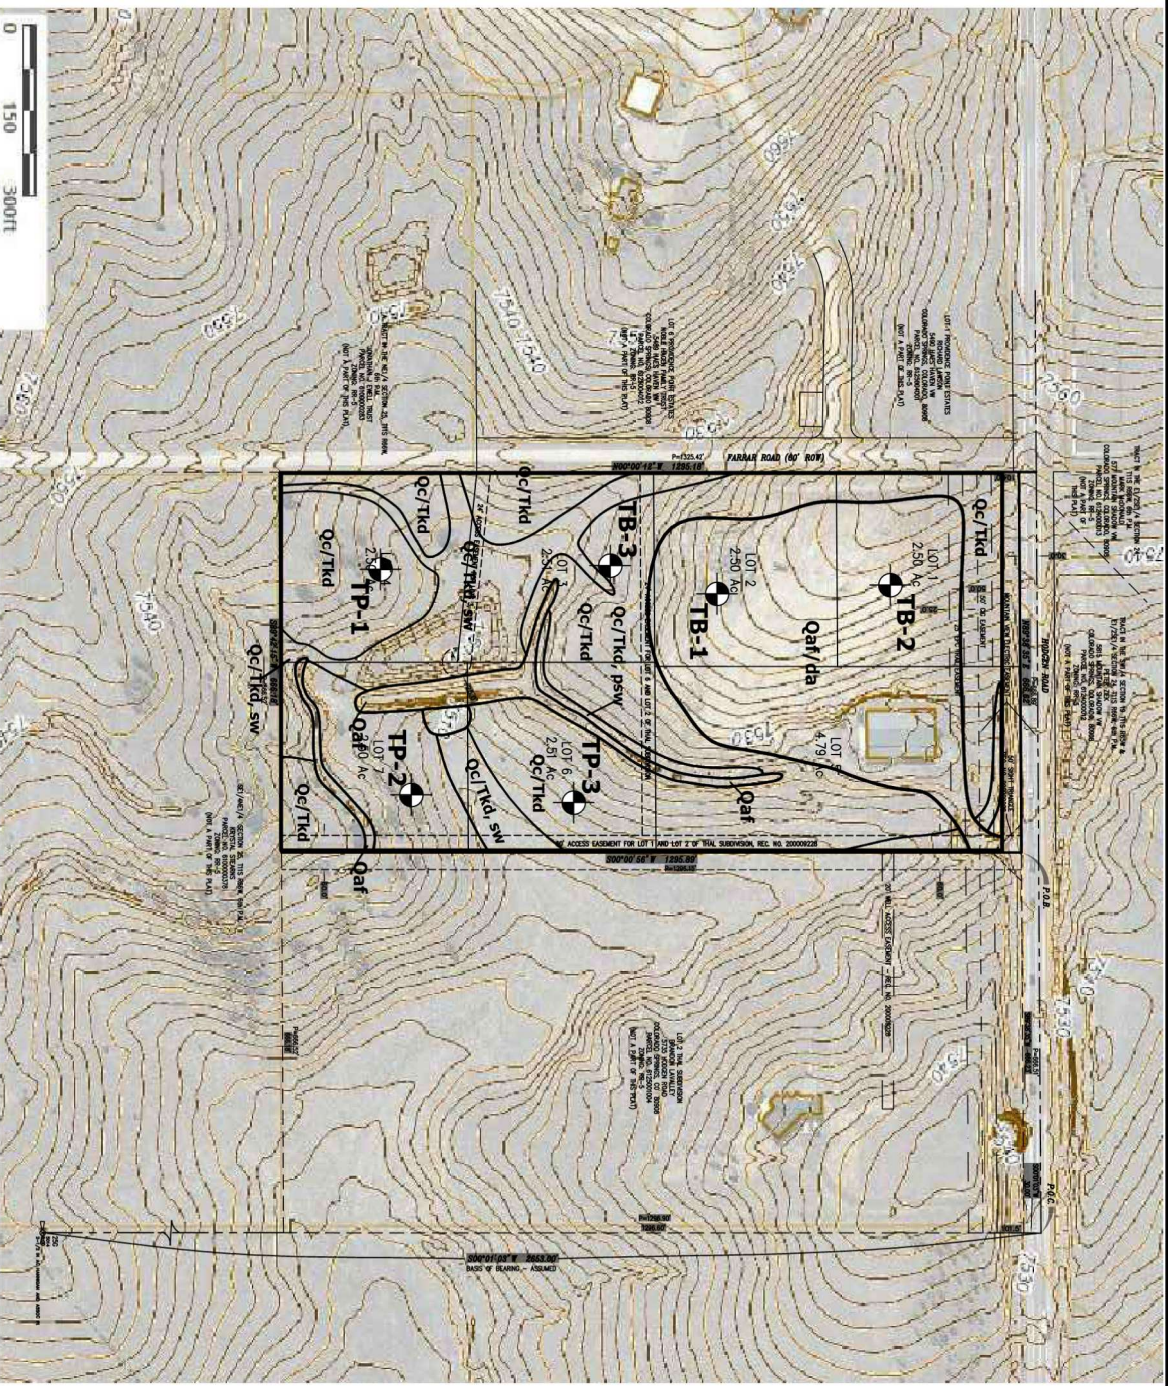
FIG. 6

Detailed mapping has been performed on this site to produce a Geology/Engineering Geology Map (Figure 6). This map shows the location of various geologic conditions the developers should monitor during the planning, design, and construction stages of the project. No significant geologic hazards were identified on the site; however, the following constraints have been identified on the site: artificial fill, potentially expansive soils, seasonally shallow groundwater areas, and areas of ponded water. These constraints and the recommended mitigation techniques include:

These are areas of man-made fill associated with earthen dams, erosion berms, and temporary stockpiles observed on the site.

Mitigation: The earthen dams lie within defined drainages and should be avoided as building sites. Some dams are to be removed or reconstructed as a part of detention ponds. The erosion berms can either be avoided or penetrated by foundations. It is anticipated that the temporary stockpiles will be removed prior to construction. The fill on this site is considered uncontrolled for construction purposes. Any uncontrolled fill encountered beneath foundations will require removal and recompaction at a minimum of 95% of the Modified Procter (ASTM D1557) maximum dry density.

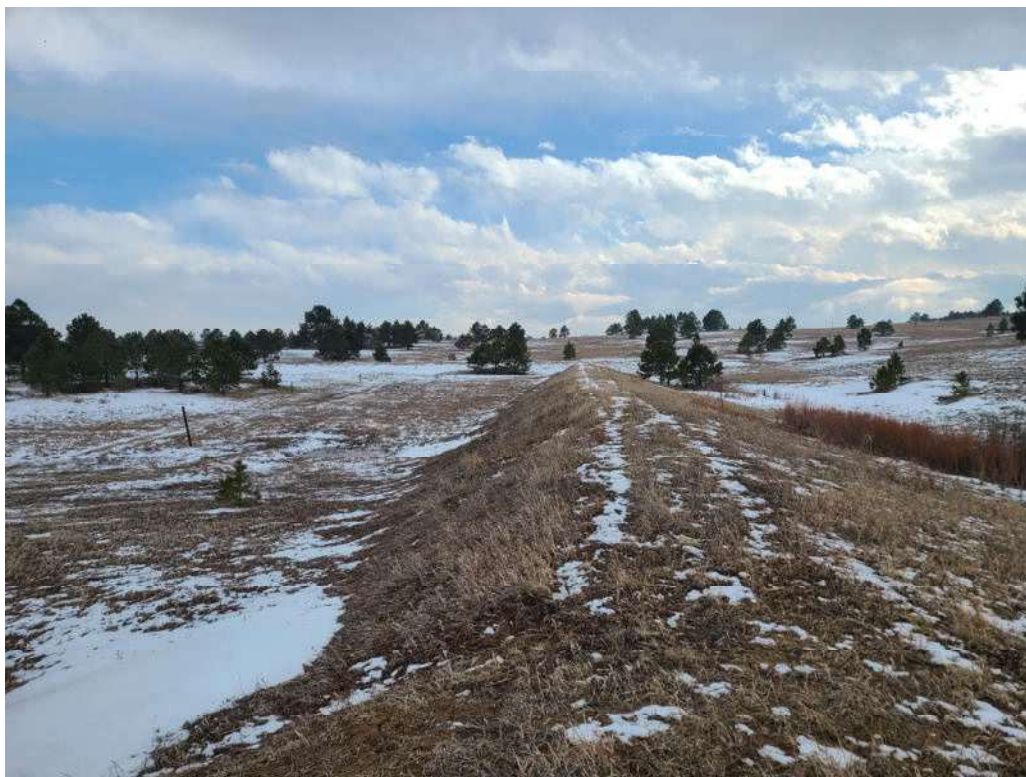
**Looking south from  
the northern side of  
the earthen dam.**

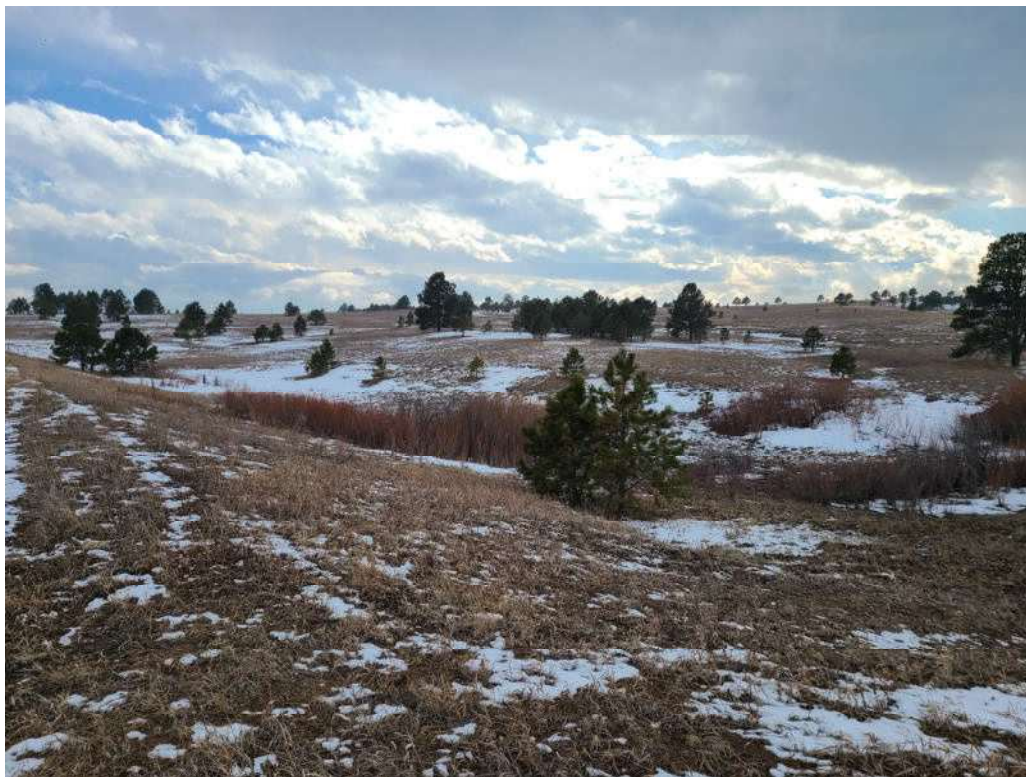
**Looking southwest  
from the northern side  
of the earthen dam.**
