**ENTECH**  
ENGINEERING, INC.

December 7, 2021

Re: Soil, Geology and Geologic Hazard Evaluation  
Trinity Subdivision  
20040 Highway 94  
Tax Schedule Nos. 34000-00-455  
El Paso County, Colorado

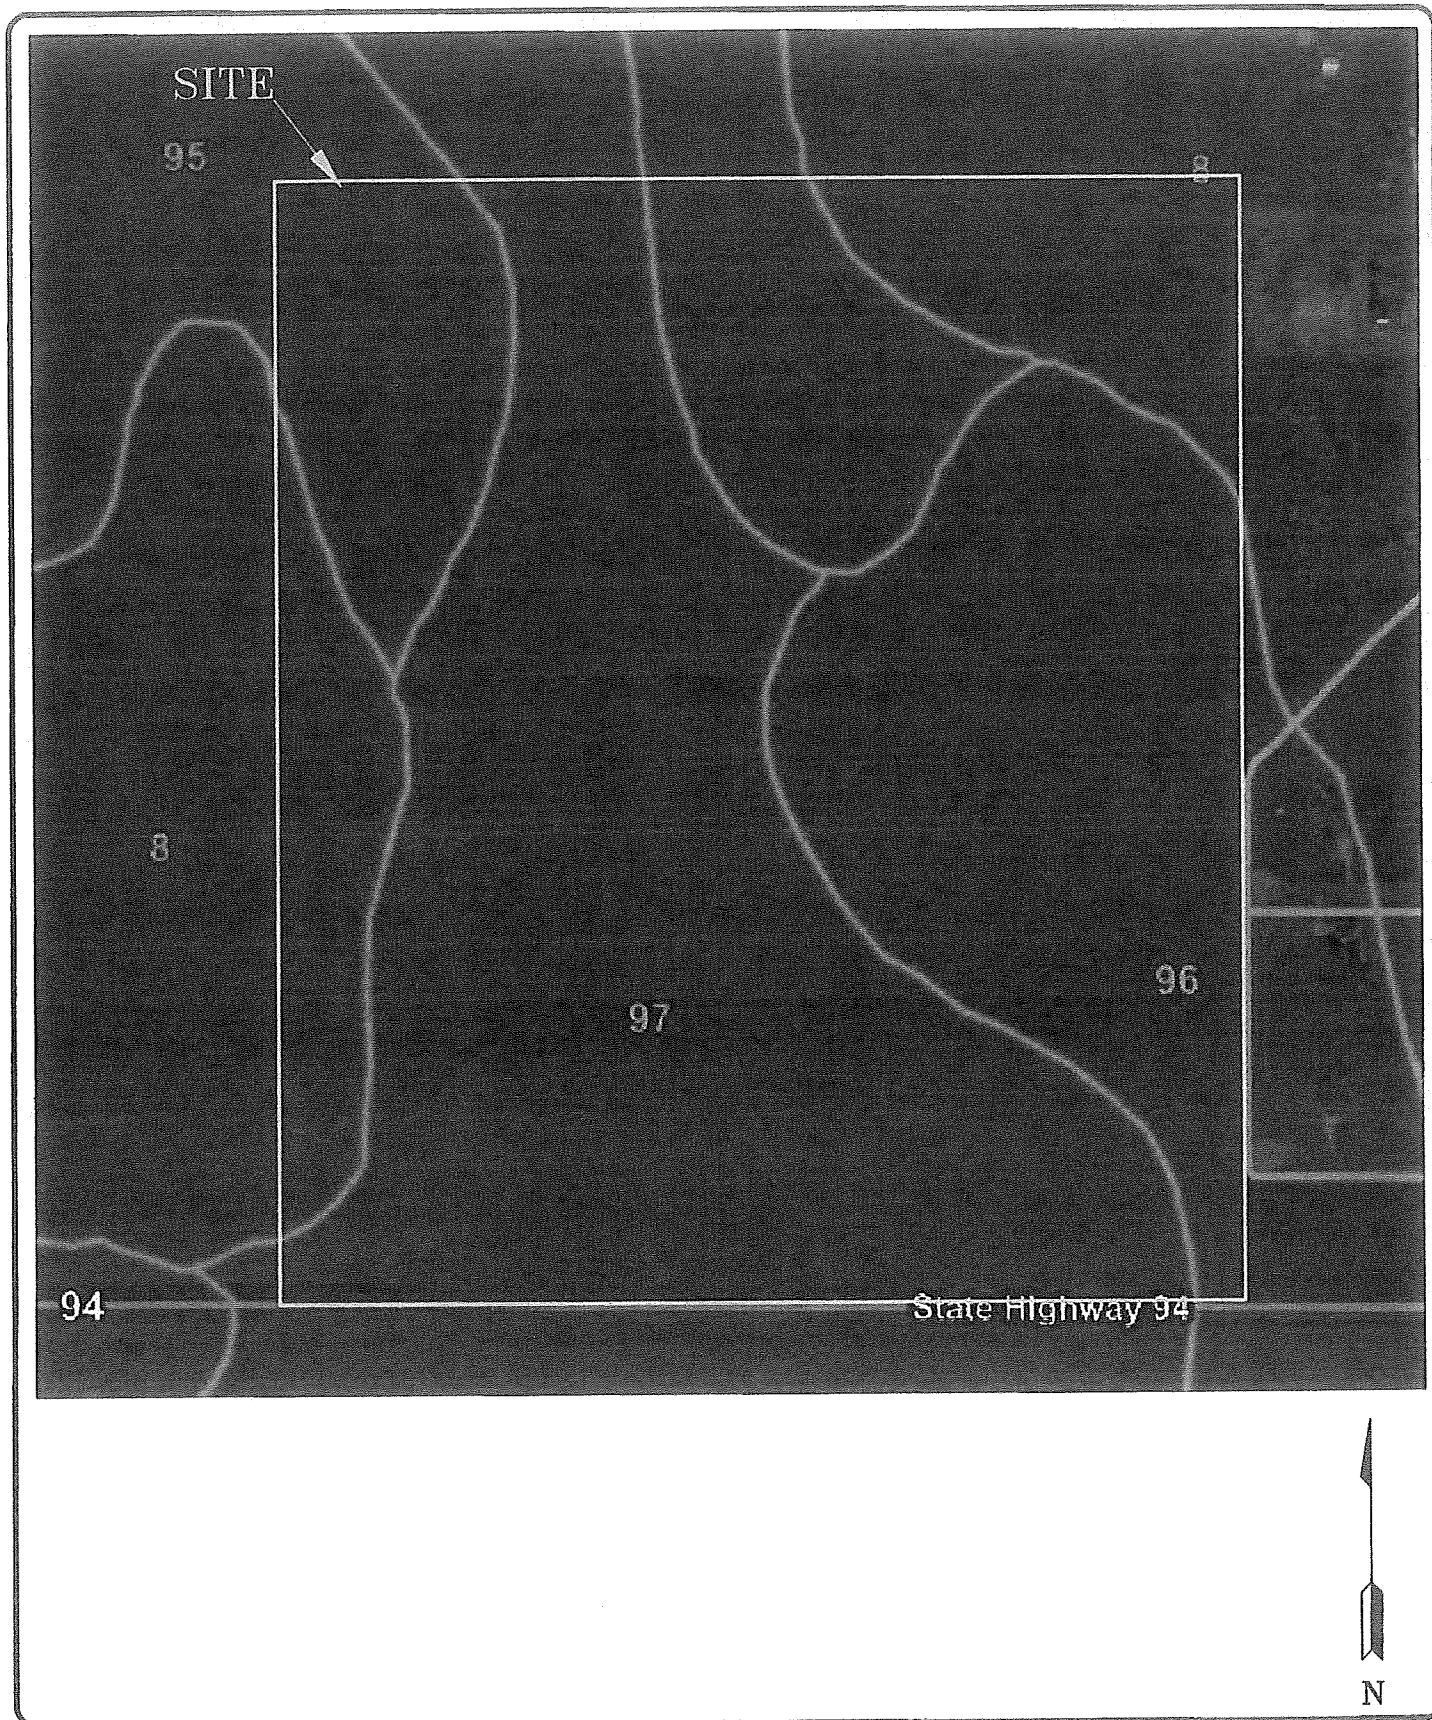
FIG NO.:  
4

The Natural Resource Conservation Service (NRCS) (Reference 2, Figure 4), previously the Soil Conservation Service (Reference 3) has mapped four soil types on the site. Complete descriptions of the soils are presented in Appendix D. In general, the soils consist of loamy sand and sandy loam. The soils are described as follows:

| Type | Description |
|---|---|
| 8 | Blakeland Loamy Sand, 1 – 9% Slopes |
| 95 | Truckton Loamy Sand, 1 – 9% Slopes |
| 96 | Truckton Sandy Loam, 0 – 3% Slopes |
| 97 | Truckton Sandy Loam, 3 – 9% Slopes |

The soils have been described to have moderate to rapid permeabilities. The soils are described as well suited for use as home sites. Possible hazards with soils erosion are present on the site. The erosion potential can be controlled with vegetation. The soils have been described to have moderate erosion hazards (Reference 2).

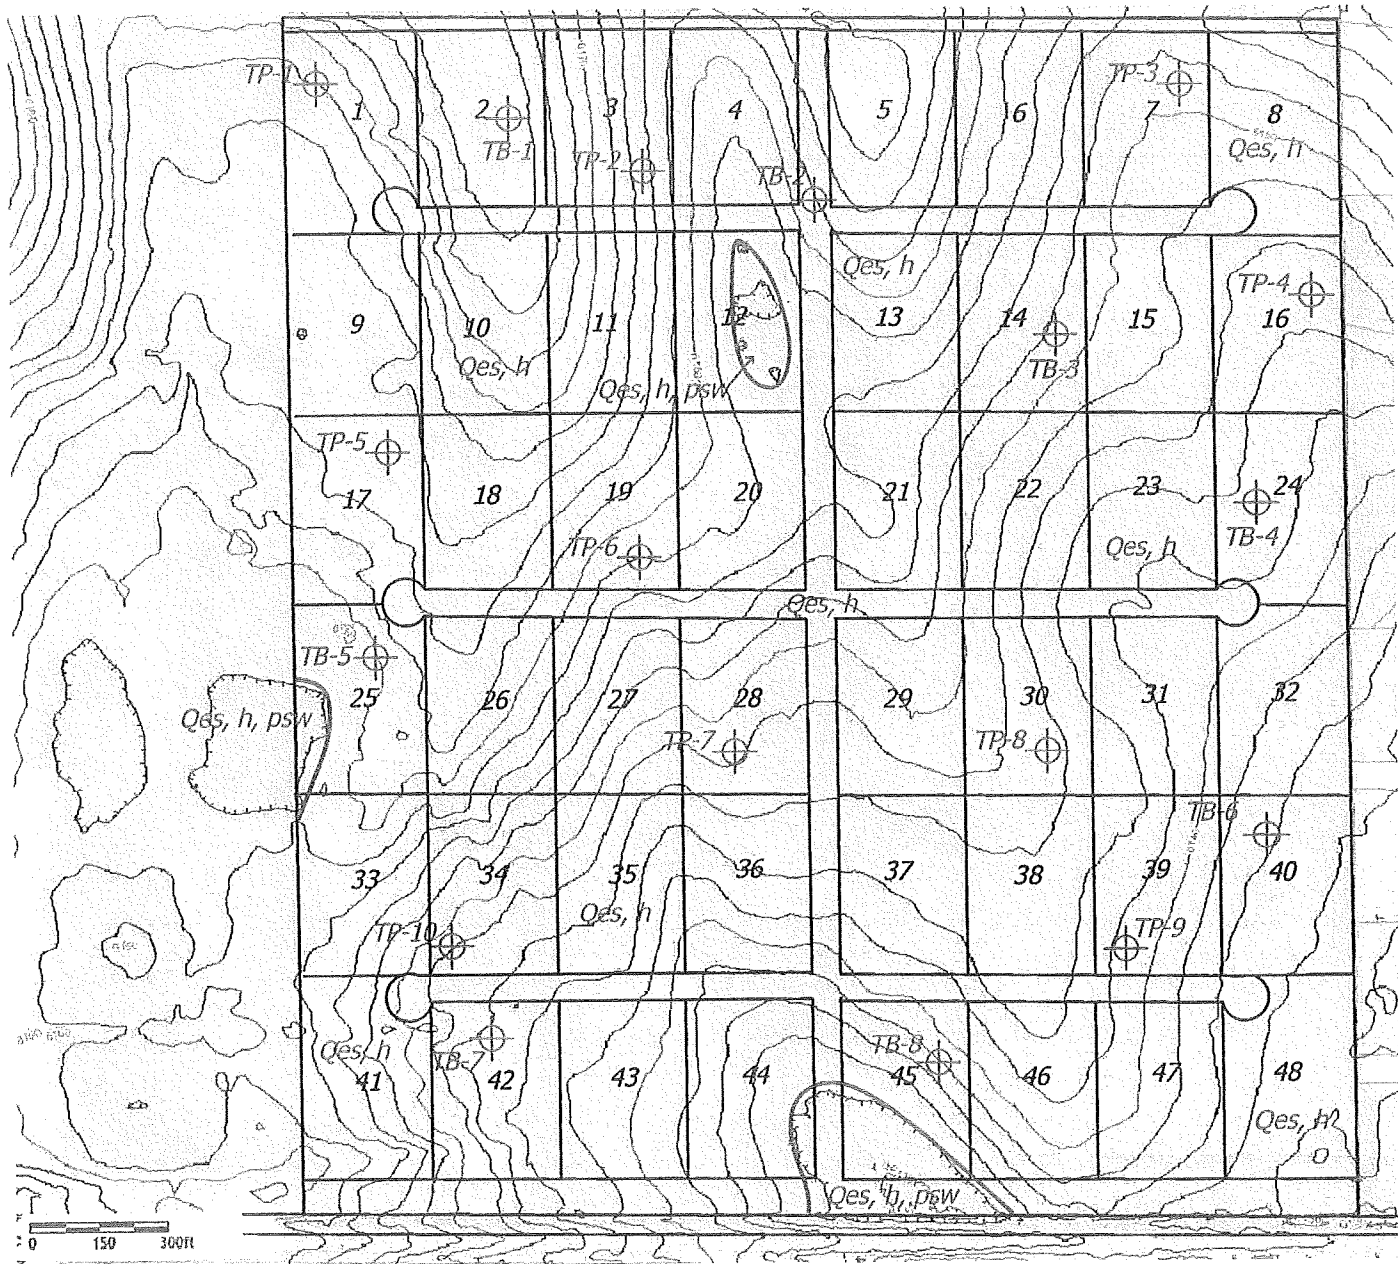
The soils listed above were mapped from site-specific mapping, the *Geologic map of the Pueblo 1-degree x 2-degrees' quadrangle, south-central Colorado* published by the U.S. Geologic Survey in 1976 (Reference 4). The test borings and test pits were used in evaluating the site and are included in Appendix B. The Geology Map prepared for the site is presented in Figure 6.

Areas in which hydrocompaction have been mapped across the site mapped as Eolian Sands of Quaternary Age (Qes). In areas identified for this hazard classification, however, we anticipate a potential for settlement movements upon saturation of these surficial soils. The low density, uniform grain sized, windblown sand deposits are particularly susceptible to this type of phenomenon. Additionally, loose or collapsible soils may be encountered in other areas on this site.

Blowouts associated with the windblown sands are located in some areas across the site and that have been mapped as potentially seasonally shallow groundwater areas and are discussed in the following section. These low-lying areas are indicated in the Geology/Engineering Geology Map (Figure 6). Due to the lot sizes these areas can be avoided. Lots affected by the potentially seasonal shallow groundwater are Lots 12, 25, 33, 44, and 45. In these areas, we would anticipate the potential for periodically high subsurface moisture conditions, frost heave potential and highly organic soils. Construction in any portions of these areas, if required, or immediately adjacent to these areas should follow these precautions.

**Mitigation:** The potential for settlement movement is directly related to saturation of the soils below the foundation areas. Therefore, good surface and subsurface drainage is extremely critical in these areas in order to minimize the potential for saturation of these soils. The ground surface around all permanent structures should be positively sloped away from the structure to all points, and water must not be allowed to stand or pond anywhere on the site. We recommend that the ground surface within 10 feet of the structures be sloped away with a minimum gradient of five percent. If this is not possible on the upslope side of the structures, then a well-defined swale should be created to intercept the surface water and carry it quickly and safely around and away from the structures. Roof drains should be made to discharge well away from the structures and into areas of positive drainage. Where several structures are involved, the overall drainage design should be such that water directed away from one structure is not directed against an adjacent building. Planting and watering in the immediate vicinity of the structures, as well as general lawn irrigation, should be minimized.

**Mitigation:** Foundations must have a minimum 30-inch depth for frost protection. In areas where high subsurface moisture conditions are anticipated periodically, subsurface perimeter drains are recommended to help prevent the intrusion of water into areas below grade. Typical drain details are presented in Figure 8. Any grading in these areas should be done to direct surface flow around construction to avoid areas of ponded water. All organic material would be completely removed prior to any fill placement. **Specific drainage studies are beyond the scope of this report.**

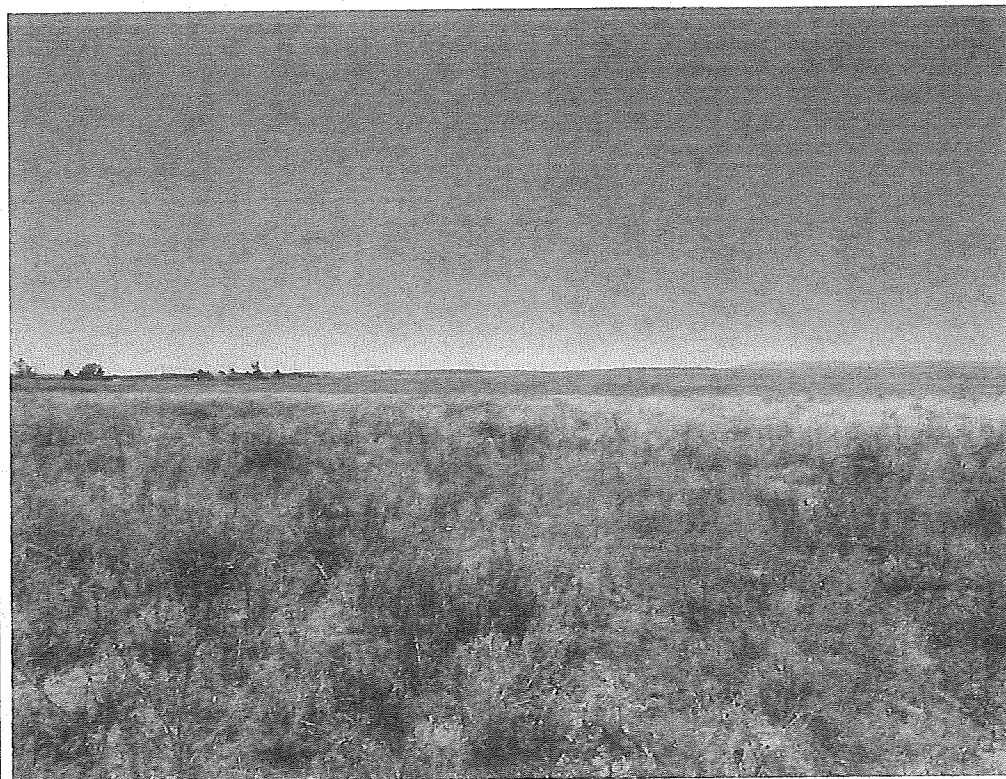
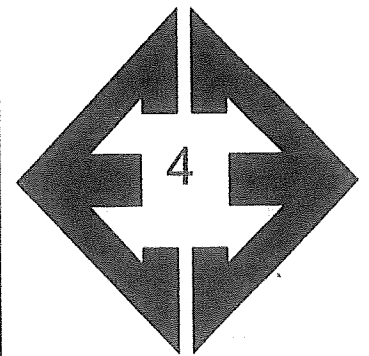
**Looking west from the  
northeastern portion of  
the site.**

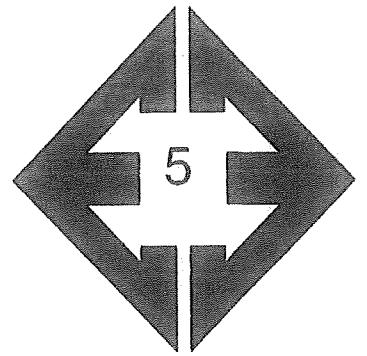
**Looking southwest  
from the northeastern  
portion of the site.**
