December 7, 2021

**ENTECH**  
ENGINEERING, INC.

Re: Soil, Geology and Geologic Hazard Evaluation  
Trinity Subdivision  
20040 Highway 94  
Tax Schedule Nos. 34000-00-455  
El Paso County, Colorado

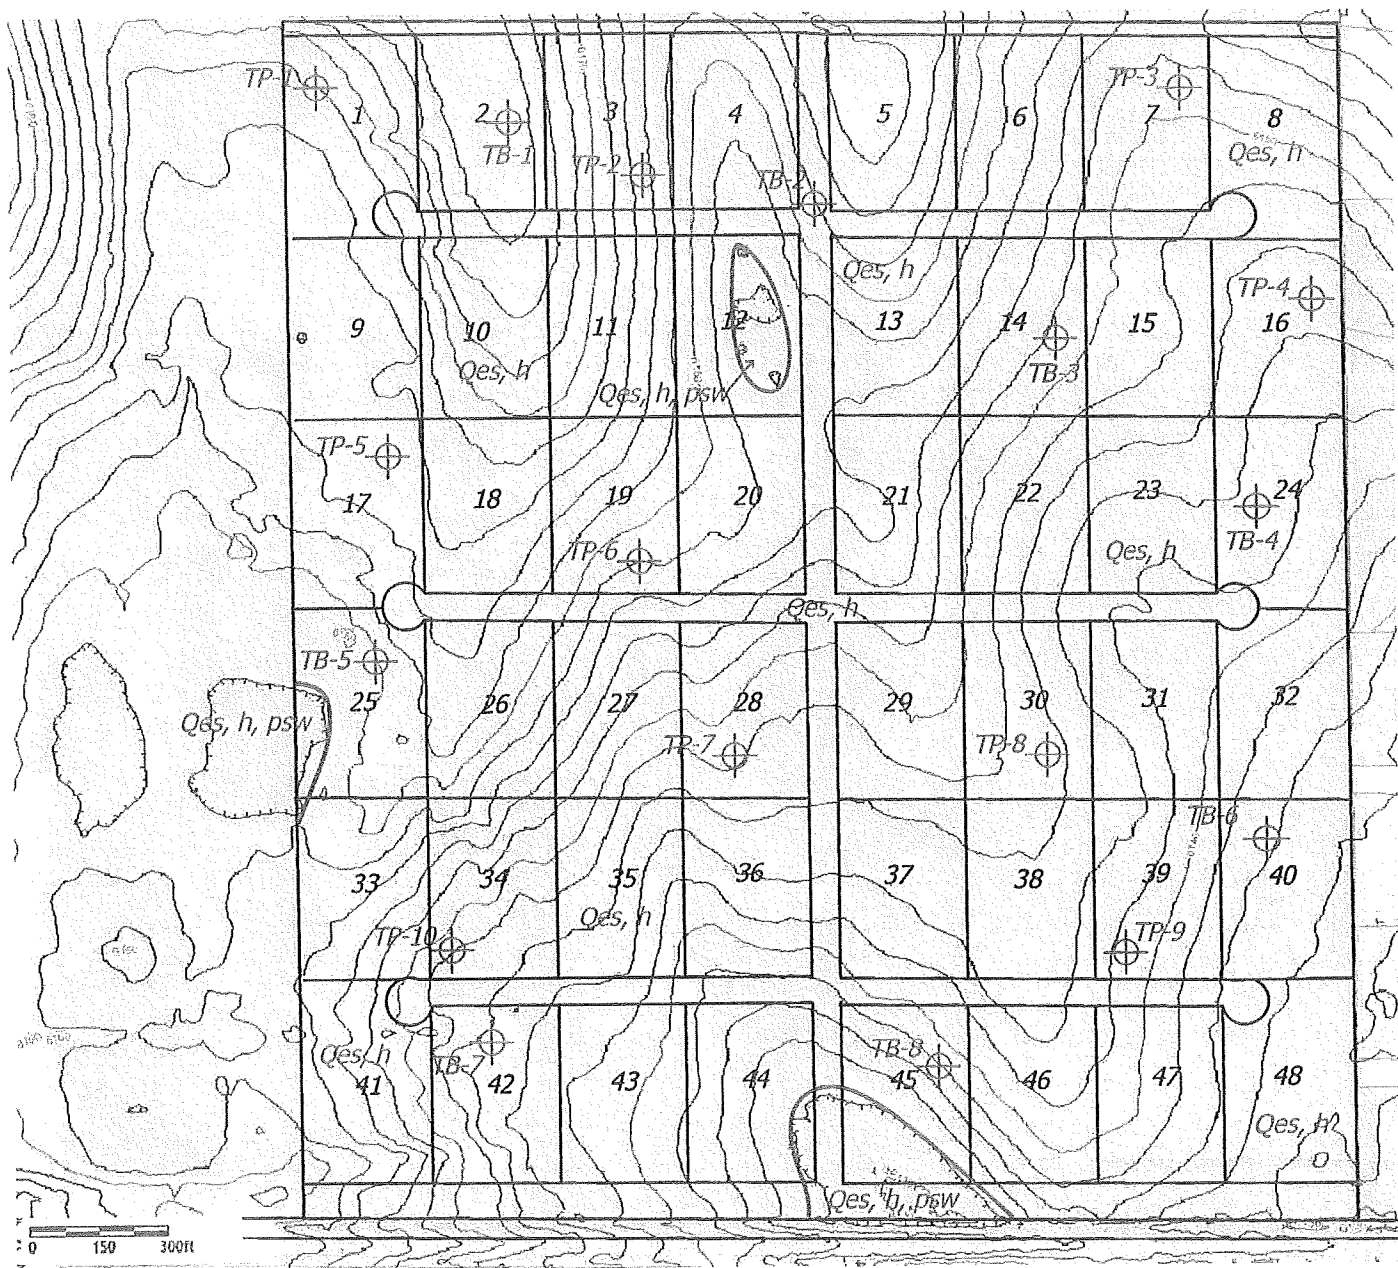
The soils listed above were mapped from site-specific mapping, the *Geologic map of the Pueblo 1-degree x 2-degrees' quadrangle, south-central Colorado* published by the U.S. Geologic Survey in 1976 (Reference 4). The test borings and test pits were used in evaluating the site and are included in Appendix B. The Geology Map prepared for the site is presented in Figure 6.

Areas in which hydrocompaction have been mapped across the site mapped as Eolian Sands of Quaternary Age (Qes). In areas identified for this hazard classification, however, we anticipate a potential for settlement movements upon saturation of these surficial soils. The low density, uniform grain sized, windblown sand deposits are particularly susceptible to this type of phenomenon. Additionally, loose or collapsible soils may be encountered in other areas on this site.

Blowouts associated with the windblown sands are located in some areas across the site and that have been mapped as potentially seasonally shallow groundwater areas and are discussed in the following section. These low-lying areas are indicated in the Geology/Engineering Geology Map (Figure 6). Due to the lot sizes these areas can be avoided. Lots affected by the potentially seasonal shallow groundwater are Lots 12, 25, 33, 44, and 45. In these areas, we would anticipate the potential for periodically high subsurface moisture conditions, frost heave potential and highly organic soils. Construction in any portions of these areas, if required, or immediately adjacent to these areas should follow these precautions.

**Mitigation:** The potential for settlement movement is directly related to saturation of the soils below the foundation areas. Therefore, good surface and subsurface drainage is extremely critical in these areas in order to minimize the potential for saturation of these soils. The ground surface around all permanent structures should be positively sloped away from the structure to all points, and water must not be allowed to stand or pond anywhere on the site. We recommend that the ground surface within 10 feet of the structures be sloped away with a minimum gradient of five percent. If this is not possible on the upslope side of the structures, then a well-defined swale should be created to intercept the surface water and carry it quickly and safely around and away from the structures. Roof drains should be made to discharge well away from the structures and into areas of positive drainage. Where several structures are involved, the overall drainage design should be such that water directed away from one structure is not directed against an adjacent building. Planting and watering in the immediate vicinity of the structures, as well as general lawn irrigation, should be minimized.

**Mitigation:** Foundations must have a minimum 30-inch depth for frost protection. In areas where high subsurface moisture conditions are anticipated periodically, subsurface perimeter drains are recommended to help prevent the intrusion of water into areas below grade. Typical drain details are presented in Figure 8. Any grading in these areas should be done to direct surface flow around construction to avoid areas of ponded water. All organic material would be completely removed prior to any fill placement. **Specific drainage studies are beyond the scope of this report.**

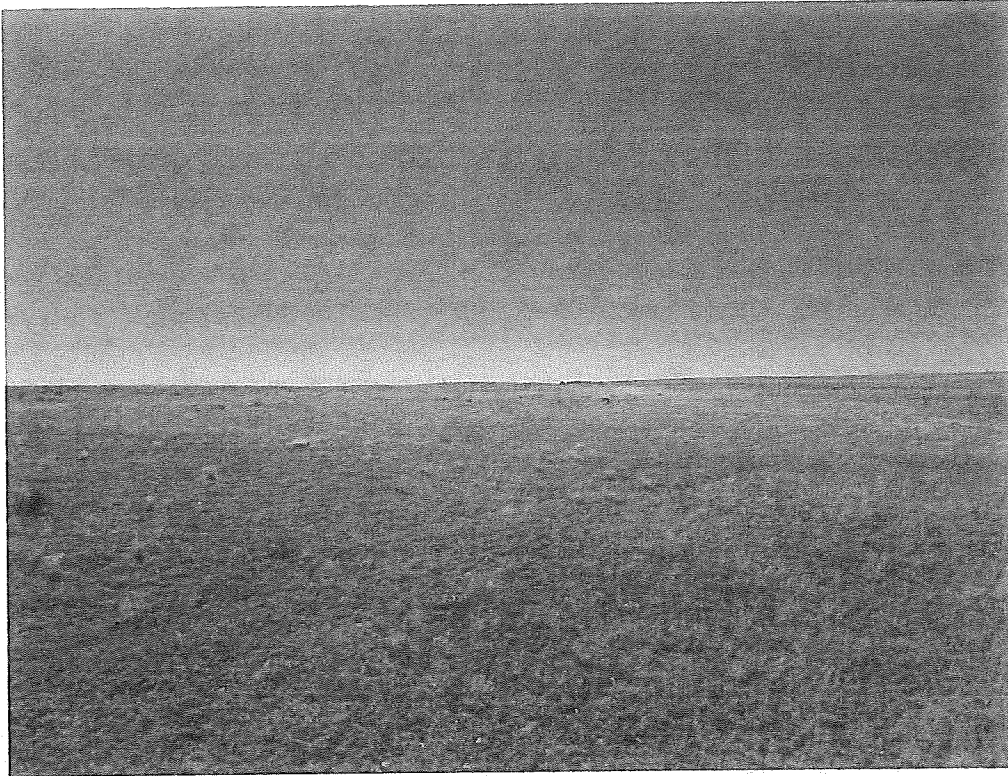
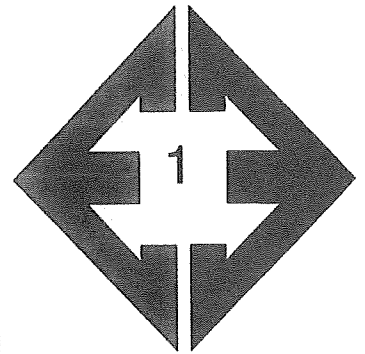
**Looking south from  
the northeastern  
corner of the site.**

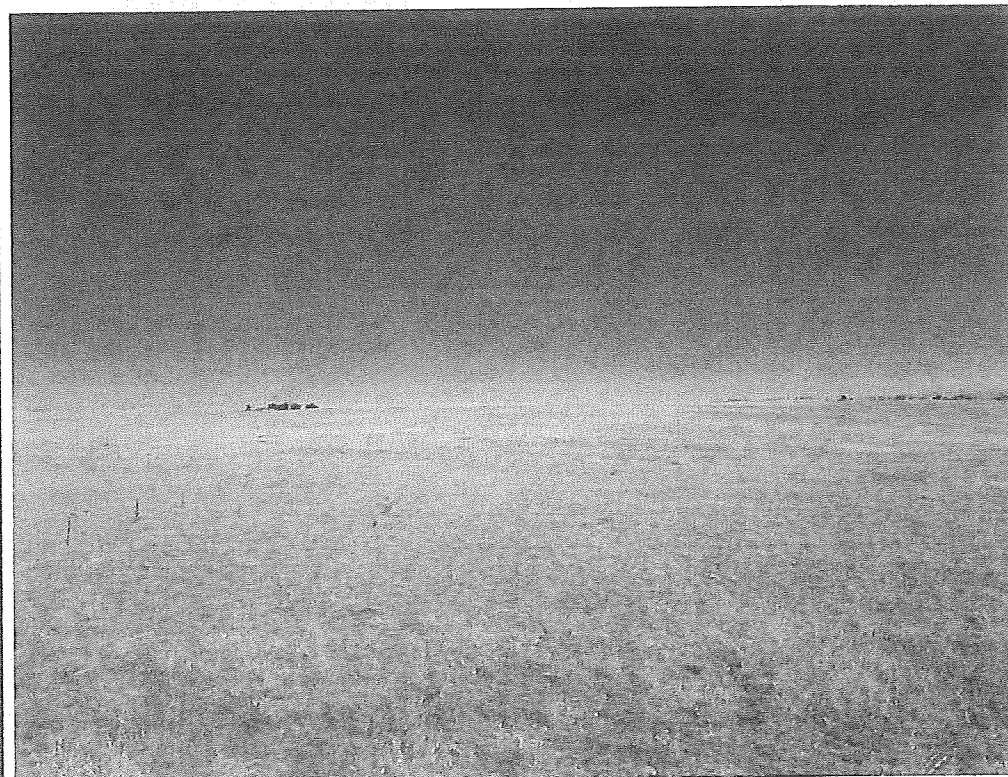
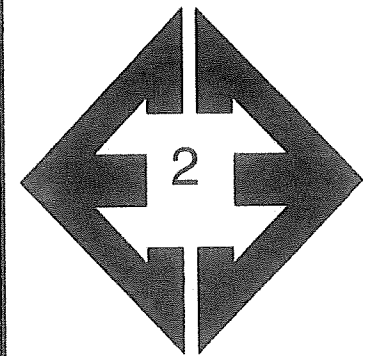
**Looking east from the  
northern side of the  
site.**

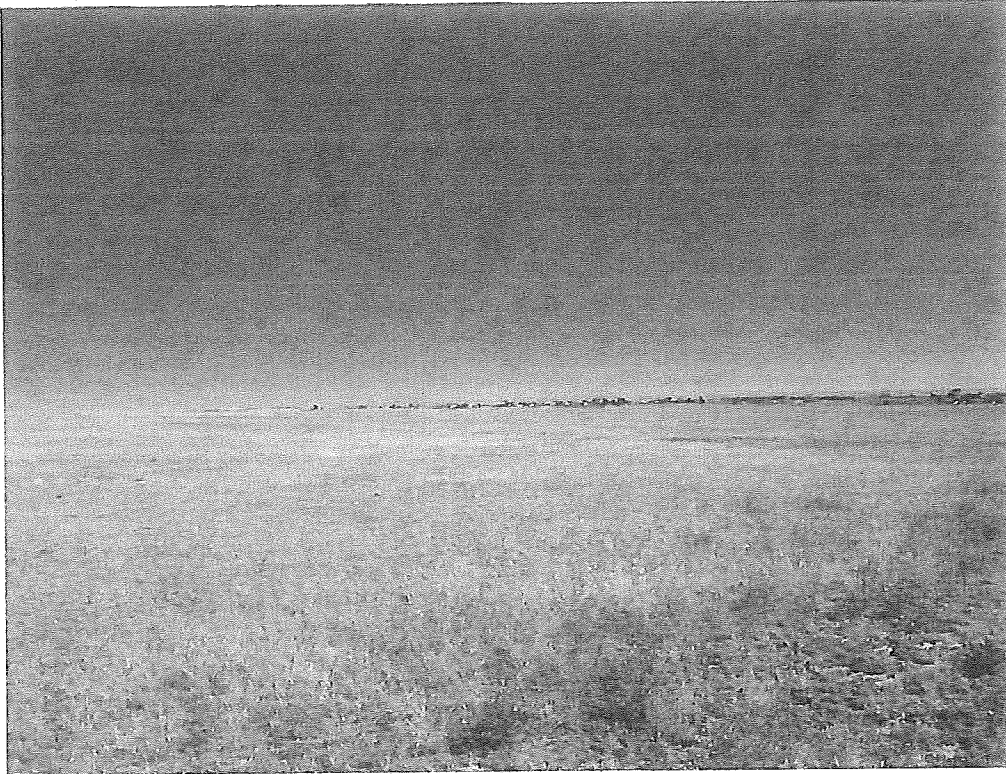
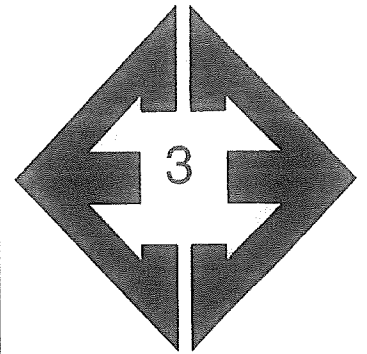
**Looking southeast  
from the north-central  
portion of the site.**

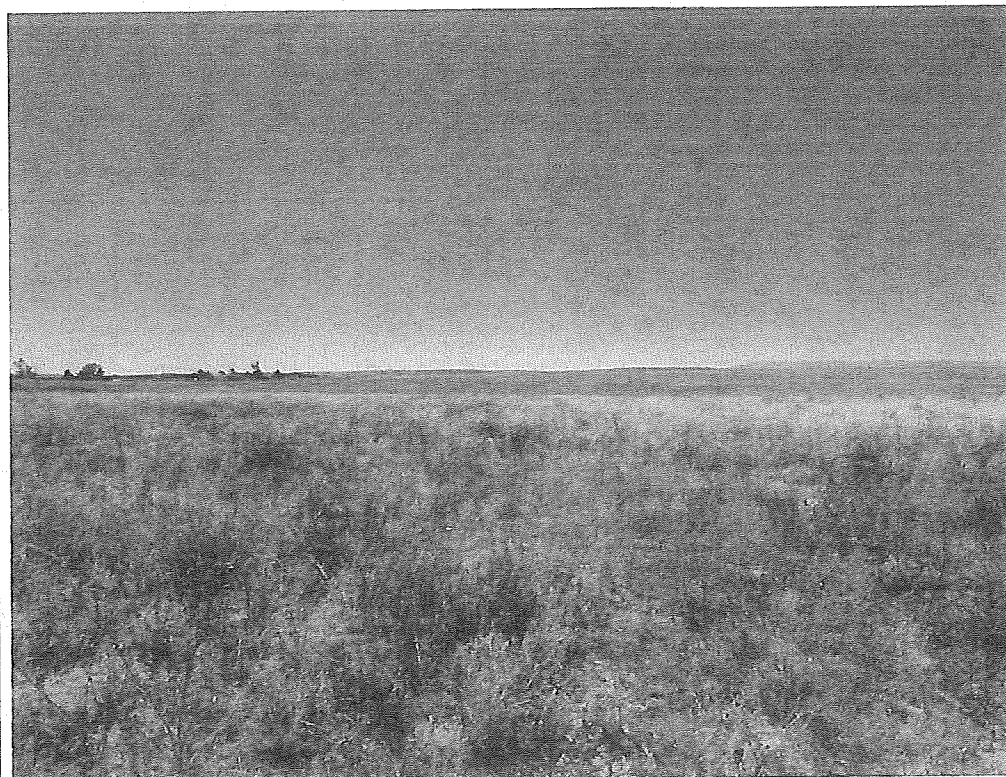
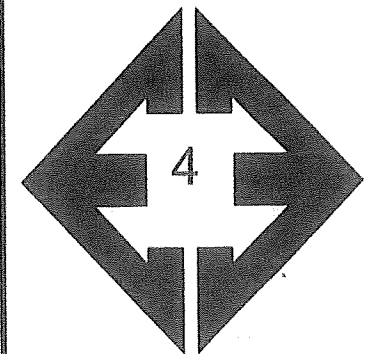
**Looking west from the  
northeastern portion of  
the site.**

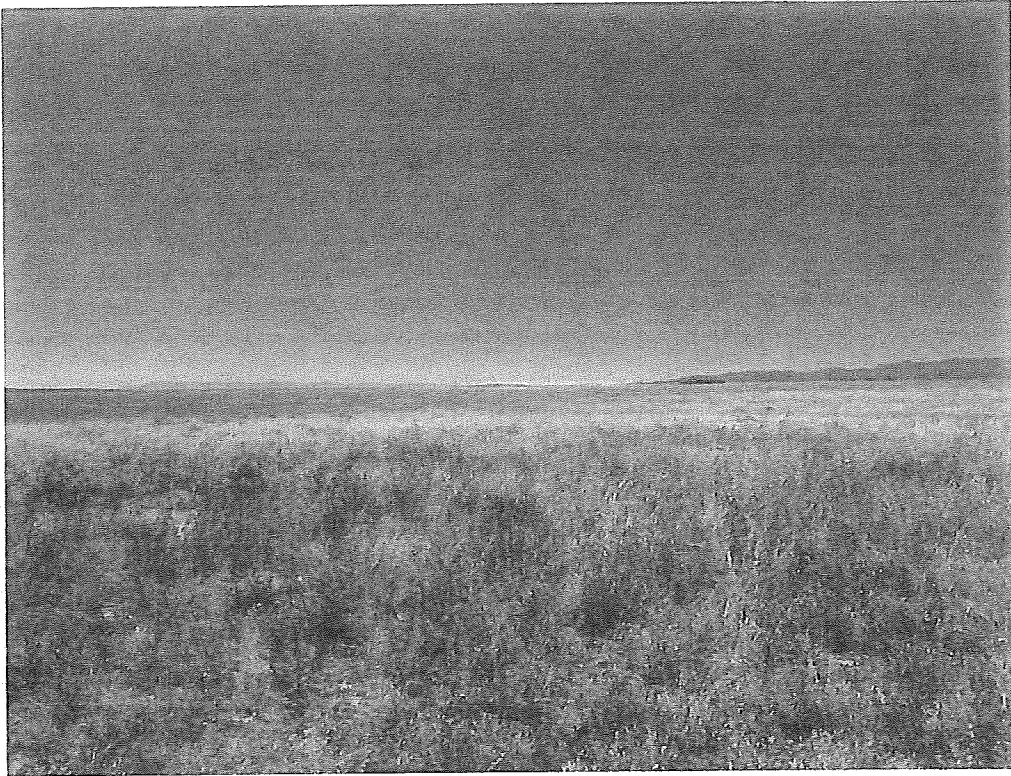
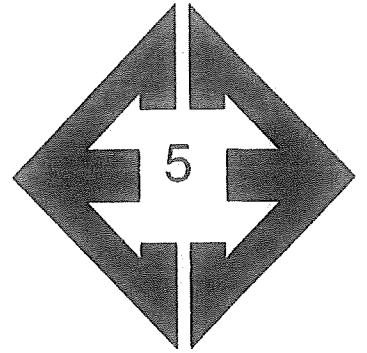
**Looking southwest  
from the northeastern  
portion of the site.**

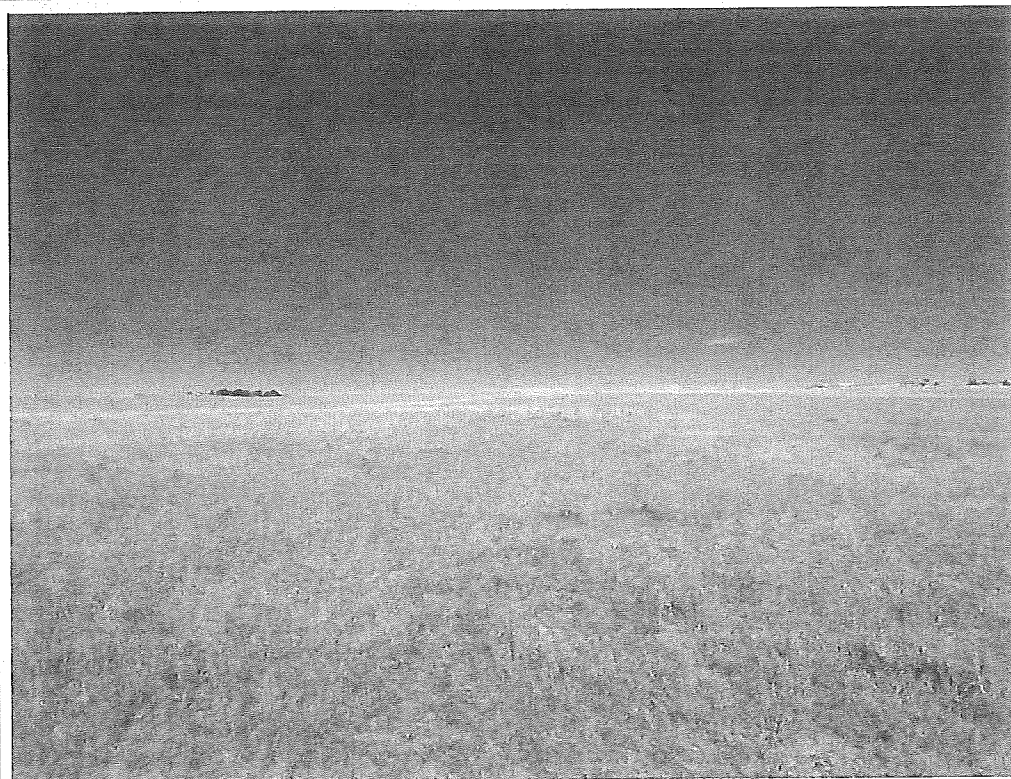
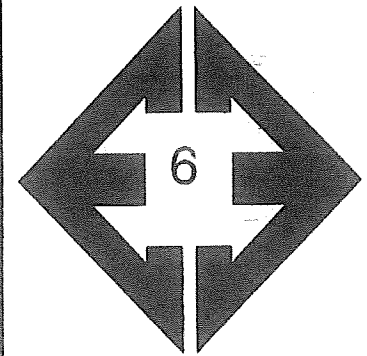
**Looking northwest  
from the southeastern  
portion of the site.**

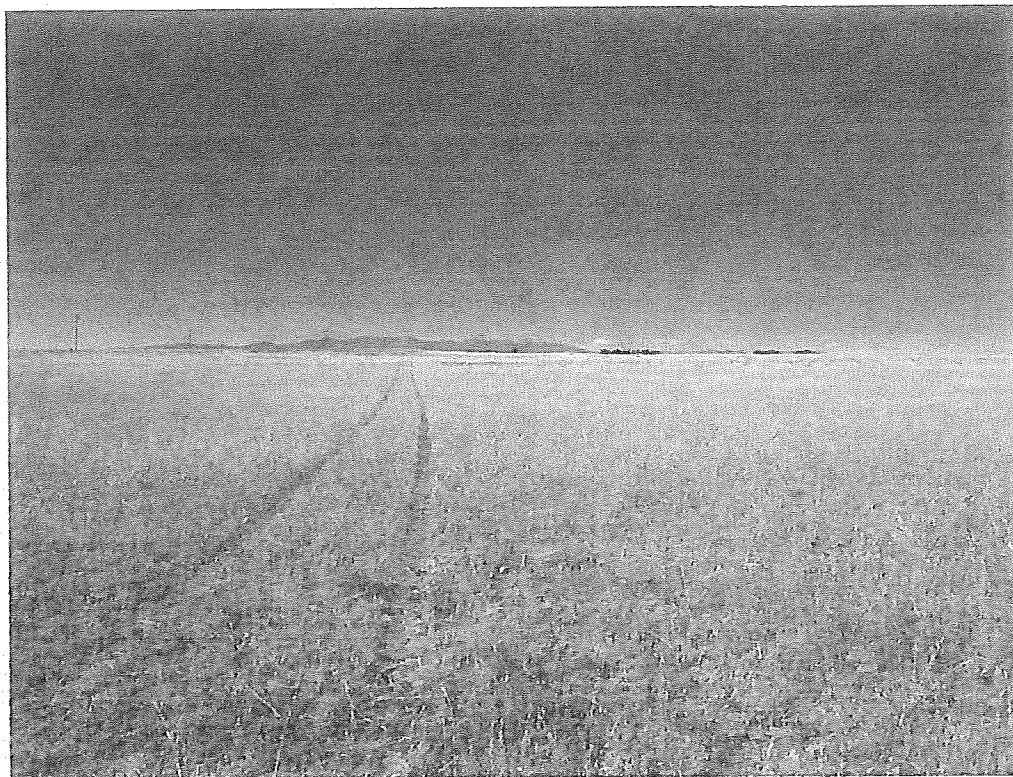
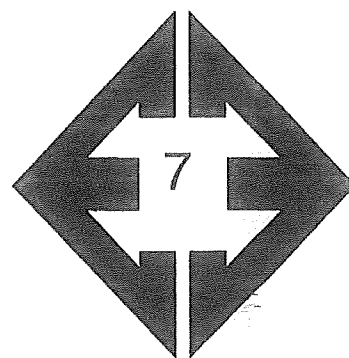
**Looking west from the  
southeastern portion  
of the site.**

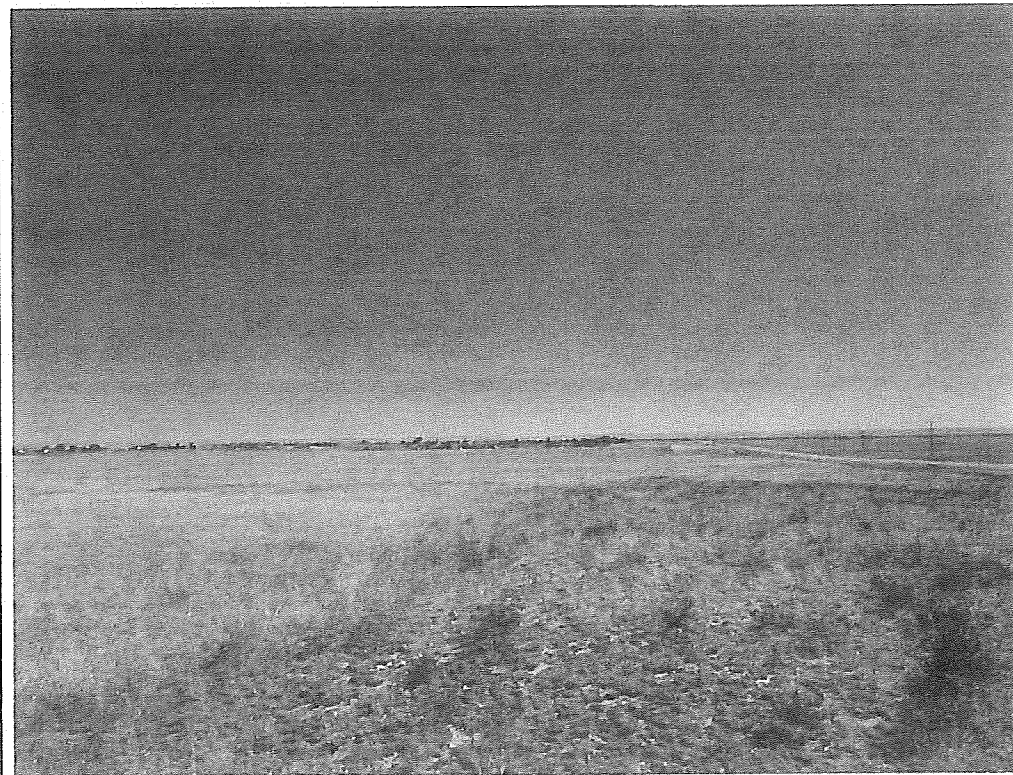
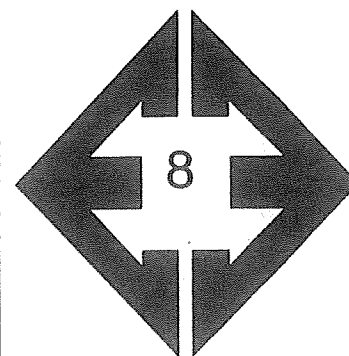
**Looking east from the  
southwestern portion  
of the site.**
