**ENTECH**  
ENGINEERING, INC.

December 7, 2021

Re: Wastewater Study  
Trinity Subdivision  
20040 Highway 94  
Tax Schedule No. 34000-00-455  
El Paso County, Colorado

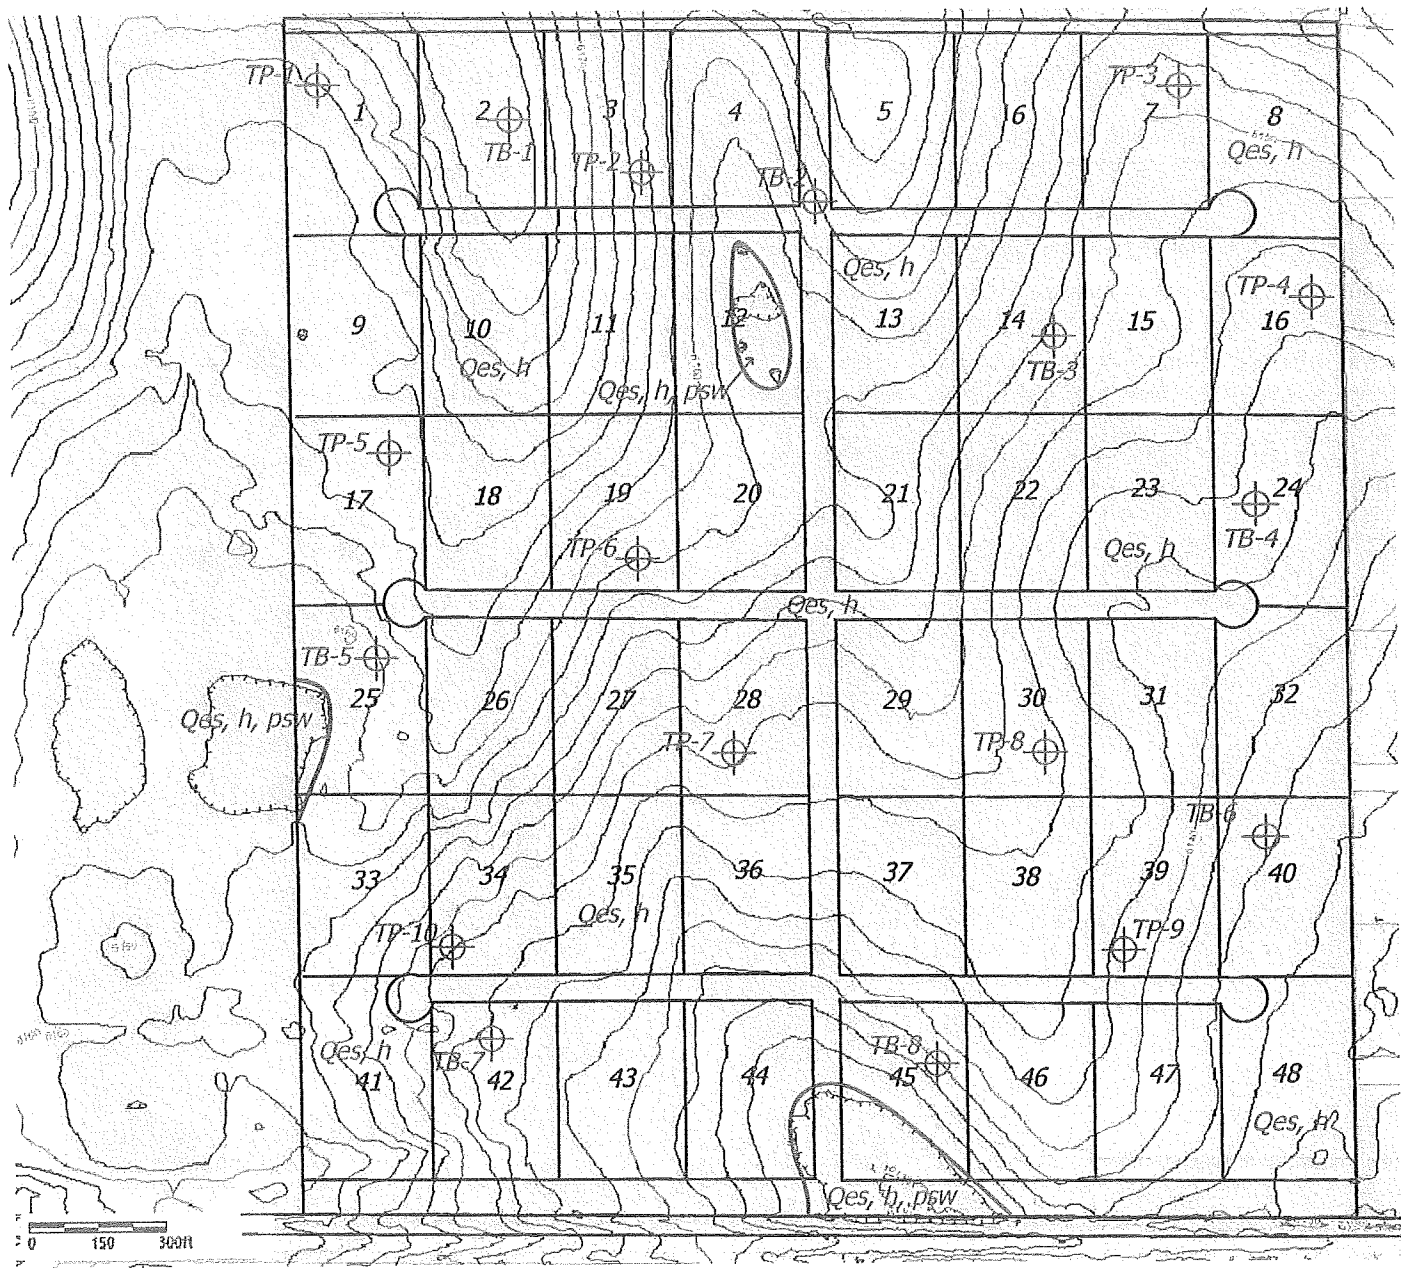
FIG NO.:  
6

Blowouts associated with the windblown sands are located in some areas across the site and that have been mapped as potentially seasonally shallow groundwater areas and are discussed in the following section. These low-lying areas are indicated in the Geology/Engineering Geology Map (Figure 6). Due to the lot sizes these areas can be avoided. Lots affected by the potentially seasonal shallow groundwater are Lots 12, 25, 33, 44, and 45. In these areas, we would anticipate the potential for periodically high subsurface moisture conditions, frost heave potential and highly organic soils.

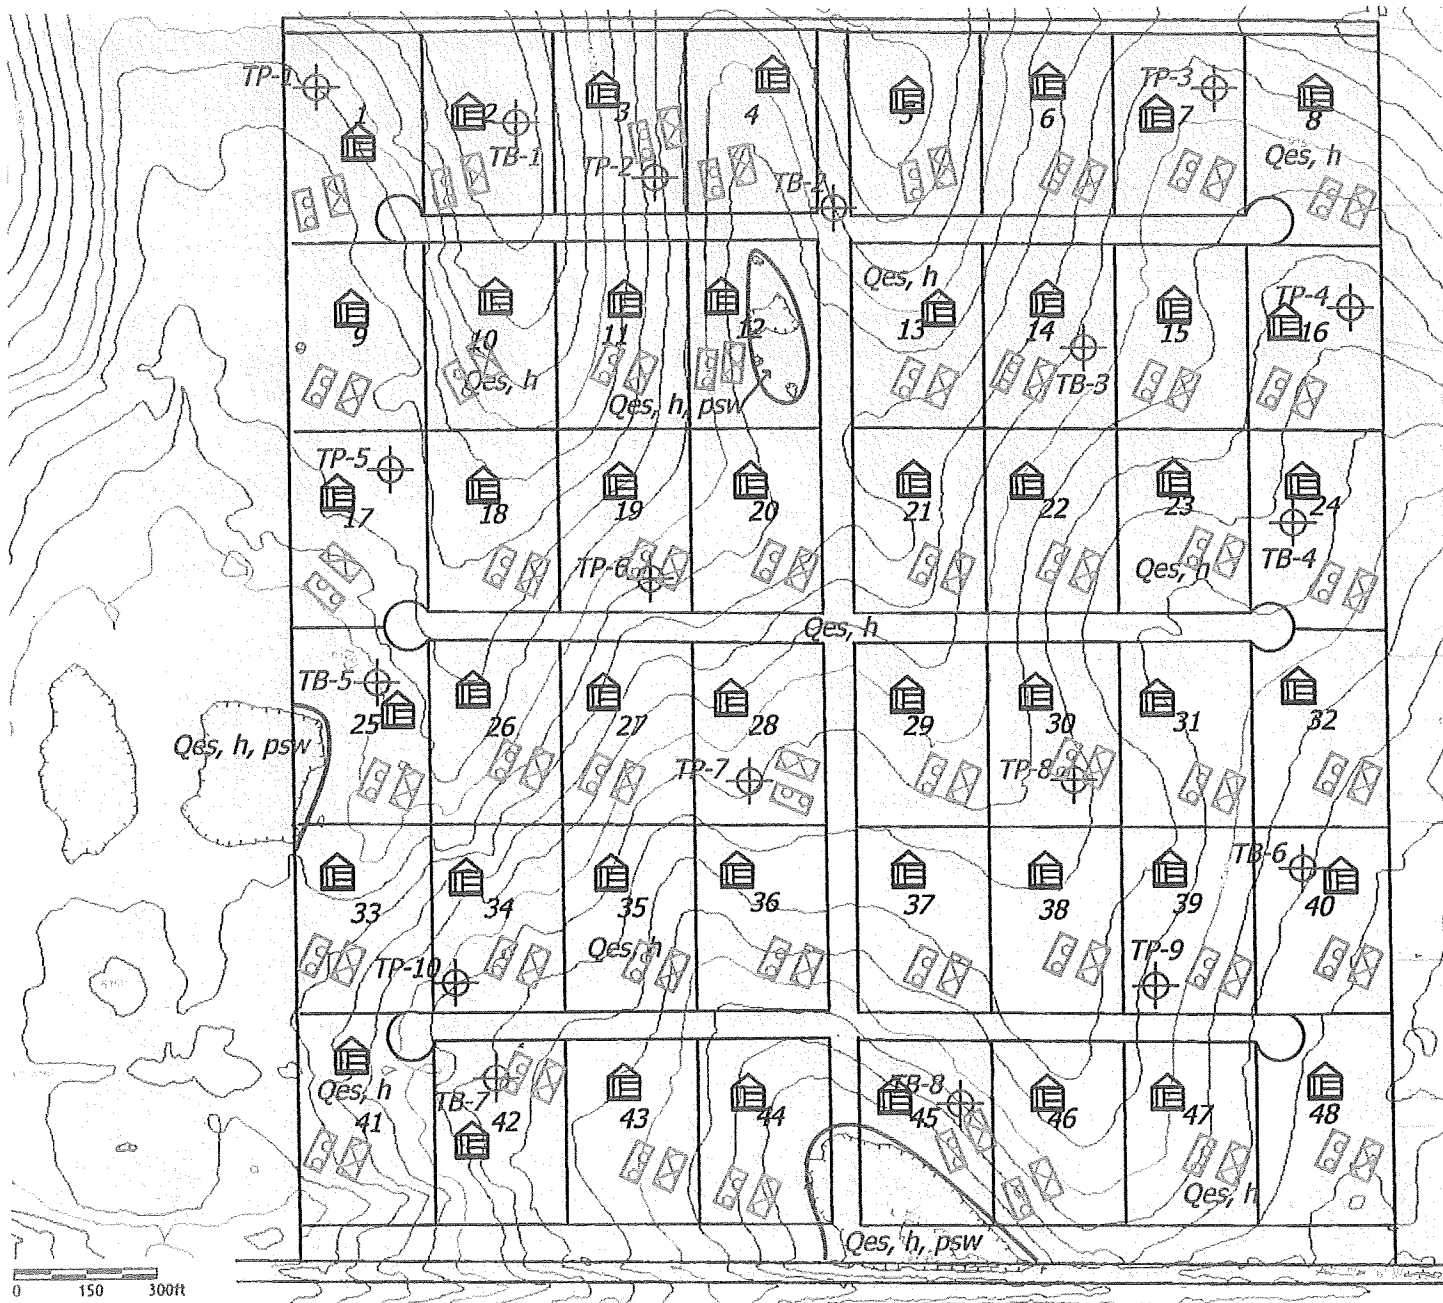
FIG NO.:  
8

In summary, it is our opinion the site is suitable for individual on-site wastewater treatment systems (OWTS) and that contamination of surface and subsurface water resources should not occur provided the OWTS sites are evaluated and installed according to El Paso County and State Guidelines and properly maintained. Based on the testing performed, conventional systems would likely be appropriate for the majority of the lots, some lots may require designed systems. The Septic Suitability Map is presented in Figure 8. Possible house locations and two septic sites for the lots are indicated on Figure 8. The subdivision is anticipated to be supplied by central water. Areas that should be avoided by septic systems are indicated on the septic suitability map.

- OWTS ARE NOT RECOMMENDED IN AREAS OF POTENTIALLY SEASONAL SHALLOW GROUNDWATER (PSW)

**Individual soil testing is required for proposed construction on each lot prior to construction.** Absorption fields must be located a minimum of 100 feet from any well, including those on adjacent properties. Absorption fields must also be located a minimum of 50 feet from any drainages, floodplains or ponded areas and 25 feet from dry gulches.

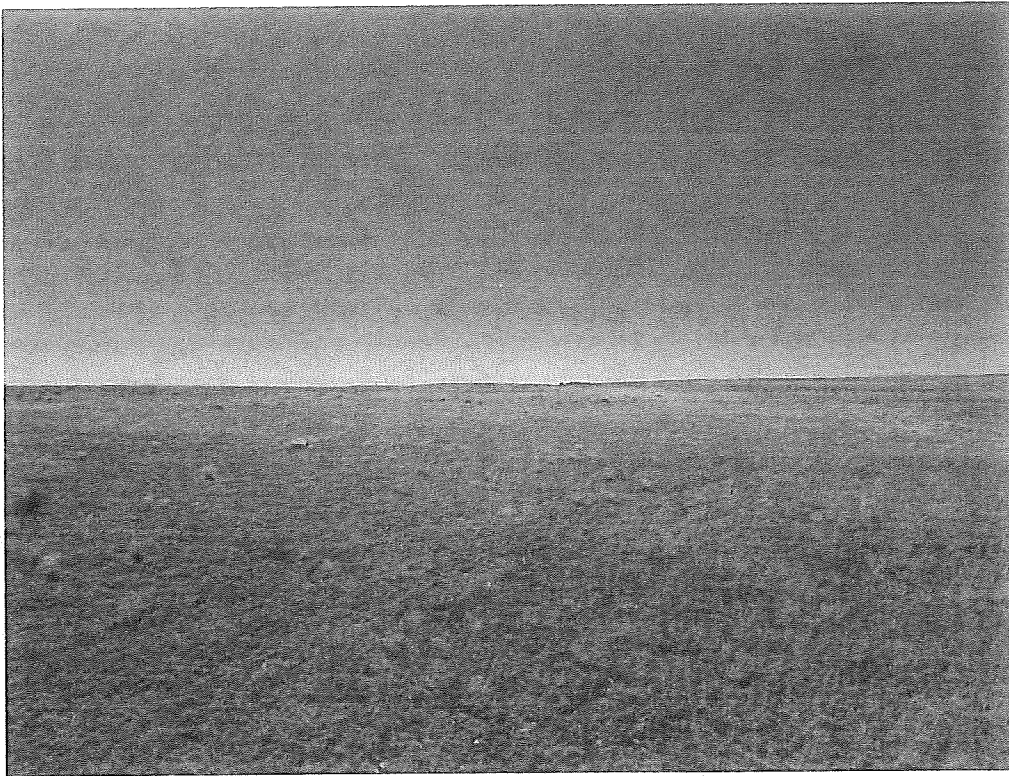
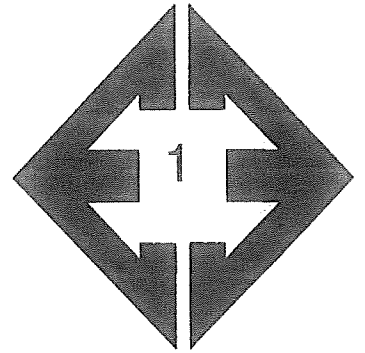
**Looking south from  
the northeastern  
corner of the site.**

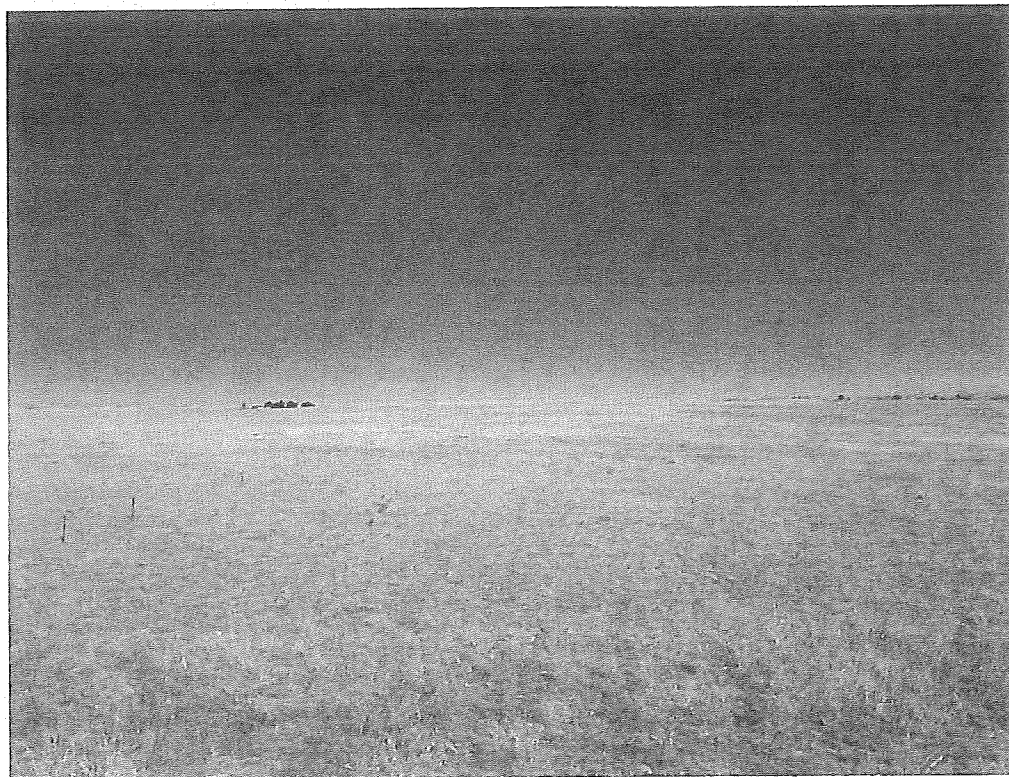
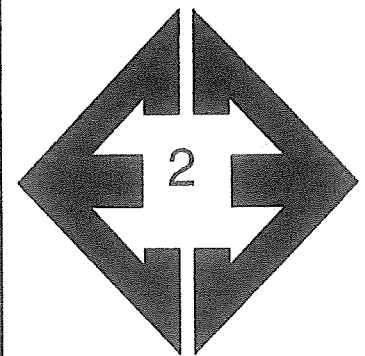
**Looking east from the  
northern side of the  
site.**

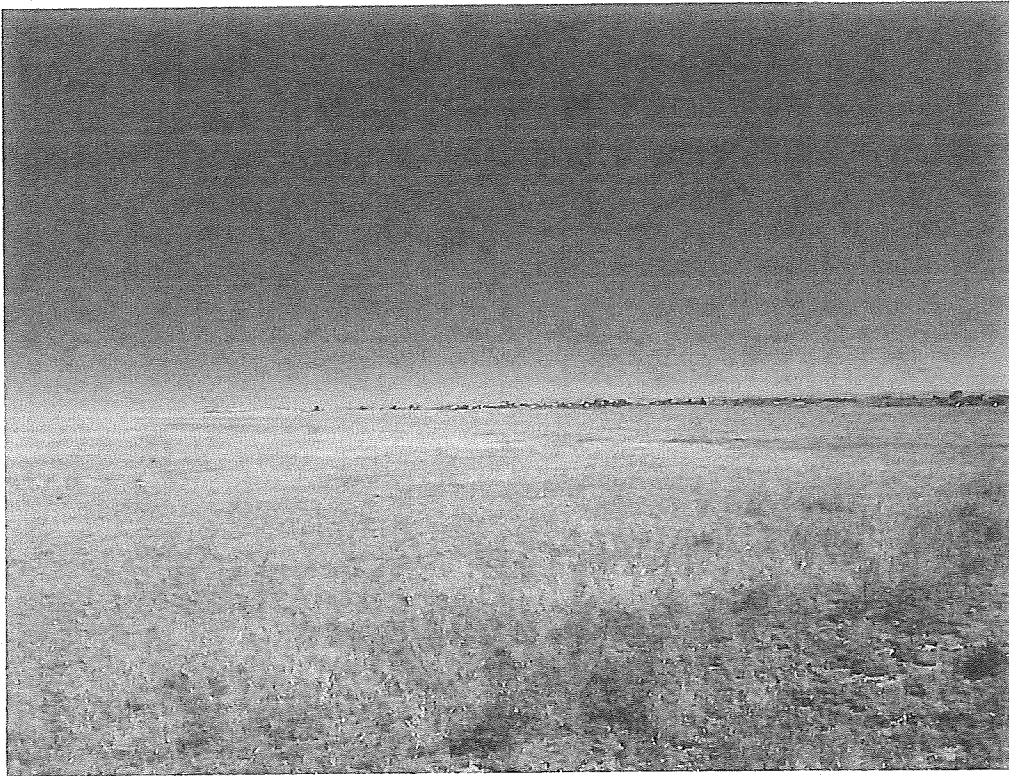
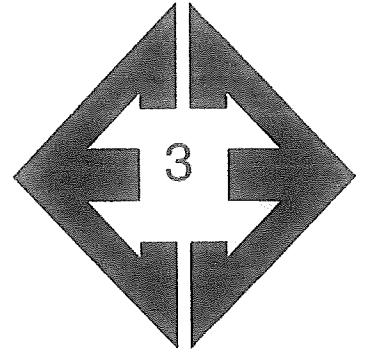
**Looking southeast  
from the north-central  
portion of the site.**

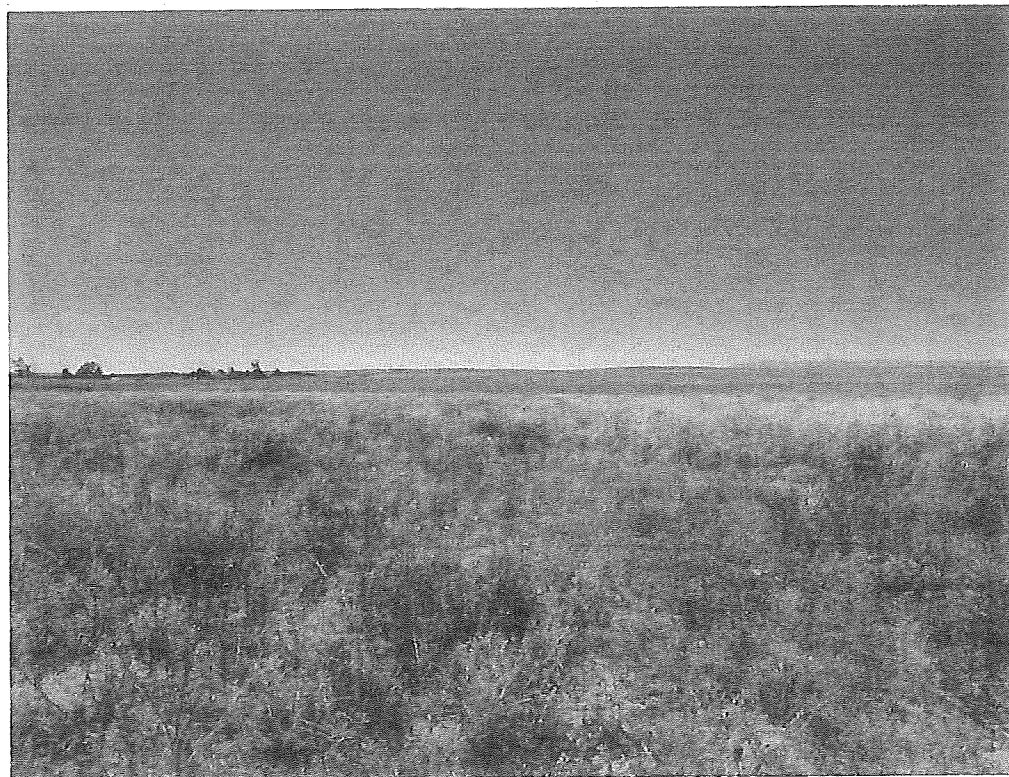
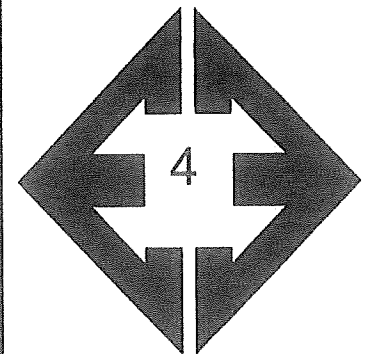
**Looking west from the  
northeastern portion of  
the site.**

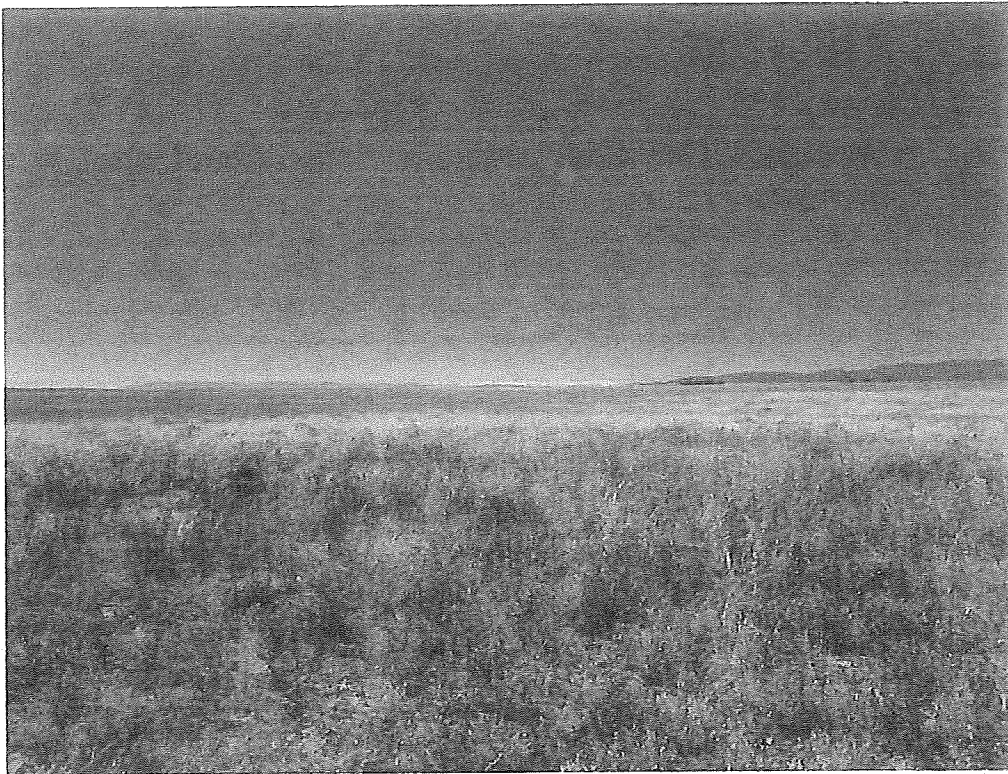
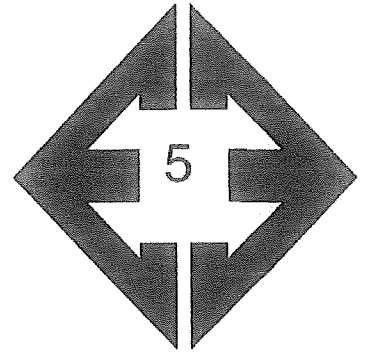
**Looking southwest  
from the northeastern  
portion of the site.**

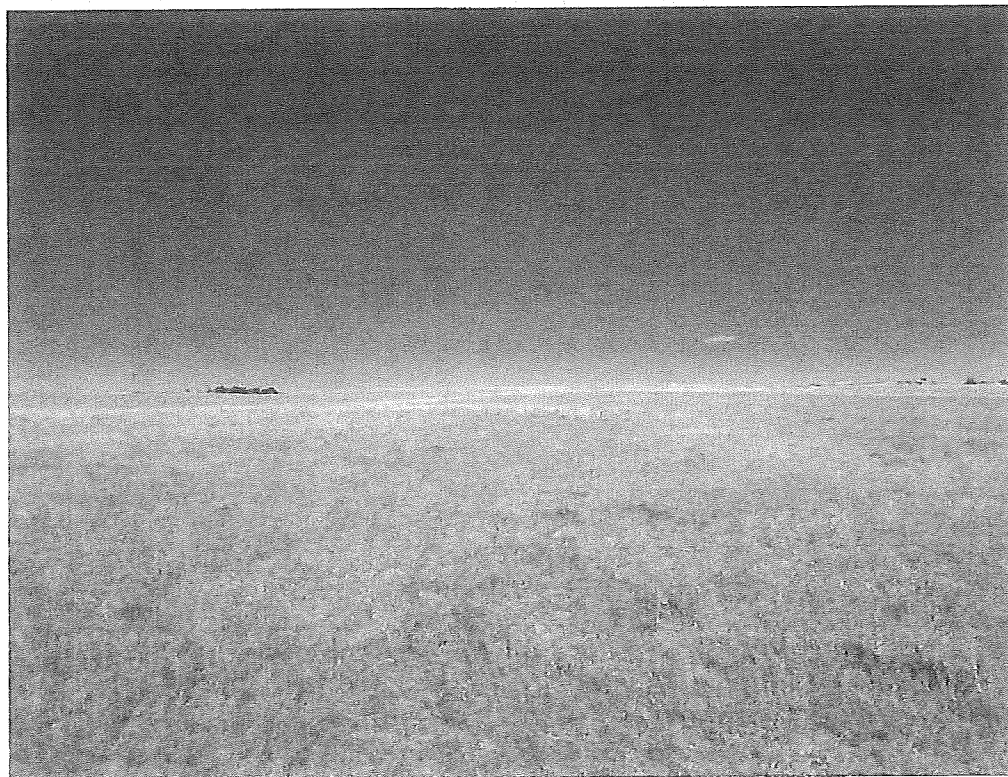
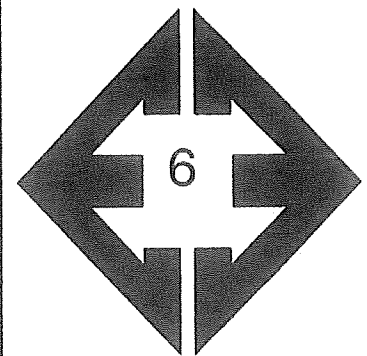
**Looking northwest  
from the southeastern  
portion of the site.**

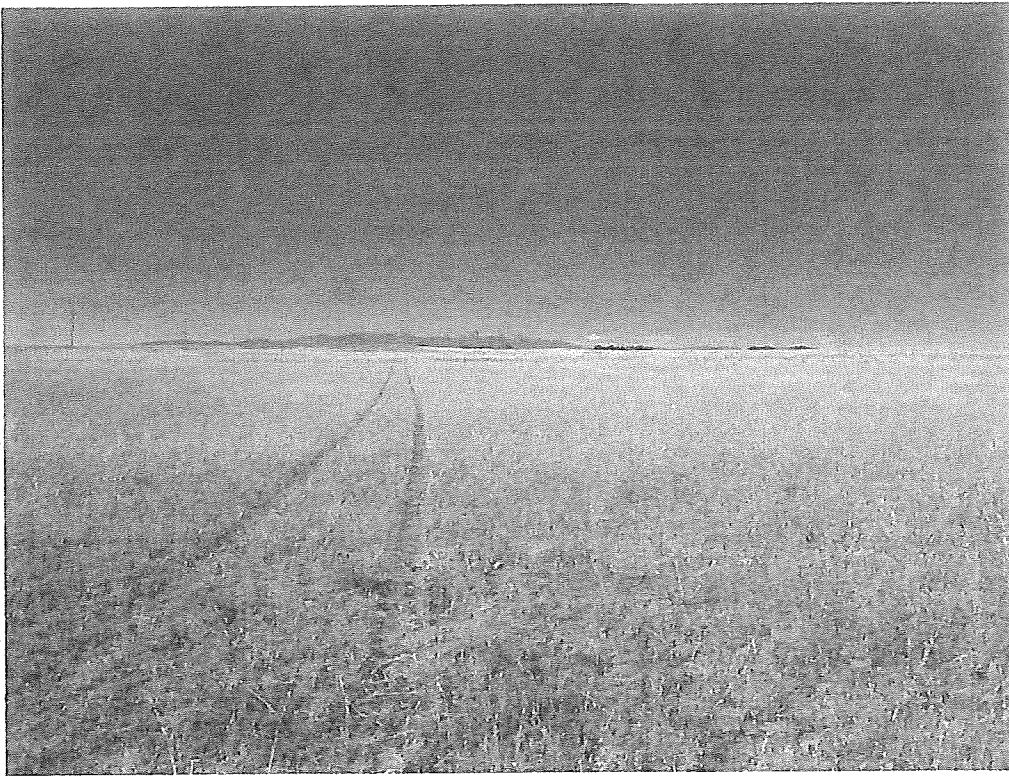
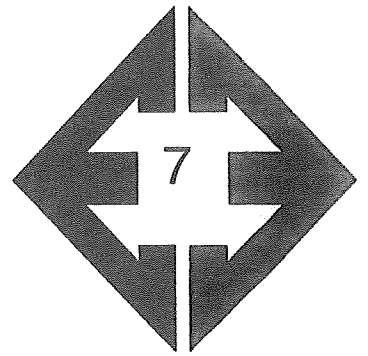
**Looking west from the  
southeastern portion  
of the site.**

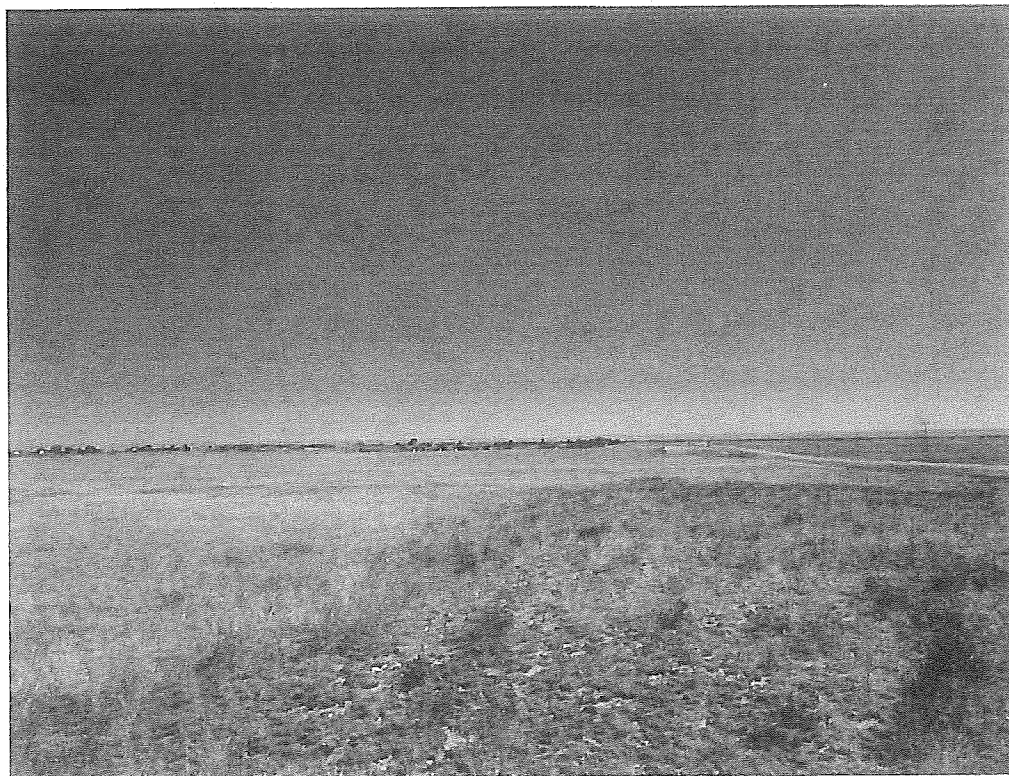
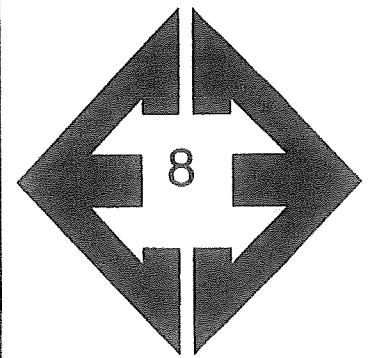
**Looking east from the  
southwestern portion  
of the site.**
