Preliminary Acceptance Punchlist
El Paso County – Department of Public Works - Stormwater Section

Project Name:	Bent Grass Residential F2
EDARP Filing Number(s):	SF1914, CON2022
ESQCP Number:	ESQ228
Attendees:	DPW SW: Dylan Finley, Ben Jones DPW Development Services: Spencer Pirzadeh, Brad Walters Developer: George Hart, Erin Ganaway
Date of Walk-Thru:	09/13/2023
Walk-Thru Number:	1

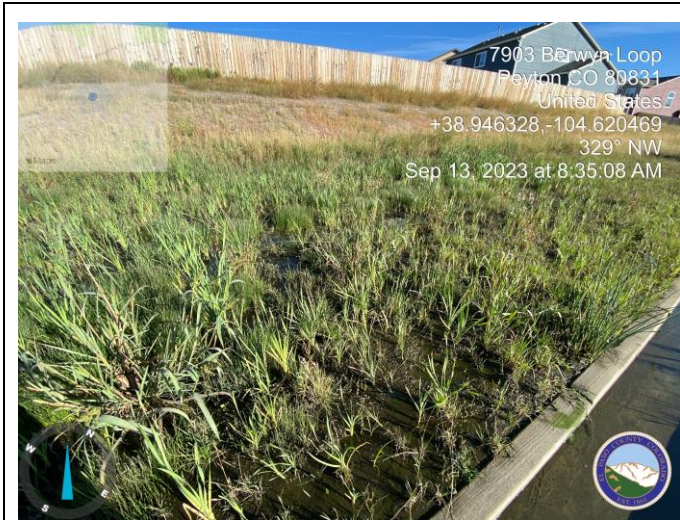
- Swale A has standing water at point near channel. Cat tails present. Sediment eroding into channel.
- Swale B (which is tributary to North Pond) not installed per plan. See GEC Plan Sheet G2.03 and G5.01.
- Swale E missing north pipe and riprap pad.
- Swale F missing riprap.
- Swale G not installed per plan.
- Swale H not installed per plan.

Photo 1: Swale A has standing water at point near channel. Cat tails present. Sediment eroding into channel. Regrade and stabilize.

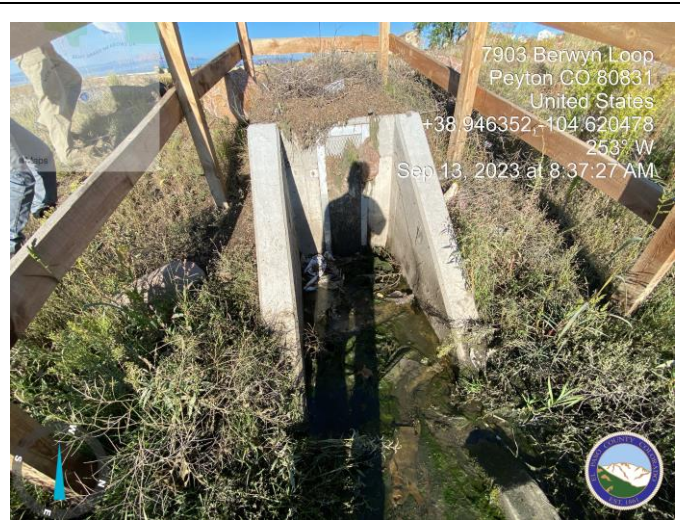
Photo 2: (South Pond) Outlet structure inspection could not be completed because of amount of debris covering it. The PA inspection will be completed once debris is removed.

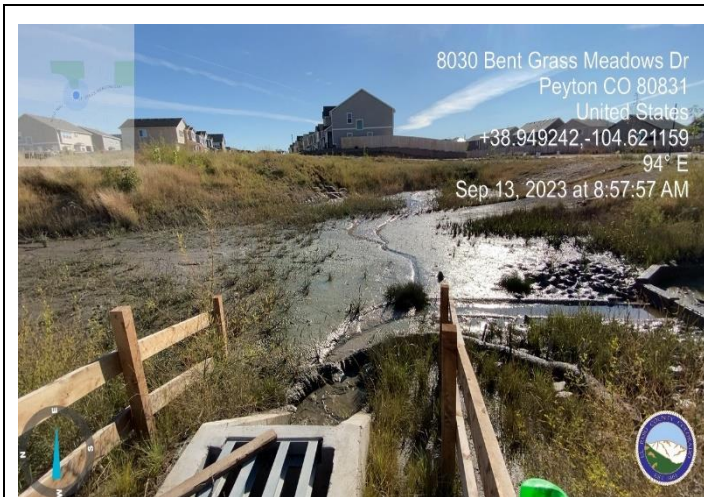
- Findings listed on 6/23/22 punchlist and still not completed:
 - Missing outlet protection. (Type L soil riprap page G5.02)
 - As of 9/13/23, all pond components and pond bottom have lots of sediment throughout that needs to be removed, including all riprap. Unable to complete inspection of the previous findings listed below because of amount of sediment covering pond. The PA inspection will be completed once sediment is removed. And the items below will be re-inspected.

Photo 3: Remove sediment and debris throughout pond. Grade pond to top of trickle channel curb. Grade pond bottom to min 3% slope towards trickle channel.

- Remove sediment and debris throughout pond.
 - Grade pond to top of trickle channel curb.
 - Grade pond bottom to min 3% slope towards trickle channel.

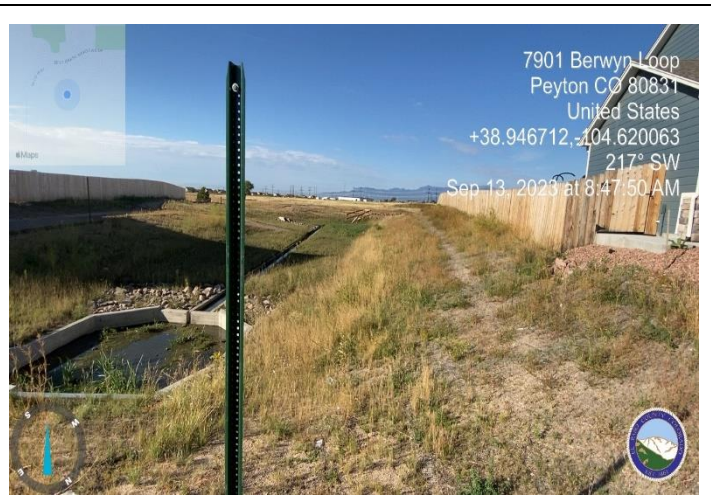
Photo 4: Signage for permanent ponds missing at both ponds.

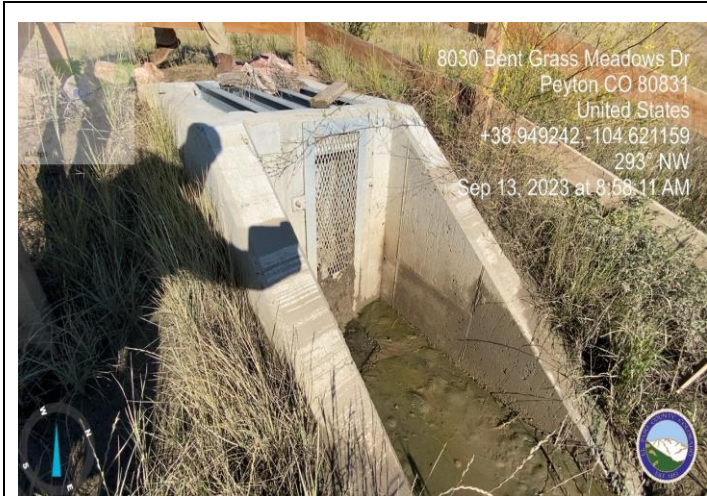
- Missing pond sign (“proposed storm facility”)
 - Well screen type not acceptable: diamond plate not allowed. Drawing calls for Johnson vee wire. See sheet G6.01. See email from Glenn Reese from 11/2/2022 titled “Screen information – SF1914 – Bent Grass F2.”

Photo 5: Well screen type not acceptable: diamond plate not allowed. Drawing calls for Johnson vee wire. See sheet G6.01

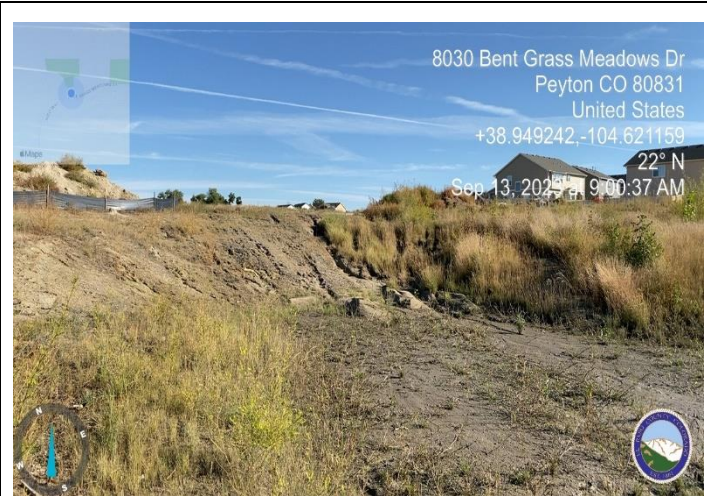
Photo 6: North Pond embankments eroding. Regrade and stabilize.

- Install restrictor plate on outlet pipe per plan and UD-Detention spreadsheet.
 - Confirm gasket at orifice plate.
- Repair erosion on northern embankment of pond.

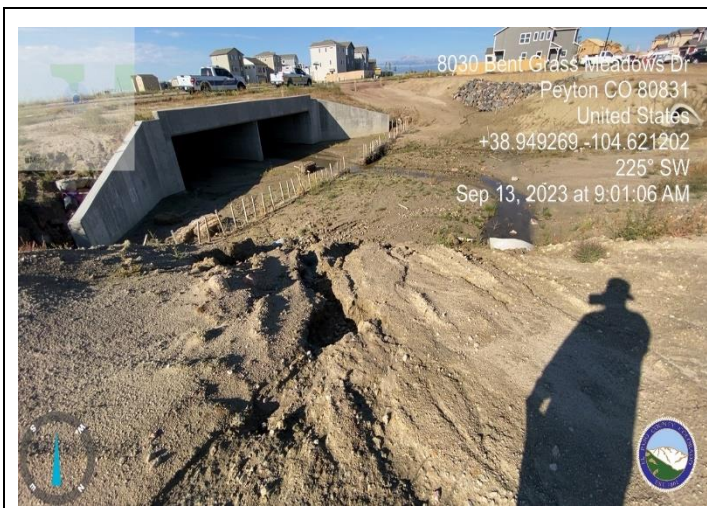
Photo 7: North pond outfall near cutoff wall eroding. Regrade and stabilize.

- Repair erosion around south side of spillway cutoff wall.
- The grade of the north side of the spillway has been raised due to an adjacent temporary access road. This appears to be causing the aforementioned erosion. Regrade north side of spillway per plan.

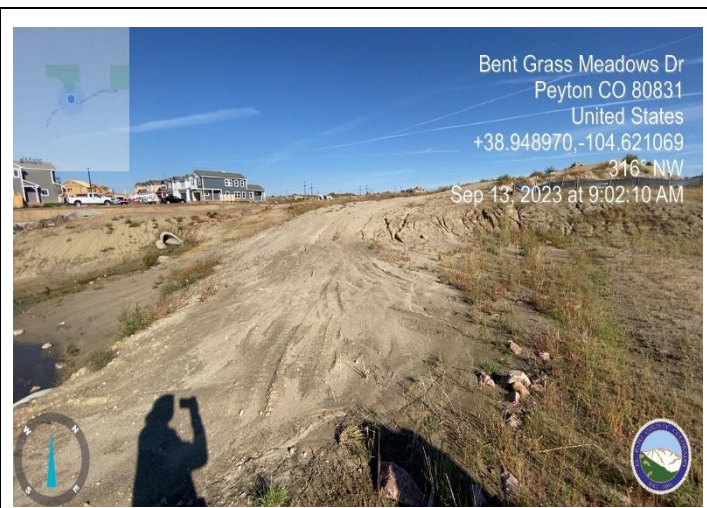
Photo 8: The grade of the north side of the spillway has been raised due to an adjacent temporary access road. This appears to be causing the erosion at cutoff wall. Regrade north side of spillway per plan.

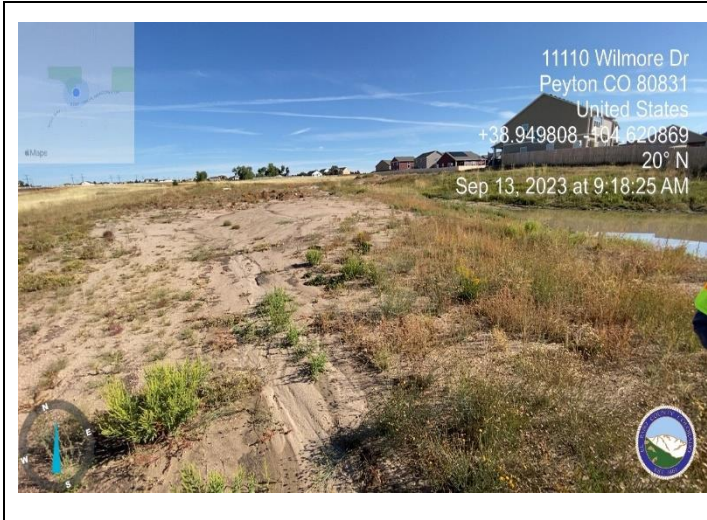
Photo 9: Install Swale B (which is tributary to North pond) per plan. See GEC Plan Sheet G2.03 and G5.01.

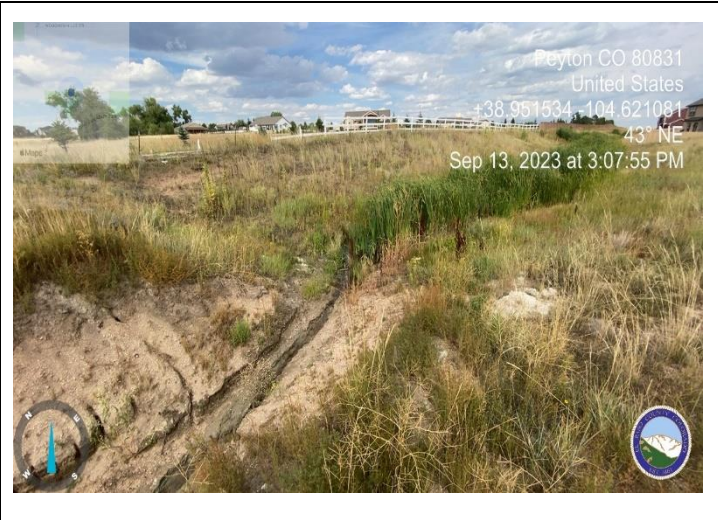
Photo 10: Swale A has standing water at point near channel. Cat tails present. Sediment eroding into channel. Regrade to promote positive drainage and stabilize.

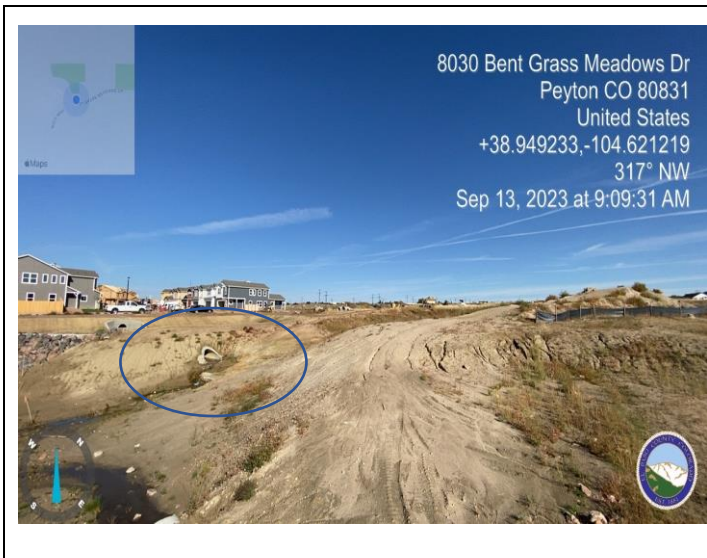
- Install drop structure in main channel with 24” grouted boulders. (West of Swale B).
- Also missing:
 - 1.5’ high riprap check dam
 - Type M Soil Riprap 24” deep
 - Six-foot deep cutoff wall
 - Three-foot deep cutoff wall
 - Type L riprap 18” deep.

Photo 11: Install drop structure and other improvements in main channel (West of Swale B). See GEC Plan Sheet G7.02.

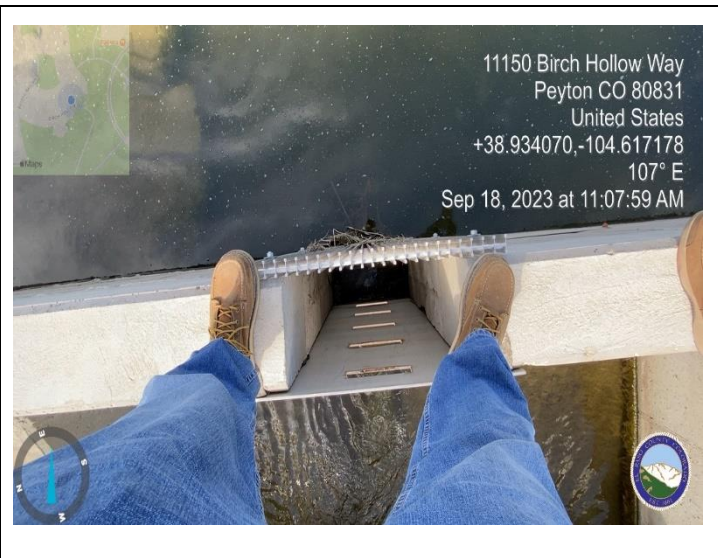
Photo 12: Pond WU - Install plate over cross member to prevent debris clogging outlet structure.

- Gaskets missing from all orifice plates. Install the watertight seal per specification.
- Install plate over cross member between trash rack and orifice plate to prevent debris clogging outlet structure.

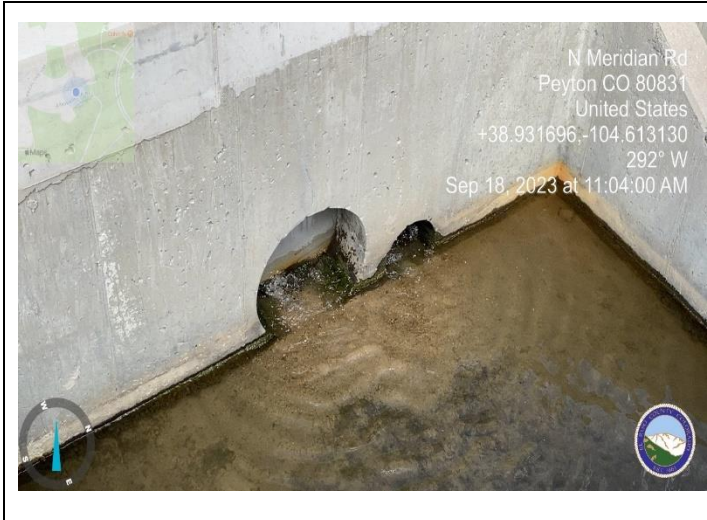
Photo 13: (Pond WU) Gaskets missing from all orifice plates. Install the watertight seal per spec. (GEC page 6.06)

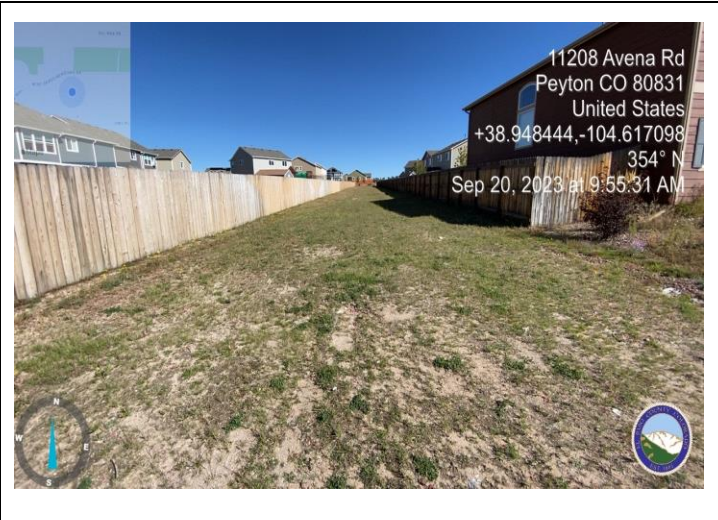
Photo 14: Swale G not Installed per plan

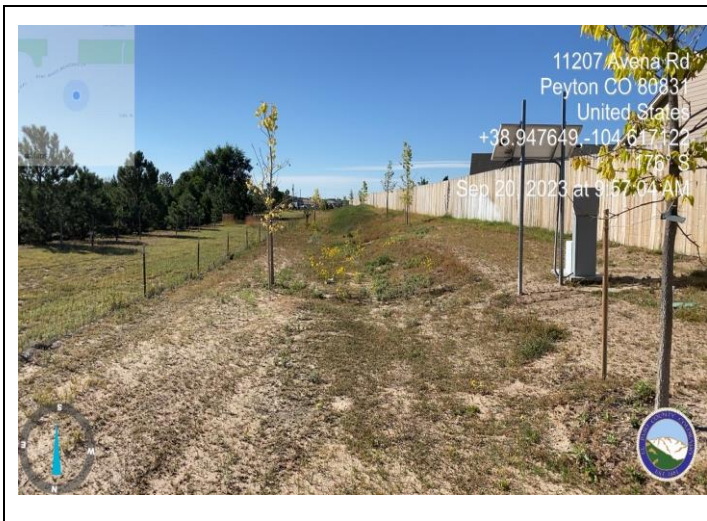
Photo 15: Swale H not installed per plan
