**ENTECH**  
ENGINEERING, INC.

October 15, 2020

Re: Soil, Geology and Geologic Hazard Evaluation  
Bentgrass Commercial, Filing 2B  
Bent Grass Meadows Drive  
El Paso County, Colorado

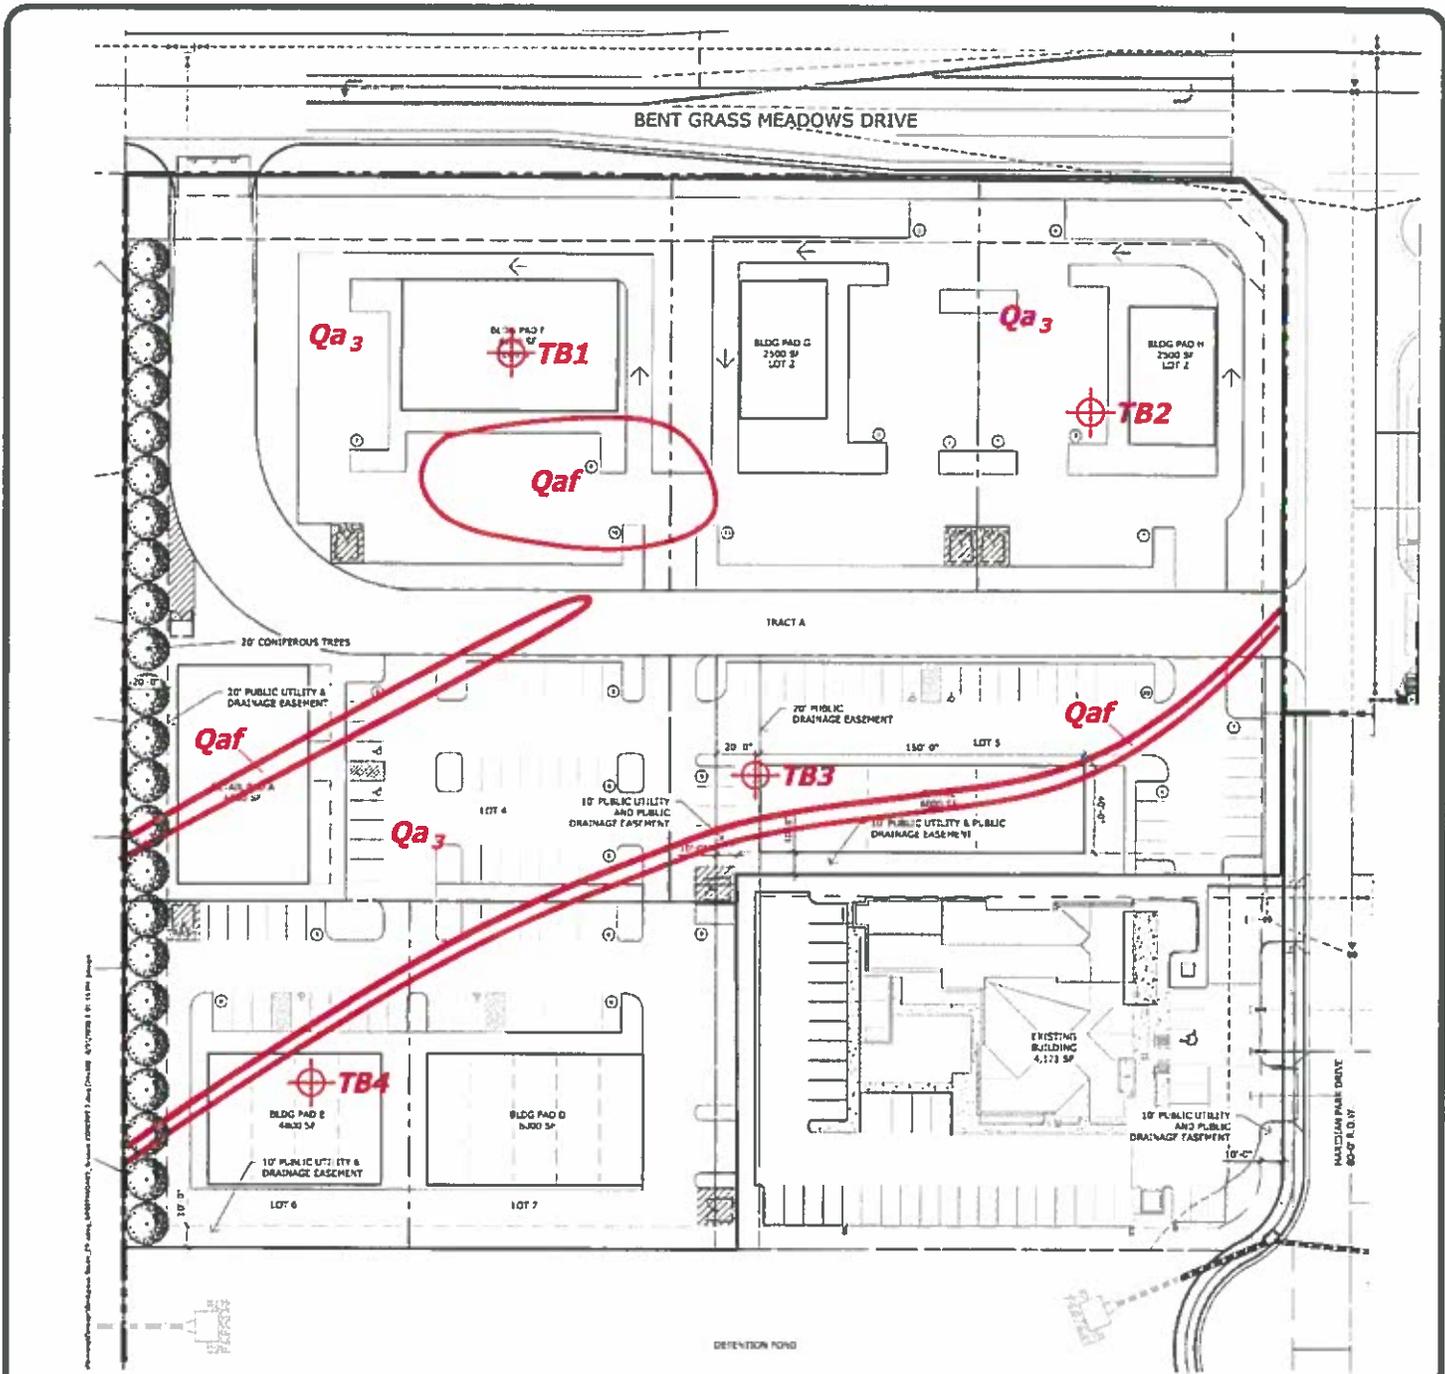
FIG NO:  
**6**

Fill associated with an existing fill stockpile and erosion berms were observed in the eastern portion of the site.

Mitigation: It is anticipated that the fill piles, and the erosions berms will be removed during site grading. Areas of fill other than those encountered may be encountered. The fill piles are considered uncontrolled. Any uncontrolled fill encountered beneath foundations should be removed and recompactd at a minimum of 95% of its maximum Modified Proctor Dry Density, ASTM D-1557.

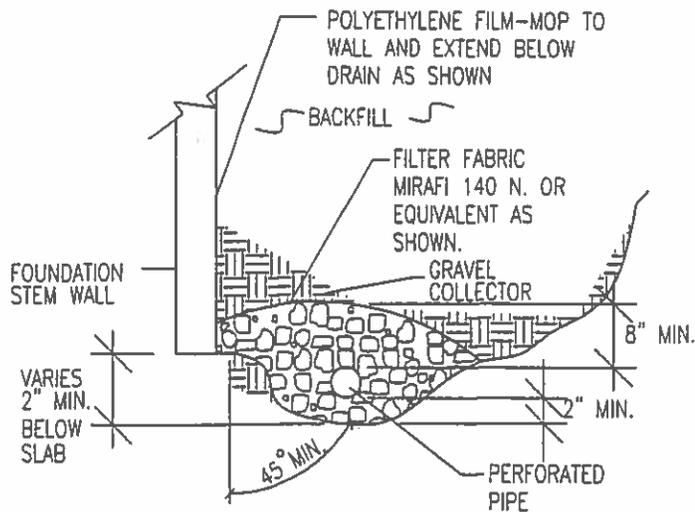
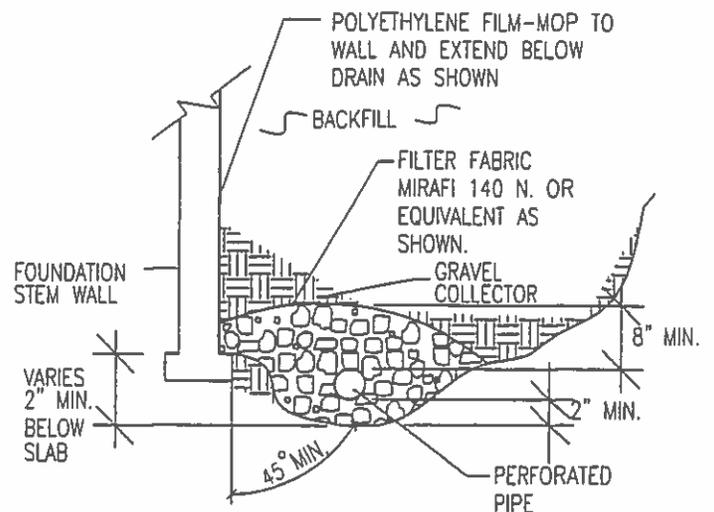
*JOB NO.:*  
202118  
*FIG NO.:*  
8

Groundwater was encountered in all of the test borings at depths ranging from 5 to 12.5 feet bgs (Reference 1, Appendix B). The borings were drilled to 20 feet. Perched groundwater tables exist due to permeable terrace alluvium overlying less permeable lenses in the Dawson Formation. Coarse grained sand lenses can carry water perched on impermeable clay lenses, claystone or sandstone. Perimeter drains, interceptor drains, or underslab drains may be necessary where foundations on encroach the groundwater table. Typical drain details are presented in Figures 8 through 10.
