**SOILS AND GEOLOGY STUDY  
ASPEN WILLOW SUBDIVISION  
PARCEL NO. 61000-00-298  
1480 E. HIGBY ROAD  
EL PASO COUNTY, COLORADO**

Prepared for:  
**Charles Woodall**  
1480 E. Higby Road  
Monument, Colorado 80132

August 21, 2026

Entech Job No. 261137

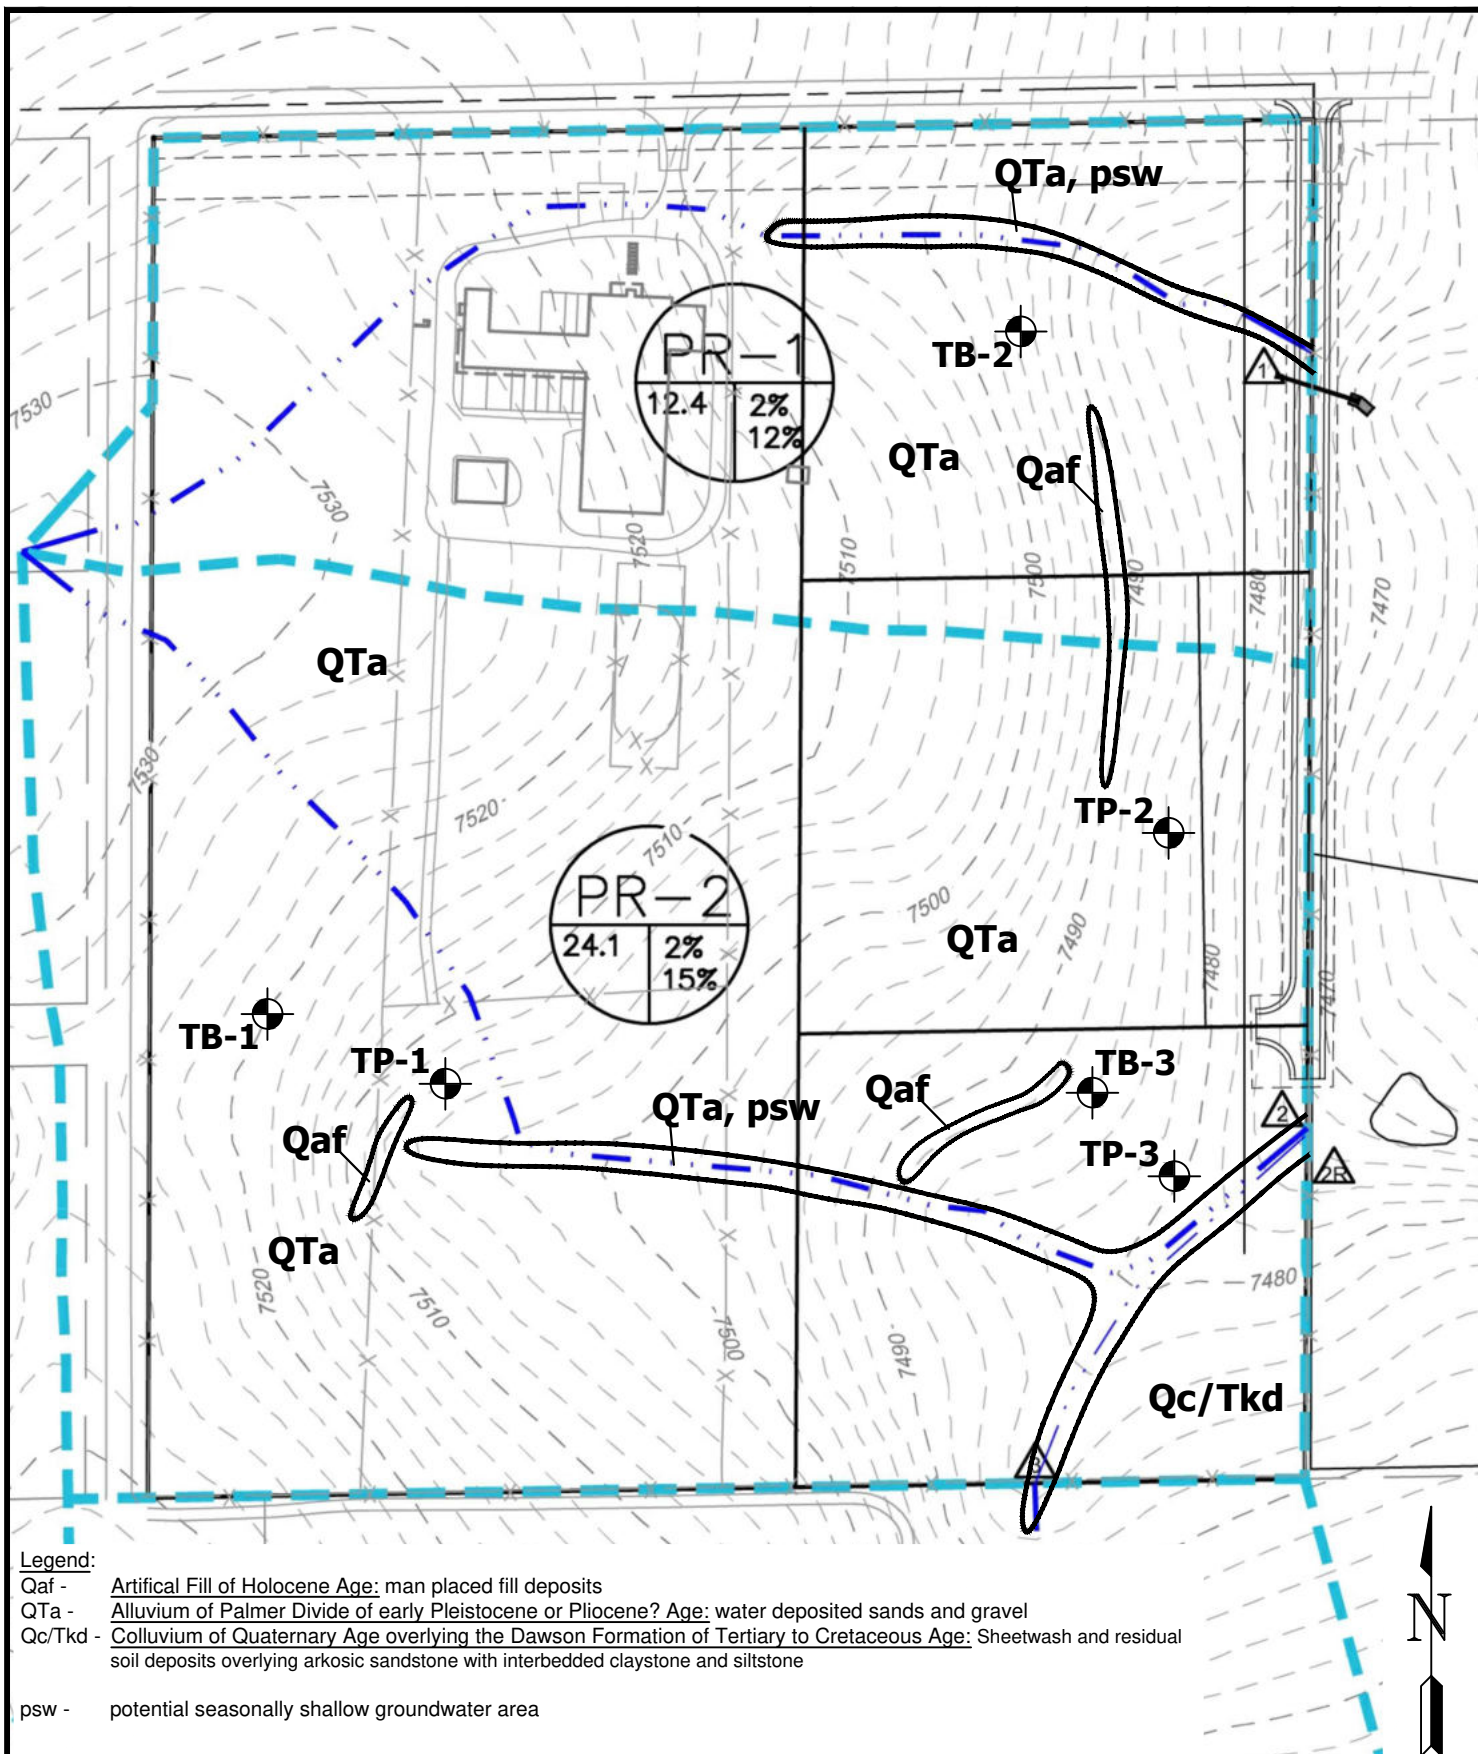
**GEOLOGY/ENGINEERING  
GEOLOGY MAP**  
ASPEN WILLOW SUBDIVISION  
CHARLES WOODALL

Detailed mapping has been performed on this site to produce a Geology/Engineering Geology Map (Figure 3). This map shows the location of various geologic conditions the developers should monitor during the planning, design, and construction stages of the project. No significant geologic hazards were identified on the site; however, the following constraints have been identified on the site: artificial fill, potentially collapsible soils, potentially expansive soils, potential seasonally shallow groundwater areas, and the potential for elevated radon levels. These constraints and the recommended mitigation techniques are discussed below.

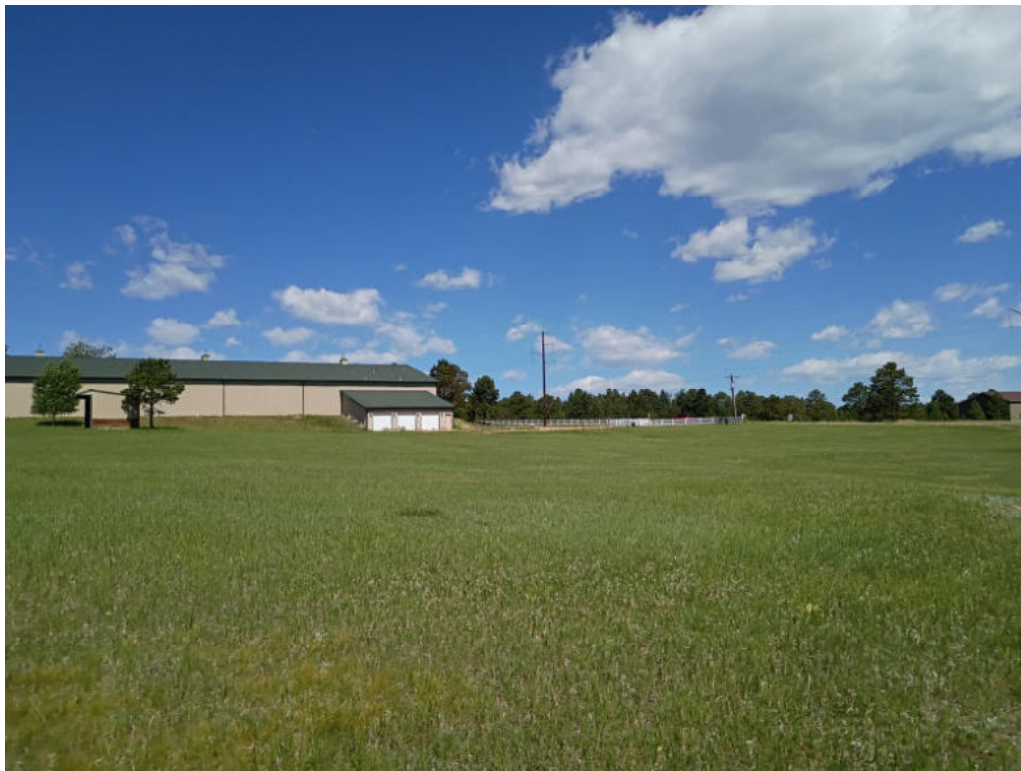
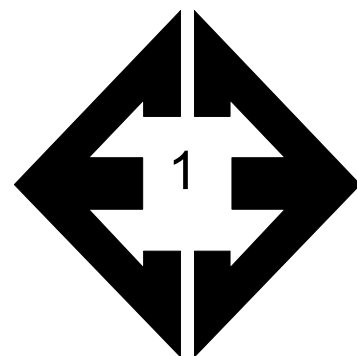
**Looking west from the  
northeastern portion of  
the site.**

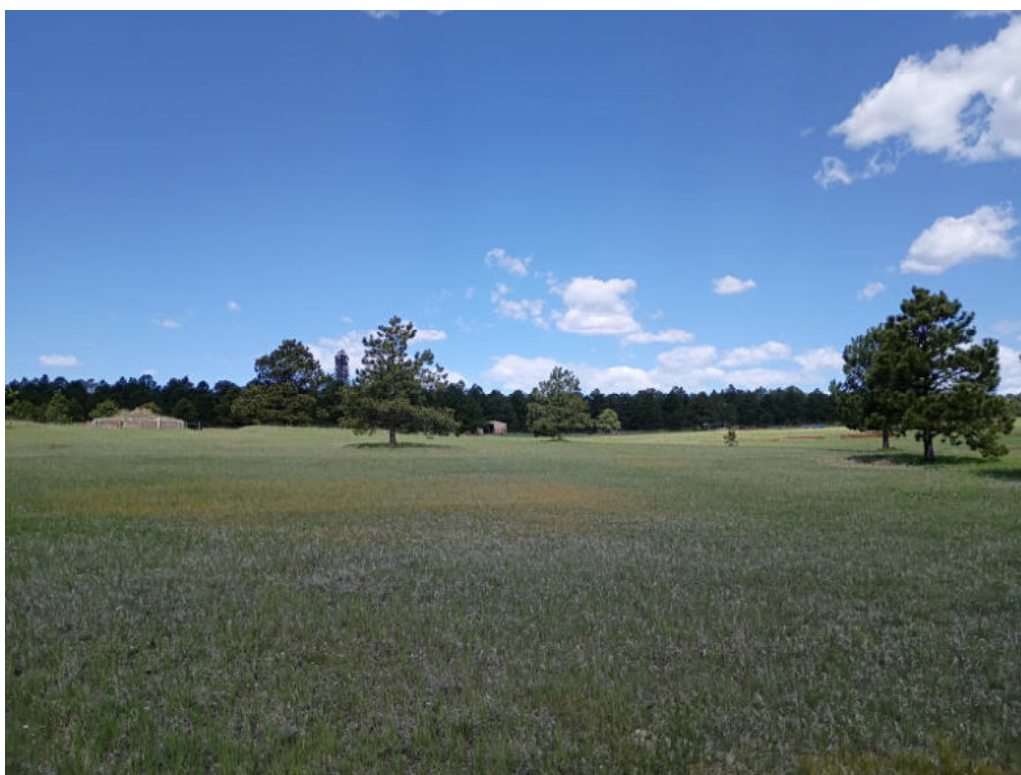
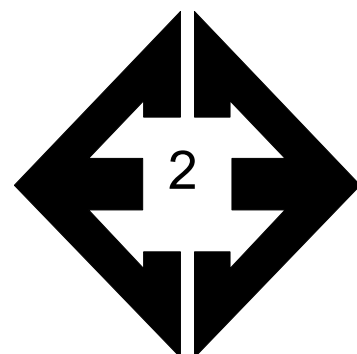
**Looking southwest  
from the northeastern  
portion of the site.**

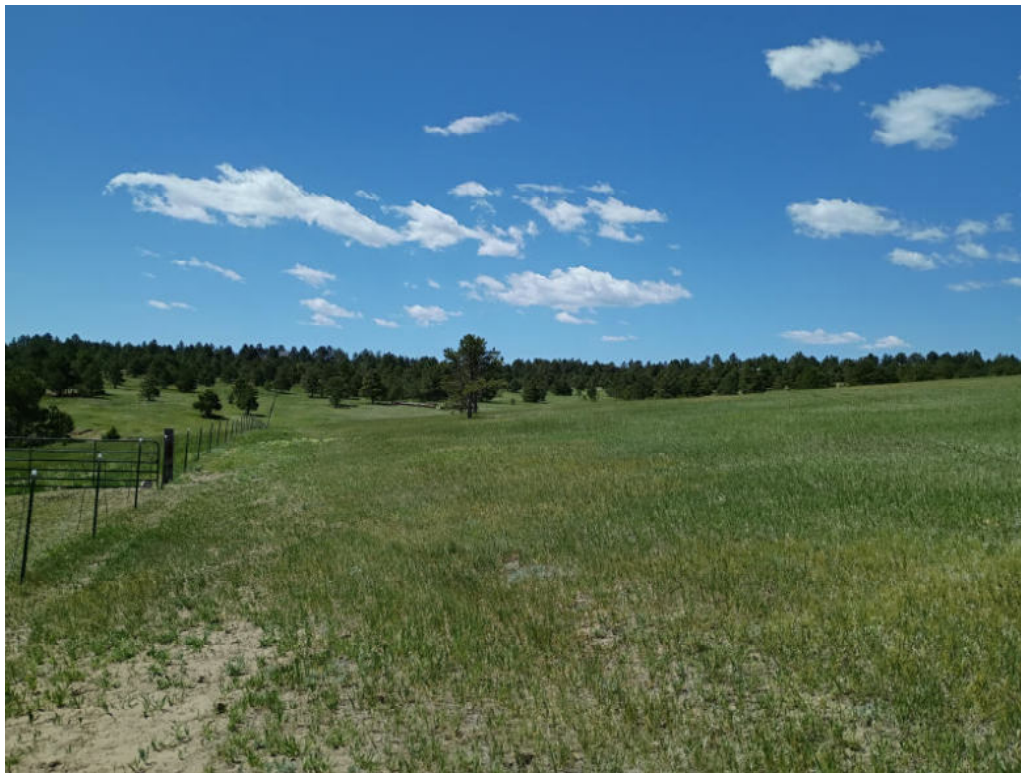
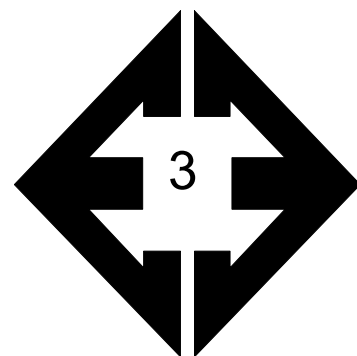
**Looking south from  
the eastern side of the  
site.**

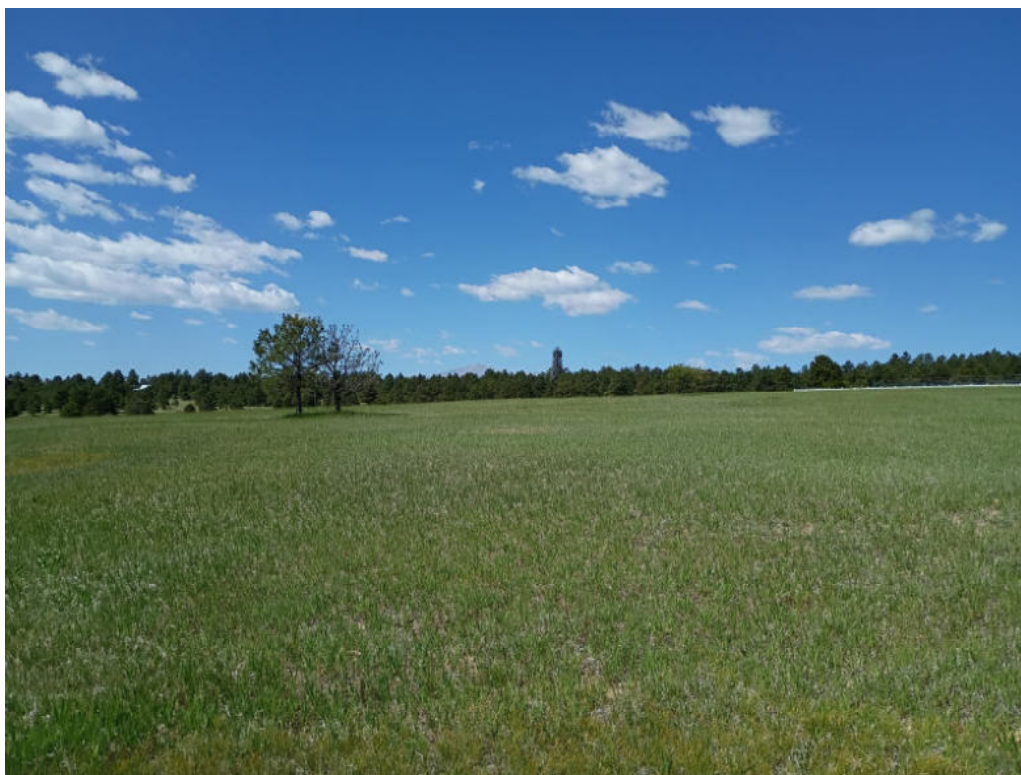
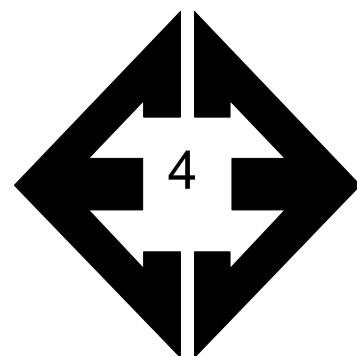
**Looking southwest  
from the eastern side  
of the site.**

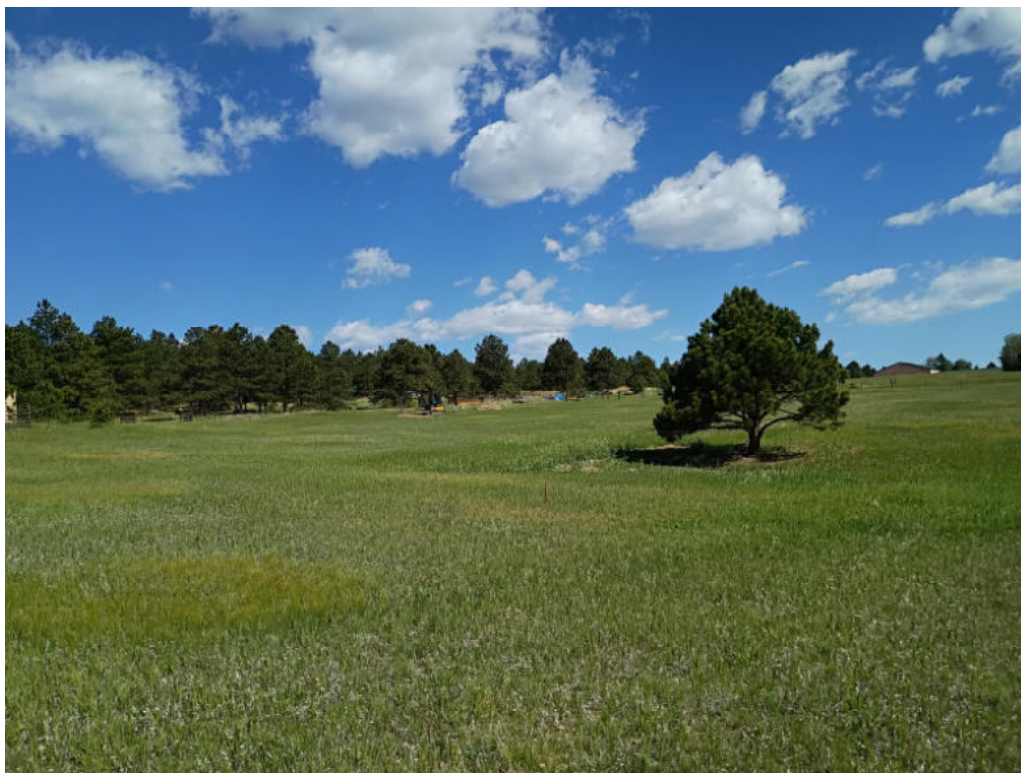
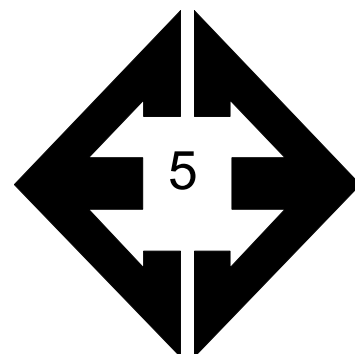
**Looking northwest  
from the southern  
portion of the site.**

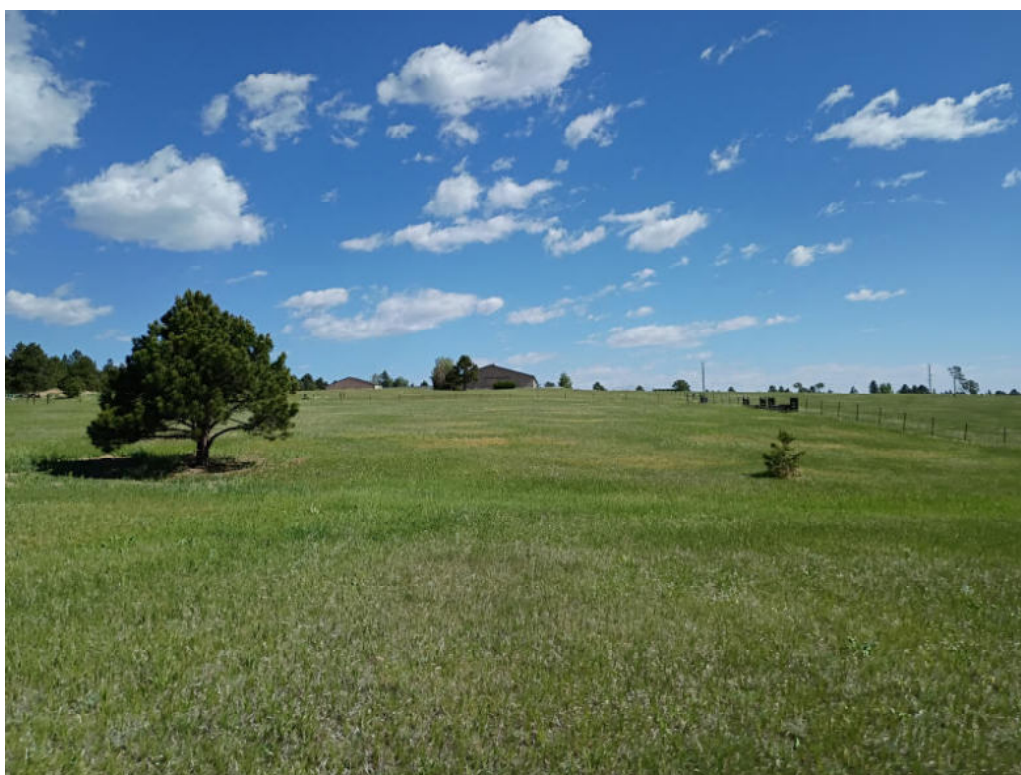
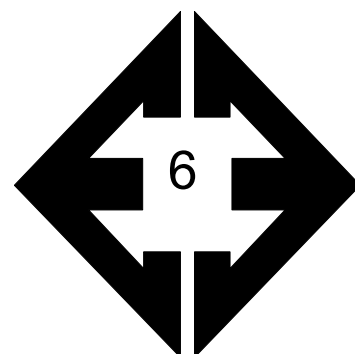
**Looking north from the  
southern portion of the  
site.**
