ENTECH
ENGINEERING, INC.

March 1, 2022

Re: Soil, Geology and Geologic Hazard Evaluation
D+K Akers Subdivision 1, Replot Lots 1 and 2
2875 Akers Drive
El Paso County, Colorado

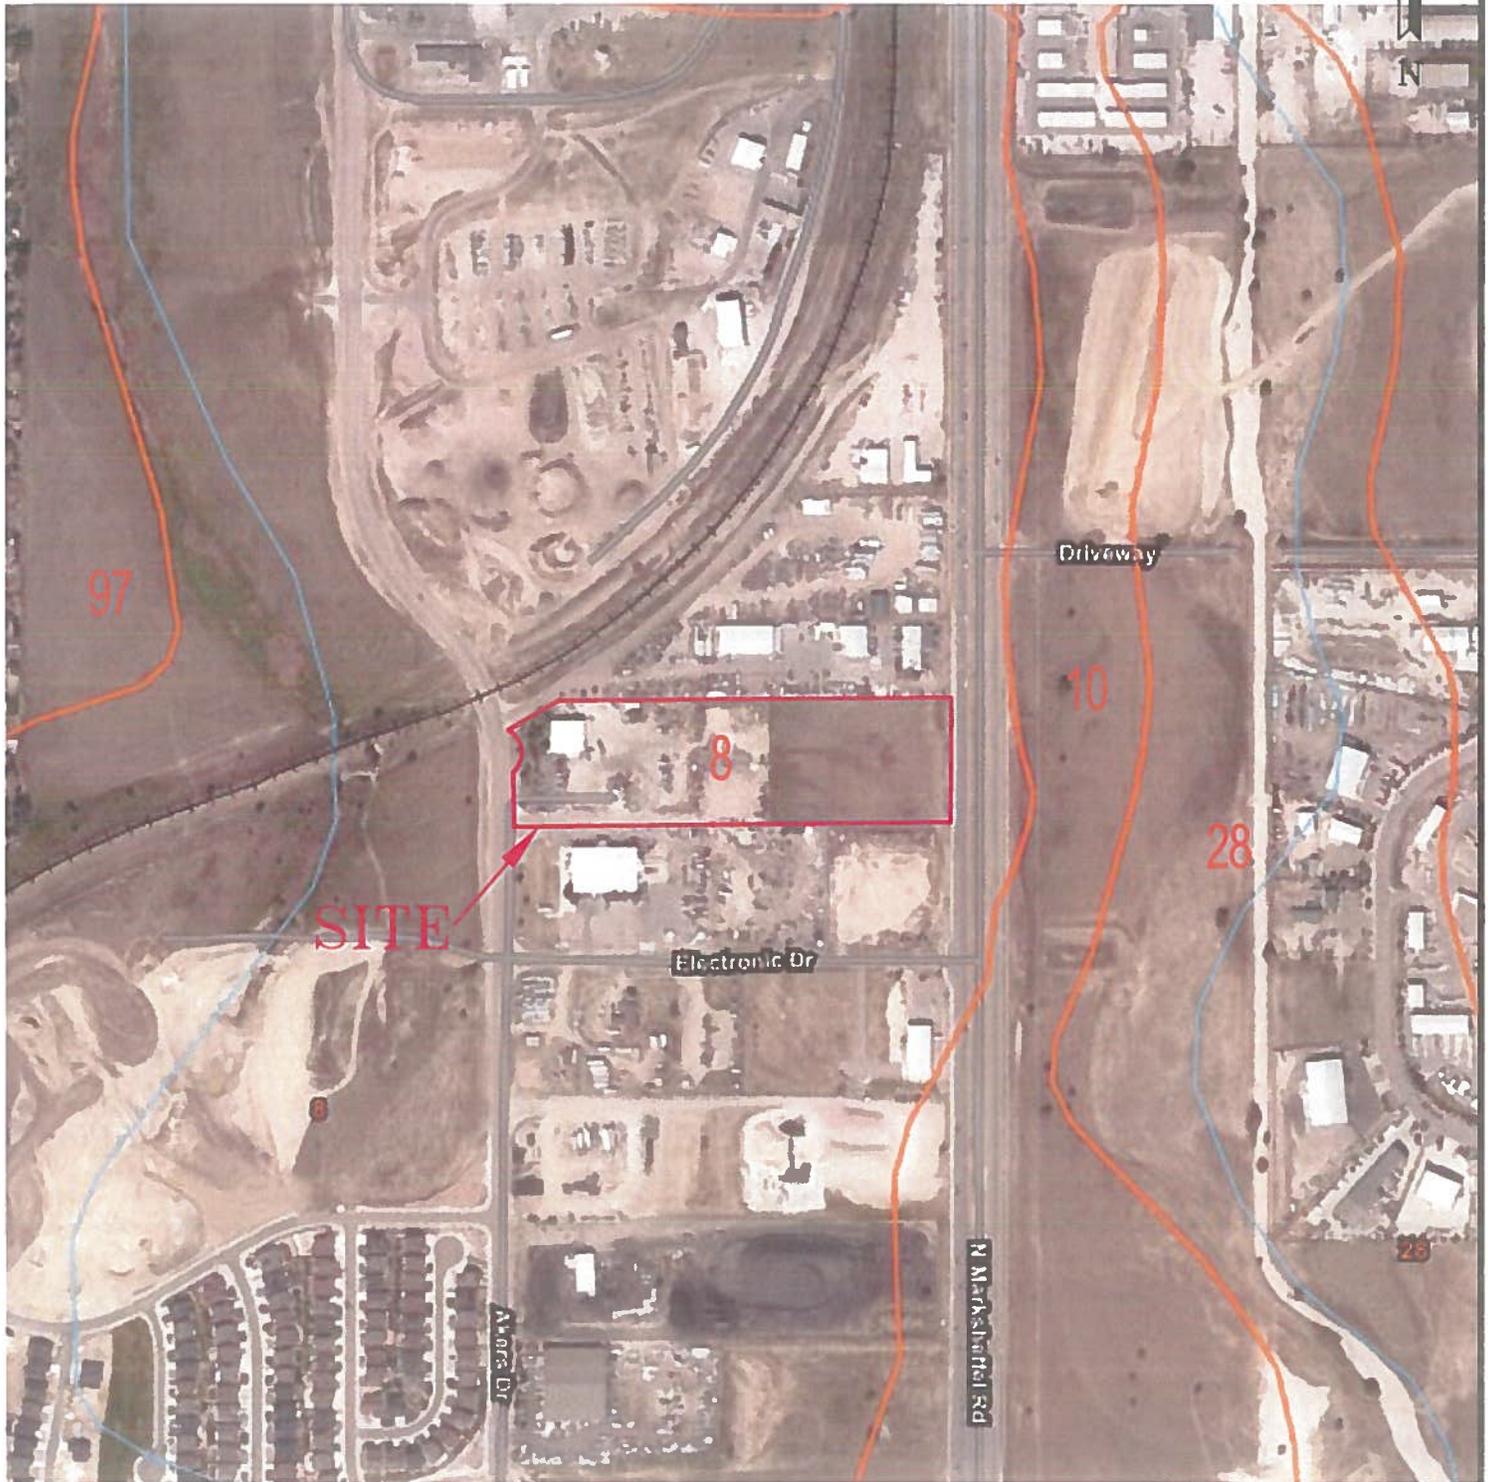
FIG NO.:
4

The Natural Resource Conservation Service (NRCS) (Reference 2, Figure 4), previously the Soil Conservation Service (Reference 3) has mapped three soil types on the site. Complete descriptions of the soils are presented in Appendix C. In general, the soils consist of gravelly sandy loam, and very gravelly loamy sand. The soils are described as follows:

The soils have been described to have moderate to rapid permeabilities. The soils are described as well suited for use as homesites. Possible hazards with soils erosion are present on the site. The erosion potential can be controlled with vegetation. The soils have been described to have moderate erosion hazards (Reference 3).

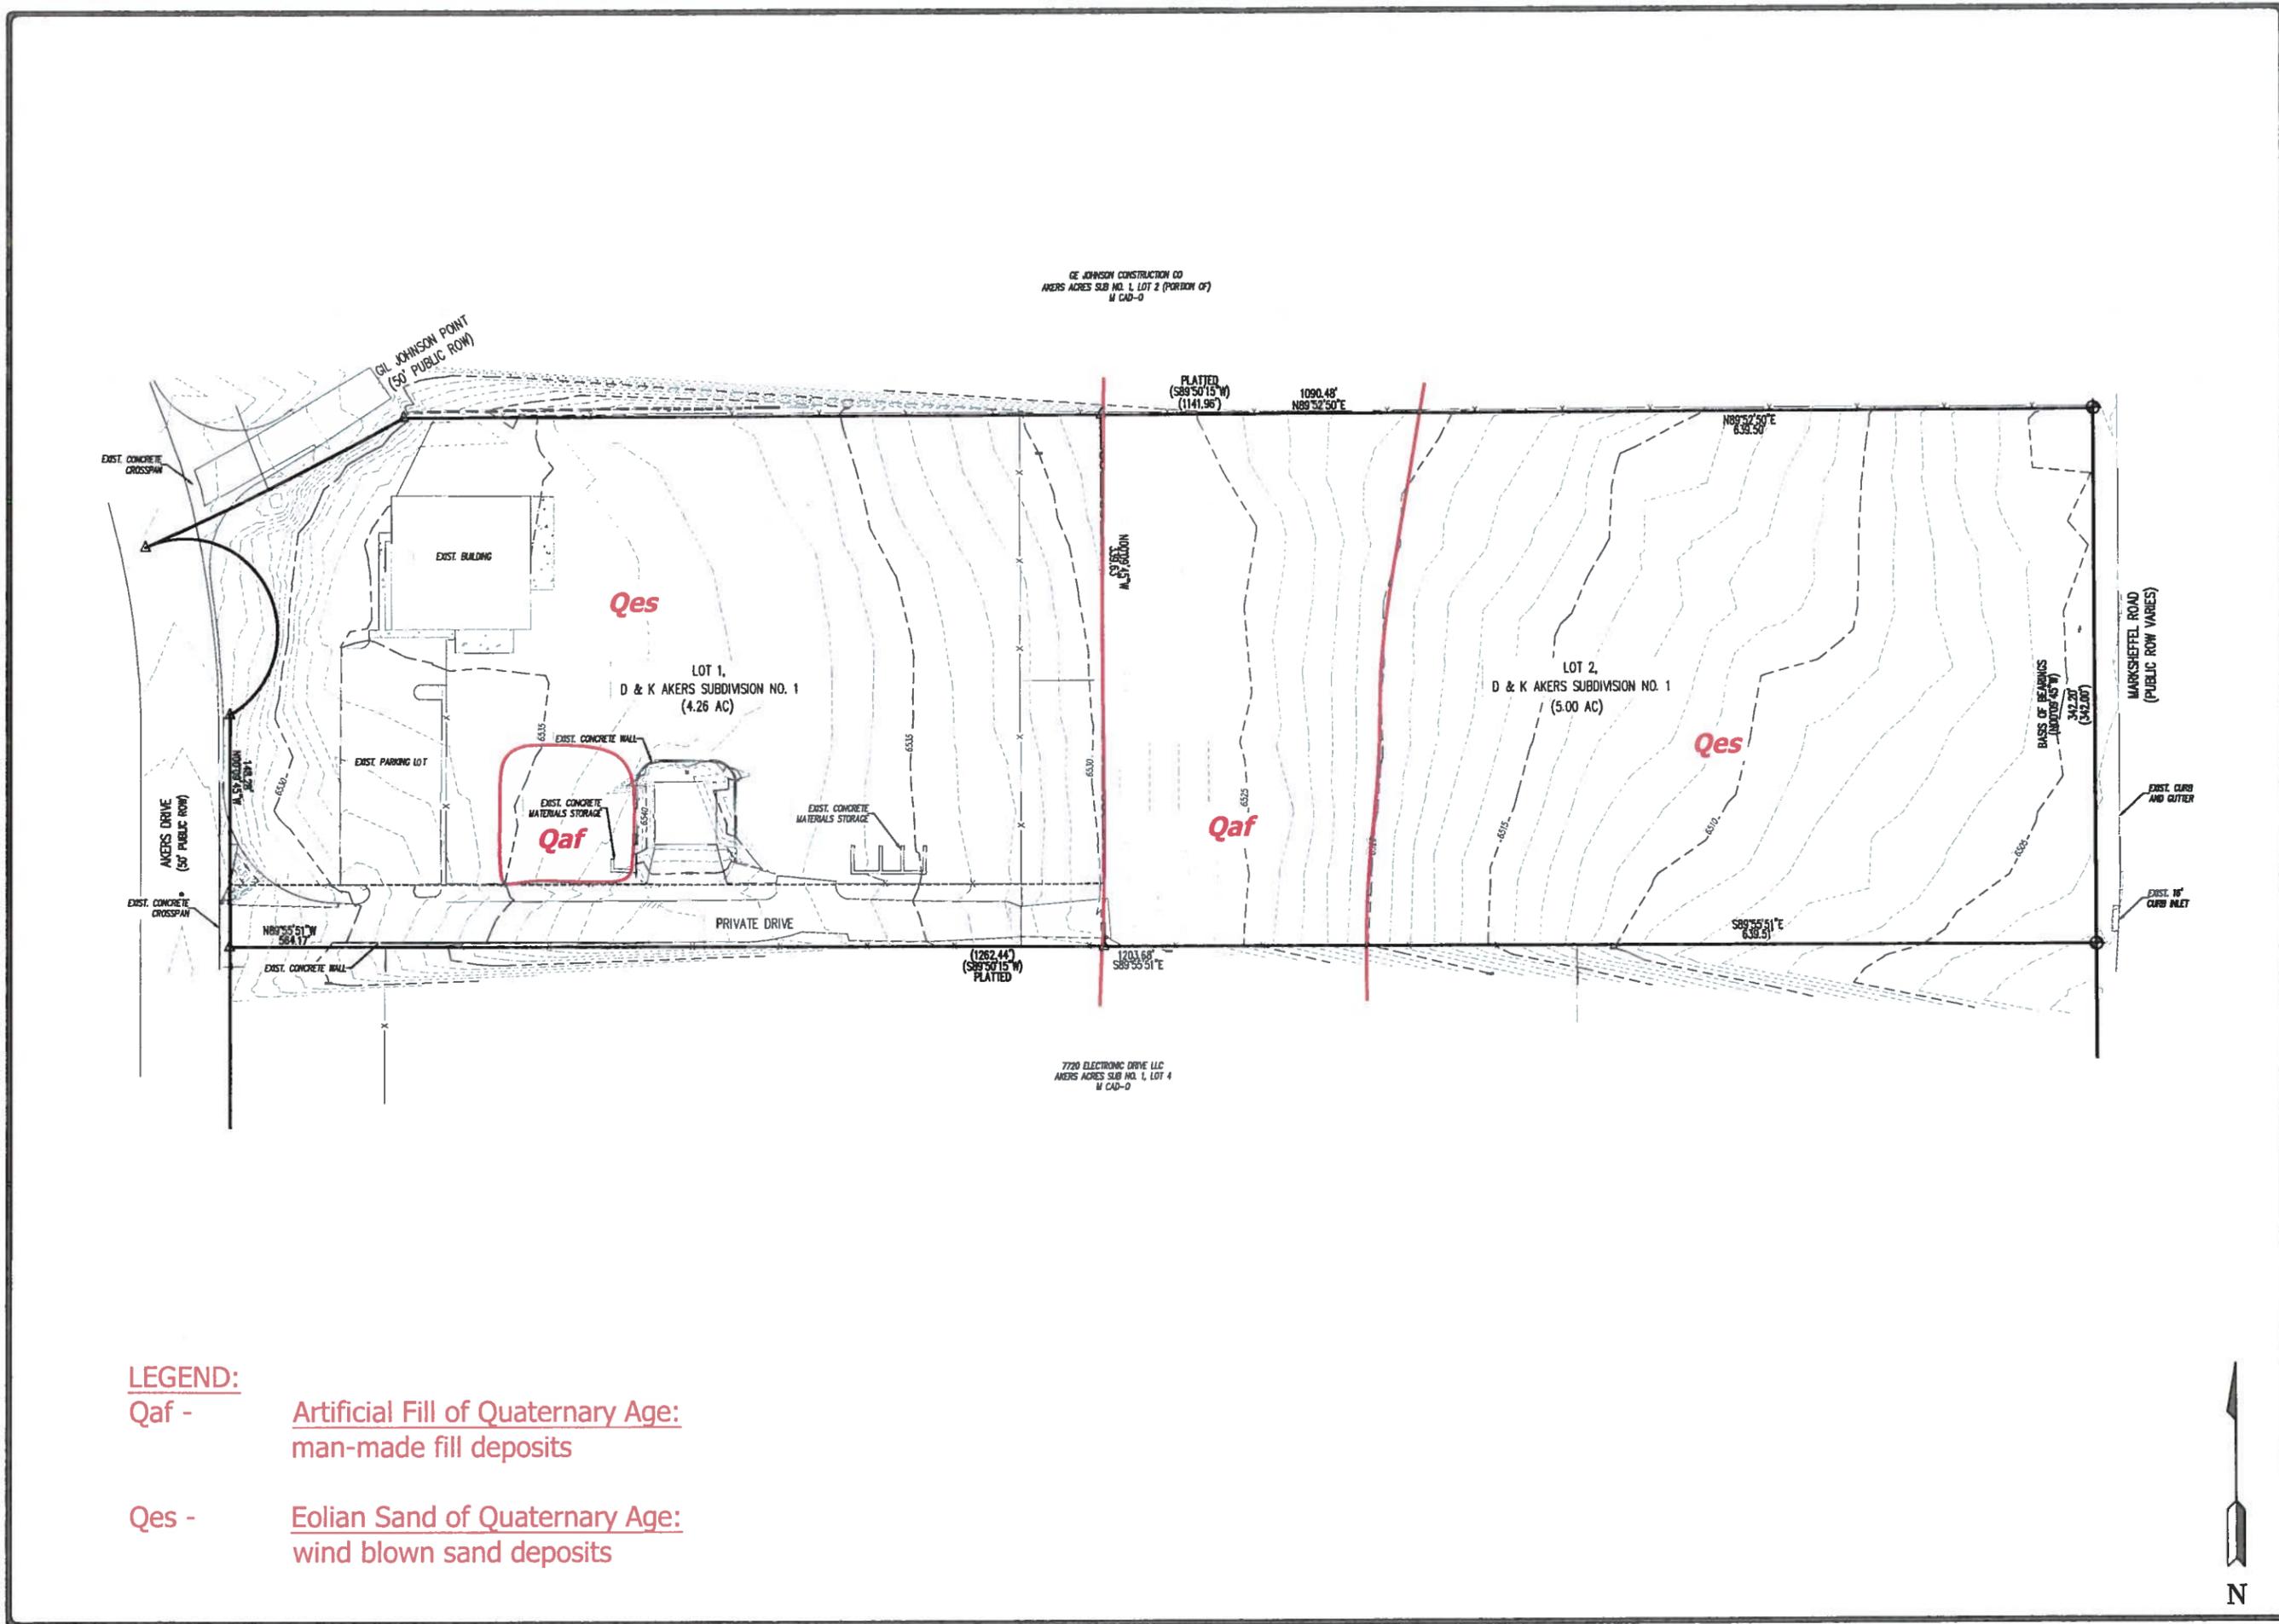
DATE	3/02/22
SCALE	AS SHOWN
SHEET NO.	230258
FIGURE NO.	6

stages should new construction be proposed. The engineering geologic hazards identified on this site include artificial fill, and loose soils. Additionally, shallow groundwater may be encountered at variable depths across the site. These hazards and recommended mitigation techniques are discussed as follows:

Fill exists associated with an existing metal building and parking lot, and cell tower on the western portion of the site. This fill is considered uncontrolled for construction purposes. Areas of fill encountered beneath foundation components or below parking lots and storage yard should be penetrated or removed on a controlled manner.

Areas of fill, may also be encountered. All fill within building areas should be completely removed prior to construction. Any uncontrolled fill encountered beneath new foundations and floor slabs will require removal and recompaction at a minimum of 95% of its maximum Modified Proctor Dry Density, ASTM D-1557.

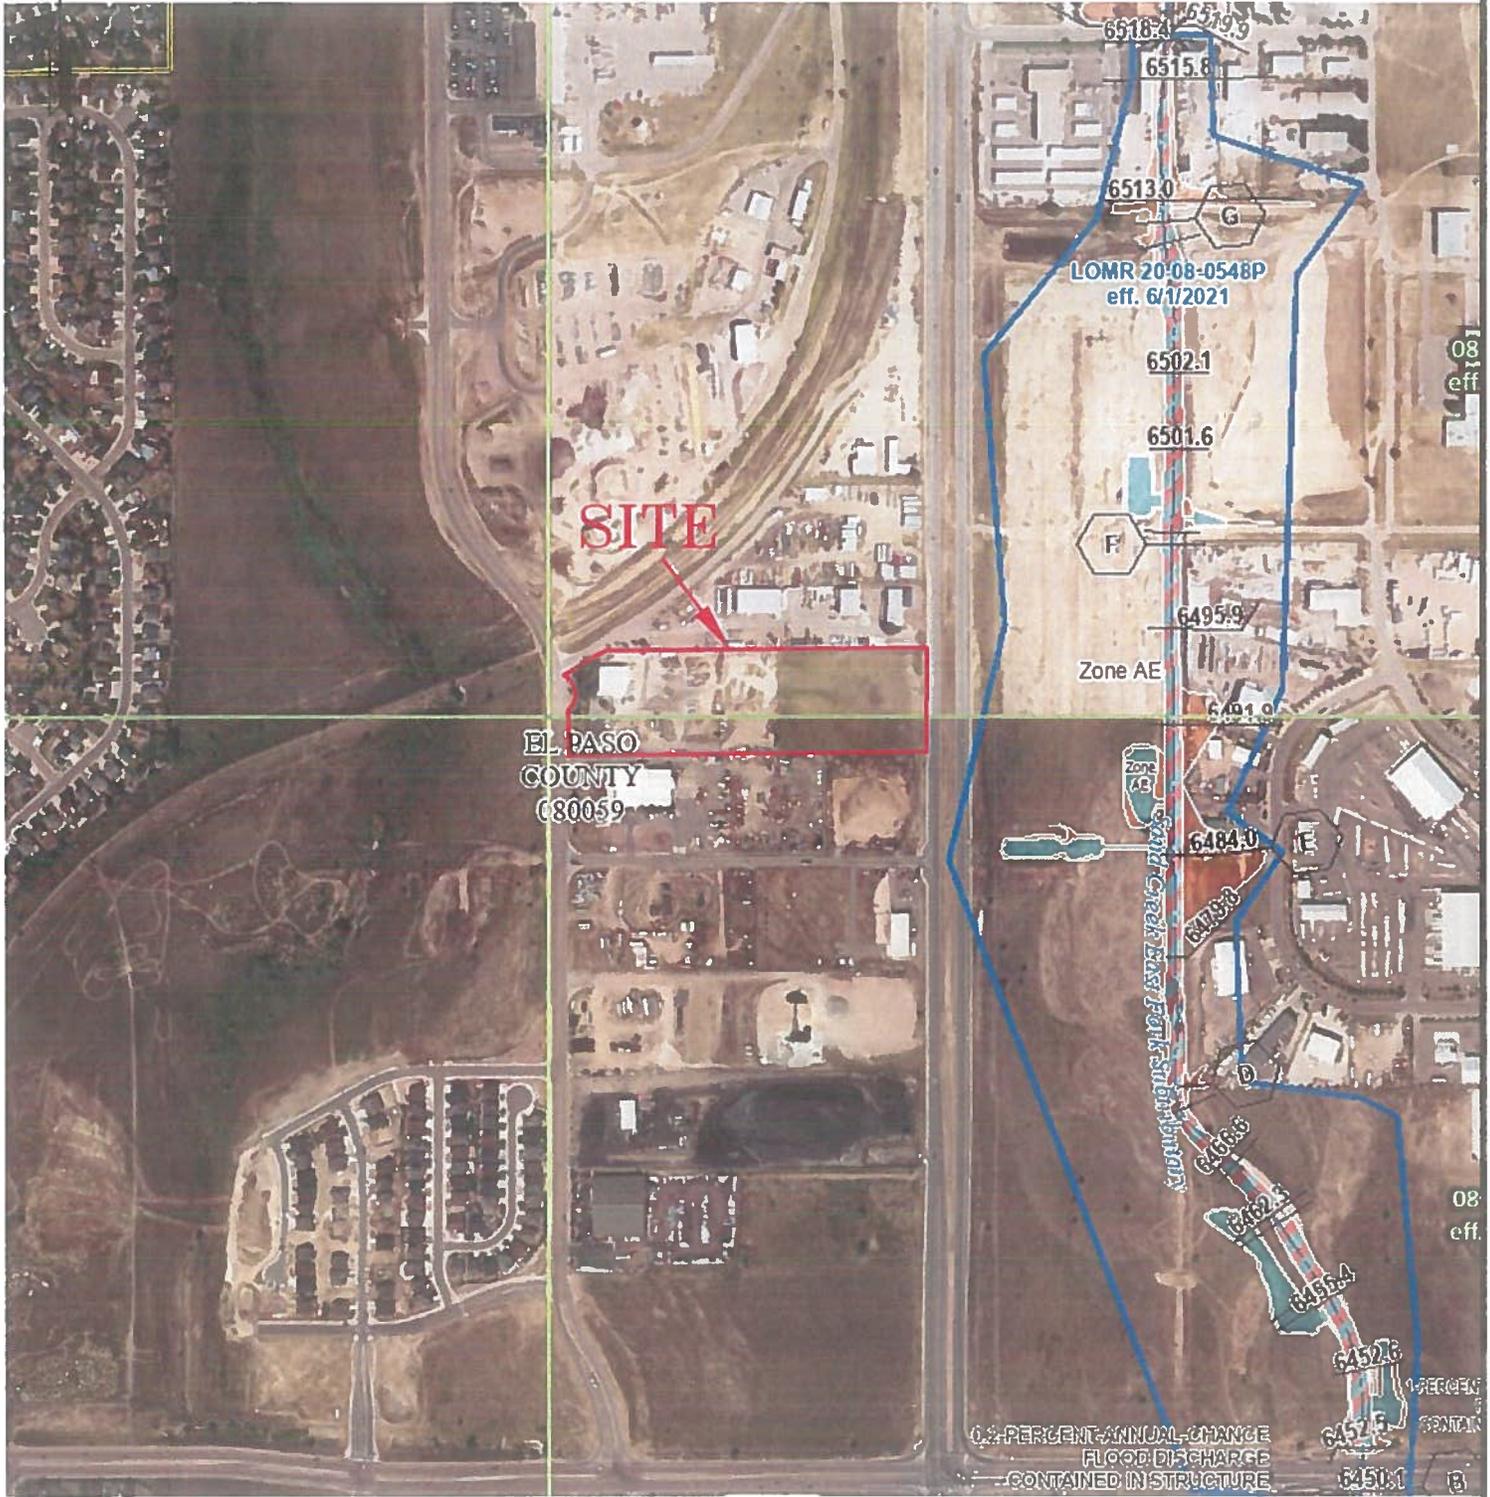
FIG NO.:
7

The site does not lie within a floodplain according to the FIRM Map, Nos. 08041CO543G and 08041CO756G (Reference 9, Figure 7). Any site grading considered should be modified to direct surface flows around the structure or roads, or carried off site to not produce any areas of ponded water. Specific drainage studies and exact floodplain locations are beyond the scope of this report.

Mitigation: Structures should not be located within the floodplain; however, structures adjacent to the floodplain may experience periods of high subsurface moisture. In these locations, foundations are subject to severe frost heave and should penetrate to a sufficient depth so as to prevent the formation of ice lenses beneath foundations. At this location and elevation, a foundation depth for frost protection of 30-inches is recommended. In areas where high subsurface moisture conditions are anticipated periodically, a subsurface perimeter drain will be necessary to help prevent the seepage of water into areas below grade. A typical perimeter drain detail is presented in Figure 8. Any grading in these areas should be done in a manner that directs surface flow around construction to avoid areas of ponded water. Areas of organic material will require removal prior to any fill placement. Unstable soil conditions should be

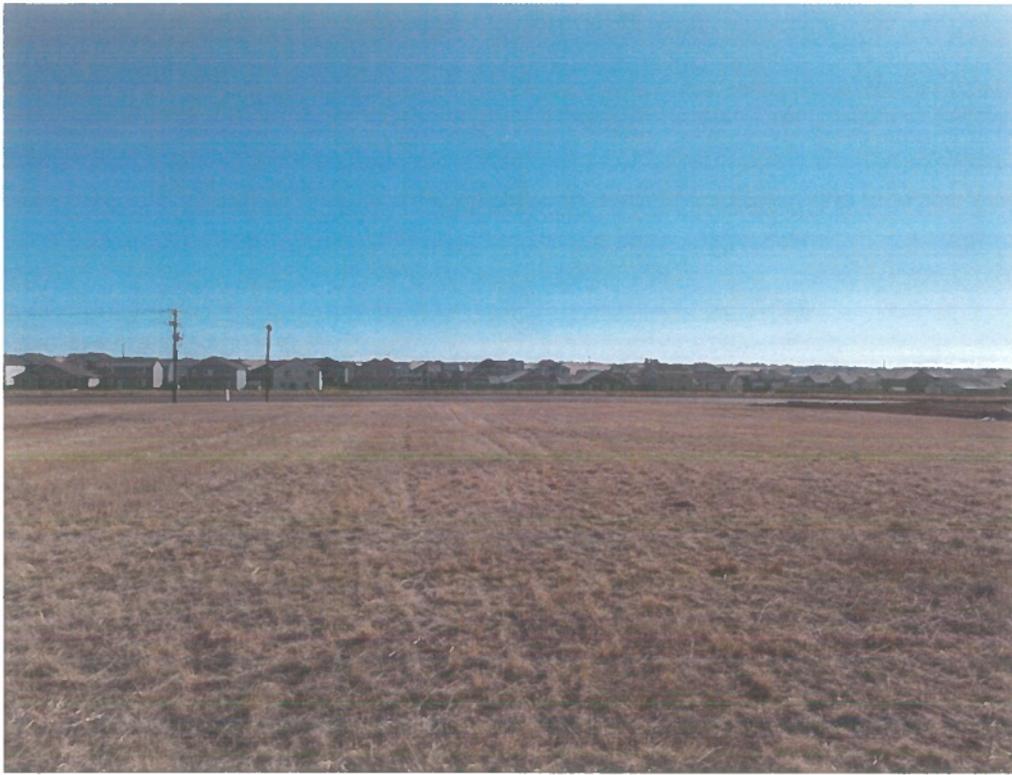
Looking east from the
central portion of Lot
2.

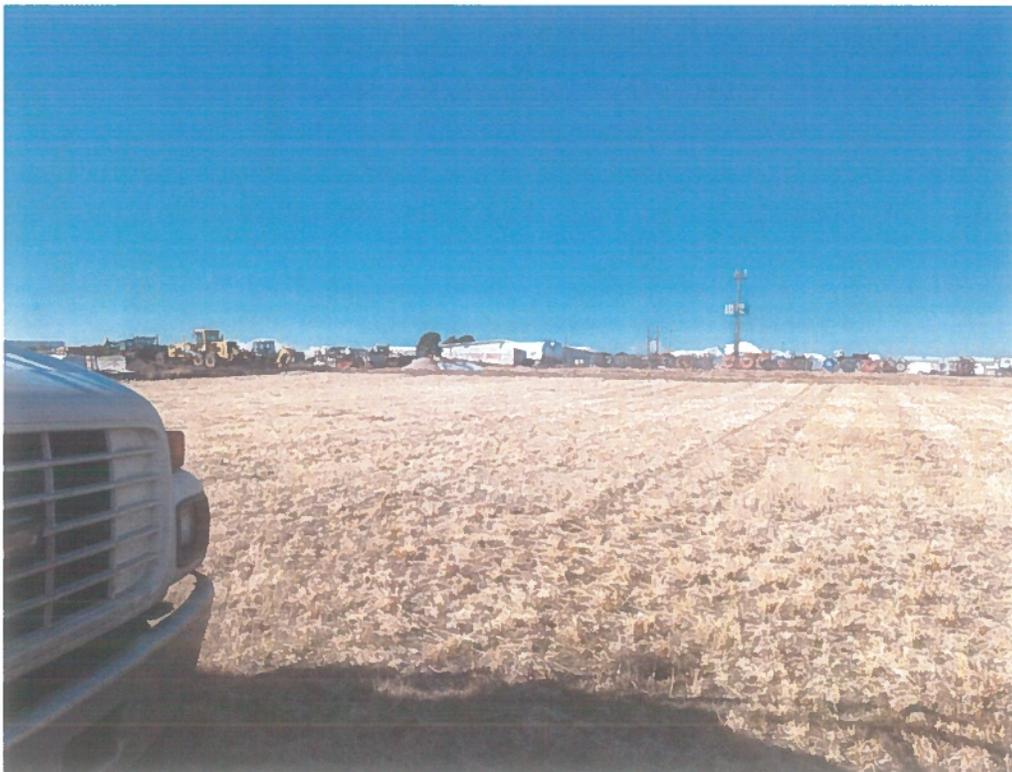
Looking west from the
central portion of Lot
2.

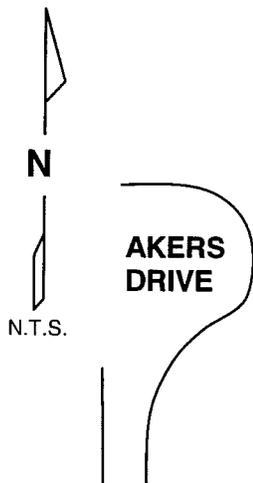
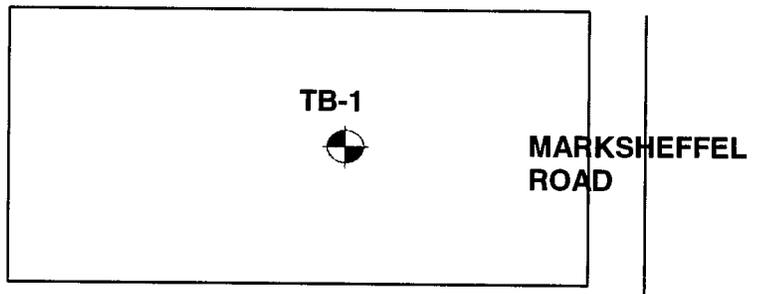
B-1

Soils encountered in the test borings drilled on Lot 2 consisted of sandy clay (CL). The boring was drilled to a depth of 20 feet. Standard Penetration Testing conducted on the clay resulted in N-values of 10 to 16 bpf, indicating firm to stiff consistencies. Moisture content and grain size analysis indicated moisture contents of 6 to 13 percent, with 83.5 percent of the soil particles passing the No. 200 Sieve. An FHA swell test on a sample of sandy clay from a depth of 5 feet resulted in a swell pressure of 890 psf which indicates a low expansion potential.

Groundwater was not encountered in the test boring which was drilled to 20 feet bgs. Groundwater is not expected affect the construction of shallow foundations proposed for this site and deeper excavations for utilities, depending on site grading and depths of excavation. Unstable conditions should be expected where excavations approach the groundwater level. Stabilization using shot rock or geo grids may be necessary. It should be noted that fluctuation in groundwater levels could change due to seasonal variations, changes in land runoff characteristics and future development of nearby areas. Isolated sand layers within the soil profile can carry water in the subsurface. Contractors should be cognizant of the potential for the occurrence of subsurface water during construction.

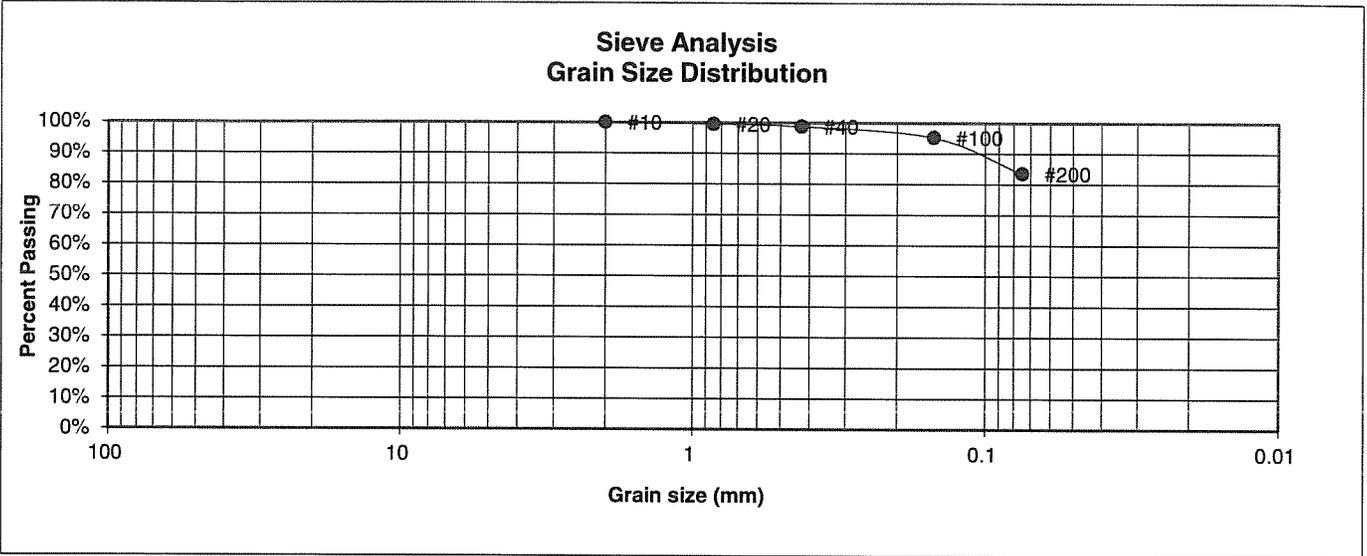
C-1

Swell
 Moisture at start 17.0%
 Moisture at finish 25.1%
 Moisture increase 8.1%
 Initial dry density (pcf) 96
 Swell (psf) 890
