## EL PASO COUNTY CONSTRUCTION STORMWATER SITE INSPECTION REPORT

Facility Name: Cloverleaf	Permittee: Joe Desjarden
Date of Inspection: 10/05/2021	Weather Conditions: Partly Cloudy
Permit Number: ESQ2133	Disturbed Acreage: 38.78/41.36
Phase of Construction: Preconstruction	Site Qualified Stormwater Manager: Larry Lee
Inspector Name: Molly Galloway	Site Contact Info: Rawland Detailing- QSM

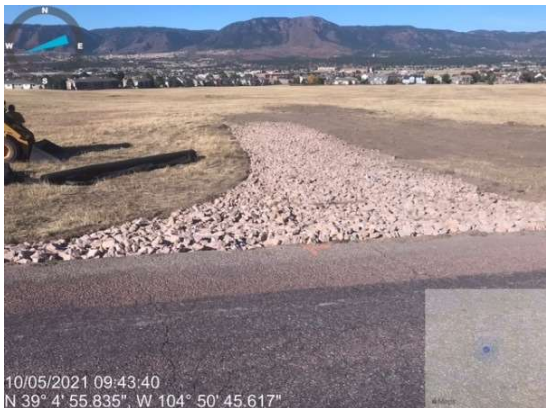
VTC off of Cloverleaf Drive implemented.
