Subject: Geologic Hazards Evaluation and
Preliminary Geotechnical Investigation
Response to El Paso County Review Comments
Grandview Reserve, Phase 1, Filing 1
Eastonville Road and U.S. Highway 24
Falcon, Colorado
CTL|T Project No. CS19345-115

**GEOLOGIC HAZARD EVALUATION AND
PRELIMINARY GEOTECHNICAL INVESTIGATION
GRANDVIEW RESERVE, FILING 1
EASTONVILLE ROAD AND U.S. HIGHWAY 24
FALCON, COLORADO**

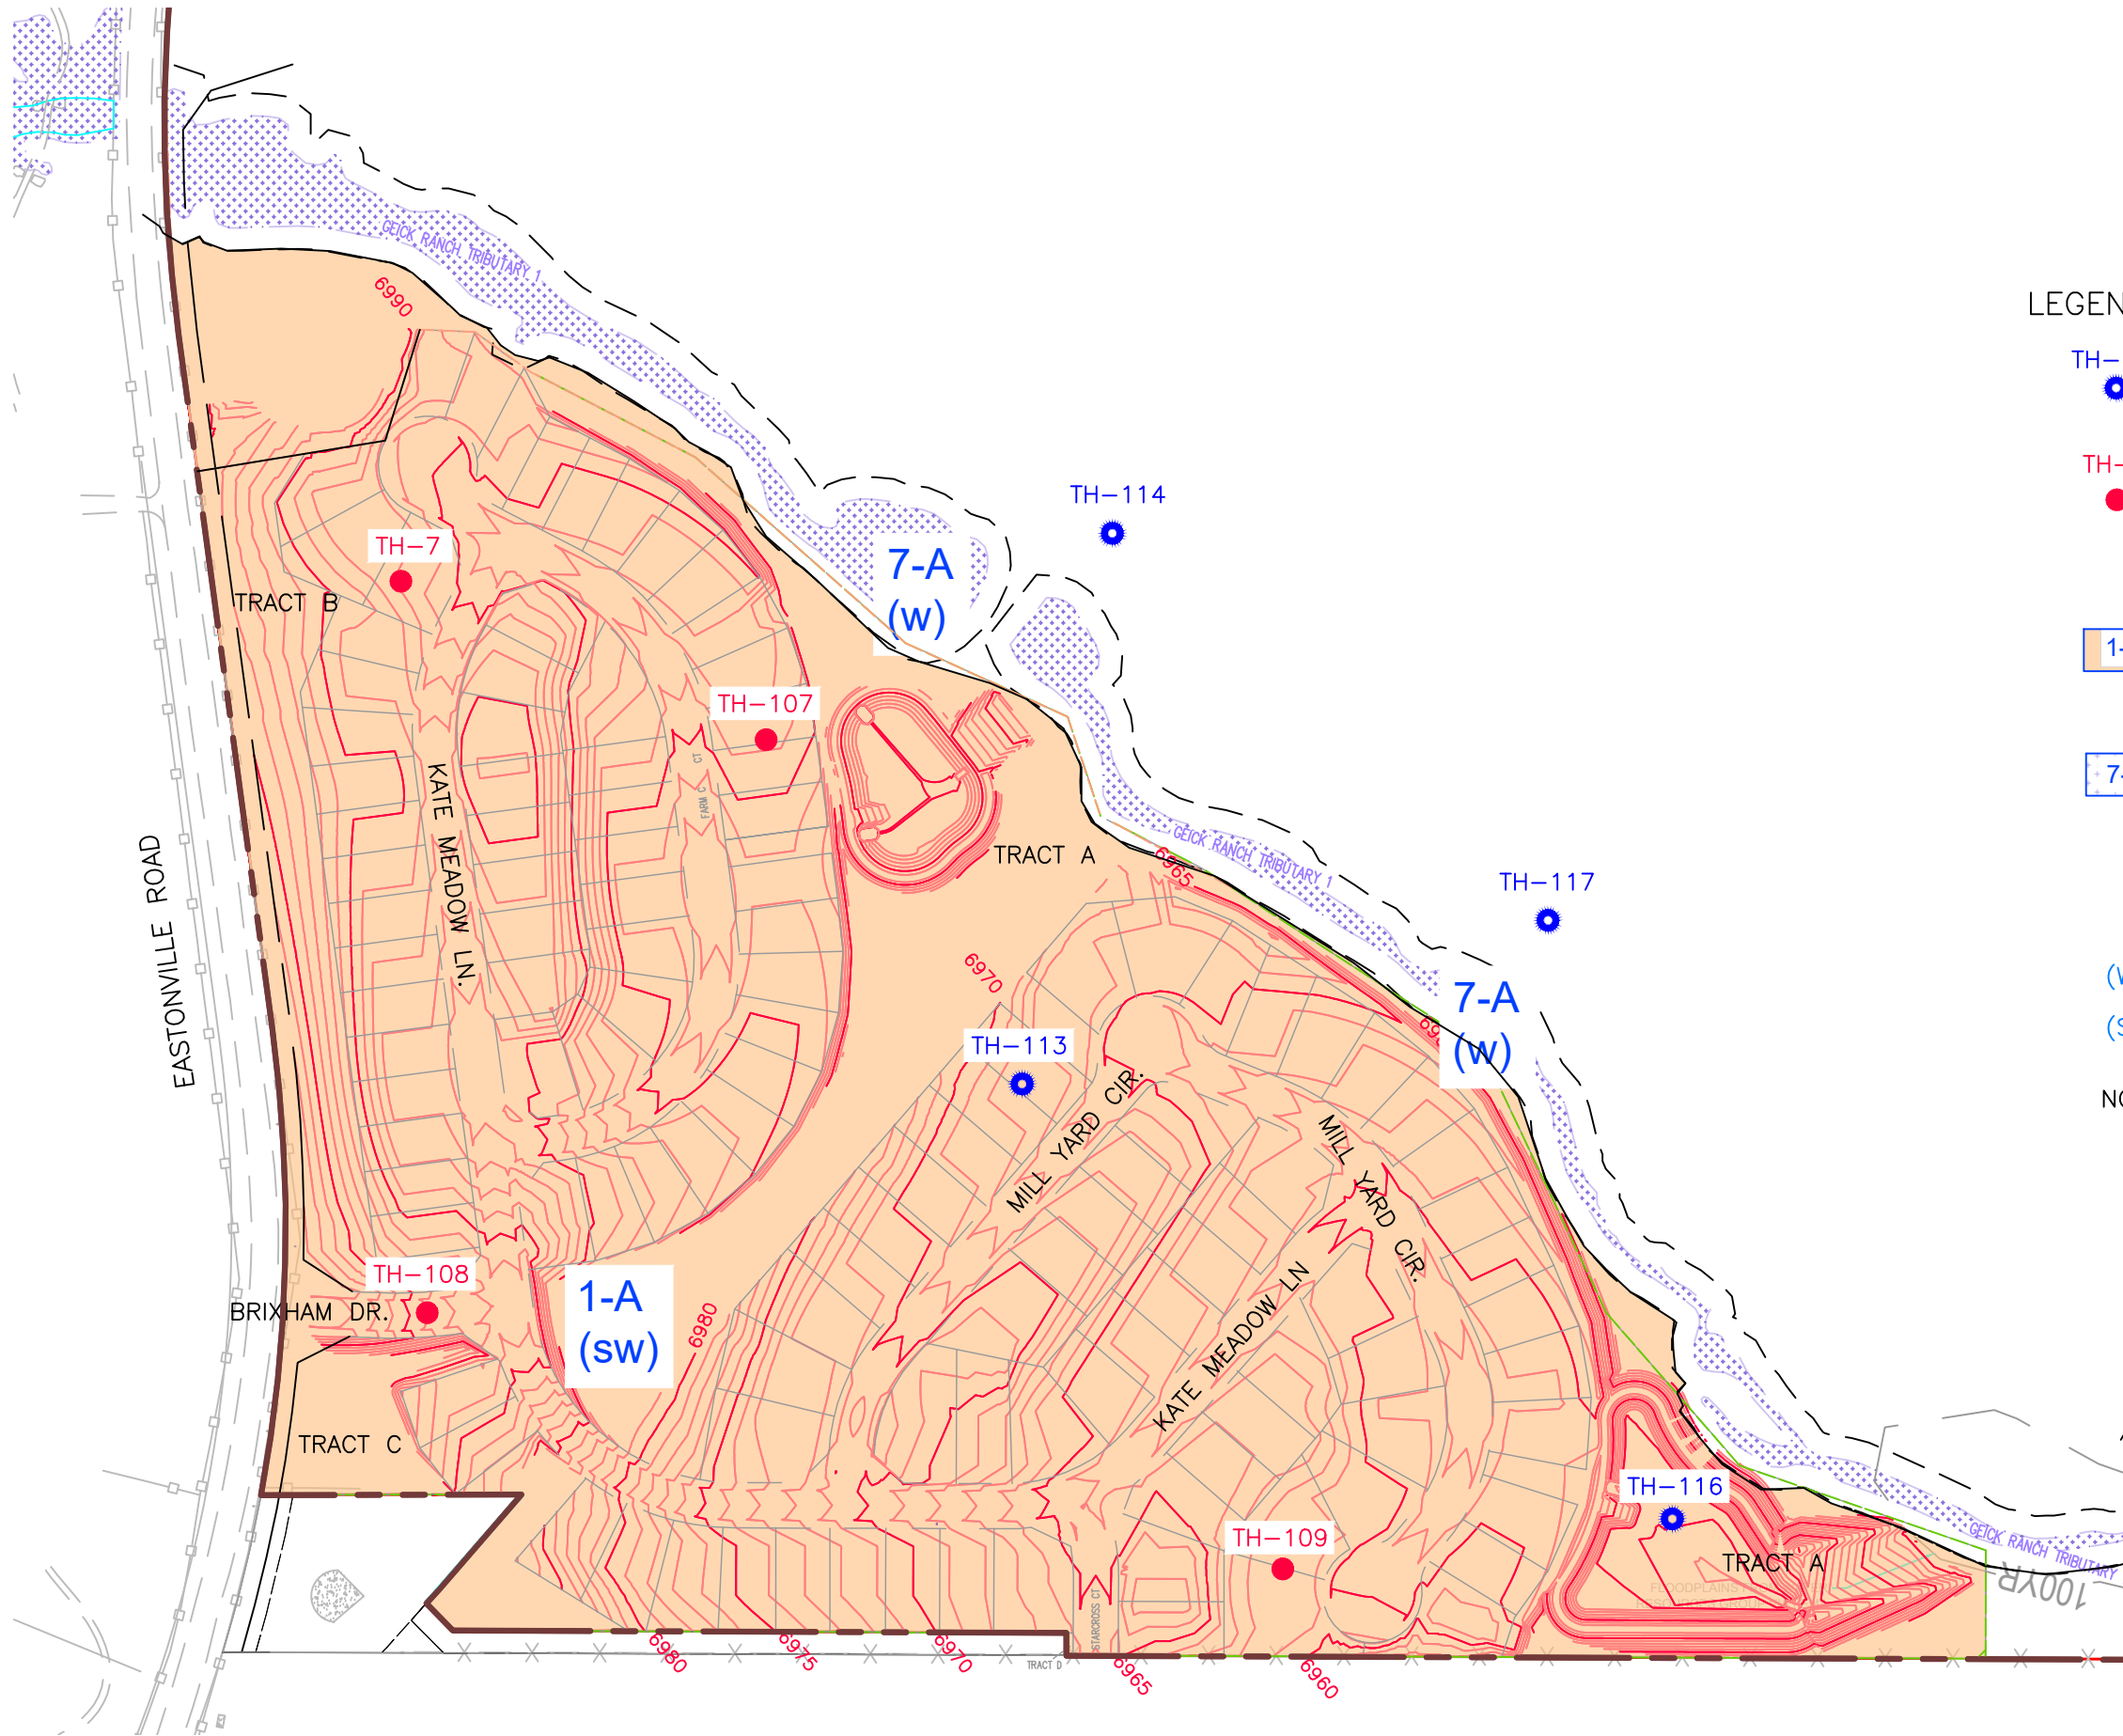
The referenced report contains a figure titled Engineering Geologic Conditions (Fig. 2). The figure indicates areas of the mapped physiographic floodplain and areas of stable alluvium. We also revised Figure 2 (attached) to clarify our interpretation of the engineering geology and to depict where flowing water may be present (in the channel) and where seasonally shallow groundwater is likely (remainder of site). A note is indicated on Figure 2 that states “Expansive soils/bedrock were found sporadically across the site. All lots may be impacted by ground heave. Total calculated ground heave ranged from less than 0.5 inches to 1 inch.” This note was included because the Dawson Formation, which underlies the site at relatively shallow depths, contains interbed-

ded and discontinuous layers of expansive claystone bedrock. This material cannot be mapped with any reasonable degree of accuracy, and it should be expected that expansive claystone may be encountered anywhere on the site. As stated in our report, lot specific soils and foundation investigations should be performed, following completion of overlot grading, to determine where expansive claystone is present and provide recommendations for mitigation.

NOTE: EXPANSIVE SOILS/BEDROCK WERE FOUND SPORADICALLY ACROSS THE SITE. ALL LOTS MAY BE IMPACTED BY GROUND HEAVE. TOTAL CALCULATED GROUND HEAVE RANGED FROM LESS THAN 0.5 INCHES TO 1 INCH. DEPTH TO GROUNDWATER ARE PEAK LEVELS MEASURED IN MONITORING WELLS BETWEEN SEPTEMBER AND NOVEMBER 2023.

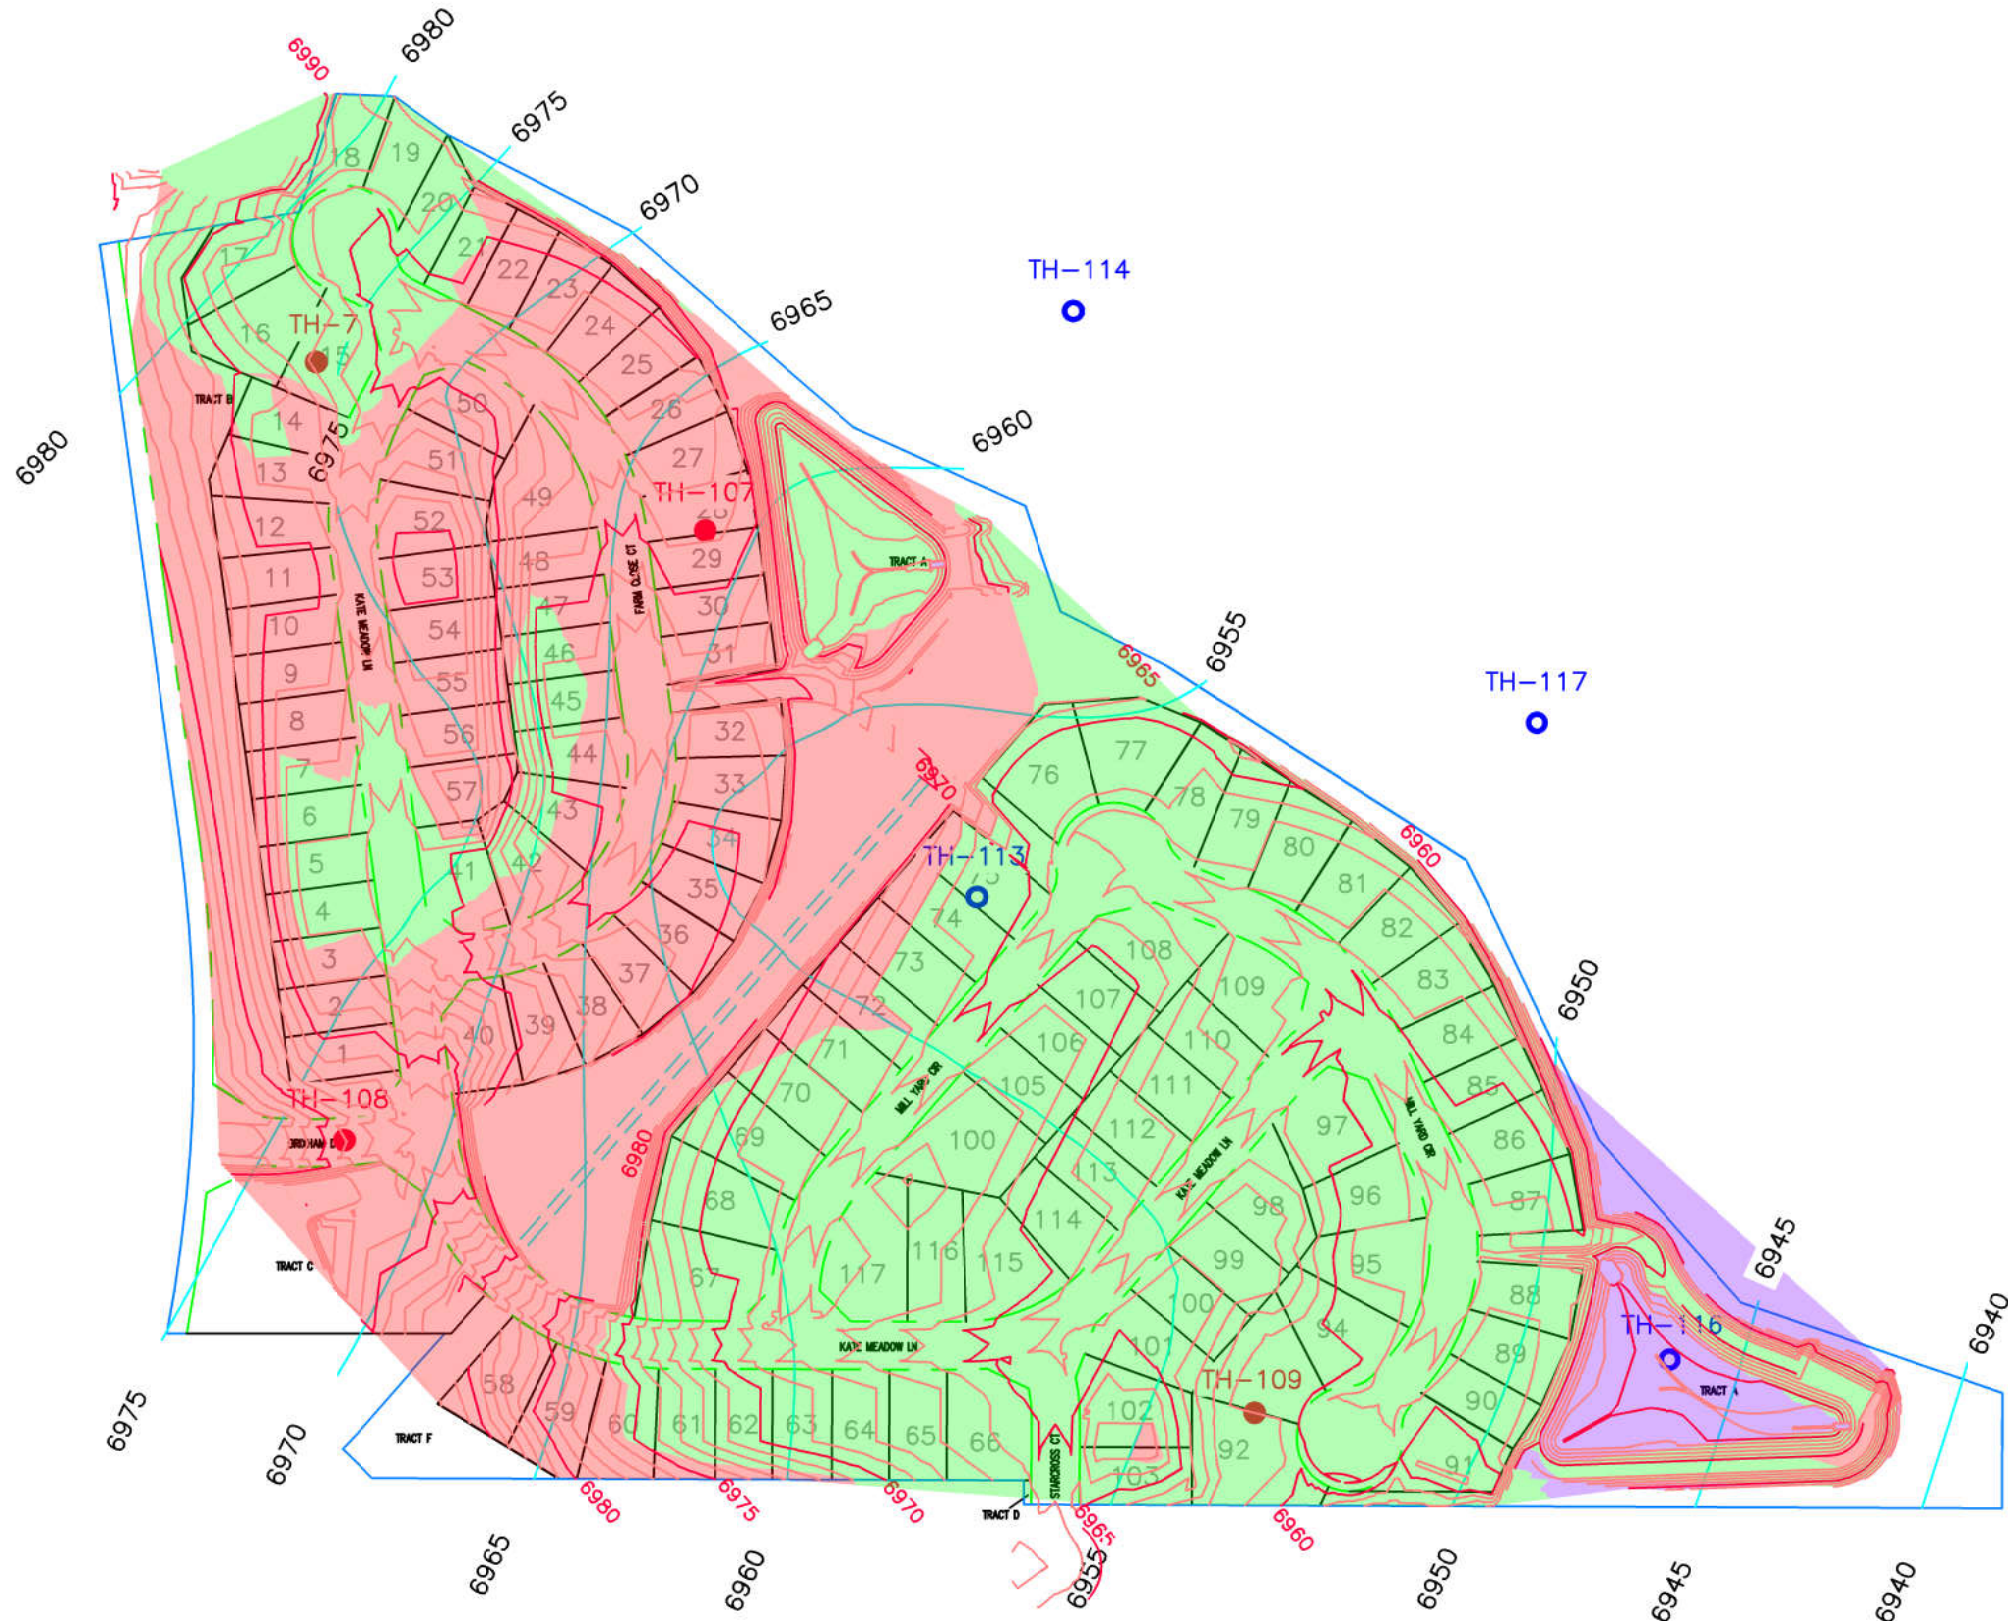
An additional figure attached with this letter, titled Groundwater Conditions (Fig. 3), was updated for Filing 1, based on the current grading plans. The figure provides approximate groundwater elevation contours and heat mapping depicting a range of approximate depths to groundwater below the proposed finish grades. The figure is based on peak groundwater monitoring data recorded in monitoring wells between July 2023 and May 2024. We also provided an updated figure attached to this letter titled Basement Construction Recommendations (Fig. 4), that depicts lots in Filing 1 that are unsuitable for basement construction based on our groundwater data and analysis.

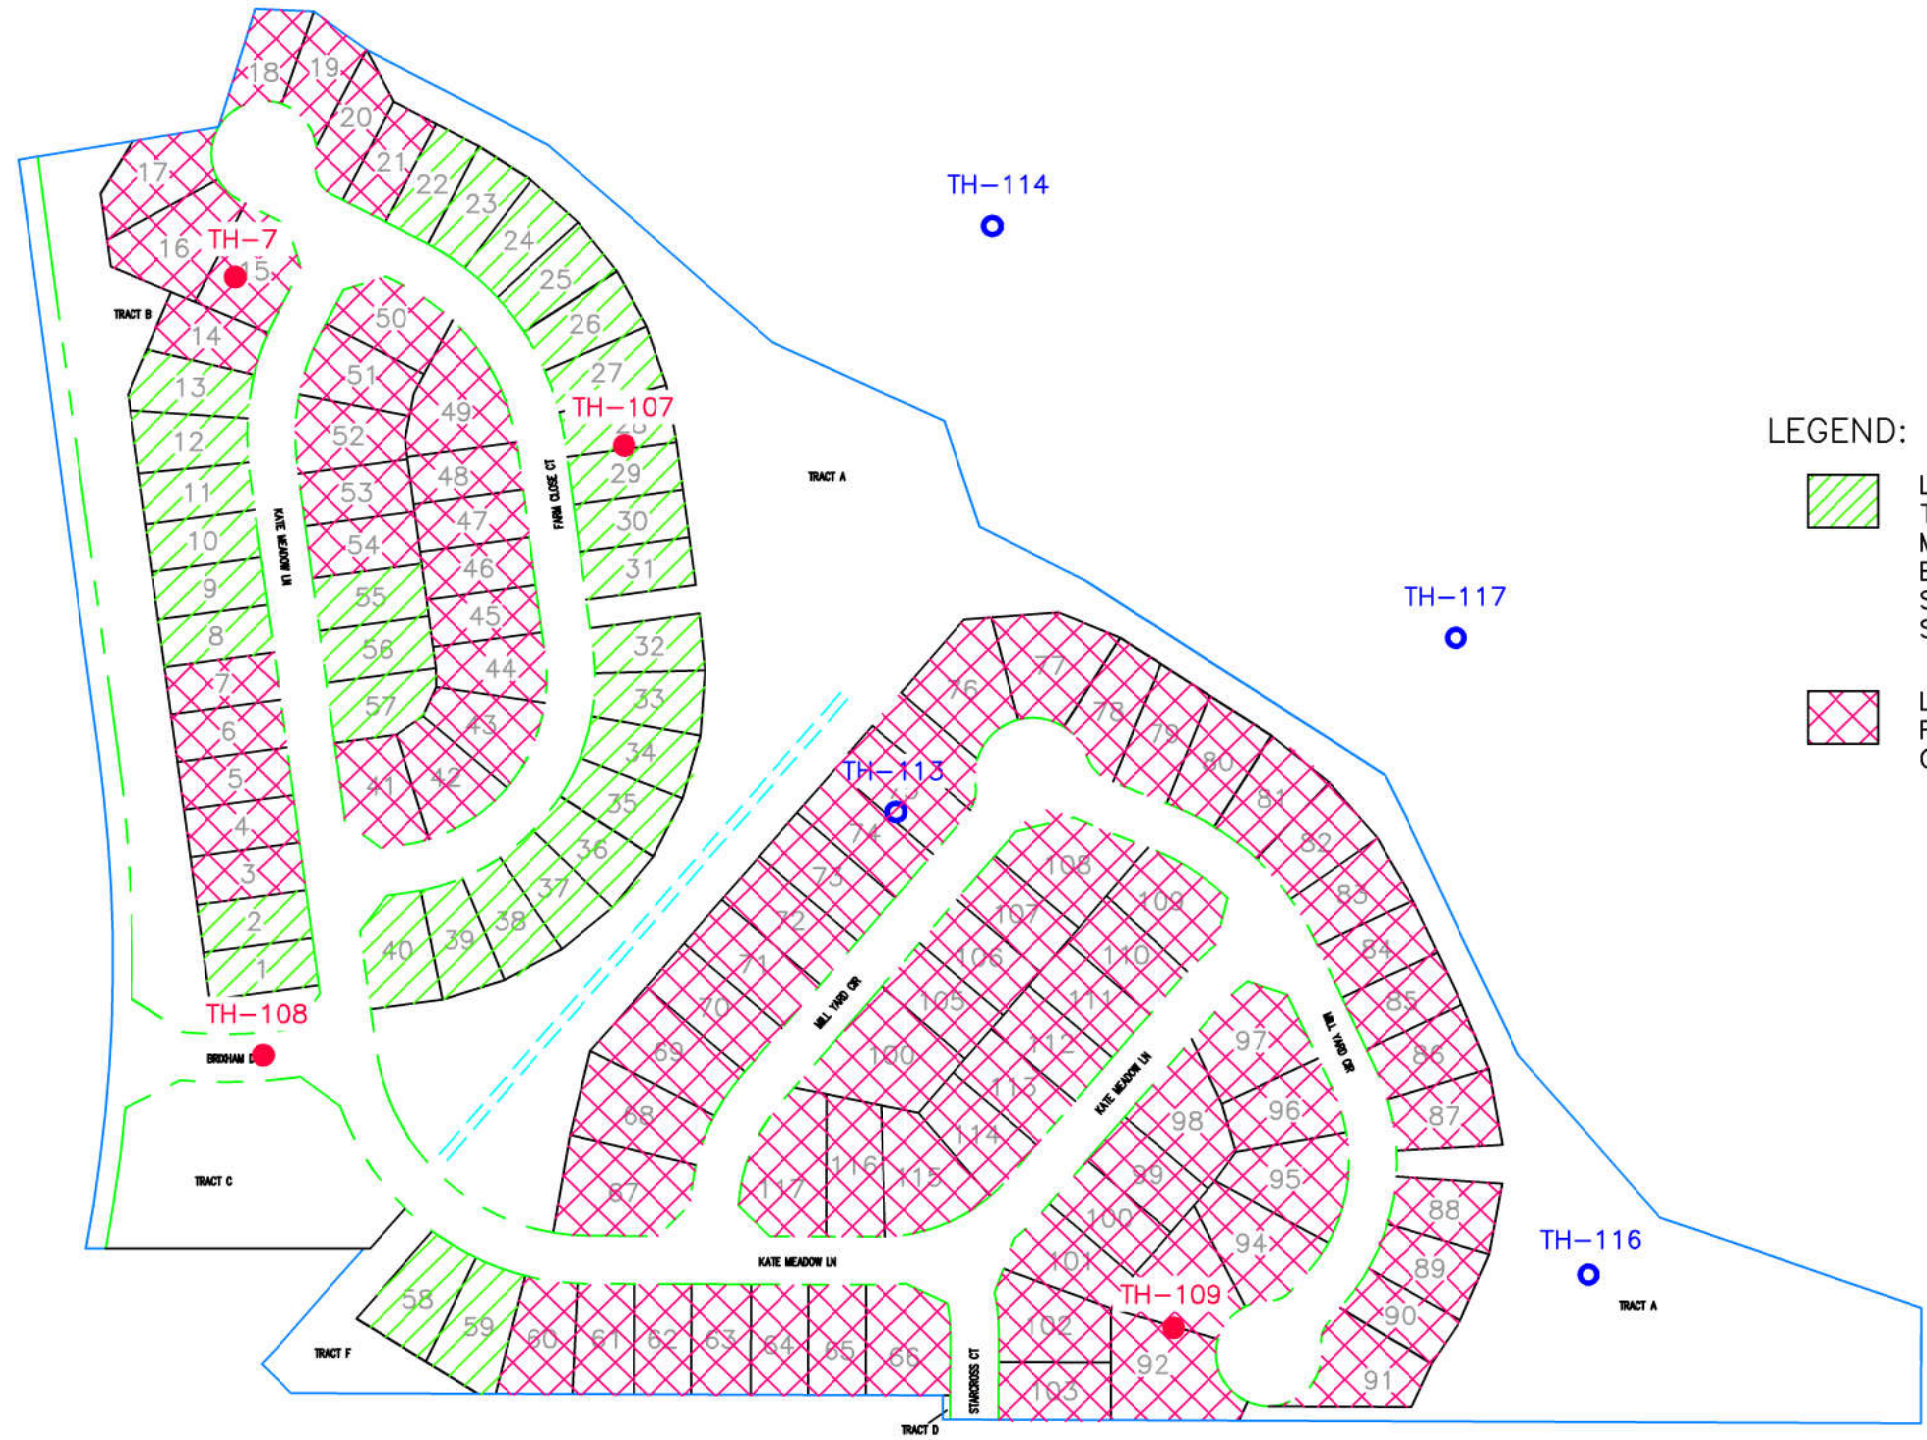
LOT WHERE GROUNDWATER IS EXPECTED TO BE WITHIN 12 FEET OF THE PROPOSED SURFACE. BASEMENTS ARE CURRENTLY RESTRICTED.

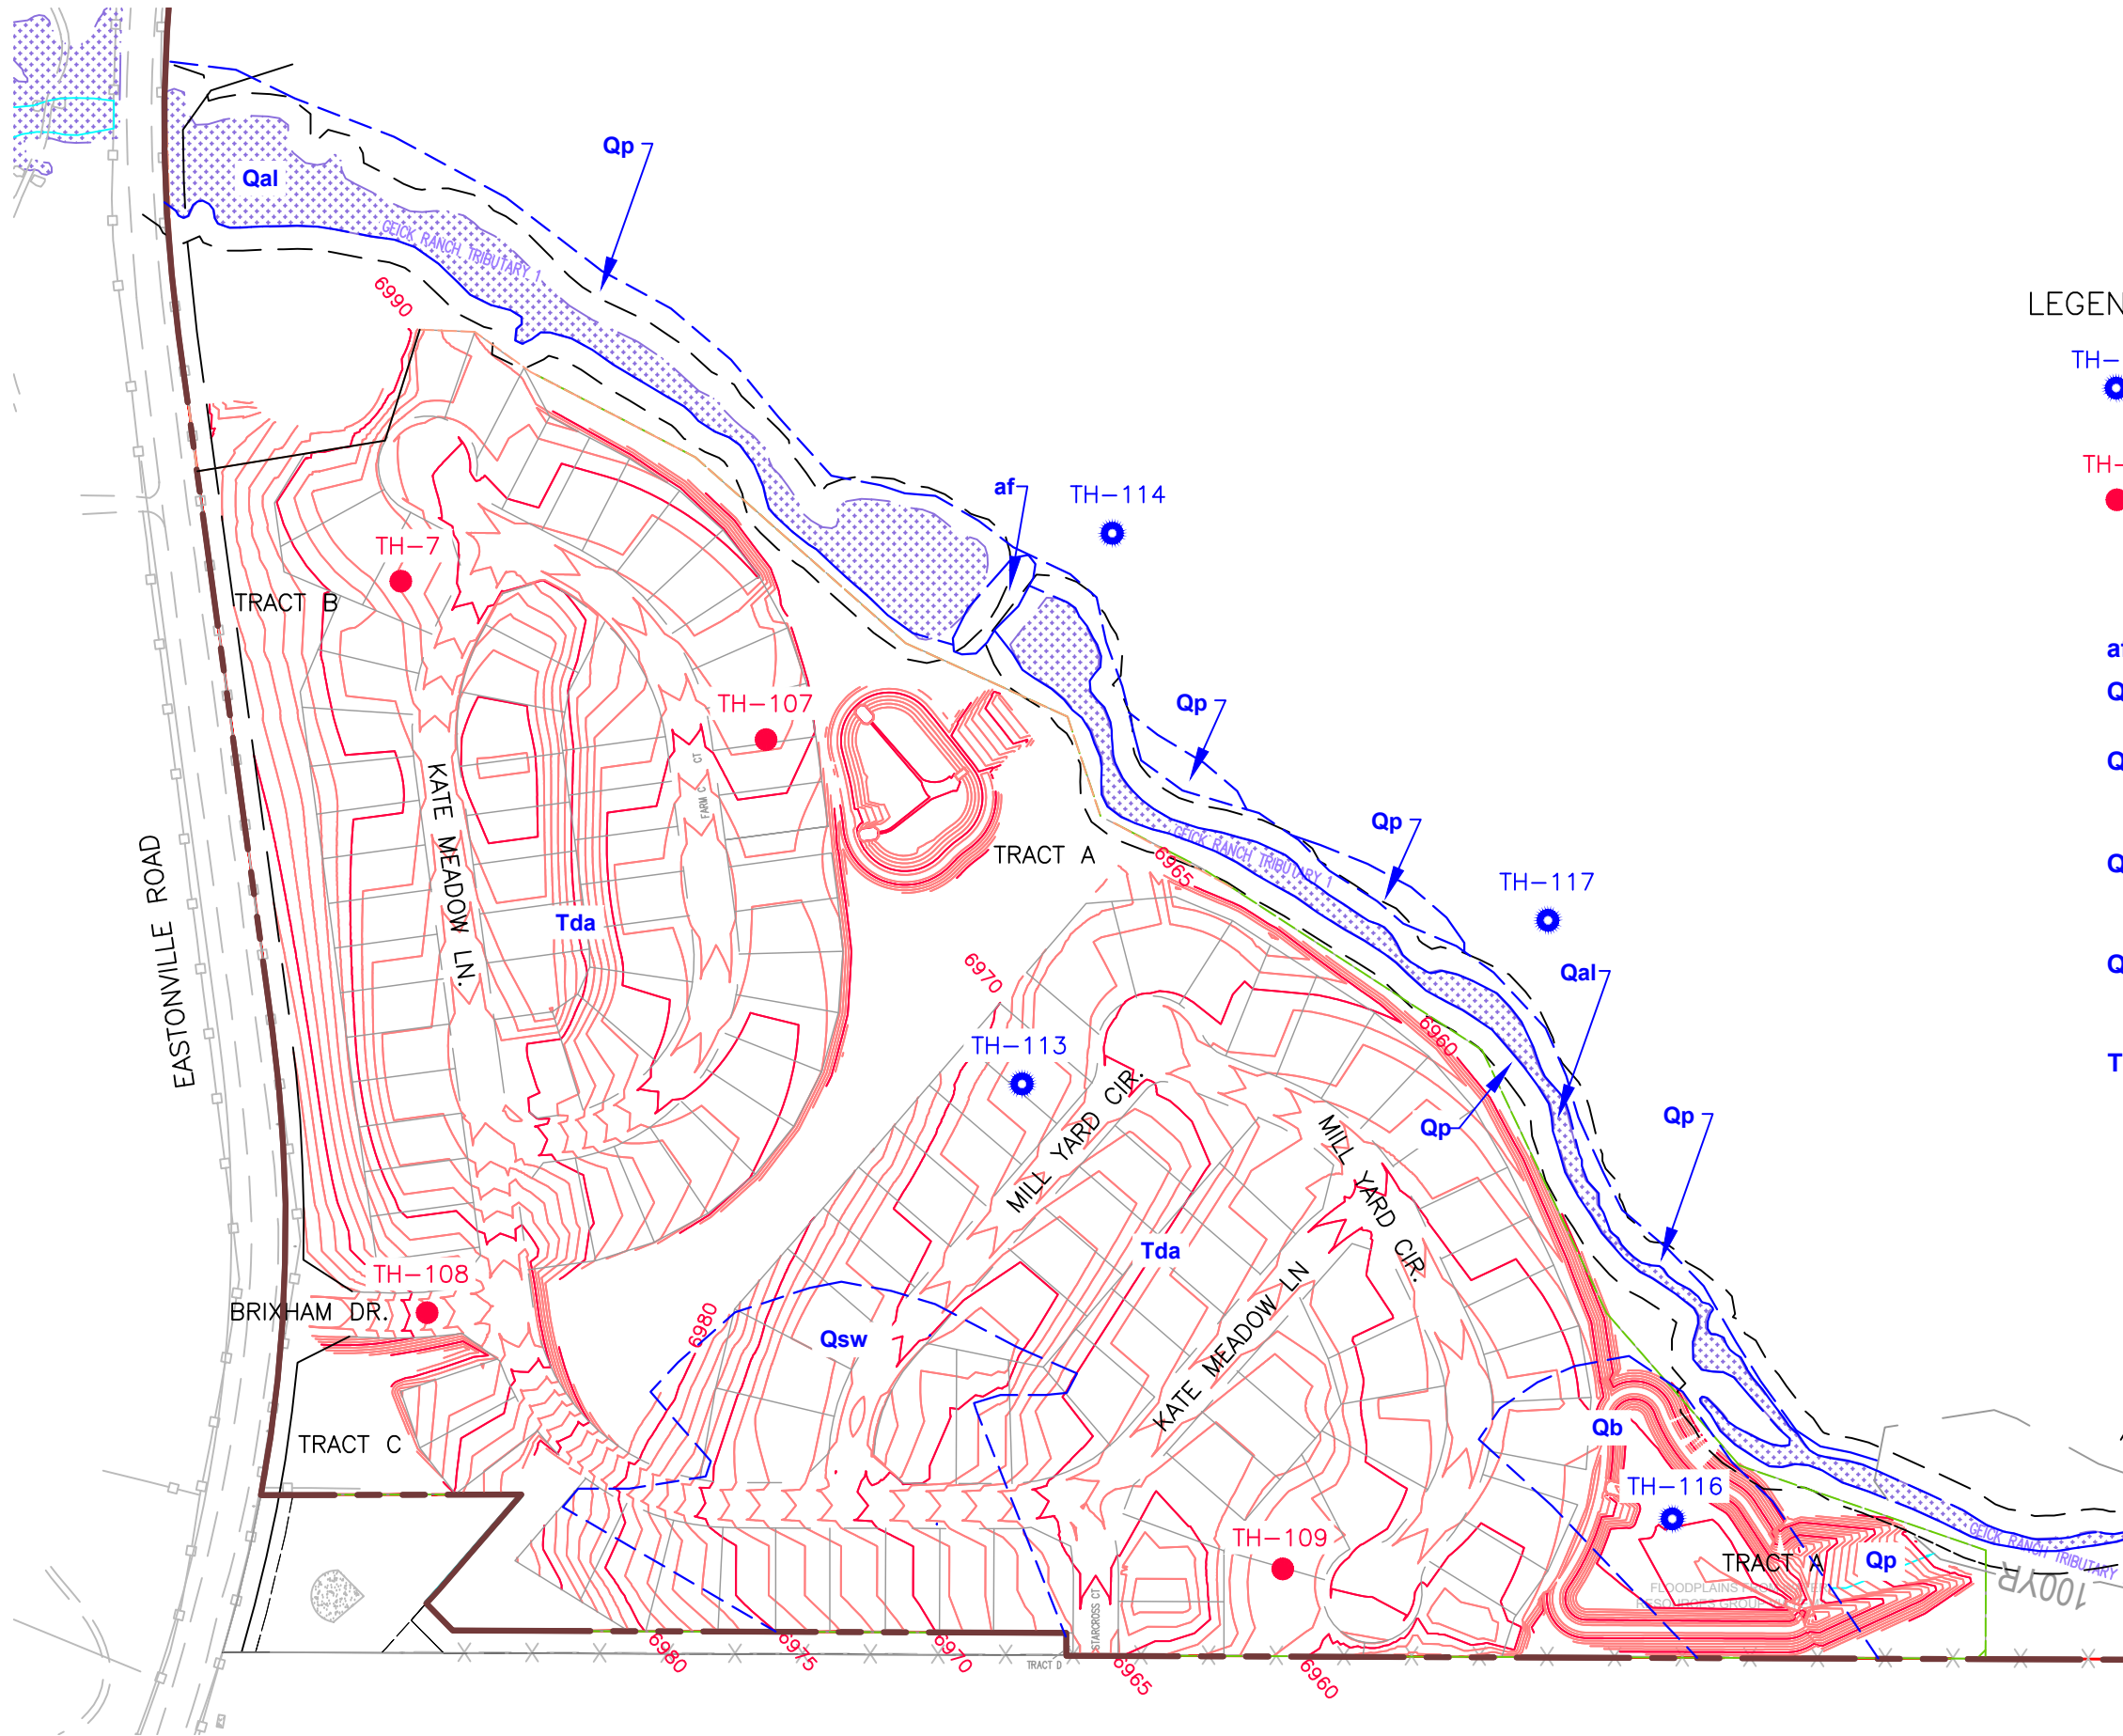
We have included a new figure attached with this letter, titled Surficial Geologic Conditions (Fig. 5), that delineates surficial geologic units across the site based on mapping and site reconnaissance. Considering the variability within the Dawson Formation, a detailed map of subsurface conditions beyond the surficial geology that is mapped in Fig. 5, cannot be produced. Additionally, the remaining geologic hazards presented in the report such as hard bedrock, seismicity, erosion, and radon/radioactivity cannot be mapped. These are generally regional hazards and it isn't possible to delineate the extents of each of the geologic hazards on every site. Attempting to do so would falsely suggest that these hazards may be possible in portions of the site and not possible in other portions of the site. A discussion of these hazards is provided in the referenced report.

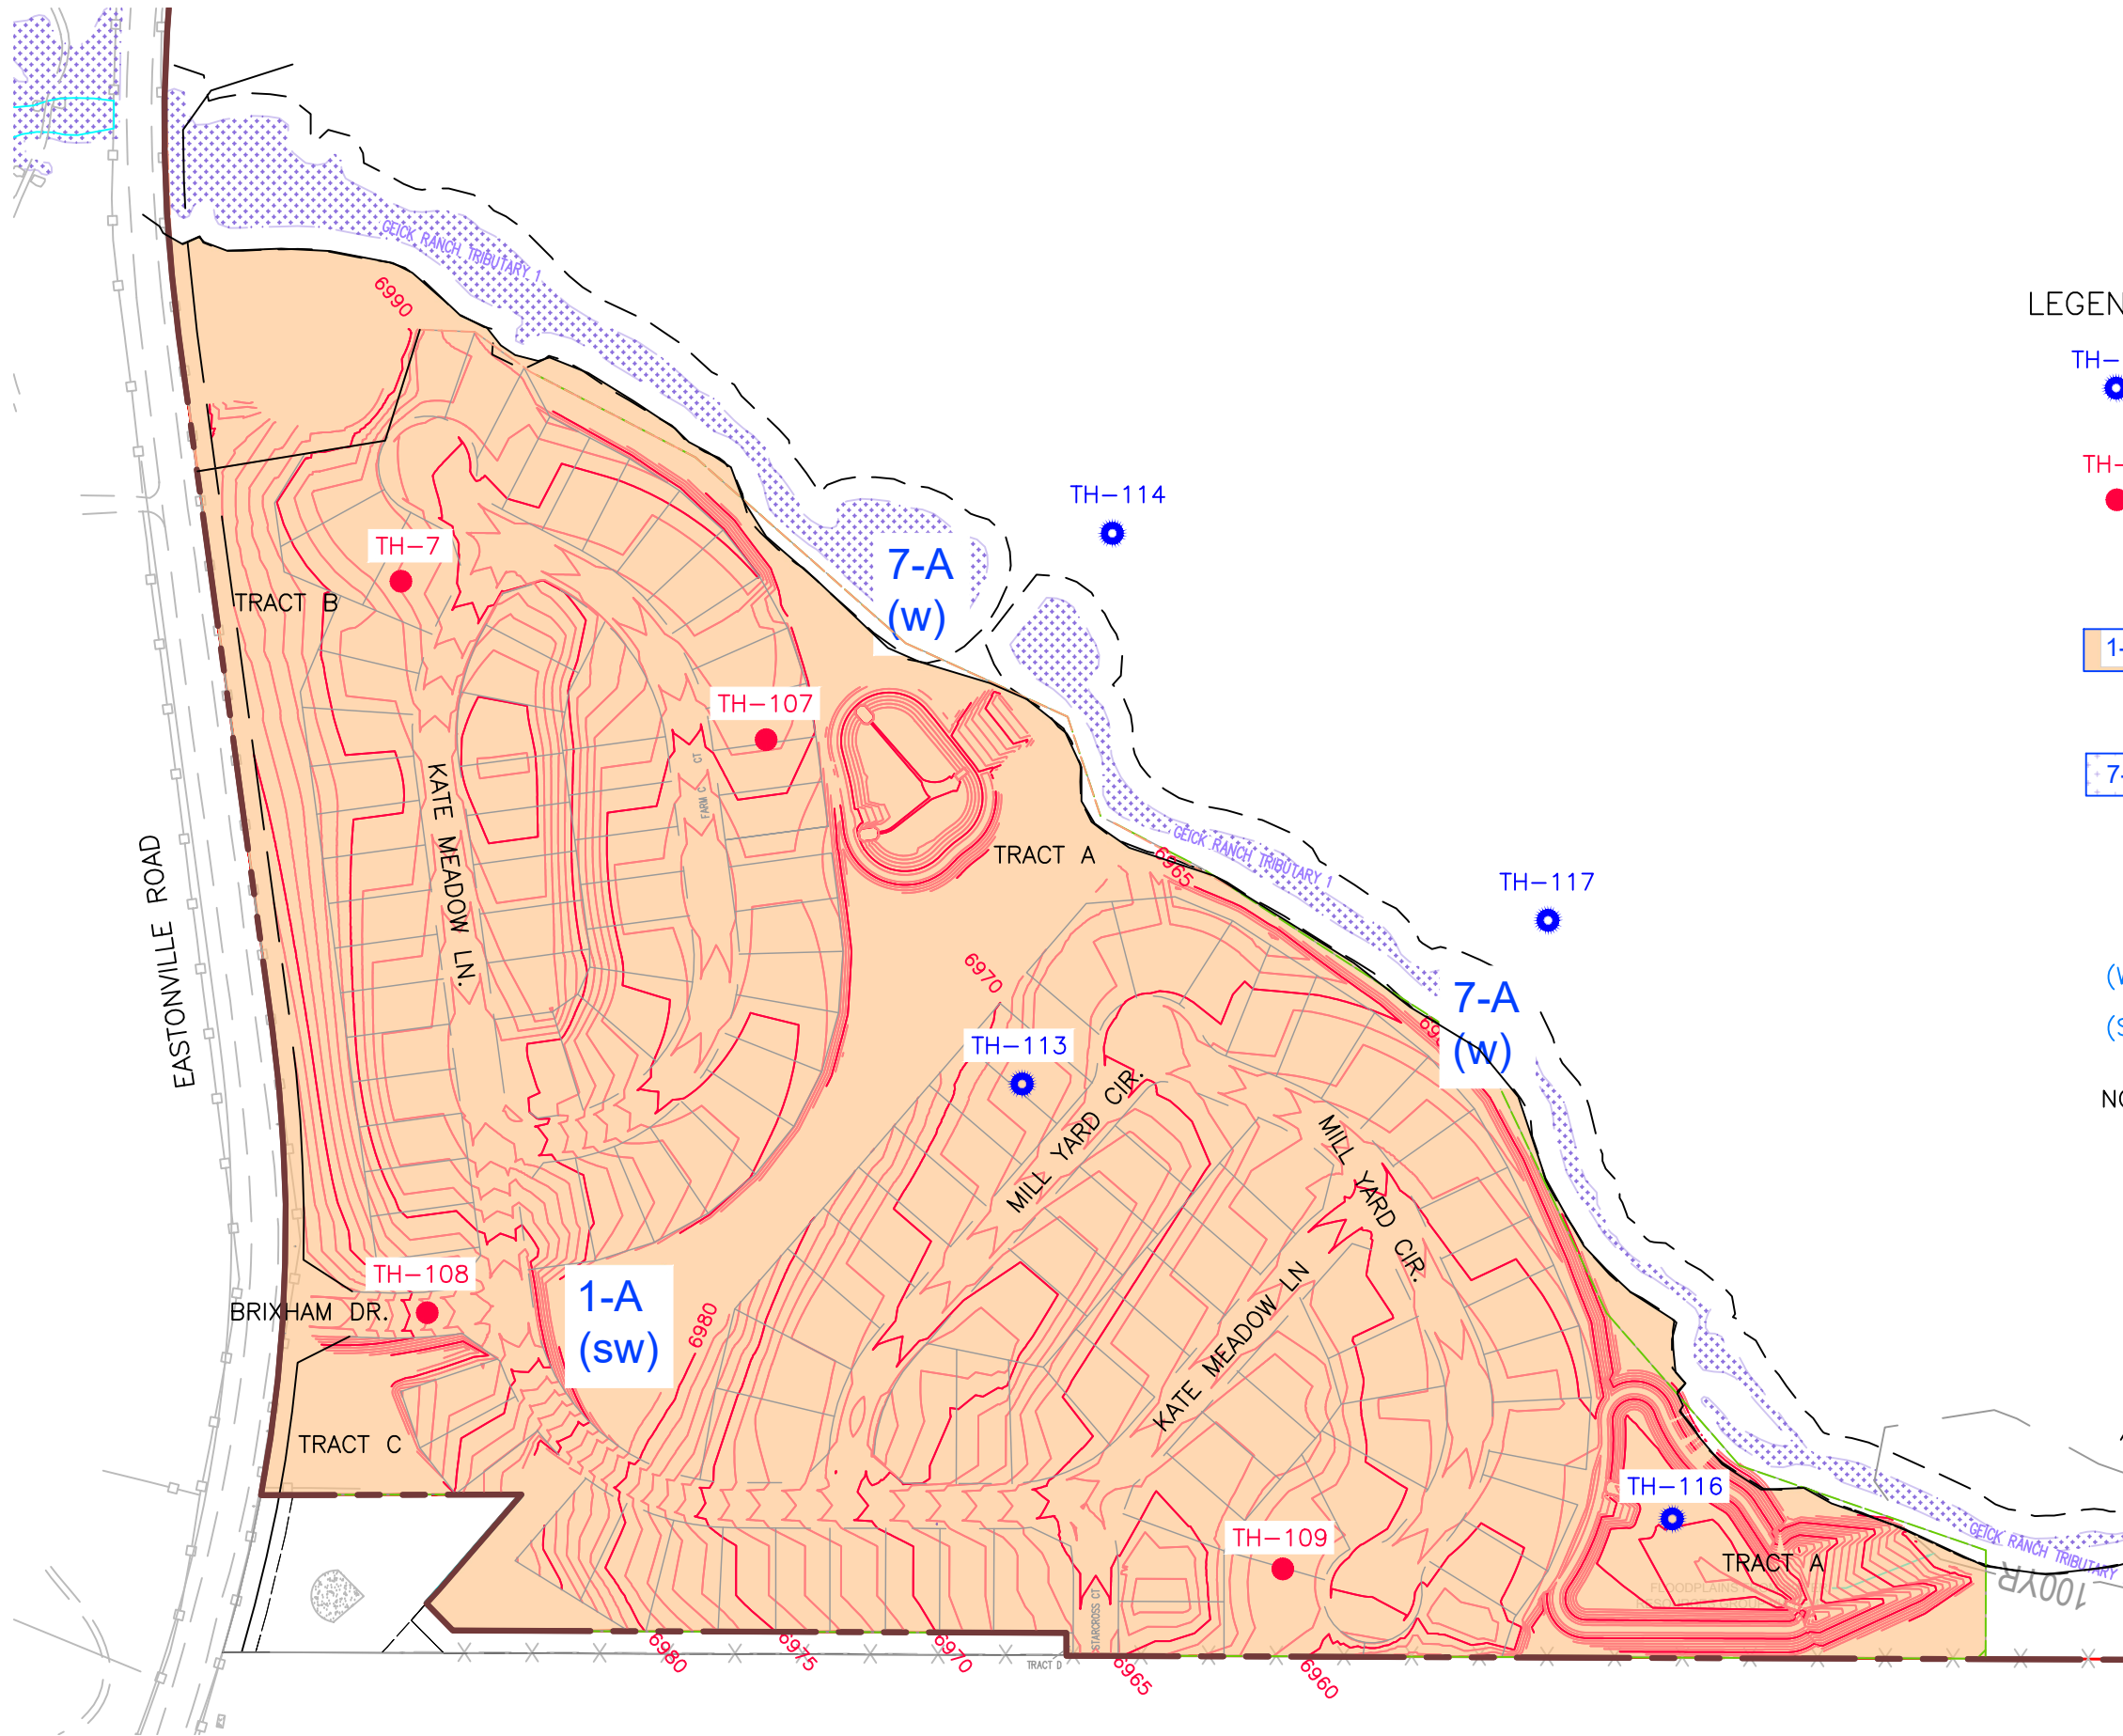
The referenced report contains a figure titled Engineering Geologic Conditions (Fig. 2). The figure indicates areas of the mapped physiographic floodplain and areas of stable alluvium. We also revised Figure 2 (attached) to clarify our interpretation of the engineering geology and depict where flowing water may be present (in the channel) and where seasonally shallow groundwater is likely (remainder of site). A note is indicated on Figure 2 that states “Expansive soils/bedrock were found sporadically across the site. All lots may be impacted by ground heave. Total calculated ground heave ranged from less than 0.5 inches to 1 inch.” This note was included because the Dawson Formation, which underlies the site at relatively shallow depths, contains interbedded and discontinuous layers of expansive claystone bedrock. This material cannot be

mapped with any reasonable degree of accuracy, and it should be expected that expansive claystone may be encountered anywhere on the site. As stated in our report, lot specific soils and foundation investigations should be performed, following completion of overlot grading, to determine where expansive claystone is present and provide recommendations for mitigation.

NOTE: EXPANSIVE SOILS/BEDROCK WERE FOUND SPORADICALLY ACROSS THE SITE. ALL LOTS MAY BE IMPACTED BY GROUND HEAVE. TOTAL CALCULATED GROUND HEAVE RANGED FROM LESS THAN 0.5 INCHES TO 1 INCH. DEPTH TO GROUNDWATER ARE PEAK LEVELS MEASURED IN MONITORING WELLS BETWEEN SEPTEMBER AND NOVEMBER 2023.

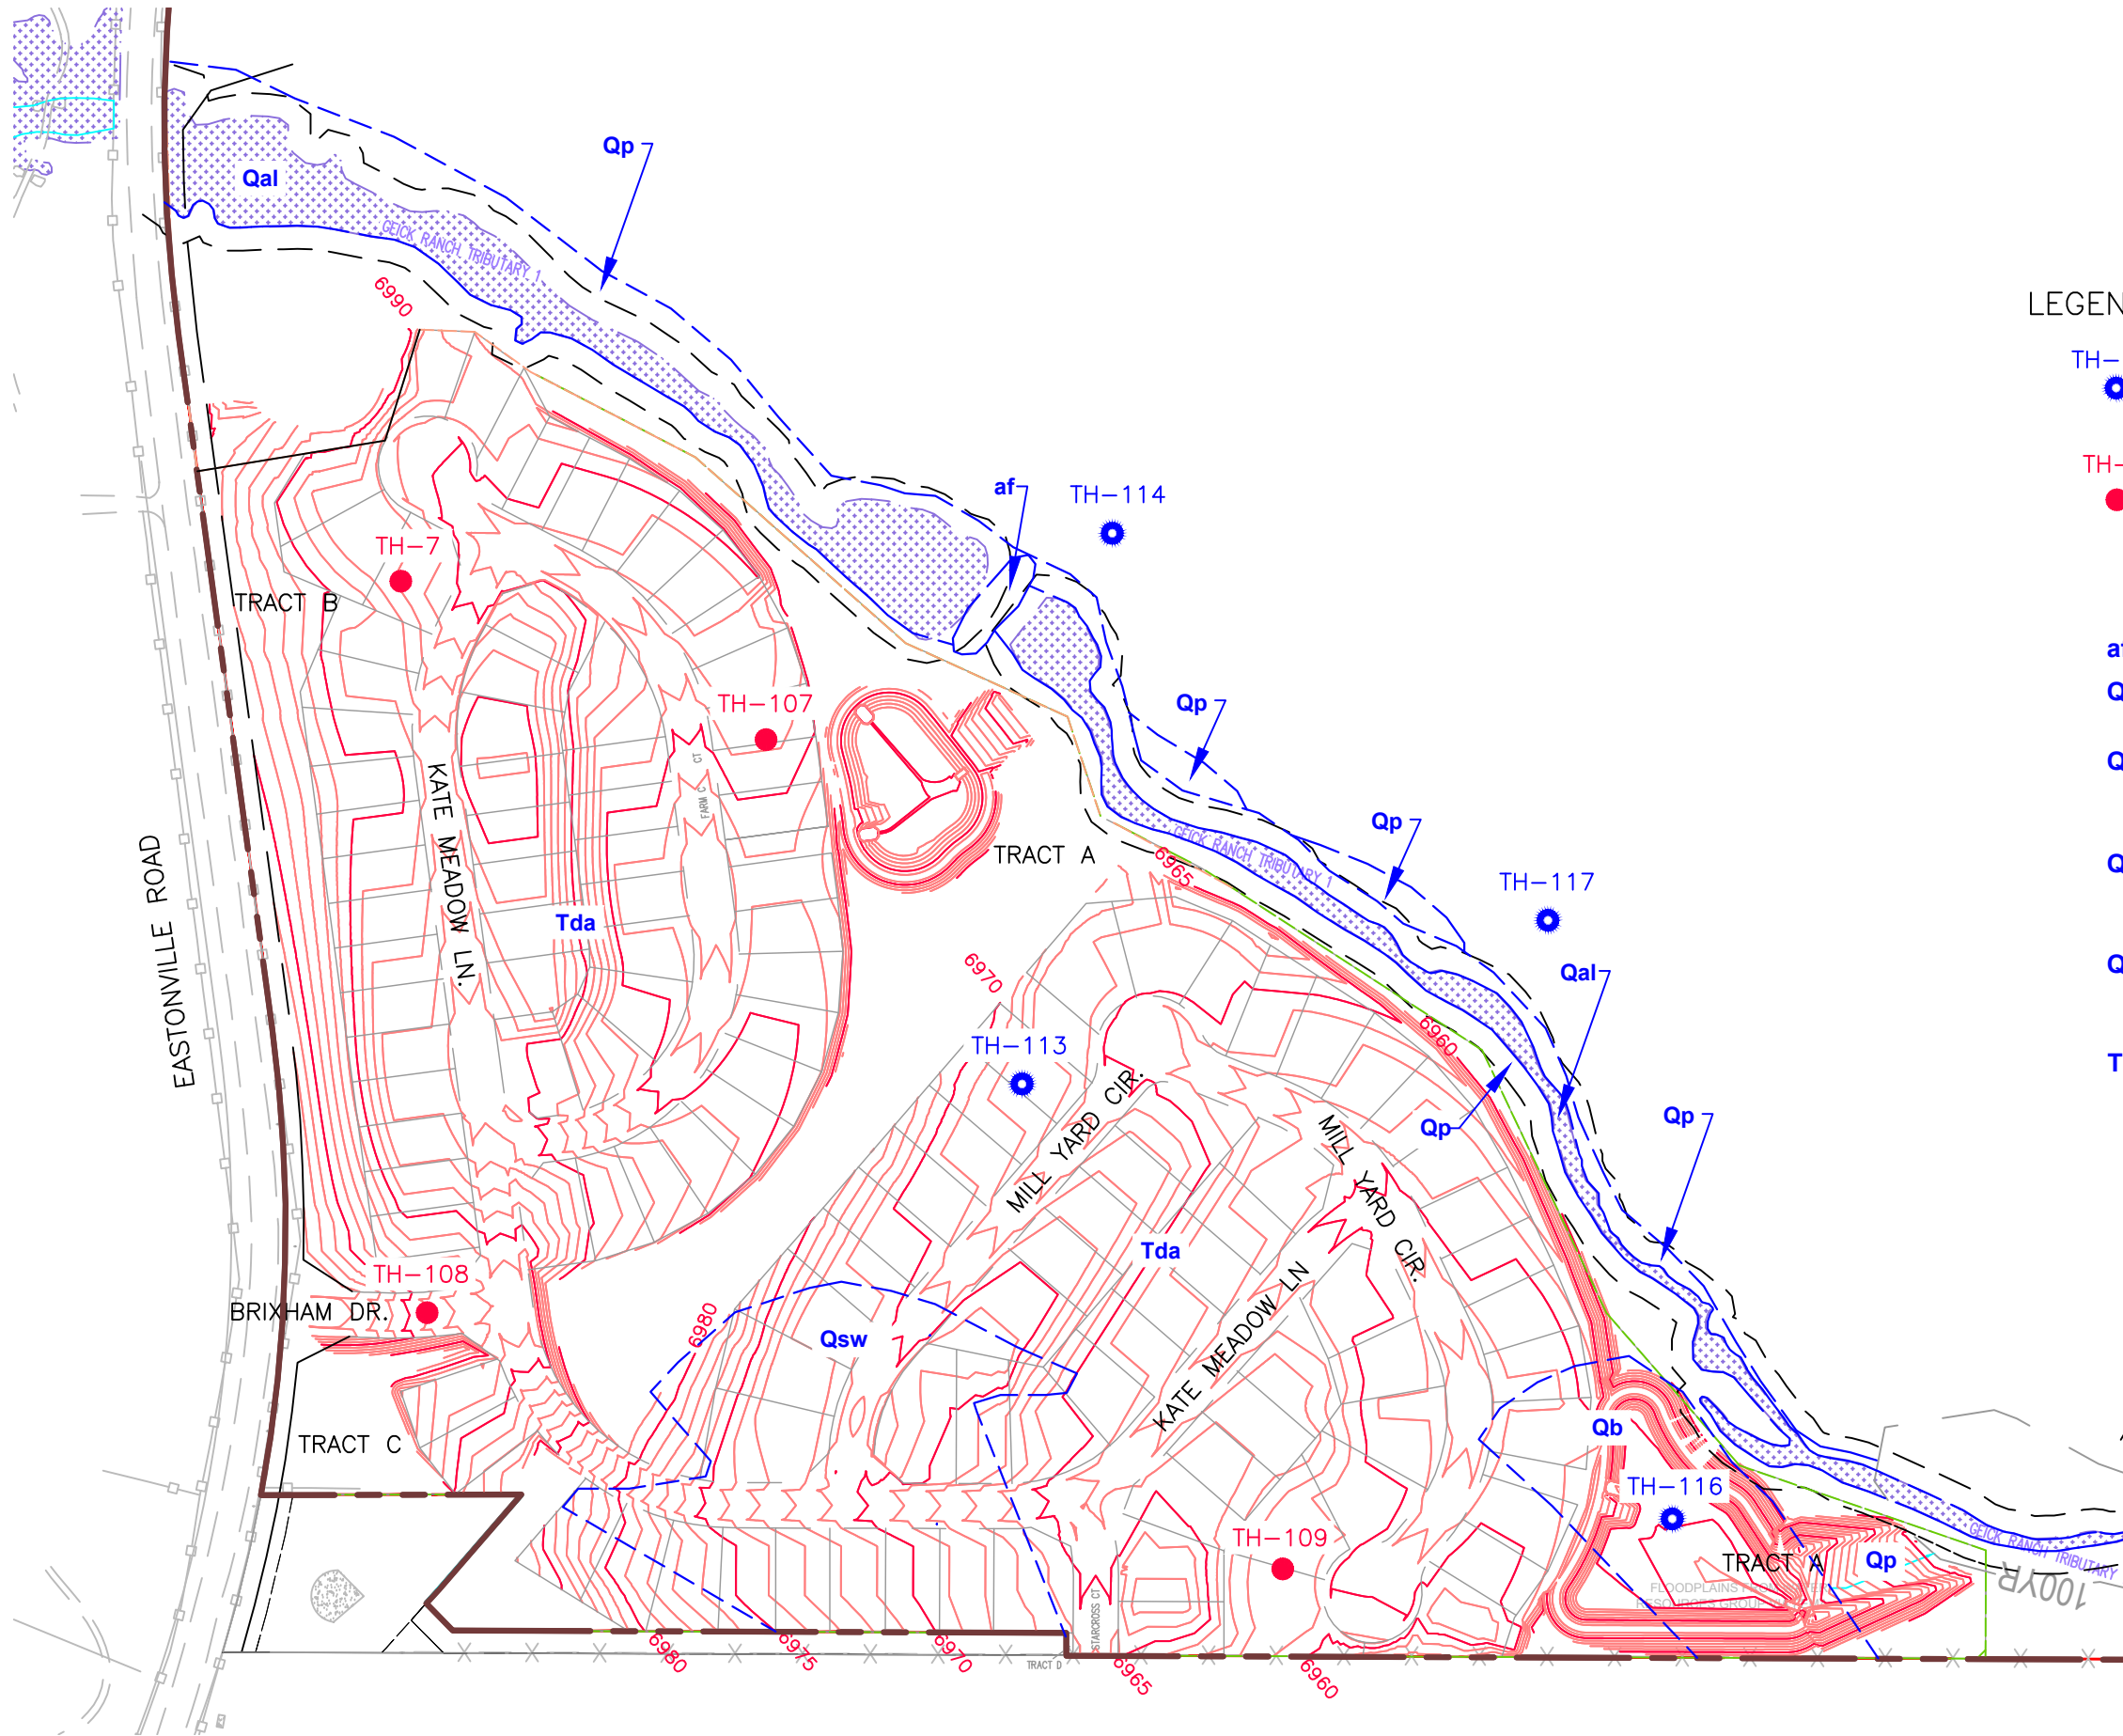
We have included a new figure attached with this letter, titled Surficial Geologic Conditions (Fig. 5), that delineates surficial geologic units across the site based on mapping and site reconnaissance. Considering the variability within the Dawson Formation, a detailed map of subsurface conditions beyond the surficial geology that is mapped in Fig. 5, cannot be produced. Additionally, the remaining geologic hazards presented in the report such as hard bedrock, seismicity, erosion, and radon/radioactivity cannot be mapped. These are generally regional hazards and it isn't possible to delineate the extents of each of the geologic hazards on every site. Attempting to do so would falsely suggest that these hazards may be possible in portions of the site and not possible in other portions of the site. A discussion of these hazards is provided in the referenced report.
