Subject: Geologic Hazards Evaluation and
Preliminary Geotechnical Investigation
Response to El Paso County Review Comments
Grandview Reserve, Phase 1, Filing 1
Eastonville Road and U.S. Highway 24
Falcon, Colorado
CTL|T Project No. CS19345-115

**GEOLOGIC HAZARD EVALUATION AND
PRELIMINARY GEOTECHNICAL INVESTIGATION
GRANDVIEW RESERVE, FILING 1
EASTONVILLE ROAD AND U.S. HIGHWAY 24
FALCON, COLORADO**

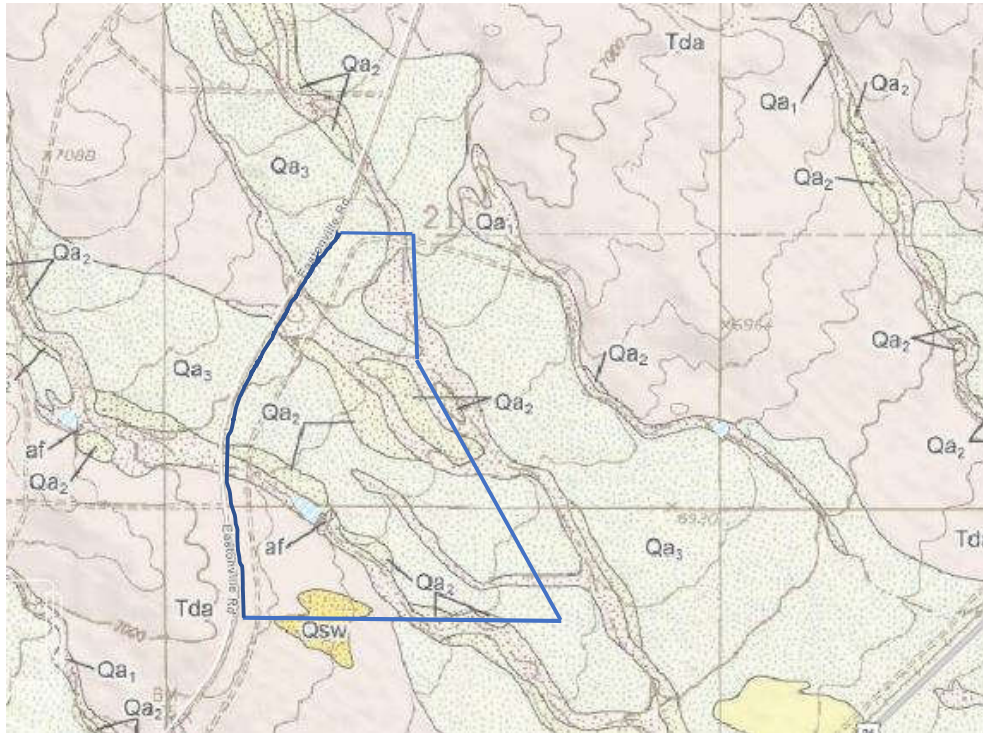
Excerpt from Falcon Quadrangle Geologic Map, El Paso County, Colorado, 2012.

The predominant geologic unit at the site Quaternary-age Alluvium (Qa₁, Qa₂, and Qa₃). The alluvium consists of poorly to well sorted, poorly to moderately consolidated, silt, sand, gravel, and minor clay along active stream channels and terraces. Artificial fill (af) is mapped at the location of a small earthen dam. A portion of the southwestern corner of the site is mapped as Dawson Formation bedrock (Tda). The Dawson Formation consists of white to tan, thick to massive, cross-bedded arkoses, pebbly arkoses, and arkosic pebble conglomerates. The Dawson Formation in the site area is predominantly sandstone with sparse interbeds of thin-bedded gray claystone and sandy claystone. The bedrock underlies the surficial alluvium throughout the site. Conditions at the site were found to be similar to the mapped conditions.

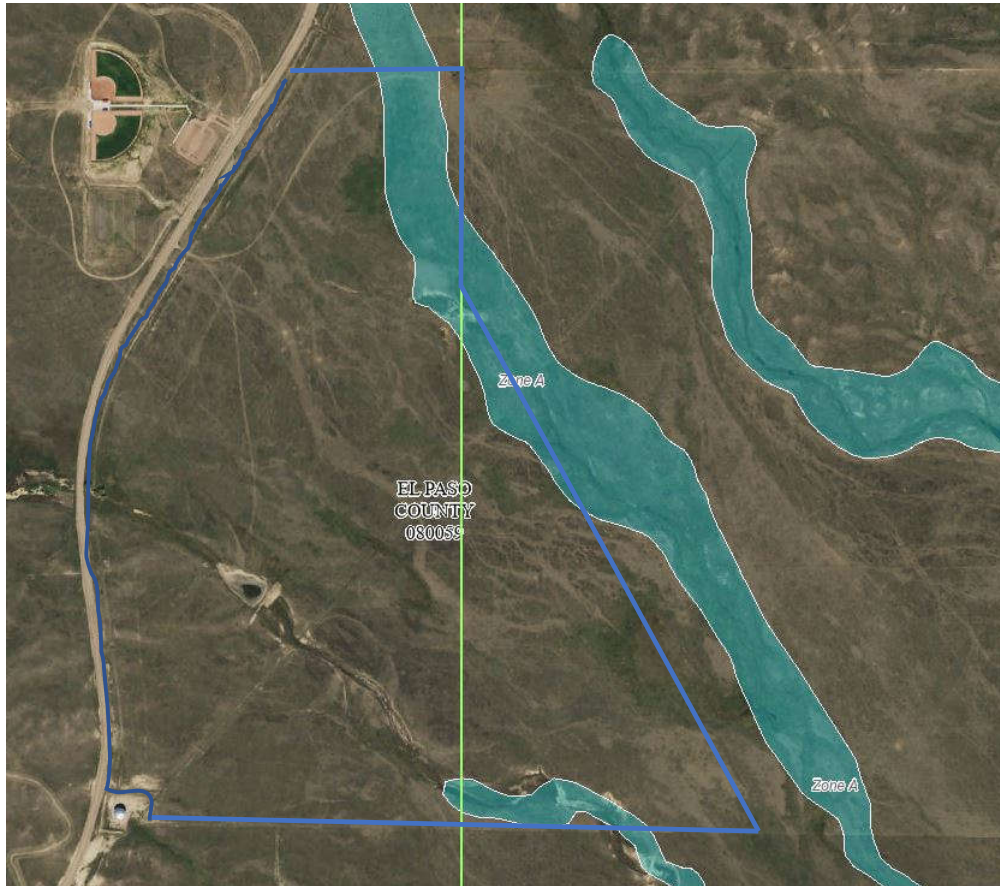
Excerpt from FEMA National Flood Hazard Layer Viewer

The majority of the site lies within Zone D (undetermined flood hazard) as shown on FIRM Community Map Numbers 08041C0552G and 08041C0556G, revised December 7, 2018. Zone D indicates floods are possible, but not likely. Some portions of the site within drainage areas lie within Zone A as shown below.

Based on the topography at the site the potential for a flood to impact the majority of the site area is low. During peak precipitation events, some accumulation of surface sheet flow in drainages is expected with possible inundation within the Zone A areas. Development will increase the relative area of impervious surfaces, which can lead to drainage problems and erosion if surface water flow is not adequately designed. Surface drainage design and evaluation of flood potential should be performed by a civil engineer as part of the project design.

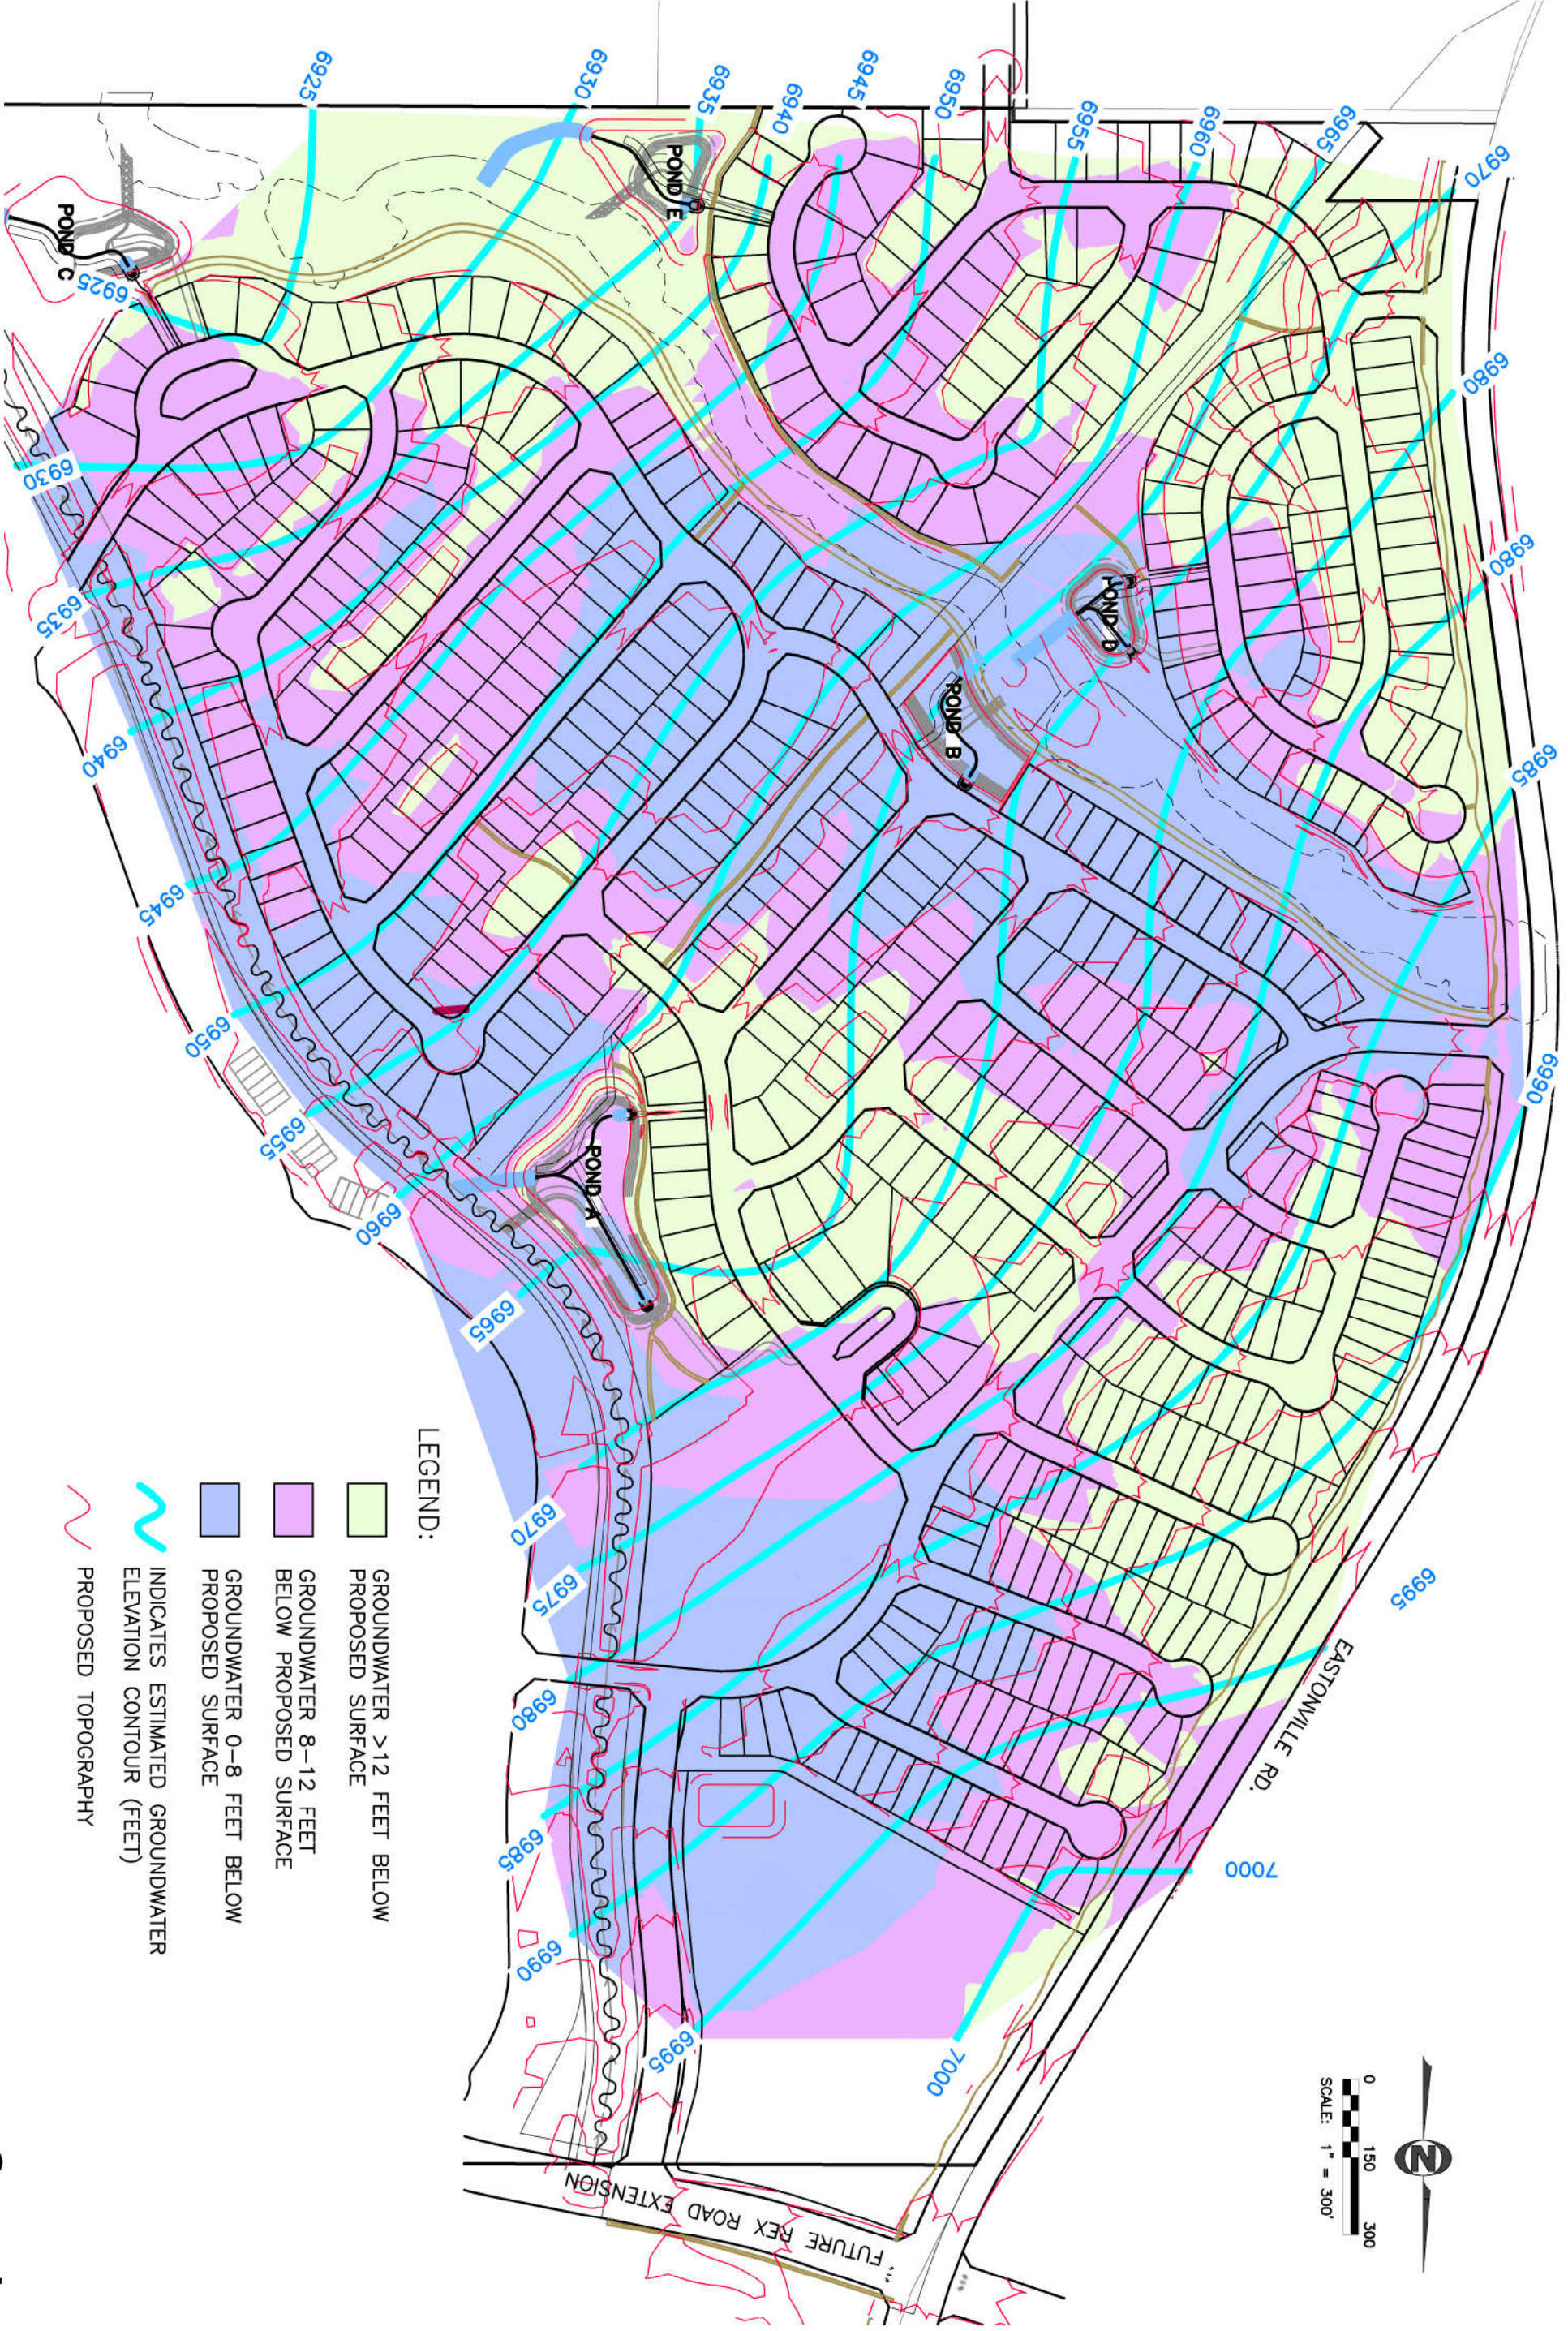
Groundwater Conditions Fig. 3

An additional figure, titled Groundwater Conditions (Fig. 3), was included in our report that provided approximate groundwater elevation contours and heat mapping, that provides an approximate depth to groundwater below the proposed finish grades. We also provided a figure titled Basement Construction Recommendations (Fig. 4), that depicted lots that are unsuitable for basement construction based on our groundwater data and analysis; however, we understand basement construction is not planned for any of the 119 lots included in Filing No. 1. All residential structures will be constructed with either a spread footing foundation supporting a structural floor system over a crawl space or a slab-on-grade foundation system.

Current groundwater depths indicate proximity of groundwater to basement level foundation systems is a concern throughout portions of the development. The presence of shallow groundwater can impact basement level construction. Lots expected to be impacted by shallow groundwater that will restrict basement construction are shown on Fig. 4. Future groundwater level monitoring studies may be conducted to further evaluate groundwater levels.
