**ENTECH**  
ENGINEERING, INC.

January 25, 2022

Re: Soil, Geology, and Geologic Hazard Study  
Lot 1, Flying Horse North Filing No. 2  
Quartz Creek Drive  
El Paso County, Colorado

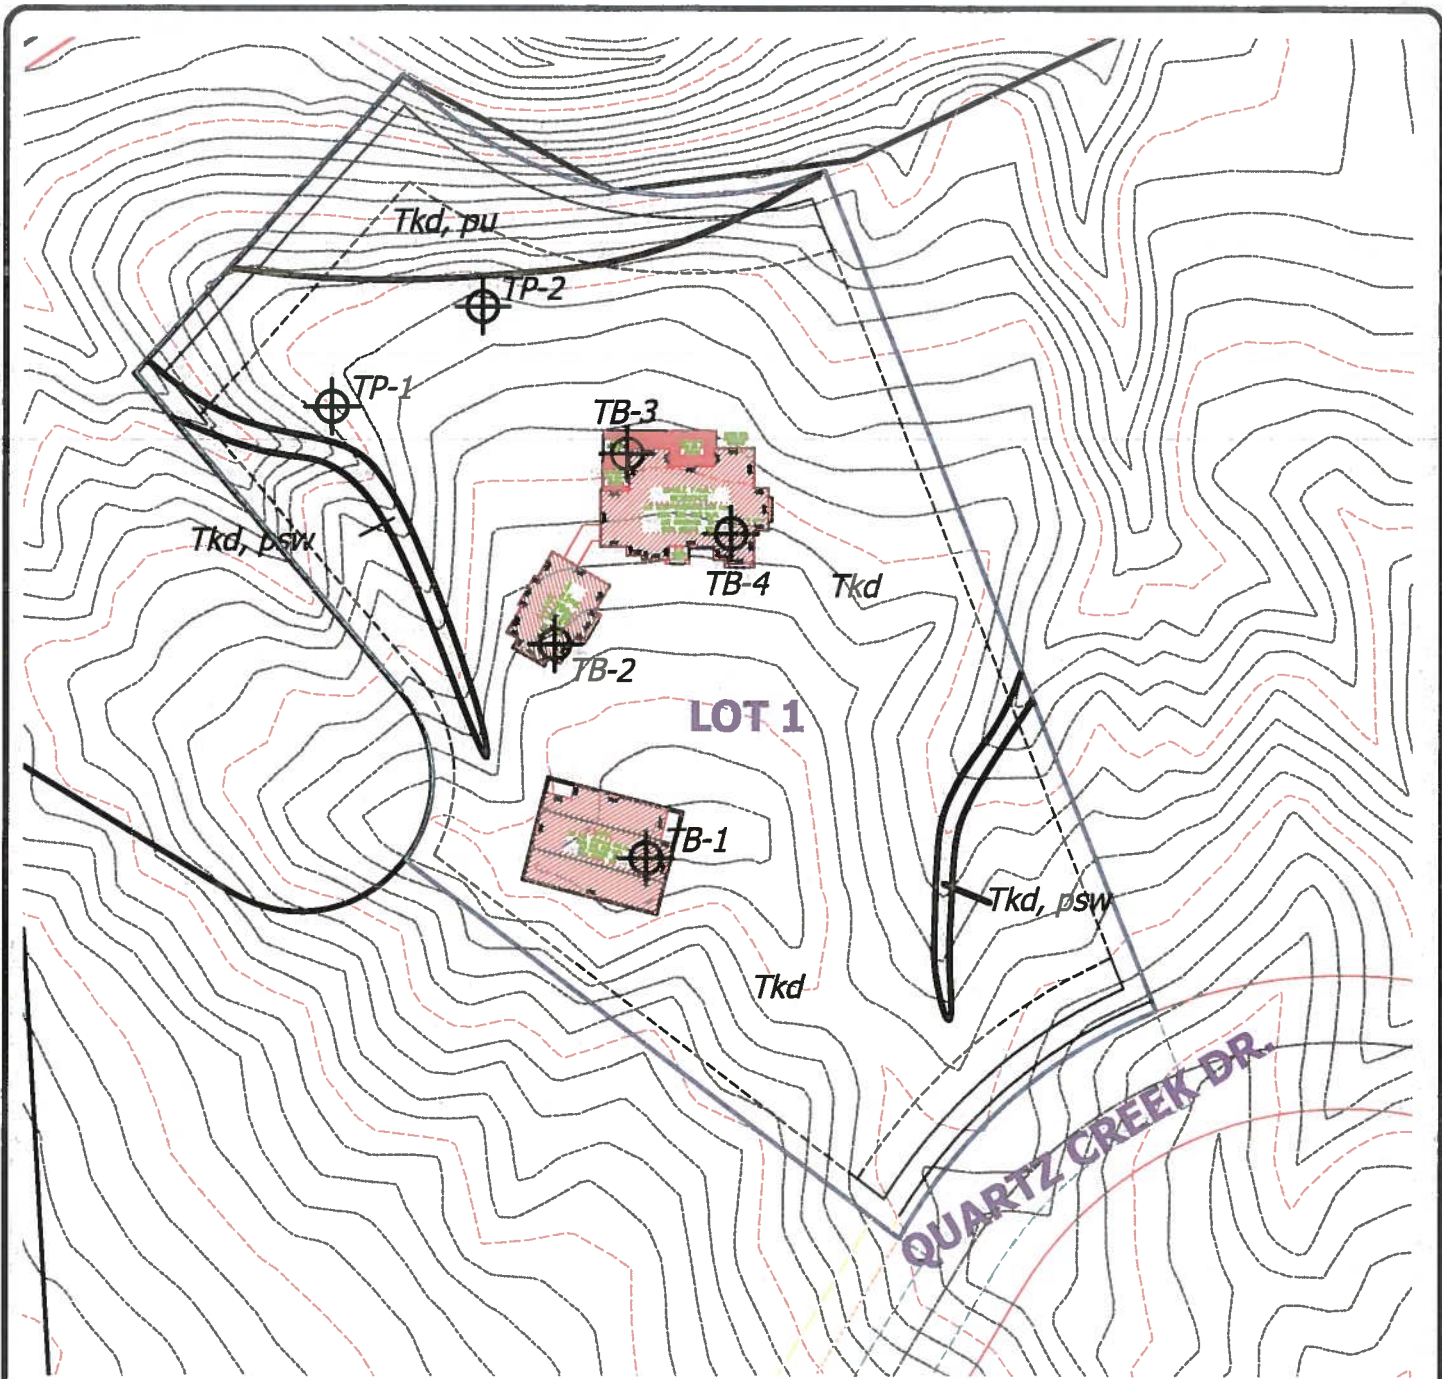
FIG NO.:  
**6**

The majority of the slopes in the building areas on site are gently to moderately sloping and do not exhibit any past or potential unstable slopes or landslides. However, the steeply sloping areas in the northern portion of the lot have been identified as potentially unstable slopes. This area is identified on the Engineering Geology Map, Figure 6. The recommendations for these areas are as follows:

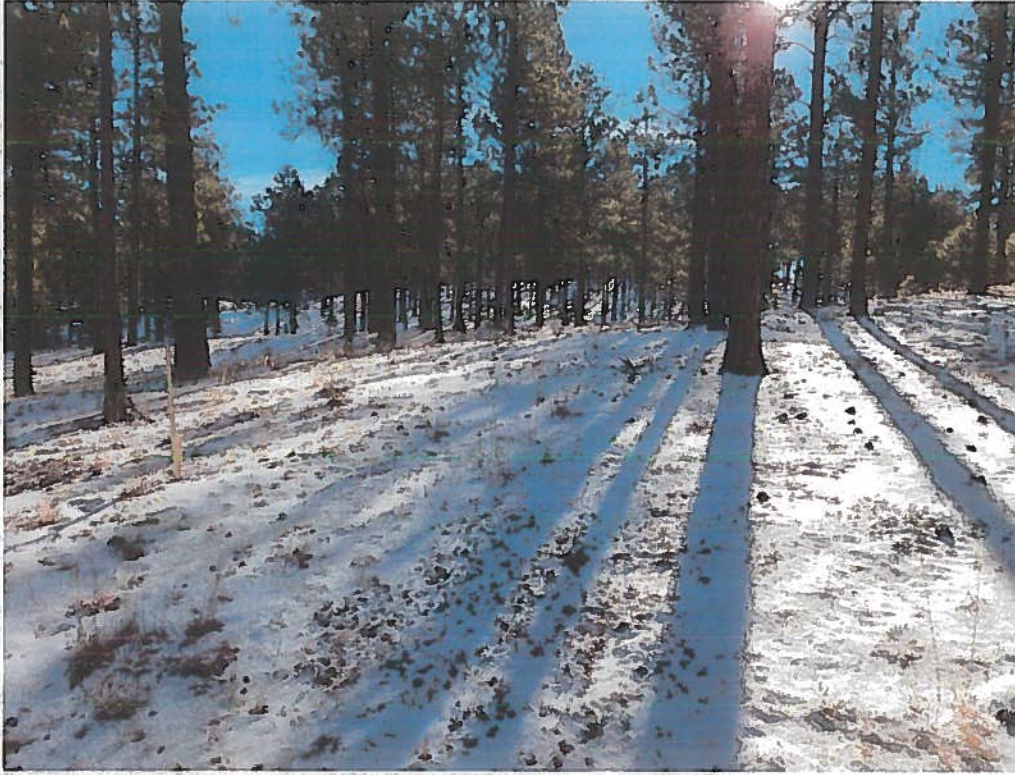
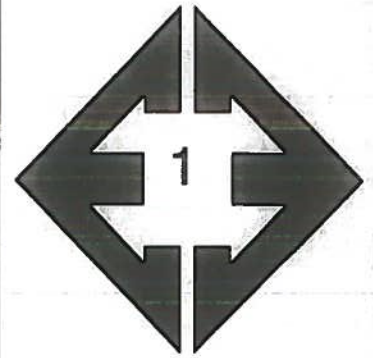
**Looking southeast  
from the proposed  
building area.**

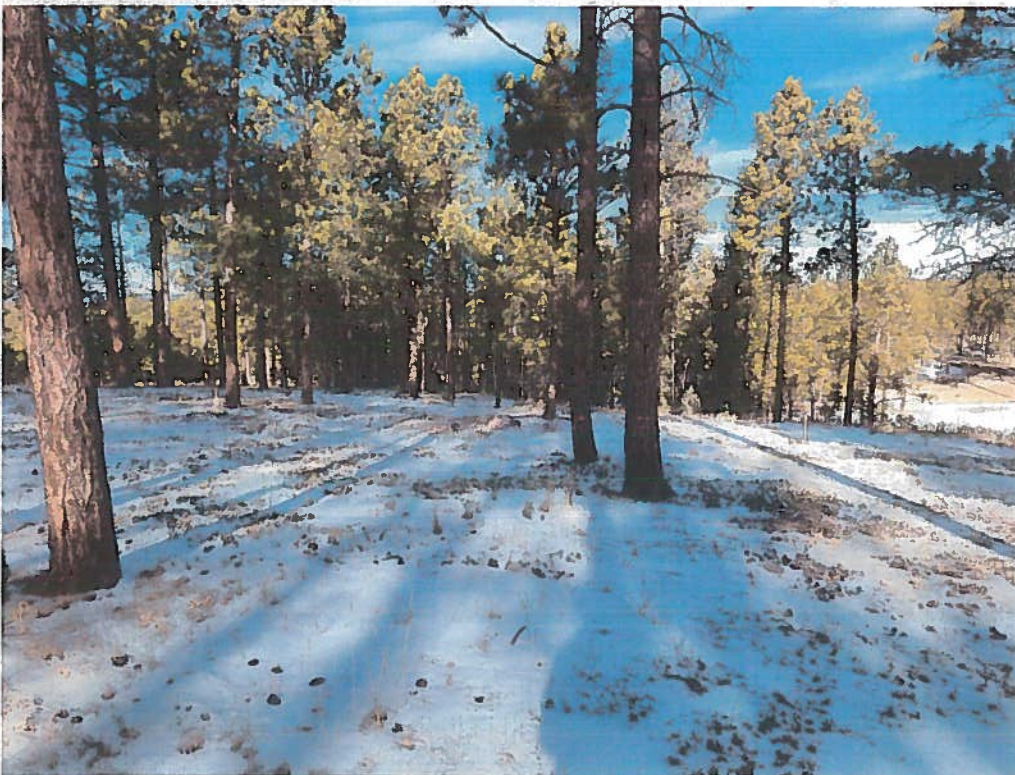
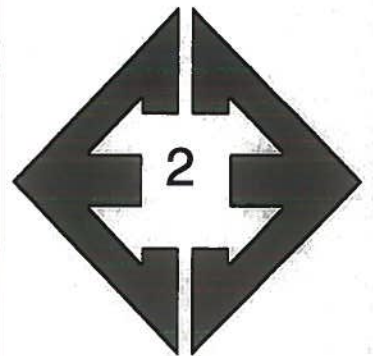
**Looking north from the  
central portion of the  
site.**

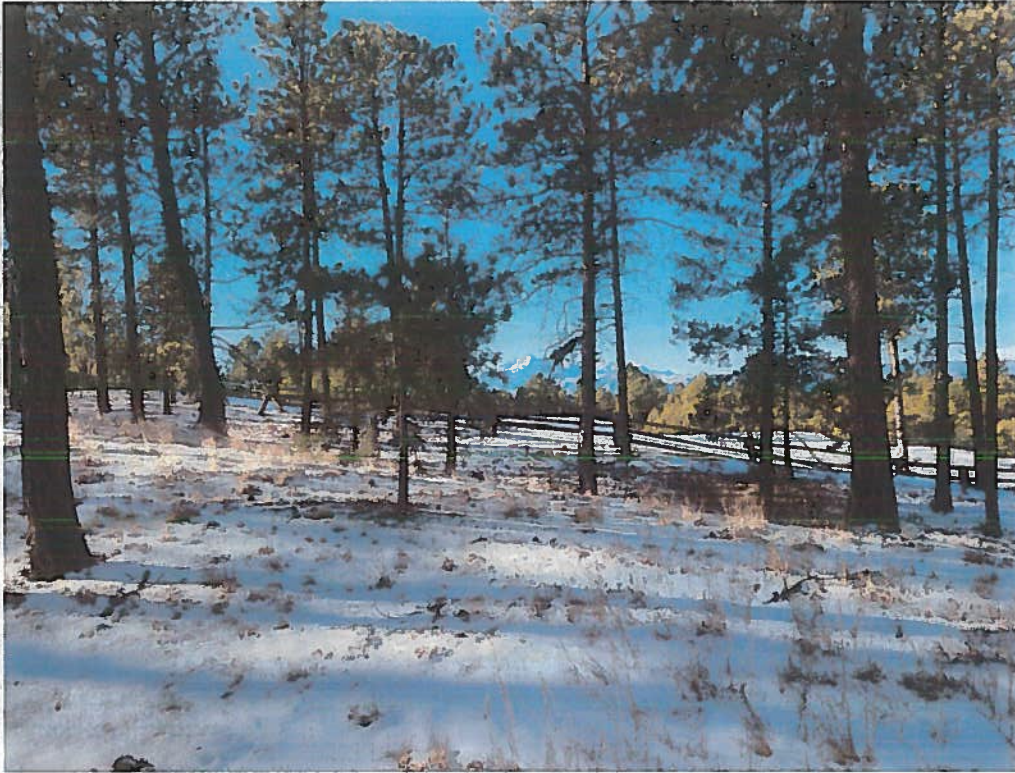
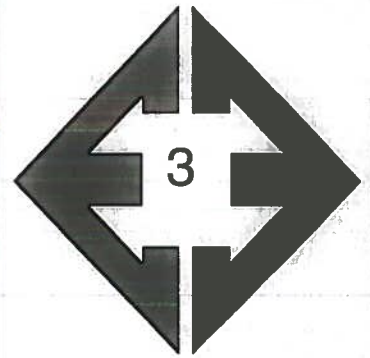
**Looking west from the central portion of the lot.**

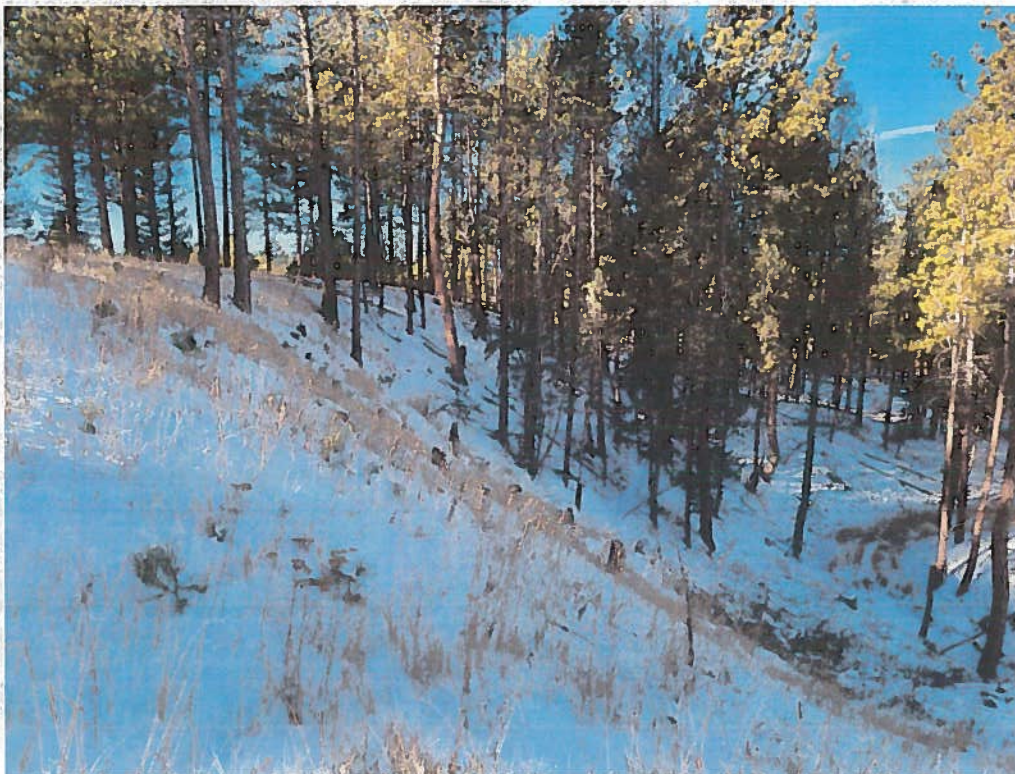
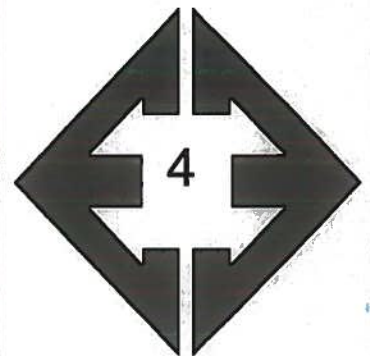
The area identified with this hazard includes the steep slopes along the northern side of the lot. These slopes are considered stable in their present condition; however, considerable care must be exercised in these areas not to create a condition which would tend to activate instability. Due to the lot size this area will be avoided by the proposed structures.

**Looking northwest along the potentially unstable slope in the northern side of the site.**

Mitigation: Building should be avoided in these areas. Proper control of drainage at both the surface and the subsurface is extremely important. Areas of ponded water at the surface should be avoided. Utility trenches, basement excavations and other subsurface features should not be permitted to become water traps which may promote saturation of the subsurface materials. Drainage should not be permitted over the potentially unstable slope but directed in a non-erosive manner away from the slope. Irrigation above these slopes should be kept to a minimum to prevent saturation of the subsurface soils.
