Preliminary Acceptance Punchlist
EPC - DPW - Stormwater Section

Project Name:	Urban Collection at Palmer Village
EDARP Filing Number(s):	SF2028
ESQCP Number:	ESQ2138
Attendees:	DPW SW: Dylan Finley, Ben Jones DPW Planning: Developer:
Date of Walk-Thru:	04/25/2023
Walk-Thru Number:	1

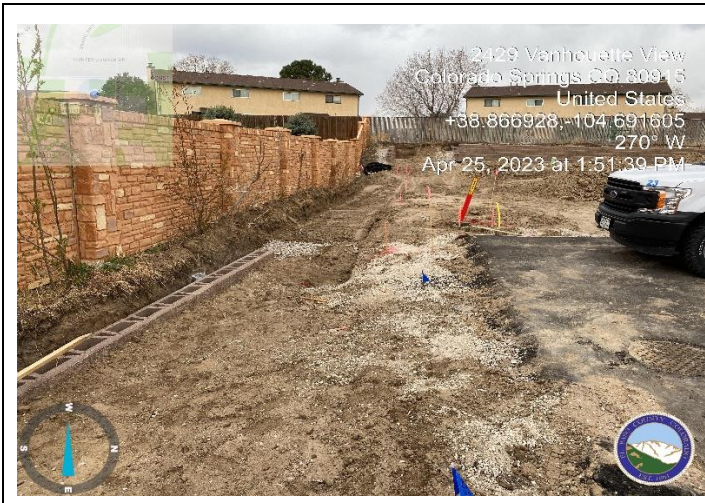
- Swale A not completed. Missing retaining wall and concrete pan.
- Swale B & C not completed. Swales are supposed to be 24' wide and clearance onsite is 17' in some areas.

Photo 1: Swale A not completed. Missing retaining wall and concrete pan. (Page 3 of GEC)

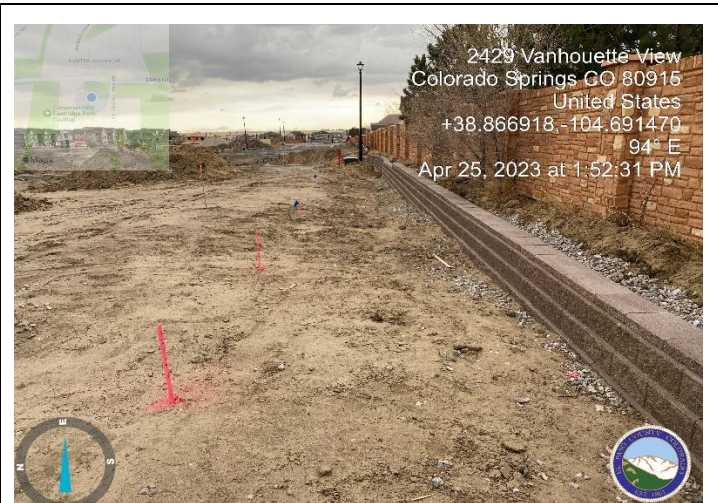
Photo 2: Swale A not completed. Missing retaining wall and concrete pan. (Page 3 of GEC) Concrete pan must extend and tie into rip rap run down.

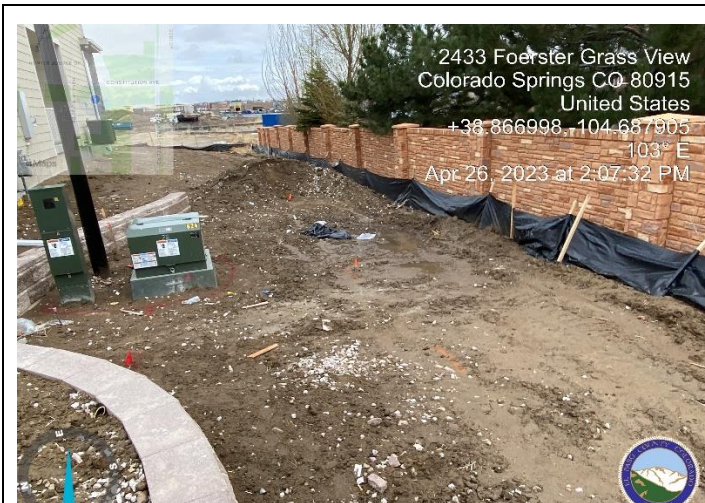
Photo 3: Swale C not completed per specification. (Swales are supposed to be 24' wide and clearance onsite is 17')

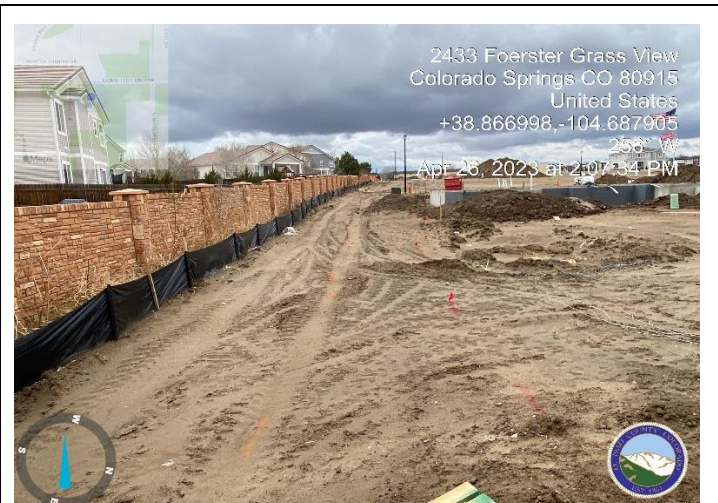
Photo 4: Swale B not completed per specification. (Swales are supposed to be 24' wide and clearance onsite is 17')

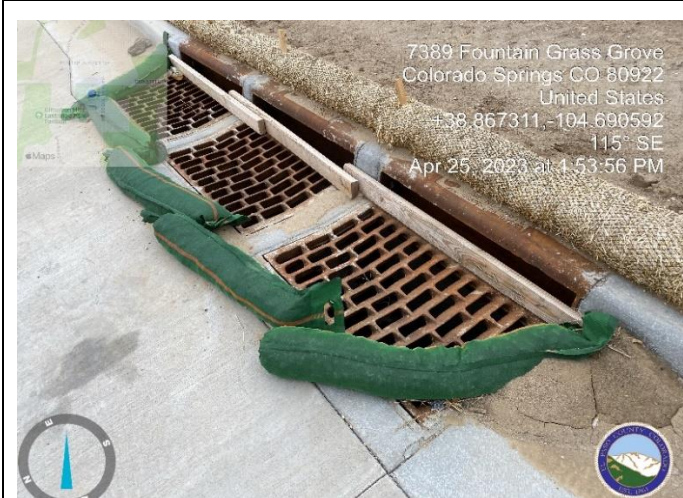
- Maintenance Stormwater inlets as needed site wide.

Photo 5: Maintenance Stormwater inlets as needed.

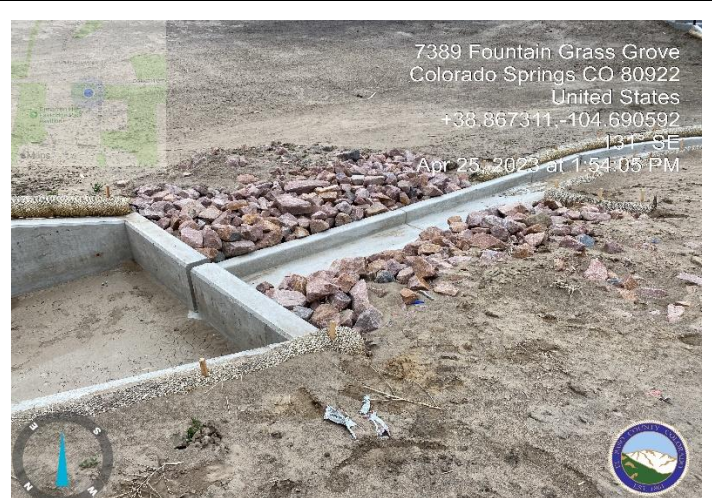
- Soil riprap not installed per specification. Riprap present with sediment spread along top. Soil riprap should be pre-mixed then installed (Pond A Page 27) (Pond B Page 31).

Photo 6: Pond A Soil Rip Rap not installed per specification. (Page 27 of CD'S) Soiled Rip rap must be flush with top of trickle channel and premixed before installation.

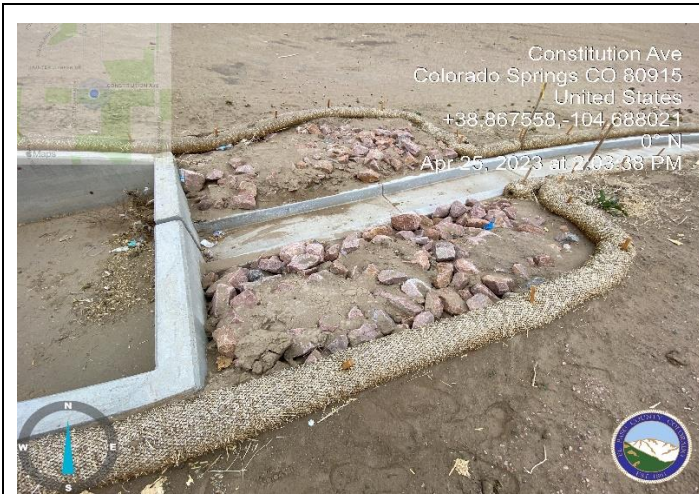
Photo 7: Pond B soil riprap not installed per plans. Soil riprap must be flush with top of trickle channel and pre-mixed before installed

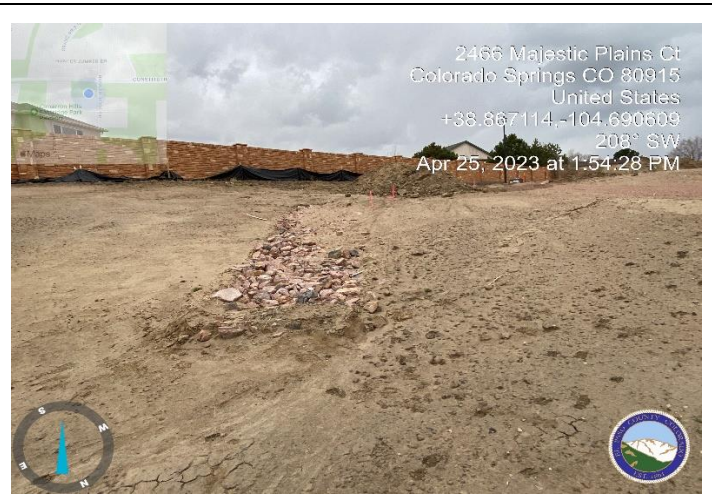
- Riprap rundown not built per specification. Flat rundown present when plans call for a trapezoid-shaped with two-foot slopes (Page 27).

Photo 8: Riprap rundown not built per plans (Page 27 of CDs)

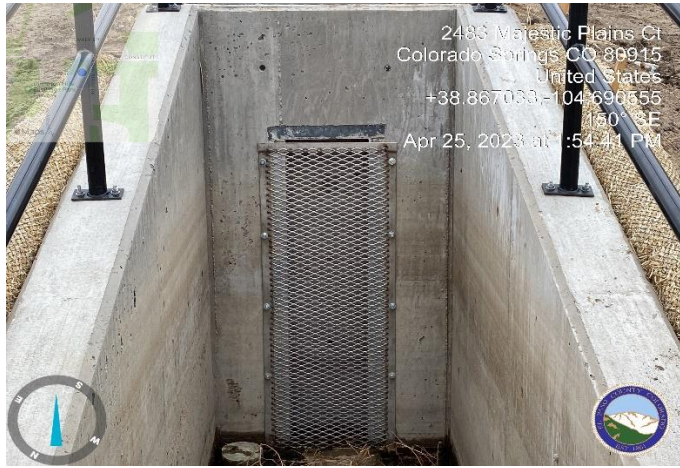
Photo 9: Well screen not installed per specification. (Pond A page 25)

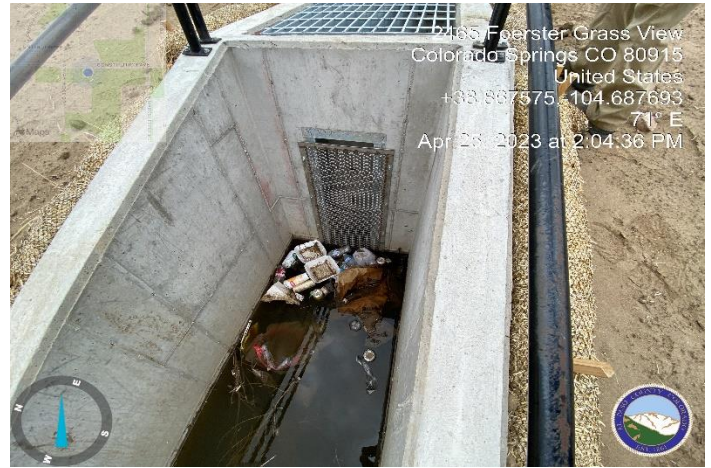
Photo 10: Well screen not installed per specification. (Pond B Page 29)

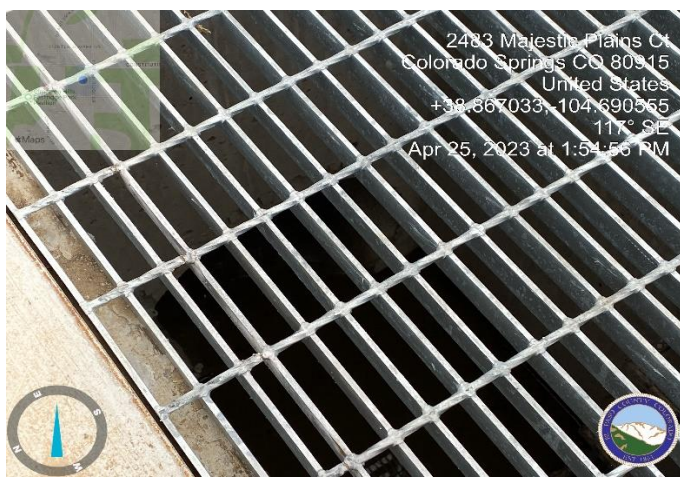
Photo 11: Restrictor plates missing. (Pond A Page 26)

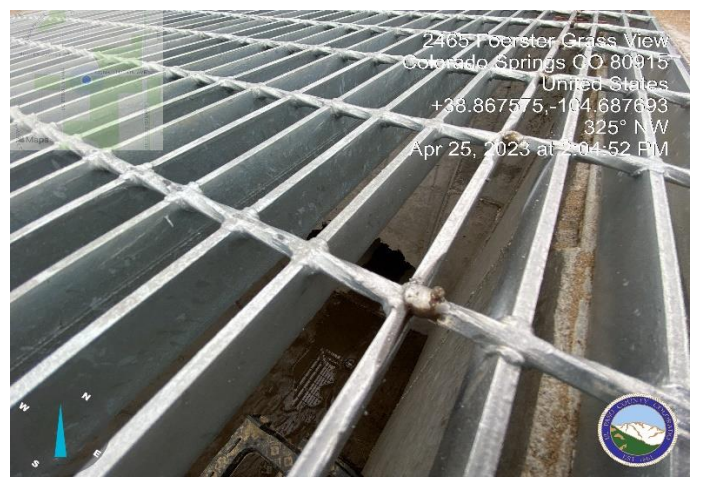
Photo 12: Restrictor plates missing. (Pond B Page 30)

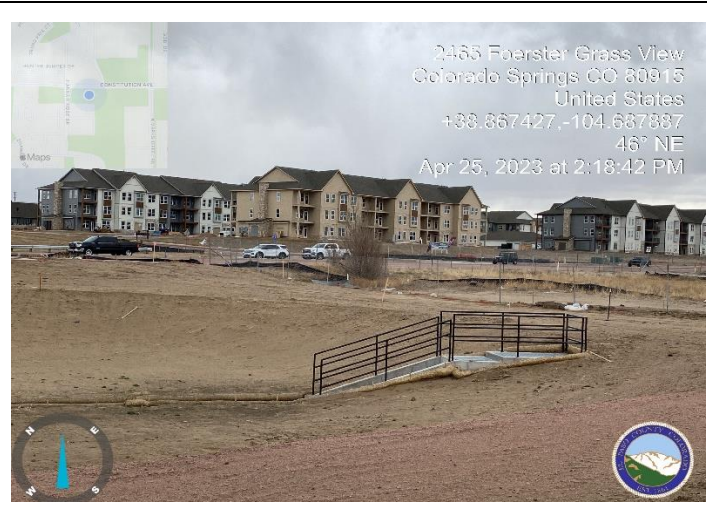
- Emergency spillway not installed per specification. Flat spillway present, missing 4:1 slopes 6' in length (Page 31).

Photo 13: Emergency spillway not installed per specification (Pond B Page 31)

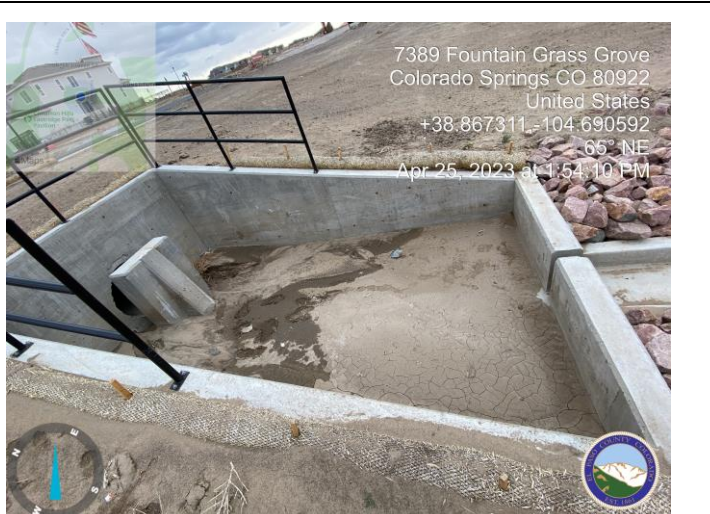
Photo 14: Ponds A & B. Clean out sediment and debris from outlet structure and trickle channels.

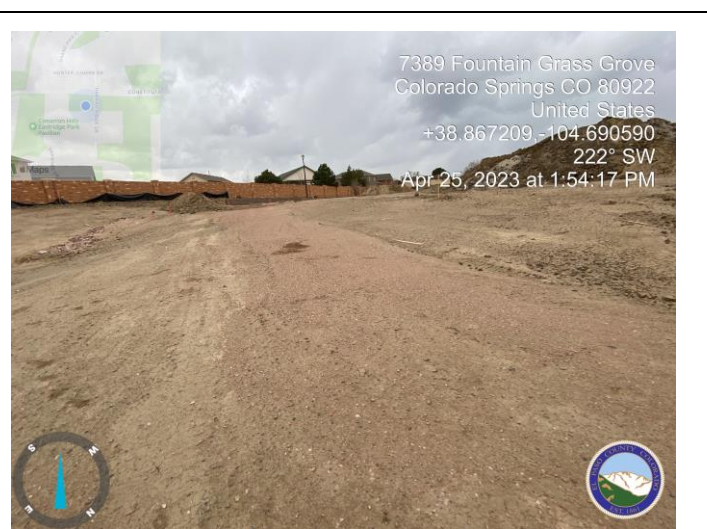
- Maintenance Road not installed per specification. Maintenance road present but is sediment laden/not the correct thickness (Pond A Page 27) (Pond B Page 31).

Photo 15: Maintenance road not installed per specification (Pond A Page 27)

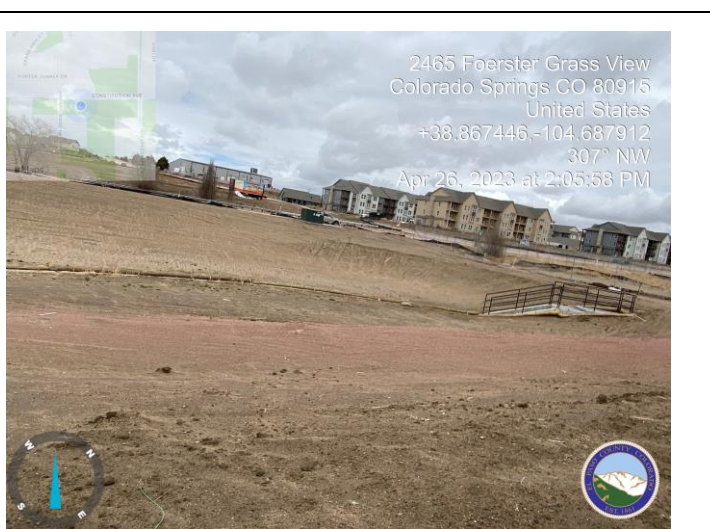
Photo 16: Maintenance road not installed per specification (Pond B Page 31)
