ENTECH
ENGINEERING, INC.

Re: Plot Plan Review
8884 Towner Avenue
Lot 58, The Meadows Filing No. 3
Peyton, Colorado

Re: Subsurface Soil Investigation- Pole Barn
8884 Towner Avenue
Lot 58, The Meadows Filing No. 3
Peyton, Colorado

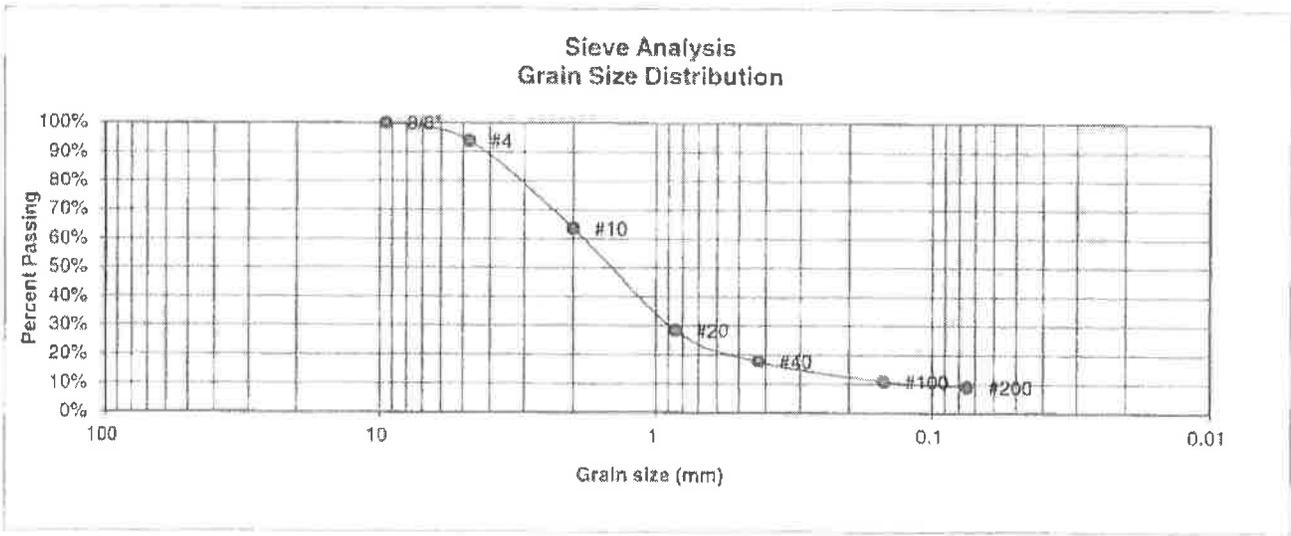
JOB NO
191187
FIG NO
2

BORING NO.	1	<u>UNIFIED CLASSIFICATION</u>	SM-SW	<u>TEST BY</u>	BL
DEPTH(ft)	2-3	<u>AASHTO CLASSIFICATION</u>		<u>JOB NO.</u>	191187
CLIENT	ERIN WARNER				
PROJECT	8884 TOWNER AVENUE

<u>U.S. Sieve #</u>	<u>Percent Finer</u>	<u>Atterberg Limits</u>
3"		Plastic Limit
1 1/2"		Liquid Limit
3/4"		Plastic Index
1/2"		
3/8"	100.0%	
#4	93.9%	<u>Swell</u>
#10	63.6%	Moisture at start
#20	28.3%	Moisture at finish
#40	17.7%	Moisture increase
#100	10.9%	Initial dry density (pcf)
#200	9.2%	Swell (psf)

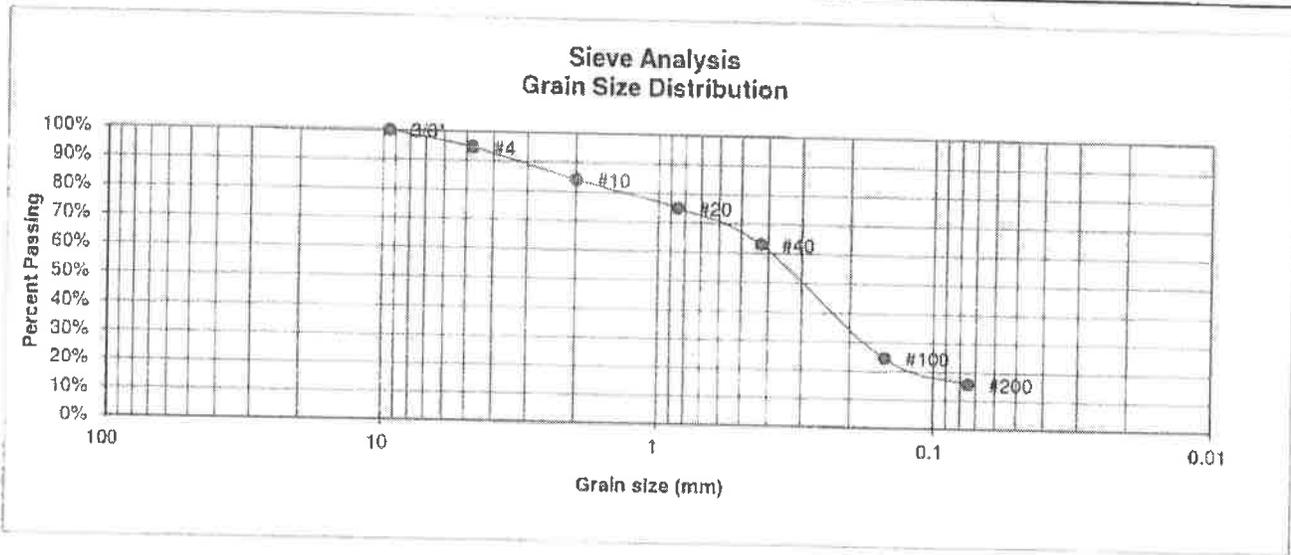
FIG NO.
3

BORING NO.	1	UNIFIED CLASSIFICATION	SM	TEST BY	BL
DEPTH(ft)	10	AASHTO CLASSIFICATION		JOB NO.	191187
CLIENT	ERIN WARNER				
PROJECT	8884 TOWNER AVENUE

U.S. Sieve #	Percent Finer
3"	
1 1/2"	
3/4"	
1/2"	
3/8"	100.0%
4	94.5%
10	84.2%
20	75.0%
40	62.9%
100	24.5%
200	15.8%

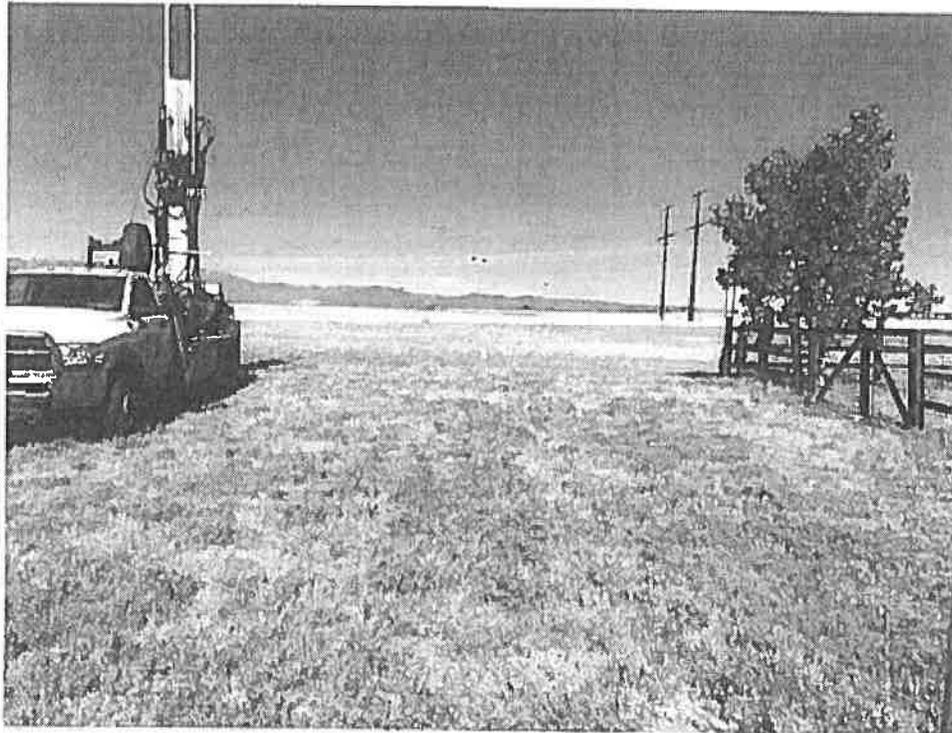
**Looking west from the
proposed building
area.**

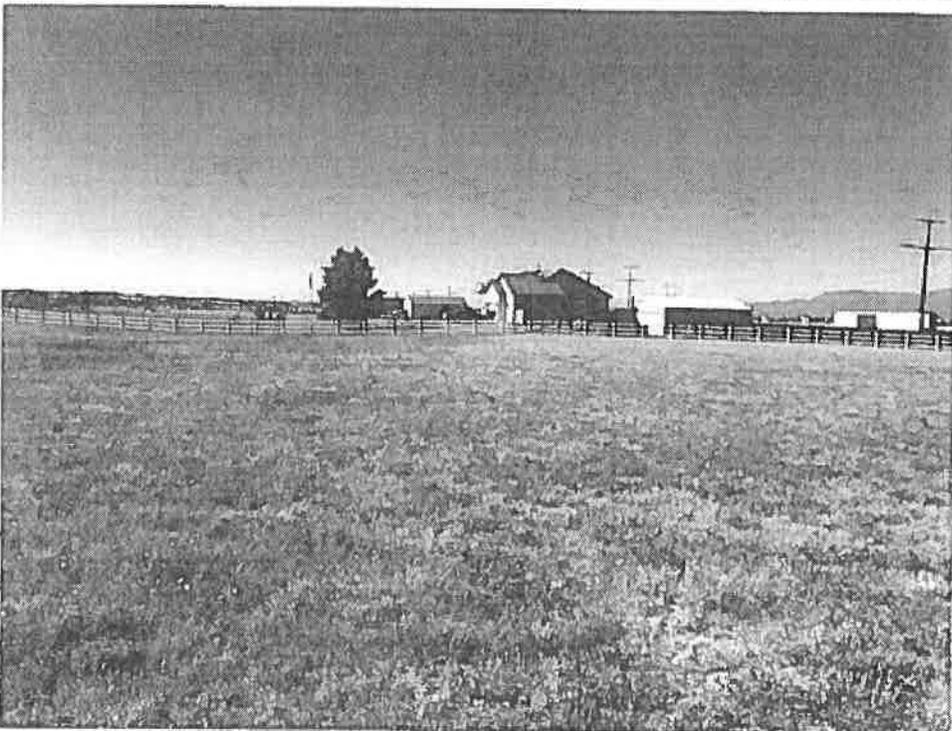
**Looking south from
the proposed building
area.**
