**SOILS AND GEOLOGY STUDY  
STERLING RANCH EAST – FILING NO. 4  
EL PASO COUNTY, COLORADO**

May 22, 2026

PBK/LLL/JG  
Entech Job No. 260187

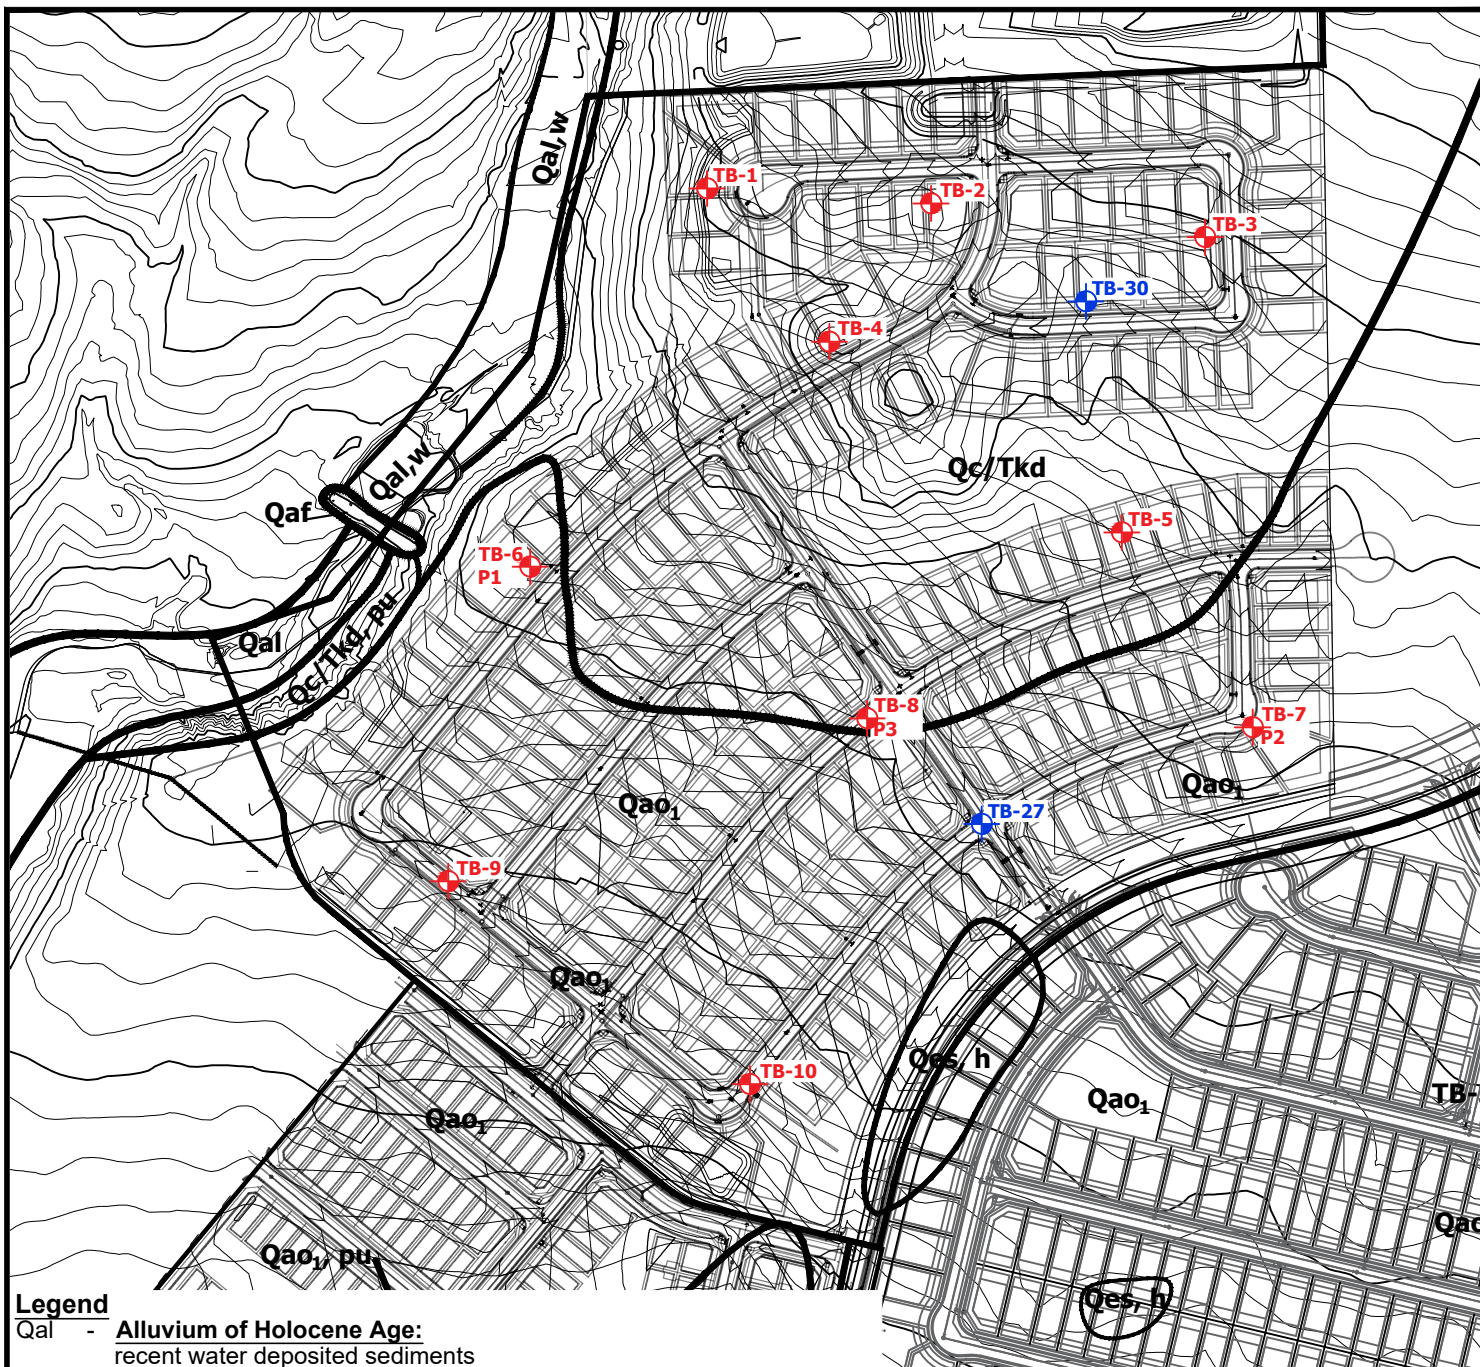
**FIG. 6**

Detailed mapping has been performed on this site to produce an Engineering Geology Map Figure 6. This map shows the location of various geologic conditions of which the developers should be cognizant during the planning, design and construction stages of the project. These hazards and the recommended mitigation techniques are as follows:

The majority of the slopes on-site are gradually sloping and do not exhibit and past or potential unstable slopes or landslides. The steeper slopes on the southwestern portion of the site sloping towards Sand Creek have been identified as potentially unstable. However, these slopes are located within an open space area and will be avoided by construction. It is recommended that any future grading or fill slopes should be 3:1 or flatter.

These are areas that are undergoing erosion by water and sheetwash producing gullies and rill erosion. The areas of significant erosion observed on the site are located on the steeper slopes on the western portion of the site.

Mitigation: Due to the nature of the soils on this site, virtually all the soils are subject to erosion by wind and water. Other minor areas of erosion were observed on site other than those mapped, particularly where some rill erosion has occurred. Areas of erosion can occur across the entire site, particularly if the soils are disturbed during construction. Vegetation reduces the potential for erosion. The areas identified where erosion is actually taking place may require check dams, regrading and revegetation using channel lining mats to anchor vegetation. Further recommendations for erosion control are discussed under Section 8.0 "Erosion Control" of this report. Recommendations pertaining to revegetation may require input from a qualified landscape architect and/or the Natural Resource Conservation Service (previously Soil Conservation Service).

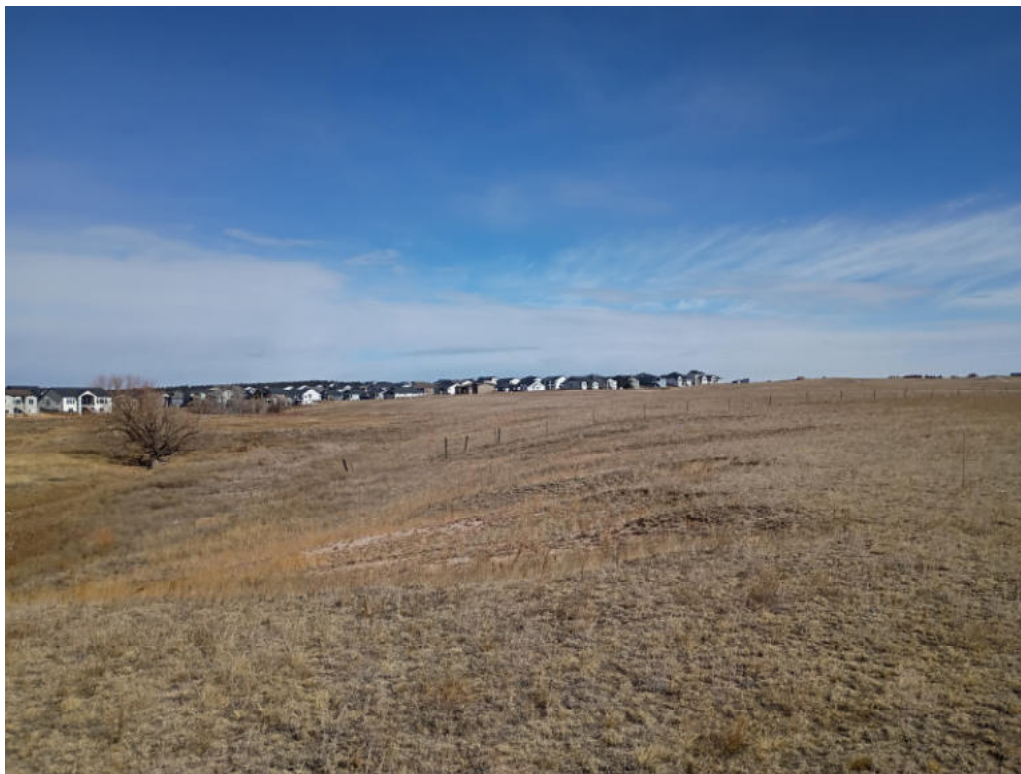
**Looking north along  
Sand Creek from the  
western side of the  
site.**

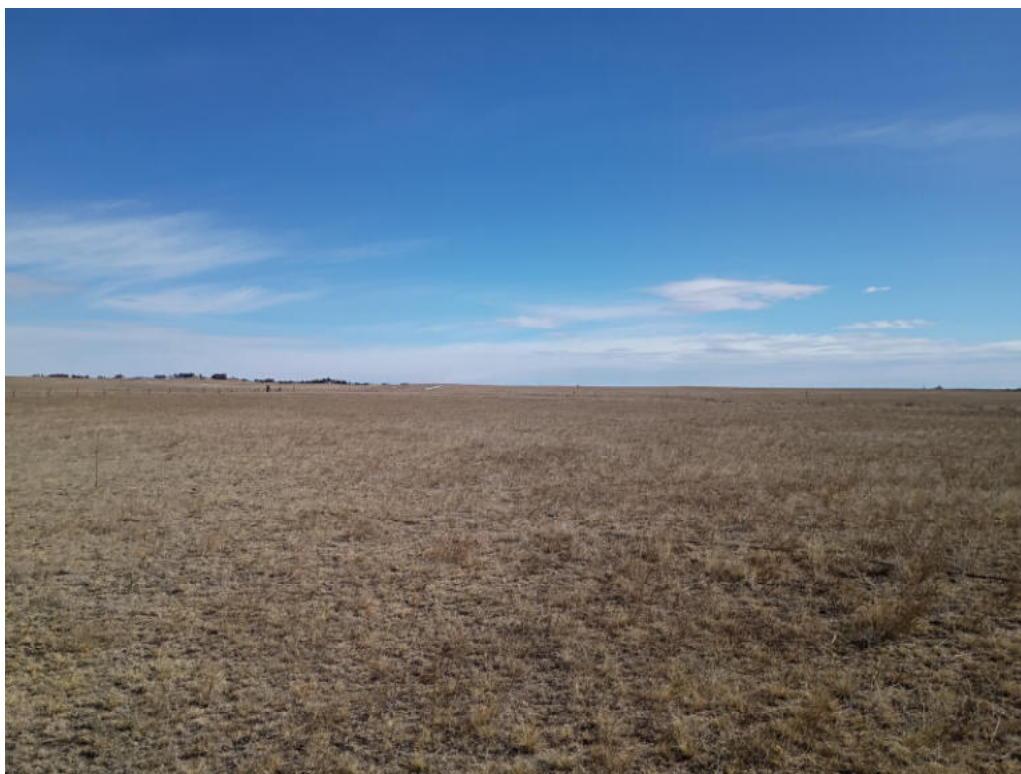
**Looking east from the  
western portion of the  
site.**

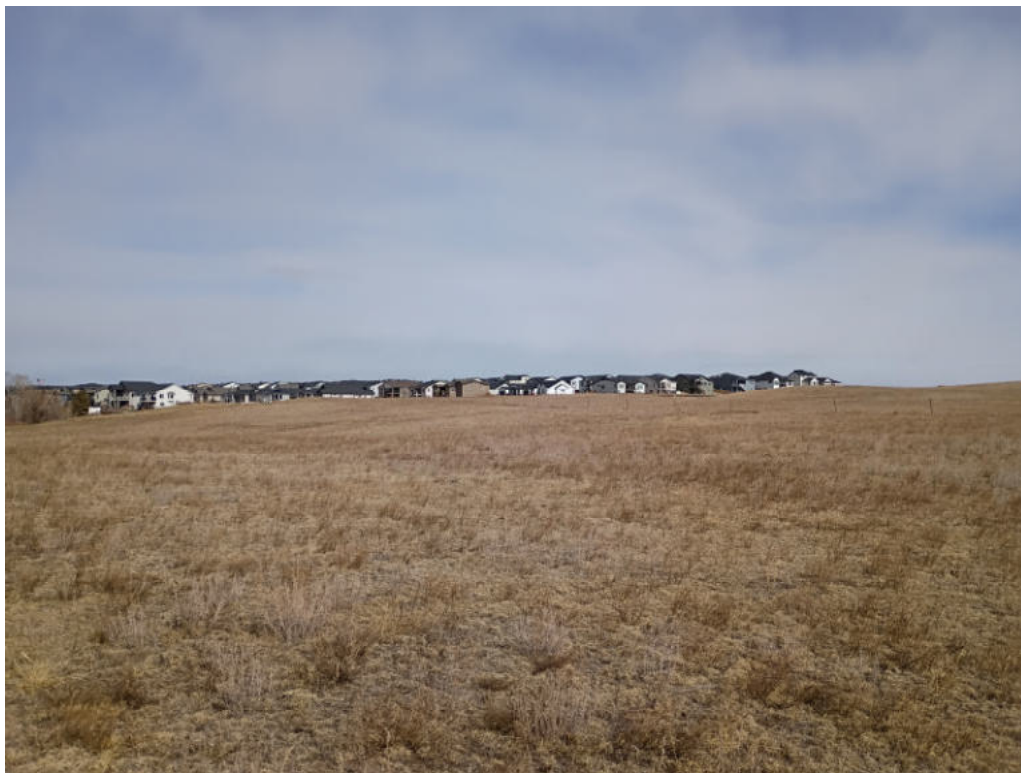
**Looking northeast  
from the northwestern  
portion of the site.**

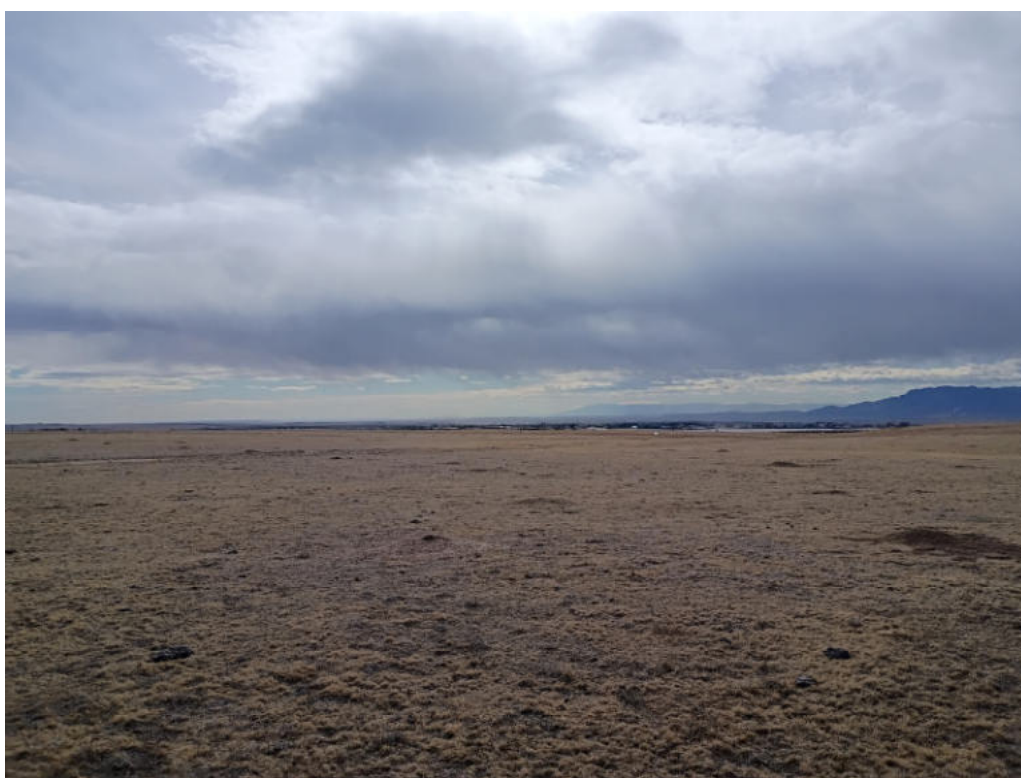
**Looking south from  
the northern portion of  
the site.**

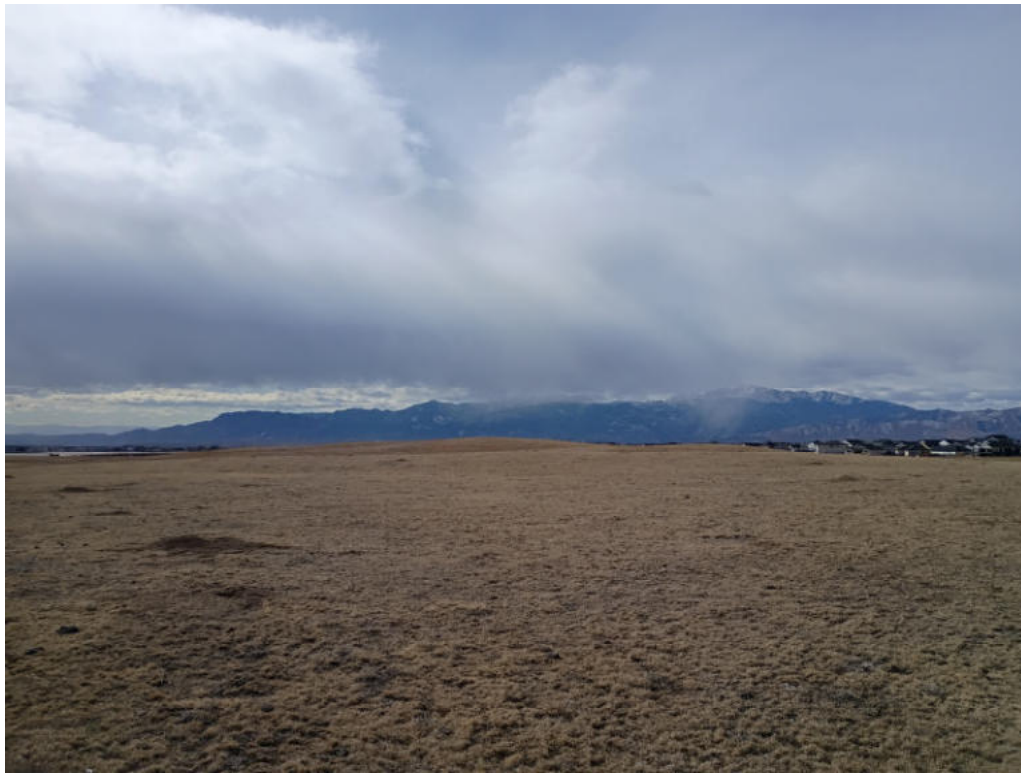
**Looking northeast  
from the southwest  
portion of the site.**

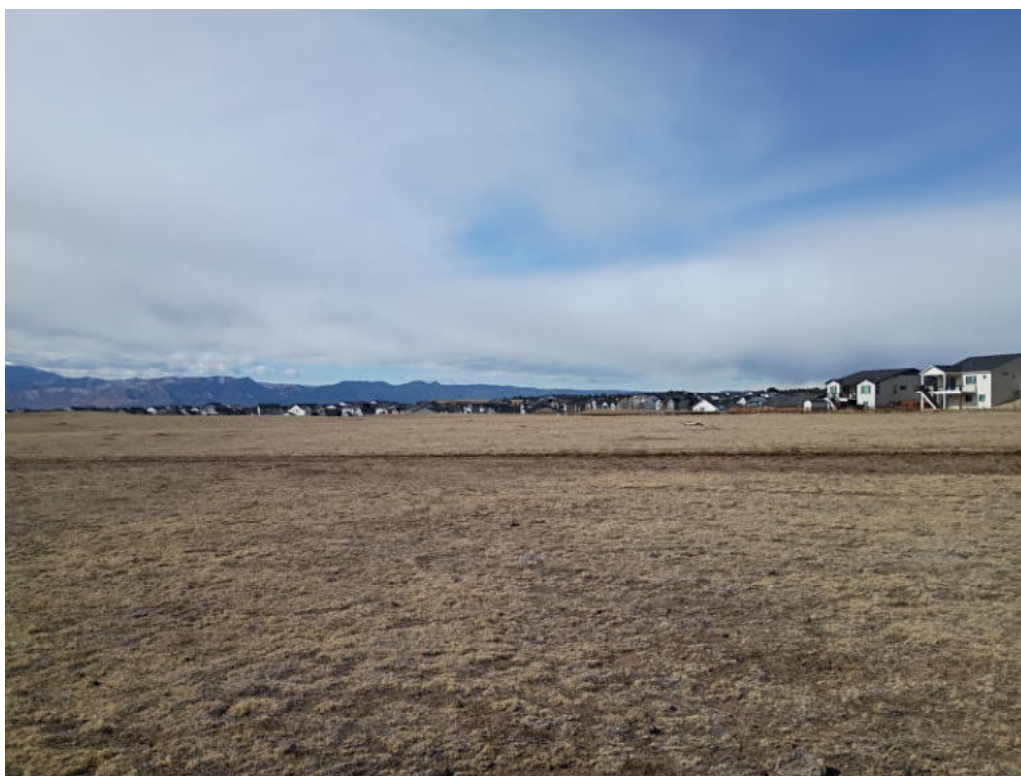
**Looking west from the  
northeastern portion of  
the site.**

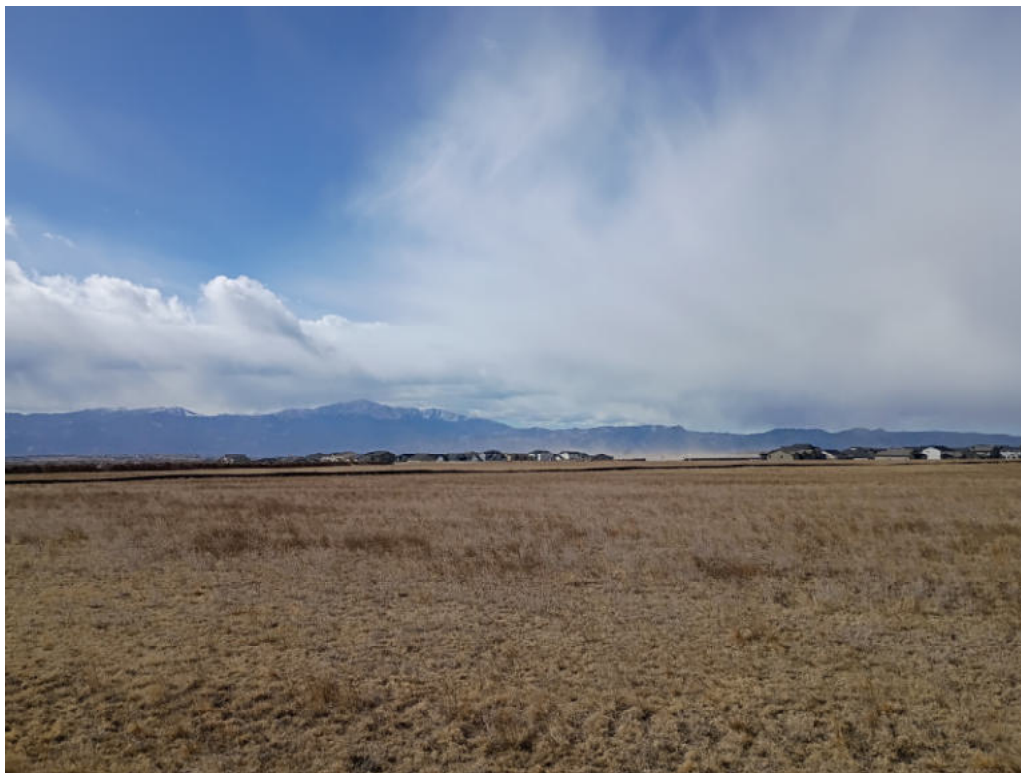
**Looking west from the  
southern portion of the  
site.**

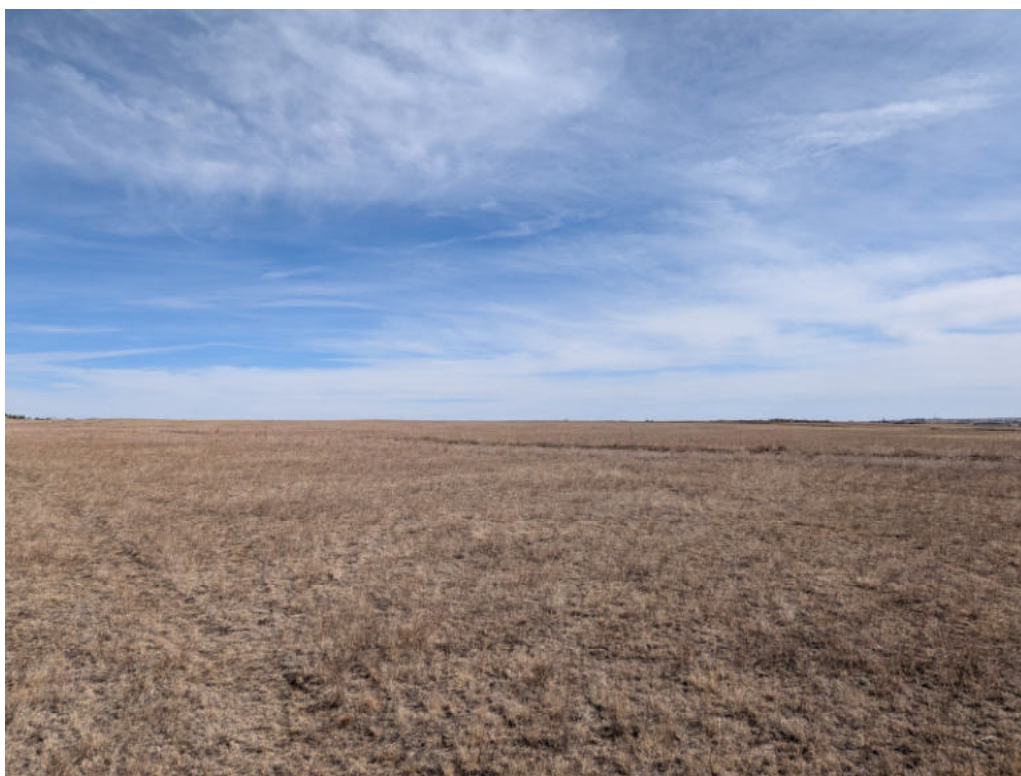
**Looking east from the  
southern portion of the  
site.**

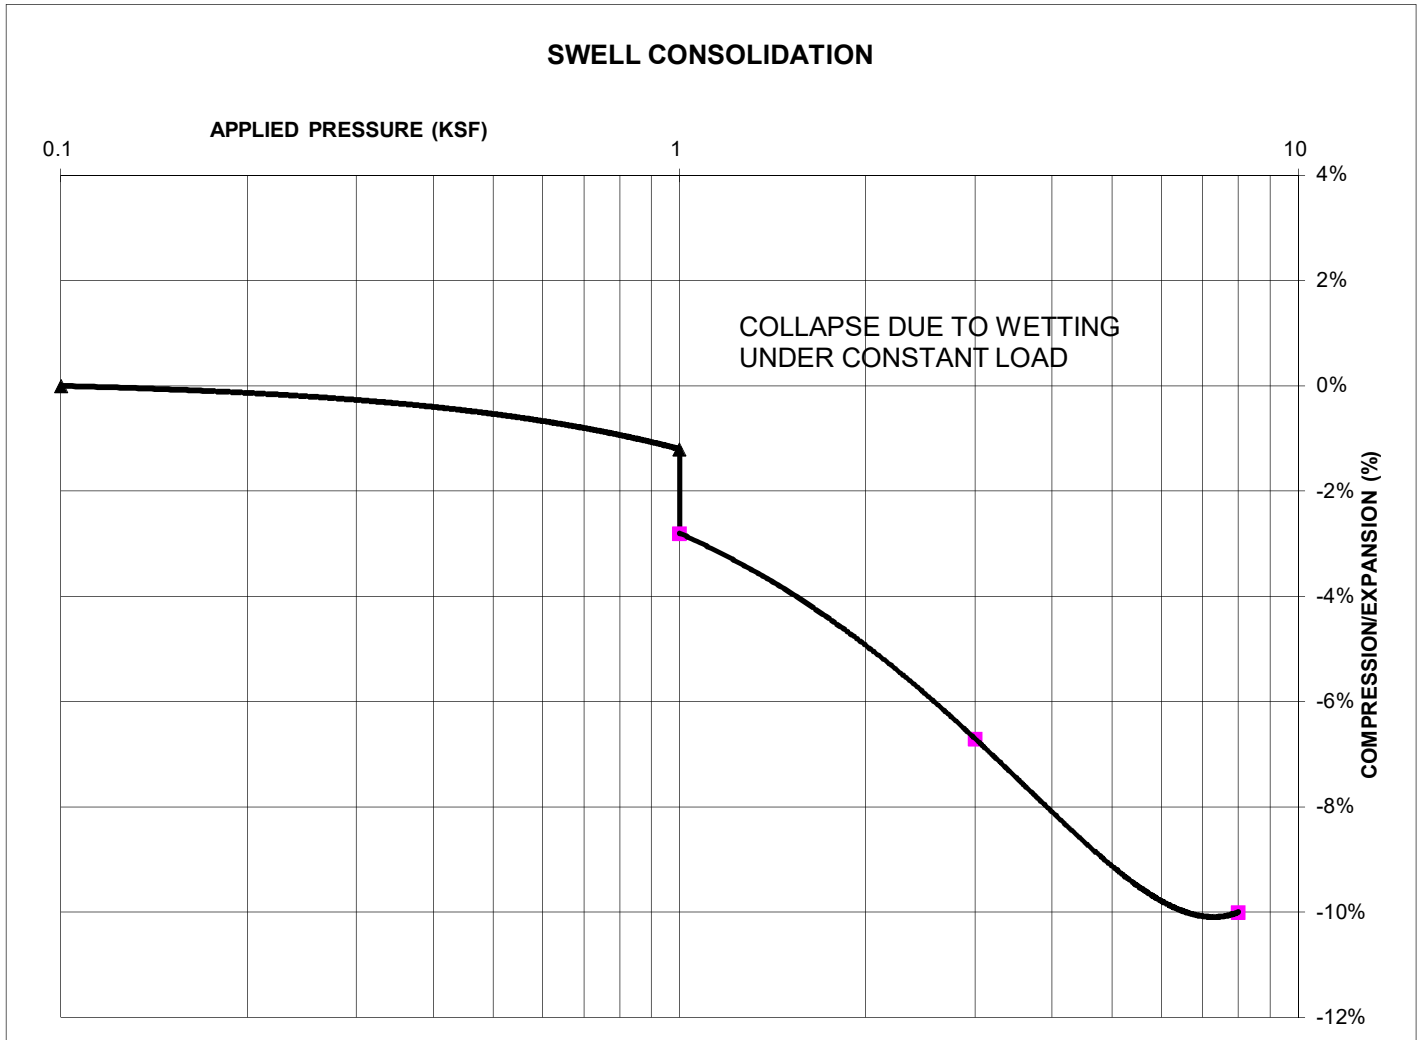
**SWELL/COLLAPSE TEST RESULTS**

The majority of the soils encountered on-site do not exhibit collapsible characteristics, however, minor areas of loose soils were encountered in the test borings drilled on site. Additionally, areas mapped as Qes (Eolian Sand) have the potential for hydrocompaction. One-dimensional swell/collapse testing on a sample of clayey sand from TB-8 at a depth of 5 feet resulted in a collapse of 1.6%, indicating a moderate potential for collapse.

NATURAL UNIT DRY WEIGHT (PCF): 109  
NATURAL MOISTURE CONTENT: 12.5%  
SWELL/COLLAPSE (%): -1.6%

Mitigation: Should loose or collapsible soils be encountered beneath foundations, removal and recompaction of the upper 2 feet of soil at 95% of the Modified Proctor (ASTM D1557) within +/- 2% of the optimum moisture content is a suitable mitigation. Roadway areas may also experience movement. Proofrolling and recompaction of soft areas should be performed during site grading.
