Preliminary Acceptance (PA) Punchlist
EPC - DPW - Stormwater Section

Project Name:	Hills at Lorson Ranch
EDARP Filing Number(s):	SF2110, PUDSP203, CDR207, PUDSP216
ESQCP Number:	ESQ2033
Attendees:	DPW SW: Natasha Grimaldo, Ben Jones DPW Planning: N/A Developer: Jeff Mark/Lorson LLC
Date of Walk-Thru:	3/6/2023
Walk-Thru Number:	1st

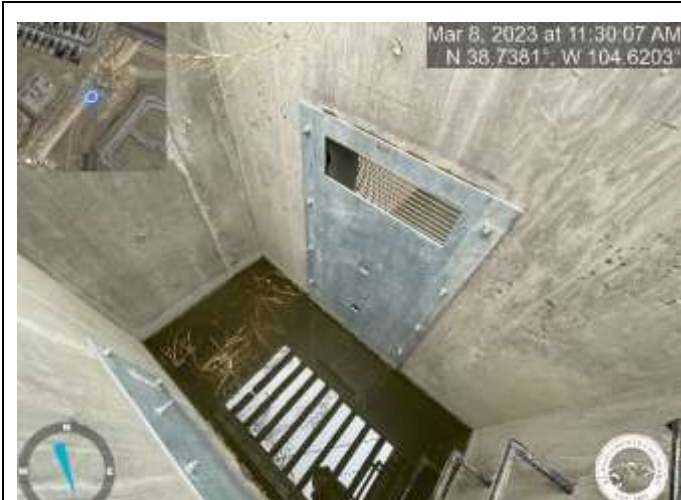
Photo 1: Pond C1: Orifice plate was not properly installed. Invert of the bottom most hole should be at the same elevation as the invert of the outlet pipe.

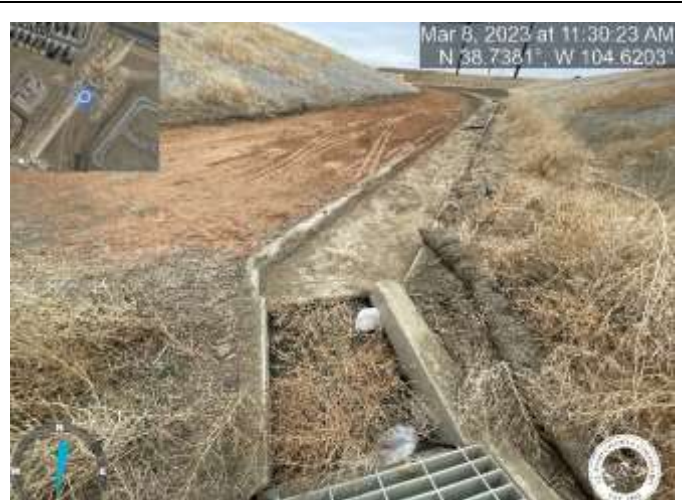
Photo 2: Pond C1: Remove excess sediment and old straw wattles from trickle channel.

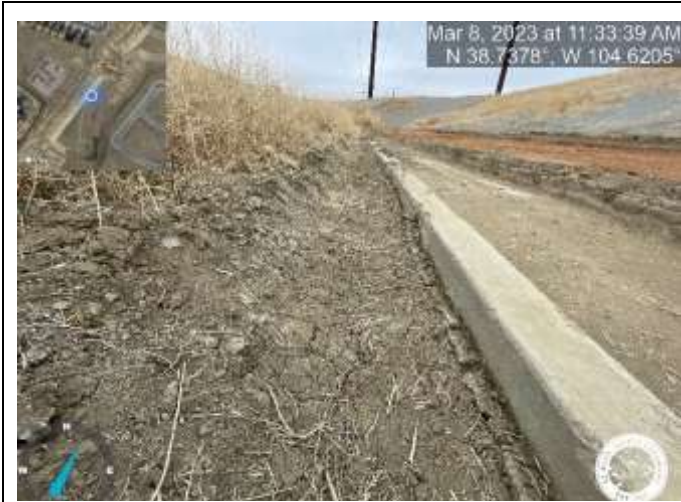
Photo 3: Pond C1: Raise pond bottom to top of trickle channel curb with a 3% slope towards trickle channel for positive drainage.

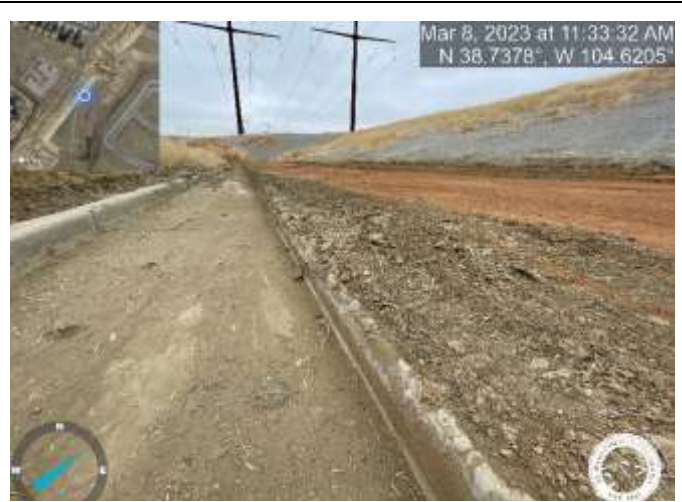
Photo 4: Pond C1: Remove sediment to match the top of trickle channel curb with a 3% slope towards trickle channel for positive drainage.

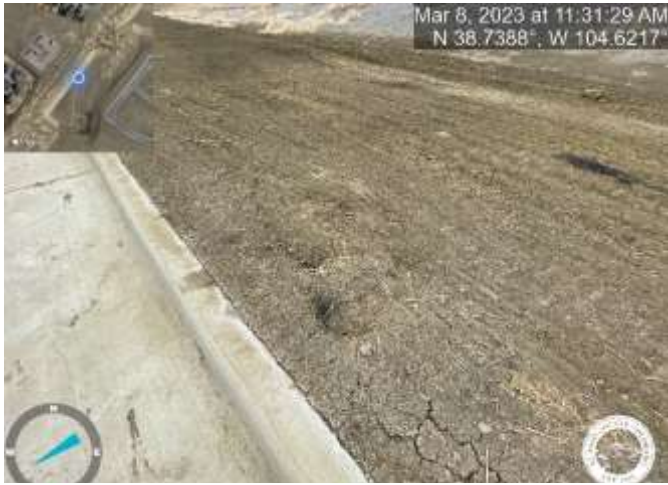
Photo 5: Pond C1: Remove old/damaged straw wattles from pond bottom.

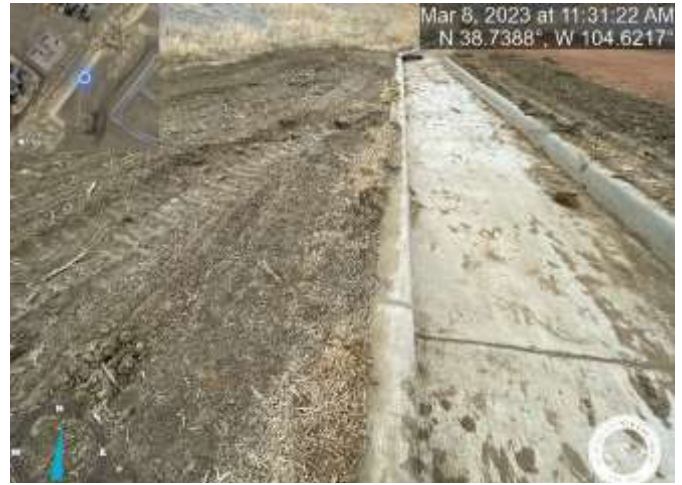
Photo 6: Pond C1: Remove old/damaged straw wattles from pond bottom.

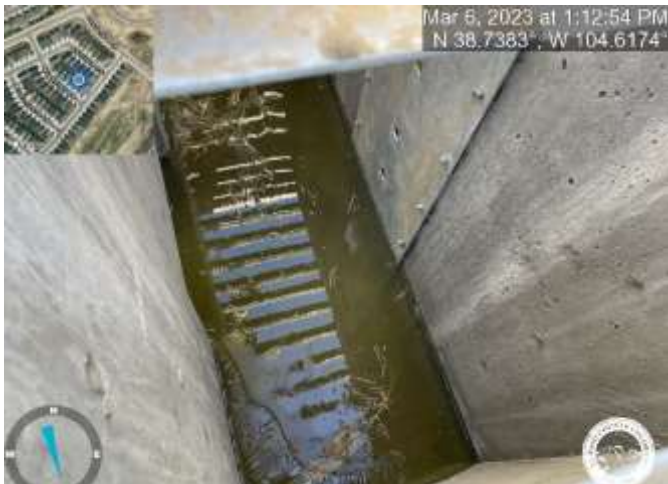
Photo 7: Pond C2.1: Orifice plate was not properly installed. Invert of the bottom most hole should be at the same elevation as the invert of the outlet pipe.

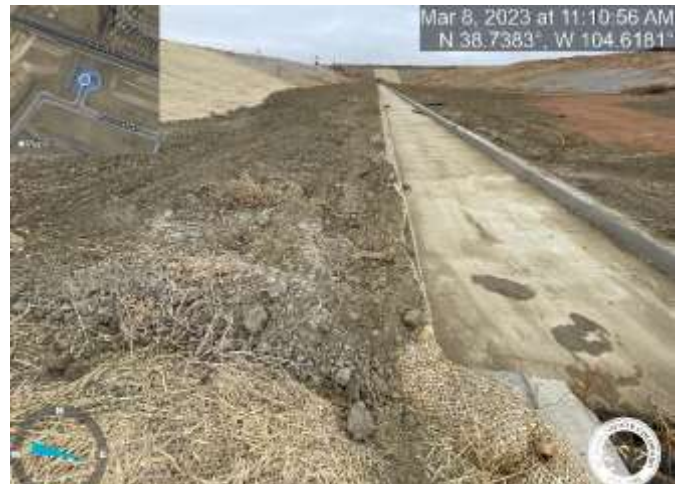
Photo 8: Pond C2.1: Remove sediment to match the top of trickle channel curb with a 3% slope towards trickle channel for positive drainage.

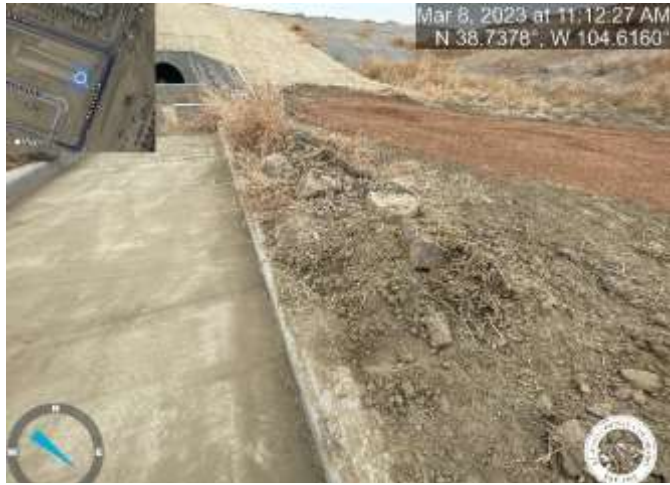
Photo 9: Pond C2.1: Remove sediment to match the top of trickle channel curb with a 3% slope towards trickle channel for positive drainage.

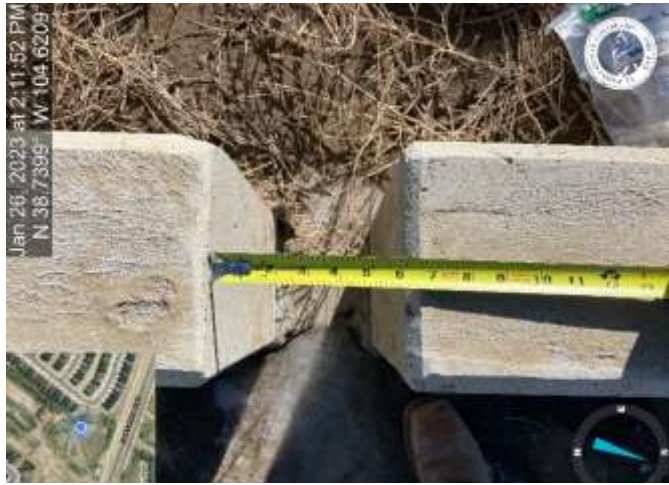
Photo 10: Pond C2.2: Notch on Forebay 'A' should be cut to 8". Reference sheet C9.6 on the CD's.

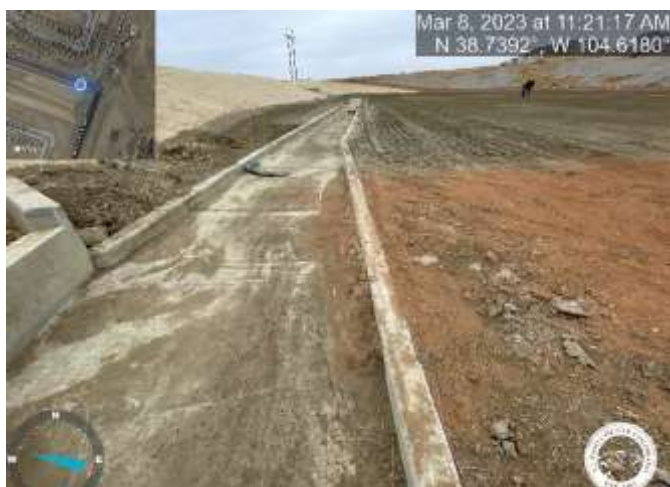
Photo 11: Pond C2.2: Remove excess sediment and road base from the trickle channel.

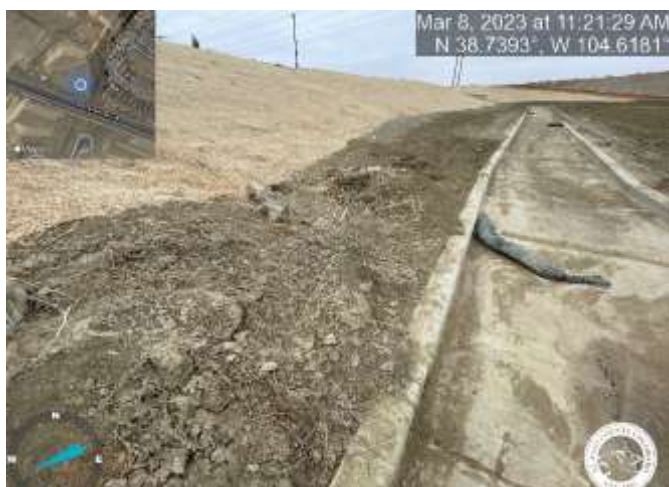
Photo 12: Pond C2.2: Remove sediment to match the top of trickle channel curb with a 3% slope towards trickle channel for positive drainage.

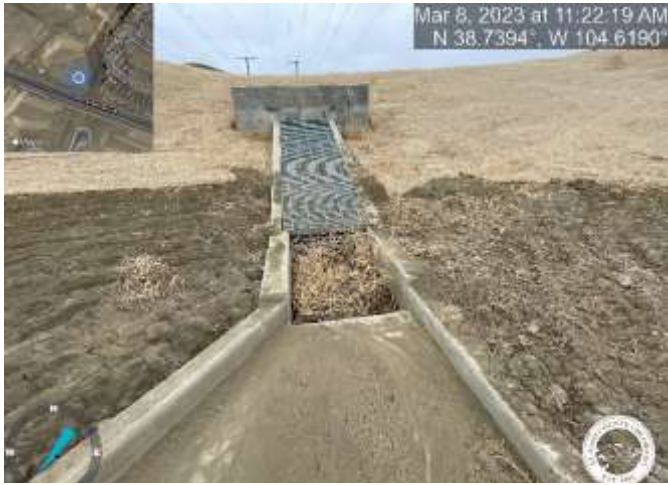
Photo 13: Pond C2.2: Match grade the top of trickle channel curb with a 3% slope towards trickle channel for positive drainage.

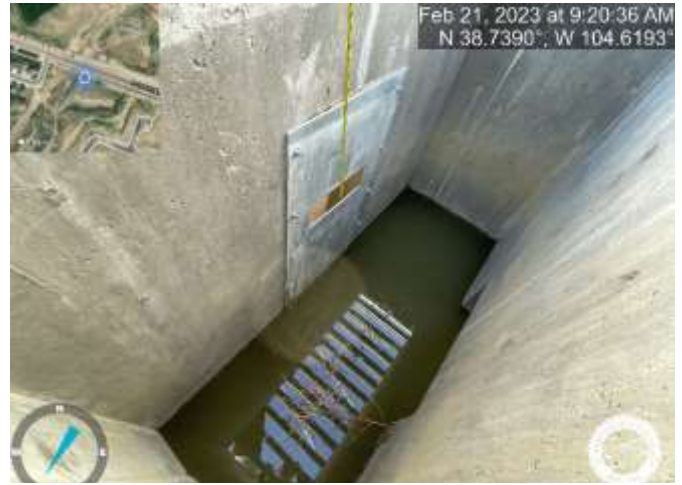
Photo 14: Pond C2.3: Orifice plate was not properly installed. Invert of the bottom most hole should be at the same elevation as the invert of the outlet pipe.

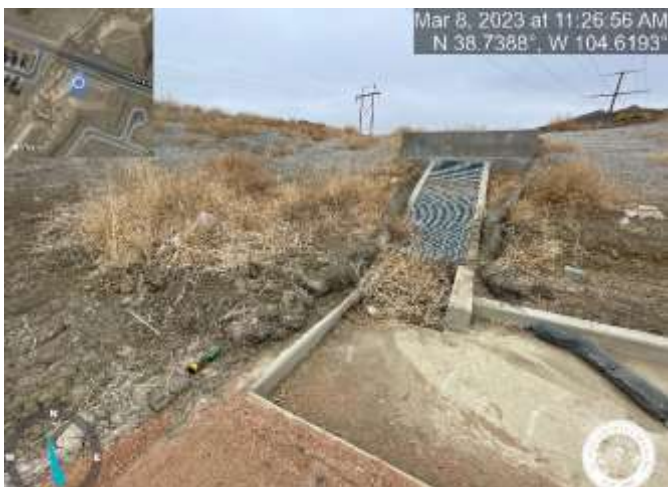
Photo 15: Pond C2.3: Remove excess sediment and damaged straw wattles around outlet structure.

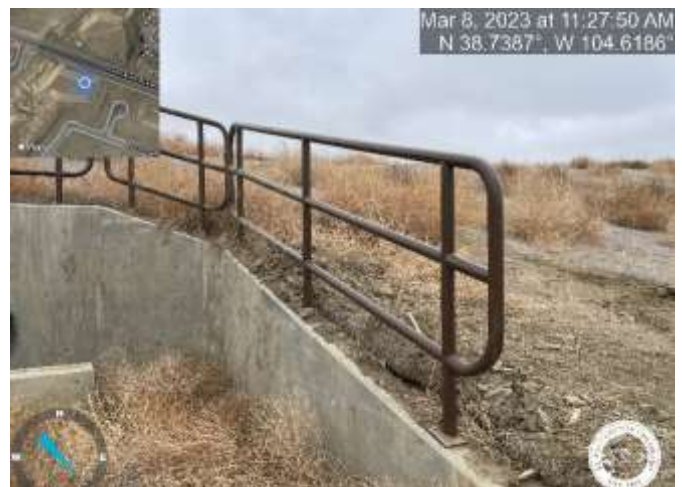
Photo 16: Pond C2.3: Remove excess sediment and damaged straw wattles around forebay.

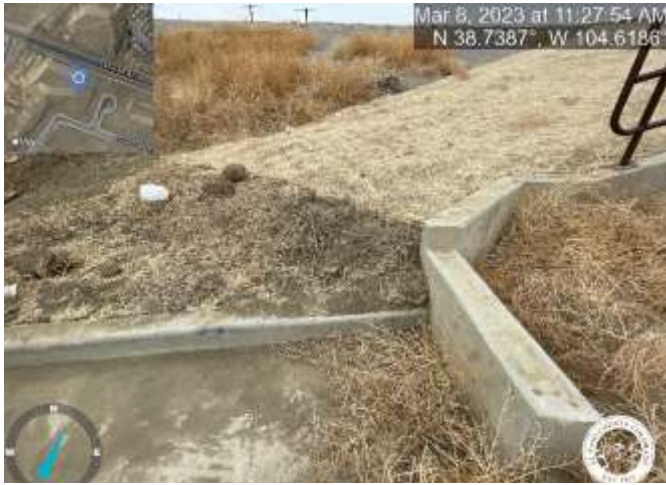
Photo 17: Pond C2.3: Remove sediment to match the top of trickle channel curb with a 3% slope towards trickle channel for positive drainage.

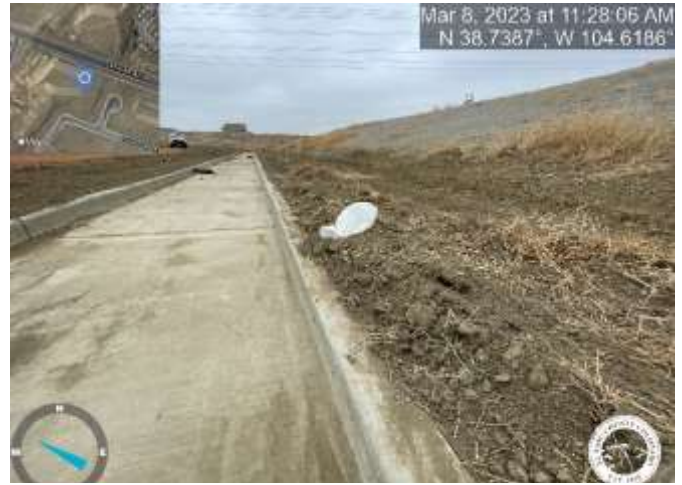
Photo 18: Pond C2.3: Remove sediment to match the top of trickle channel curb with a 3% slope towards trickle channel for positive drainage.

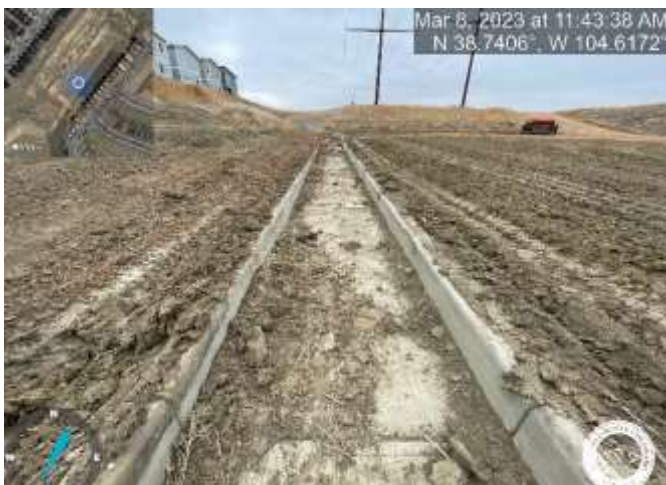
Photo 19: Pond C3: Remove excess sediment from trickle and match grade the top of trickle channel curb with a 3% slope towards trickle channel for positive drainage.

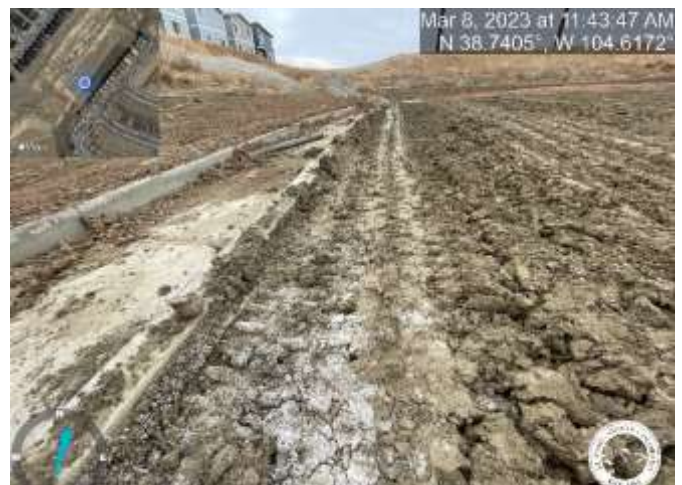
Photo 20: Pond C3: Remove excess sediment from trickle and match grade the top of trickle channel curb with a 3% slope towards trickle channel for positive drainage.

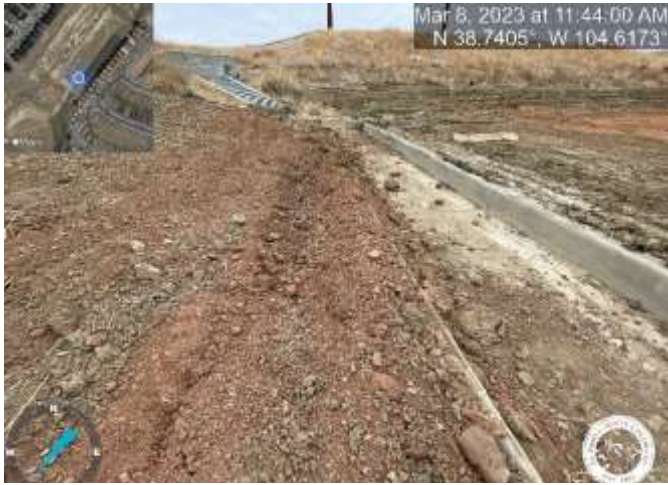
Photo 21: Pond C3: Remove road base from east perimeter of trickle channel near outlet structure.

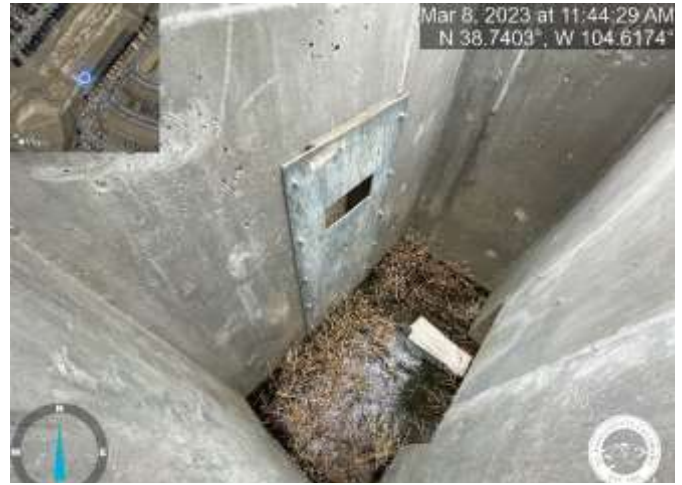
Photo 22: Pond C3: Orifice plate was not properly installed. Invert of the bottom most hole should be at the same elevation as the invert of the outlet pipe.

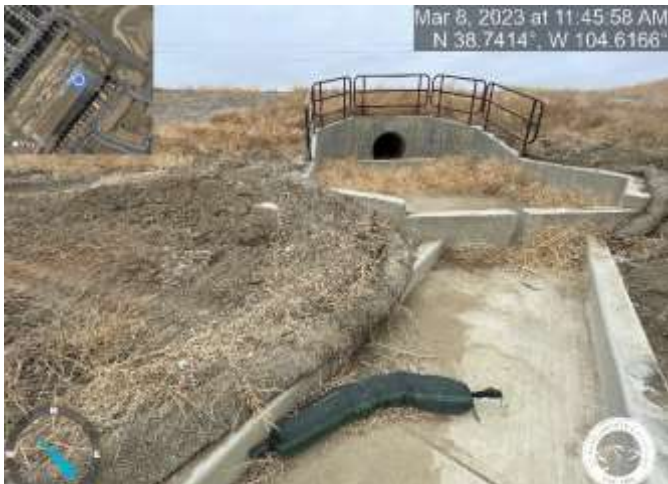
Photo 23: Pond C3: Remove old/damaged straw wattles from forebay.

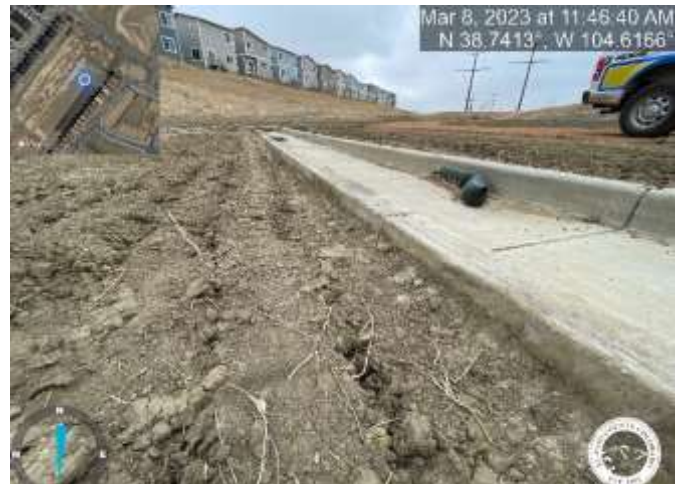
Photo 24: Pond C3: Raise pond bottom to top of trickle channel curb with a 3% slope towards trickle channel for positive drainage.

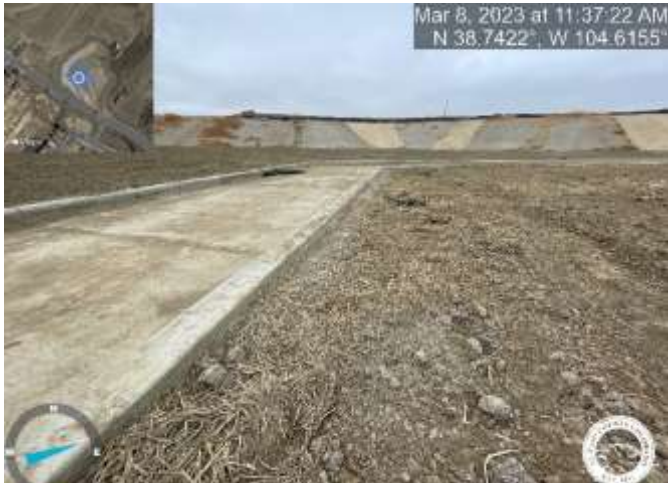
Photo 25: Pond C4: Raise pond bottom to top of trickle channel curb with a 3% slope towards trickle channel for positive drainage.

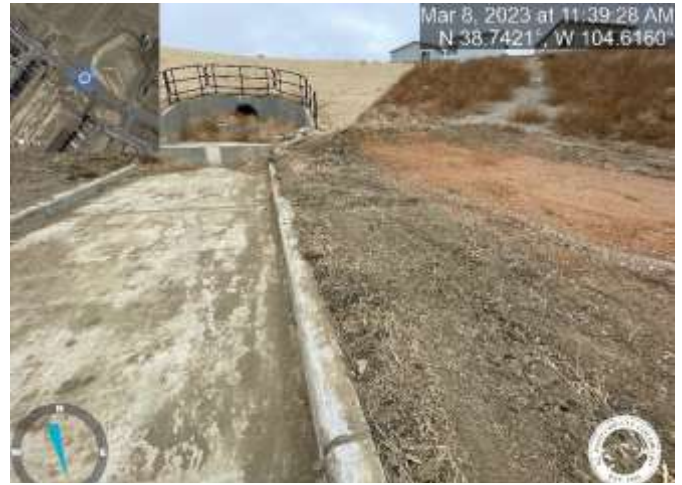
Photo 26: Pond C4: Remove excess sediment from trickle channel and old/damaged straw wattles.

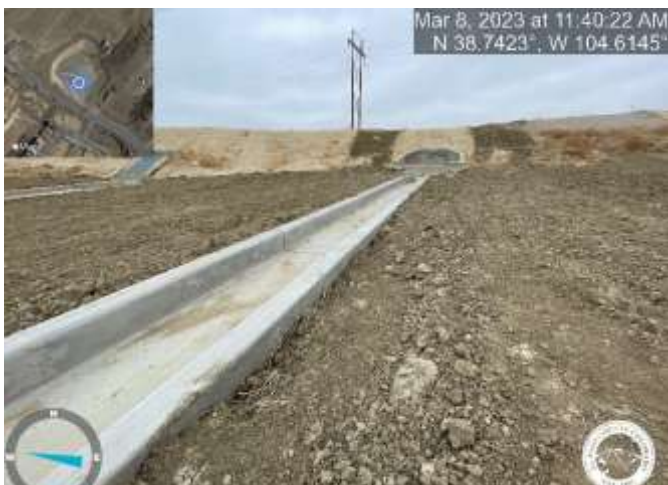
Photo 27: Pond C4: Raise pond bottom to top of trickle channel curb with a 3% slope towards trickle channel for positive drainage.

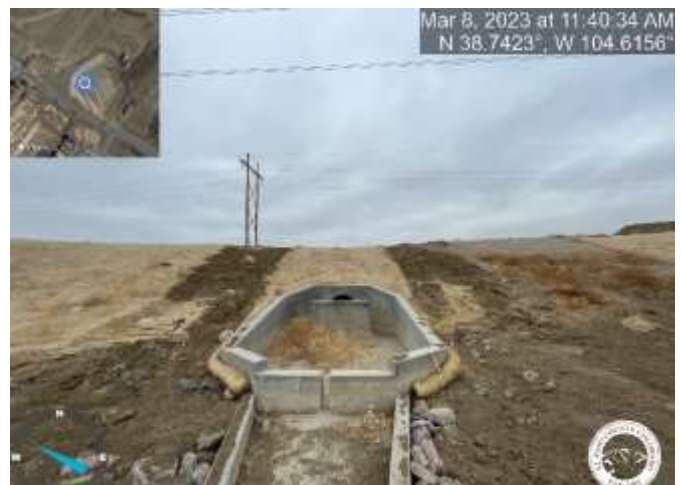
Photo 28: Pond C4: Reinstall erosion control blankets along pond slopes.

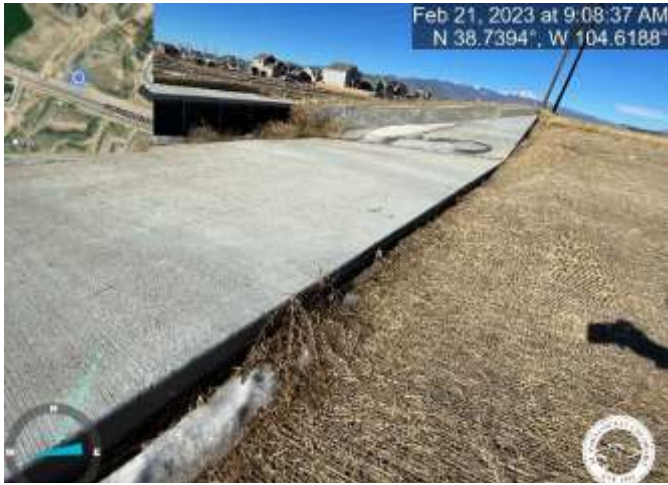
Photo 29: Emergency overflow form pond C2.2: Raise grade to be flush with overflow structure.

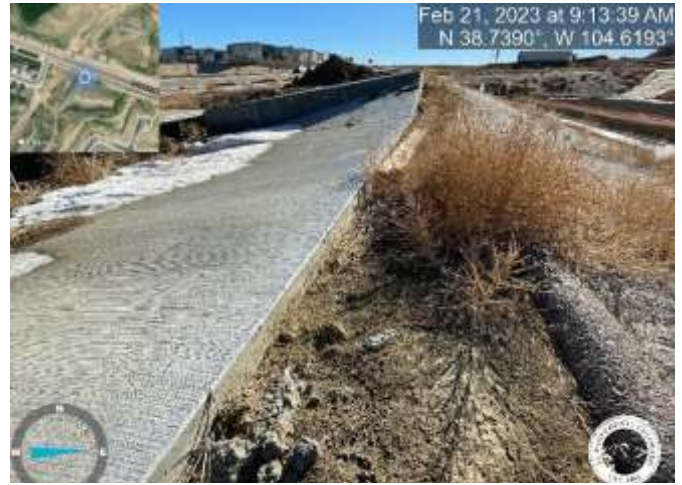
Photo 30: Emergency overflow form pond C2.3: Raise grade to be flush with overflow structure.

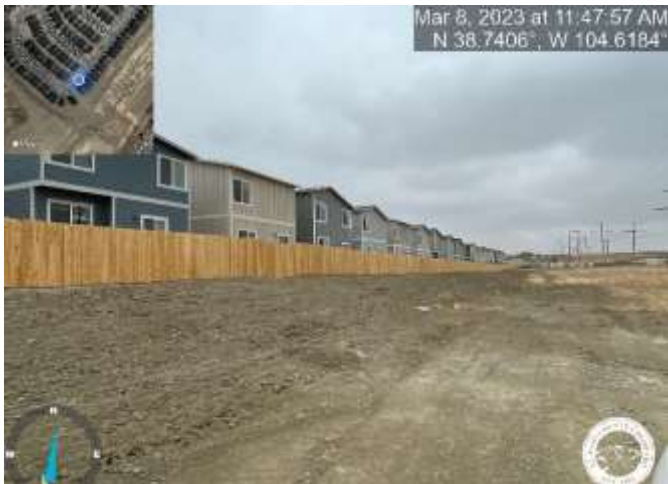
Photo 31: East perimeter of Area 'B': Failure to implement permanent seeding.

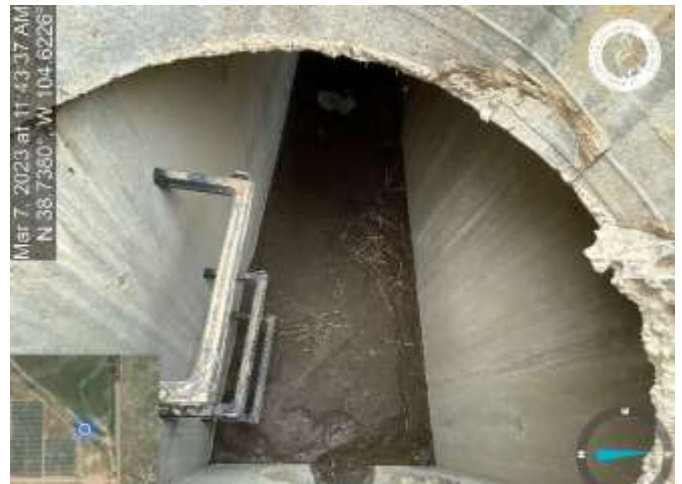
Photo 32: Remove sediment and debris from inlets throughout site. Inlets are marked with a green dot on the lid (approximately 23 inlets).
