**Preliminary Acceptance (PA) Punchlist**  
**EPC - DPW - Stormwater Section**

Project Name:	Hills at Lorson Ranch
EDARP Filing Number(s):	SF2110, PUDSP203, CDR207, PUDSP216
ESQCP Number:	ESQ2033
Attendees:	DPW SW: Natasha Grimaldo, Ben Jones, and Glen Reese DPW Planning: N/A Developer: Jeff Mark/Lorson LLC
Date of Walk-Thru:	11-06-2023
Walk-Thru Number:	4 <sup>th</sup>

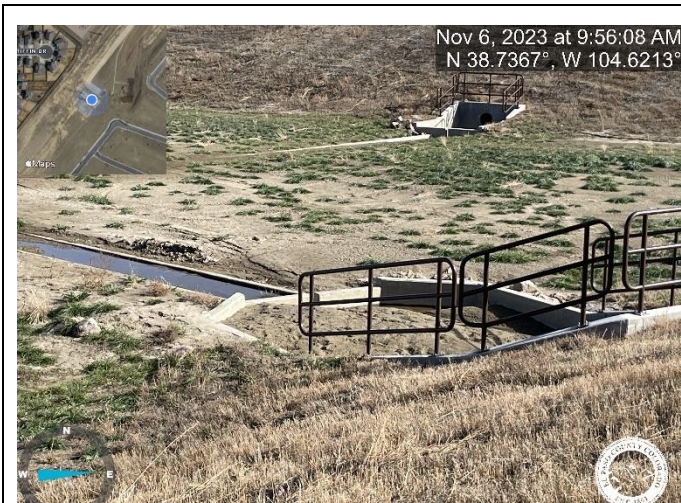
- **Repair cracking at south forebay pipe entrance.** – Item to be verified once pond is cleaned.
- **Remove debris and sediment from trickle channel, outlet structure, micropool, and forebay.**

Photo 1: Pond C1: Repair cracking at south forebay pipe entrance. Item will be checked once pond is cleaned.

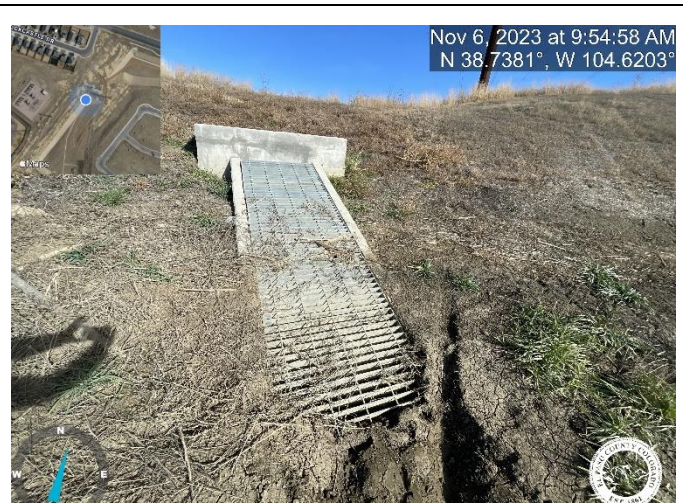
Photo 2: Pond C1: Remove debris and sediment from outfall structure micropool.

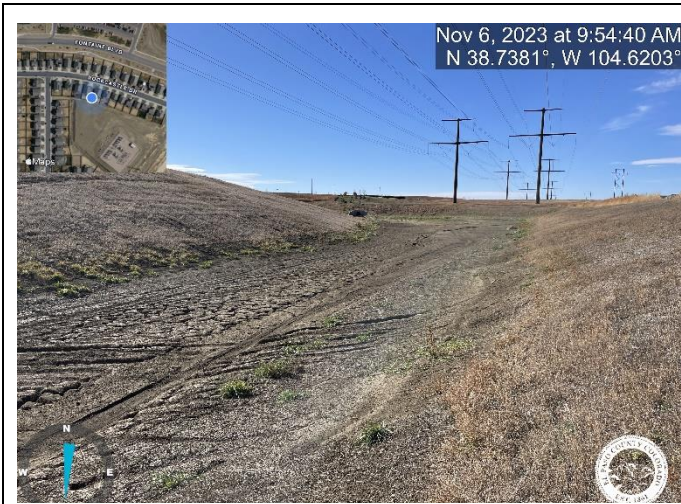
Photo 3: Pond C1: Remove debris and sediment from trickle channel, outlet structure, micropool, and forebay.

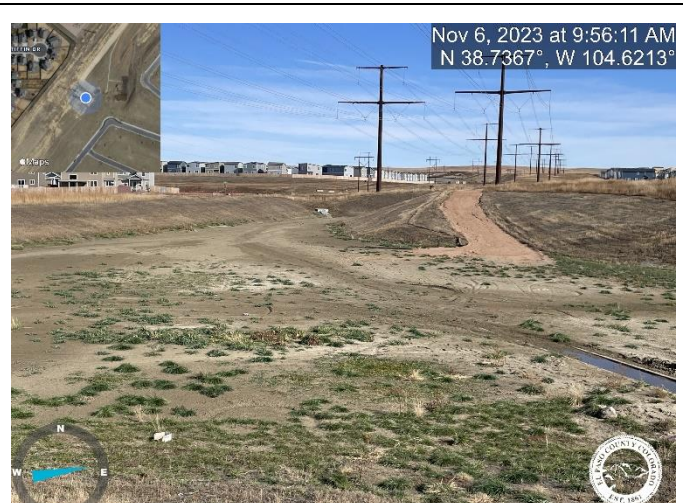
- ~~Remove sediment and debris from forebay 1 (SF 2110).~~
- **Repair crack in concrete where forebay 1 meets the trickle channel.** – Item to be verified once pond is cleaned.

Photo 4: Pond C1: Repair crack in concrete where forebay 1 meets the trickle channel. Item will be checked once pond is cleaned.

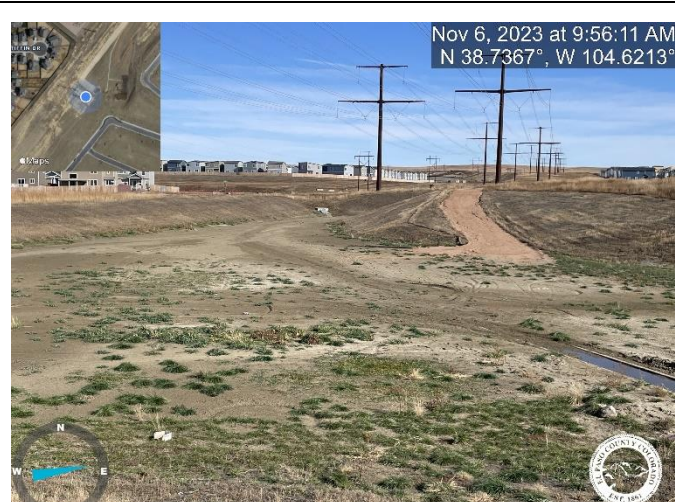
- **Grade pond bottom to match approved specs.**
- **Reinstall maintenance access road per plans. Plans call for 12" deep road base.**
- ~~Remove excess sediment and old straw wattles from trickle channel.~~

Photo 5: Pond C1: Grade pond bottom to match approved specs and Reinstall maintenance access road per plans. Plans call for 12" deep road base.

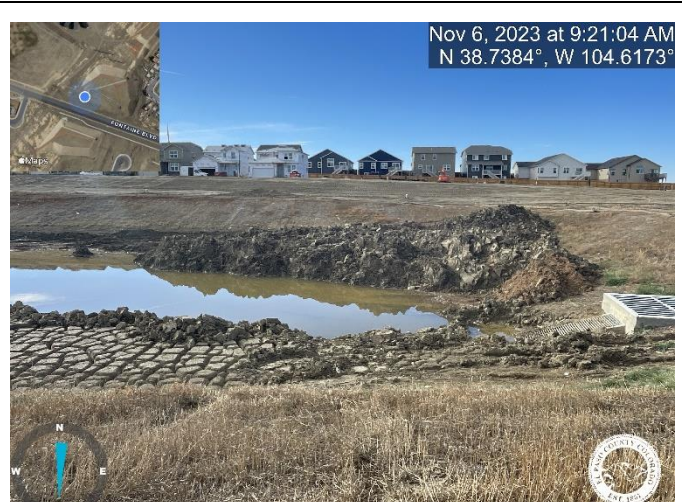
- ~~Orifice plate was not properly installed. Invert of the bottom most hole should be approximately ¼" higher than the invert of the outlet pipe per detail on sheet C9.4.~~ – Item to be verified in the As-builts
- **Repair crack in concrete where forebay meets the trickle channel.** – Item to be verified once the pond is cleaned.
- **Remove debris and sediment from trickle channel, outlet structure, micropool, and forebay.**
- **Grade pond bottom to match approved specs.**
- **Reinstall maintenance access road per plans. Plans call for 12" deep road base.**
- ~~Remove sediment to match the top of trickle channel curb with a 3% slope towards trickle channel for positive drainage.~~
- ~~Remove sediment and debris in forebay.~~
- ~~Remove debris and sediment from outfall structure micropool.~~

Photo 6: Pond C2.1: Repair crack in concrete where forebay meets the trickle channel.

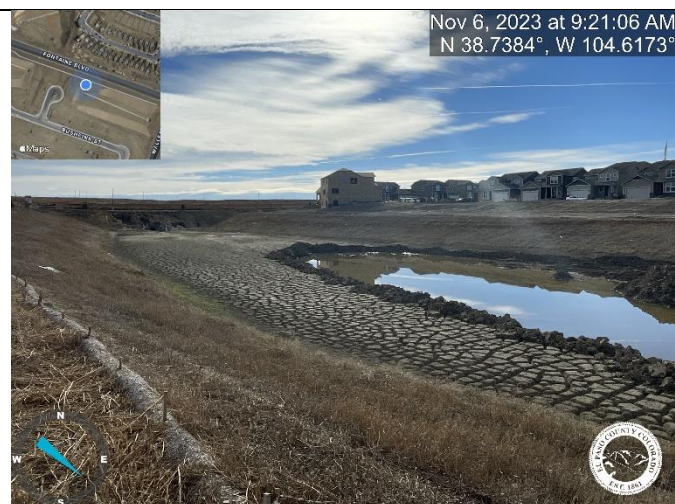
Photo 7: Pond C2.1: Remove debris and sediment from trickle channel, outlet structure, micropool, and forebay.

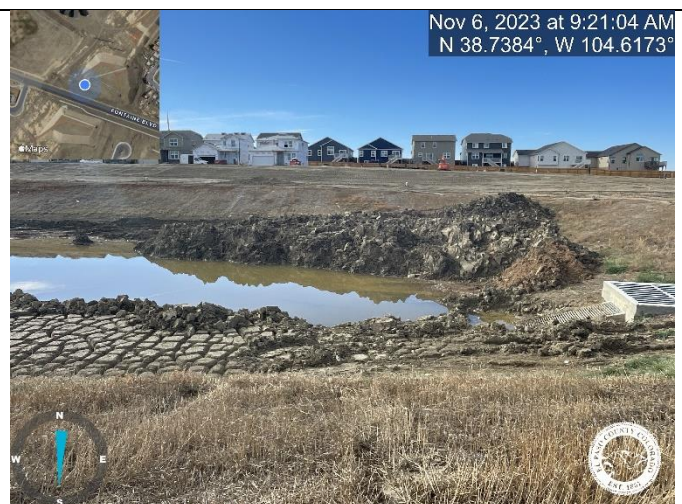
Photo 8: Pond C2.1: Grade pond bottom to match approved specs and Reinstall maintenance access road per plans. Plans call for 12" deep road base.

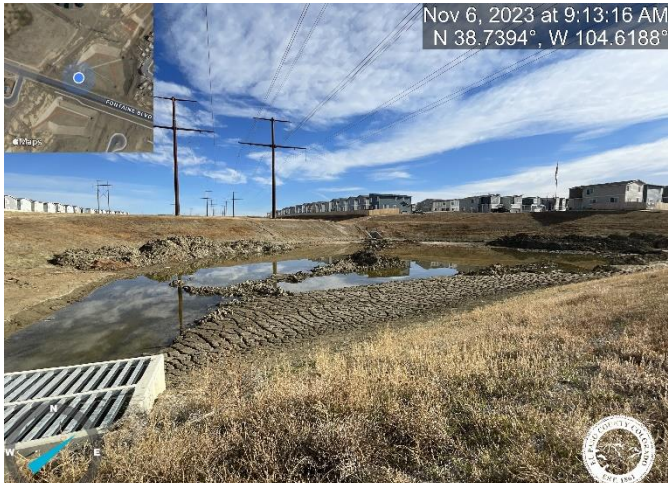
- Remove debris and sediment from trickle channel, outlet structure, micropool, and forebay.
- Notch on Forebay 'A' should be cut to 8". Reference sheet C9.6 on the CD's. – Item to be verified once pond is cleaned.

Photo 9: Pond C2.2: Notch on Forebay 'A' should be cut to 8". Reference sheet C9.6 on the CD's. Item will be checked once pond is cleaned.

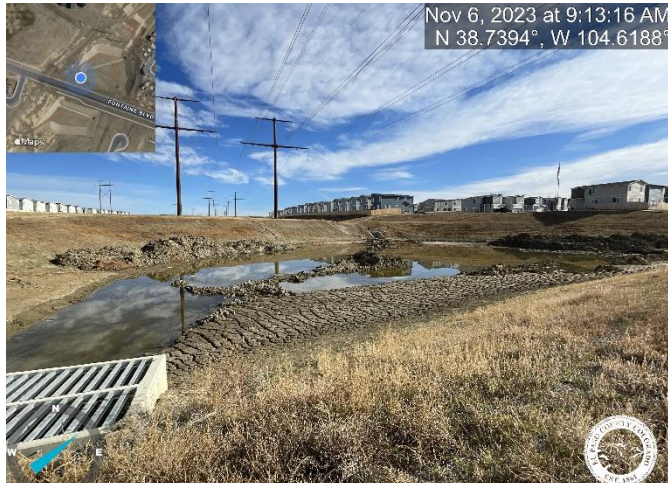
- Repair crack in concrete where the forebay meets the trickle channel. – Item to be verified once pond is cleaned.
- ~~Remove debris and sediment from outfall structure micropool.~~

Photo 10: Pond C2.2: Repair crack in concrete where the forebay meets the trickle channel. Item will be checked once pond is cleaned.

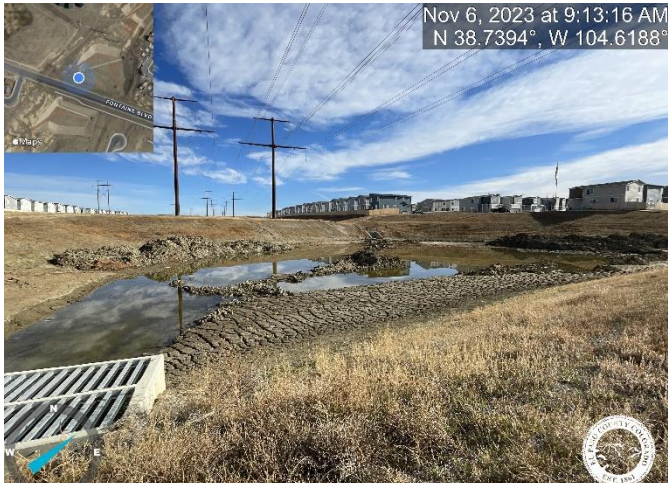
- ~~Remove debris and sediment from forebays.~~
- ~~Clean out spillway inlet structure.~~
- Repair damage to trickle channel curb approximately 30 feet from Forebay 'B'. – Item to be verified once pond is cleaned.

Photo 11: Pond C2.2: Repair damage to trickle channel curb approximately 30 feet from Forebay 'B'. Item will be checked once pond is cleaned.

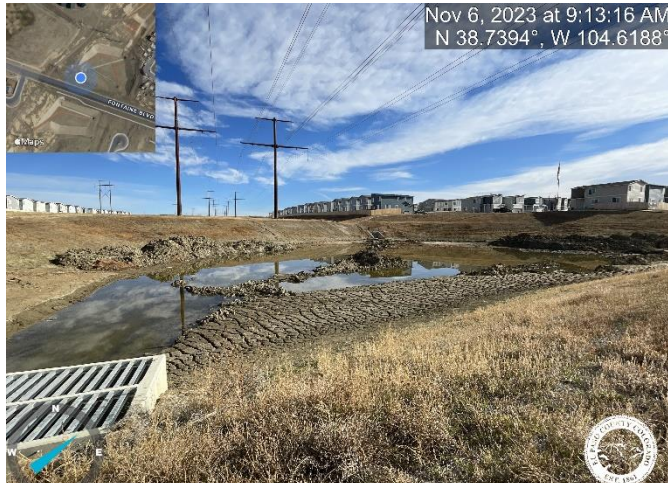
- Grade pond bottom to match approved specs.
- Reinstall maintenance access road per plans. Plans call for 12" deep road base.
- ~~Remove old/damaged straw wattle.~~

Photo 12: Pond C2.2: Grade pond bottom to match approved specs and Reinstall maintenance access road per plans. Plans call for 12" deep road base.

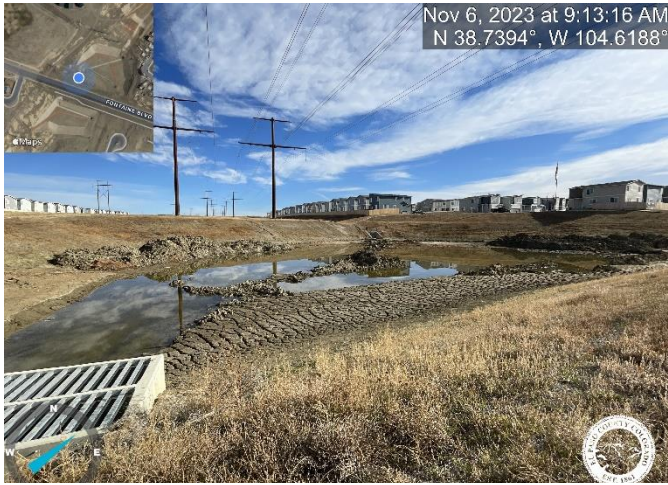
Photo 13: Pond C2.2: Remove debris and sediment from trickle channel, outlet structure, micropool, and forebay.

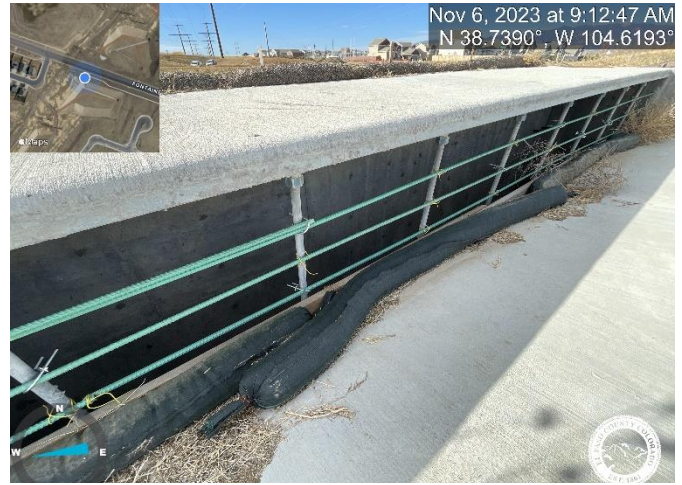
- Install spillway inlet bars per detail. Approved detail calls for #4 epoxy rebar welded to existing vertical rods. The current installation of U-bolts and tied wire is not adequate.

Photo 14: Pond C2.2: Install spillway inlet bars per detail. Approved detail calls for #4 epoxy rebar welded to existing vertical rods. The current installation of U-bolts and tied wire is not adequate.

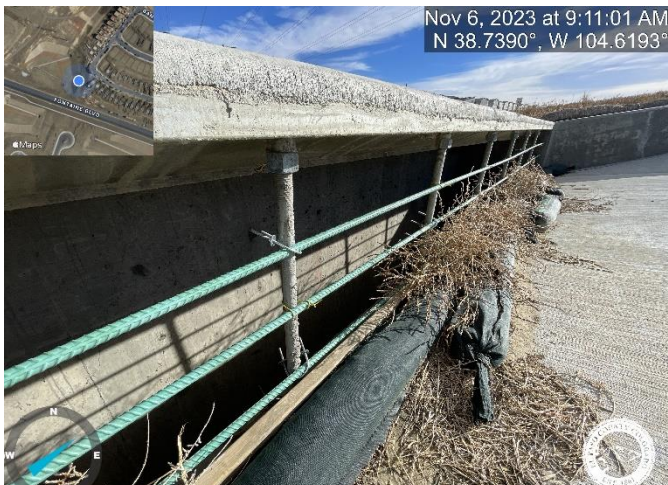
- Install spillway inlet bars per detail. Approved detail calls for #4 epoxy rebar welded to existing vertical rods. The current installation of U-bolts and tied wire is not adequate.

Photo 15: Pond C2.3: Install spillway inlet bars per detail. Approved detail calls for #4 epoxy rebar welded to existing vertical rods. The current installation of U-bolts and tied wire is not adequate.

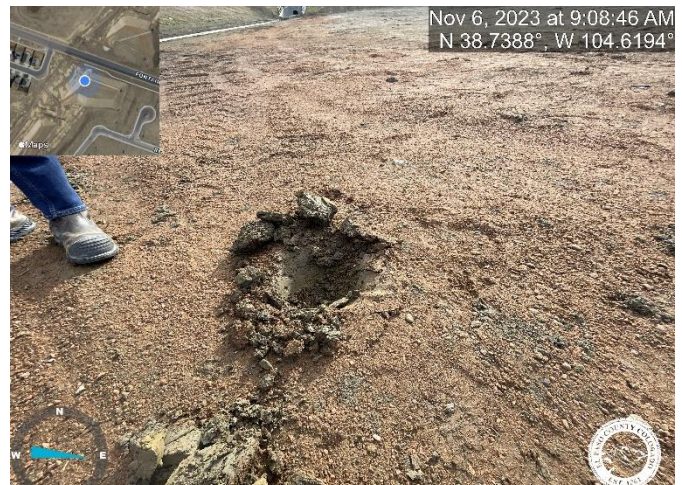
- Reinstall maintenance access road per plans. Plans call for 12" deep road base. Current road base does not meet minimum specs.
- ~~Remove sediment from trickle channel.~~

Photo 16: Pond C2.3: Reinstall maintenance access road per plans. Plans call for 12" deep road base. Current road base does not meet minimum specs.

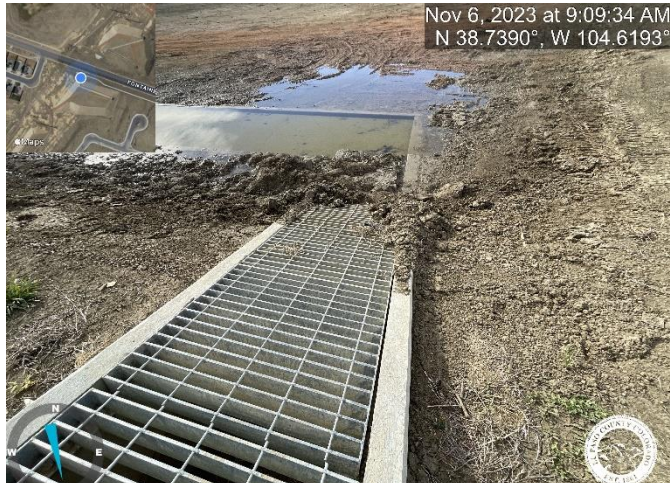
Photo 17: Pond C2.3: Remove debris and sediment from outfall structure micropool.

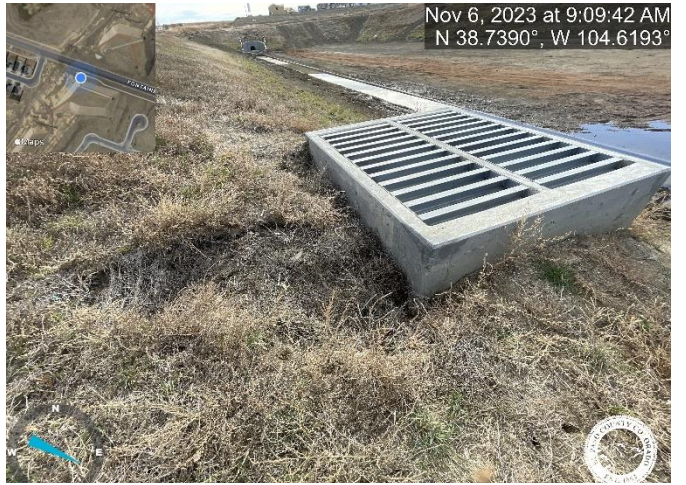
- Remove debris and sediment from outlet structure micropool.
- Backfill and stabilize erosion behind outlet structure.
- ~~Grade the entire pond bottom to achieve a 3% slope towards trickle channel for positive drainage.~~

Photo 18: Pond C2.3: Backfill and stabilize erosion behind outlet structure.

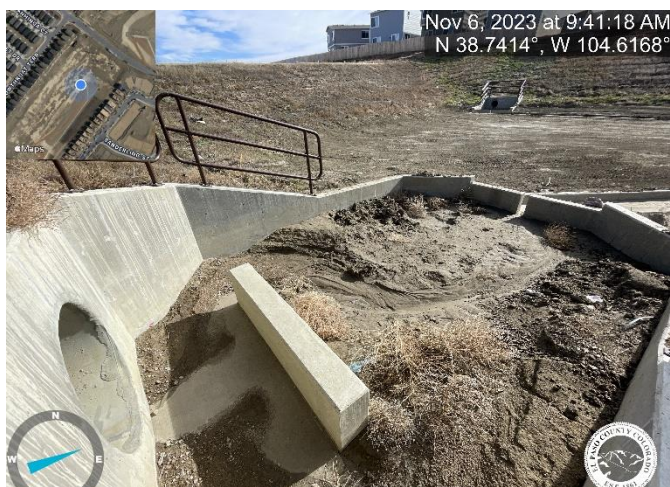
Photo 19: Pond C3: Remove debris and sediment from forebays, trickle channel and outlet structure micropool.

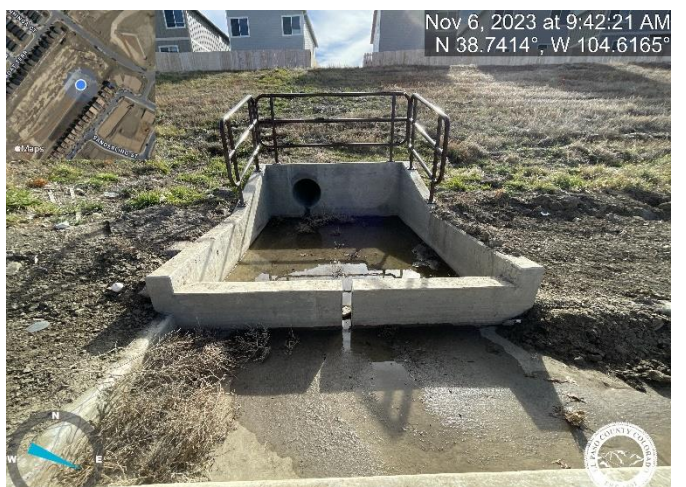
Photo 20: Pond C3: Remove debris and sediment from forebays, trickle channel and outlet structure micropool.

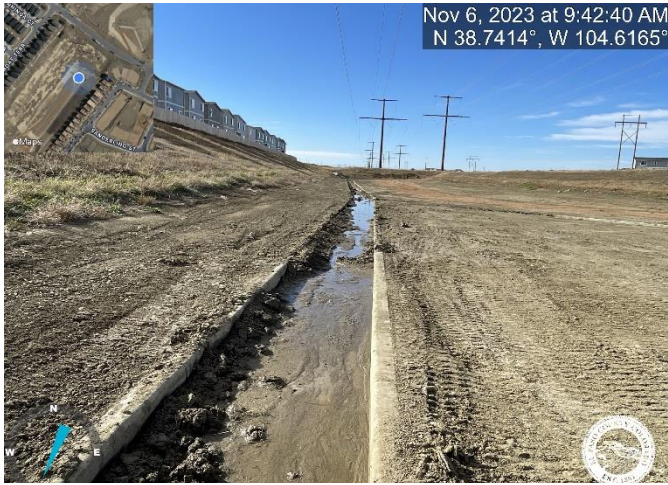
Photo 21: Pond C3: Remove debris and sediment from forebays, trickle channel and outlet structure micropool.

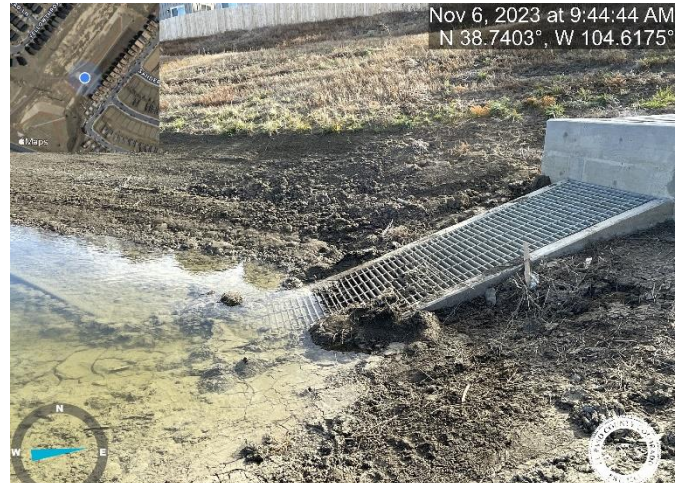
Photo 22: Pond C3: Remove debris and sediment from forebays, trickle channel and outlet structure micropool.

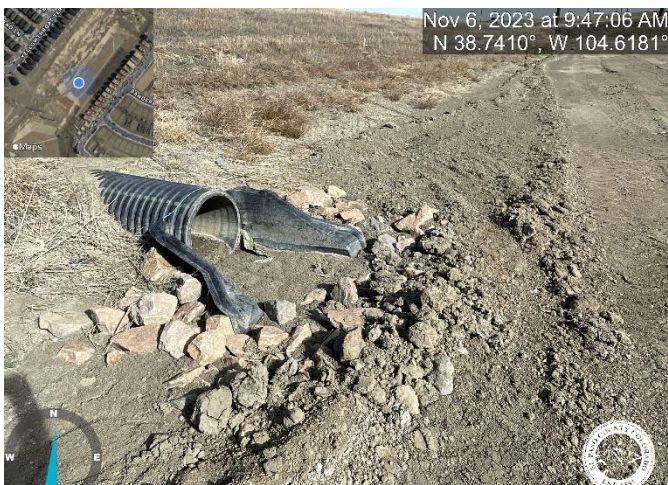
- Remove debris and sediment from forebays, trickle channel and outlet structure micropool.
- Reestablish the 15'x10' riprap pad at the outfall of the 18" HDPE FES. Reference sheet C9.8 of the Construction Plans.

Photo 23: Pond C3: Reestablish the 15'x10' riprap pad at the outfall of the 18" HDPE FES. Reference sheet C9.8 of the Construction Plans.

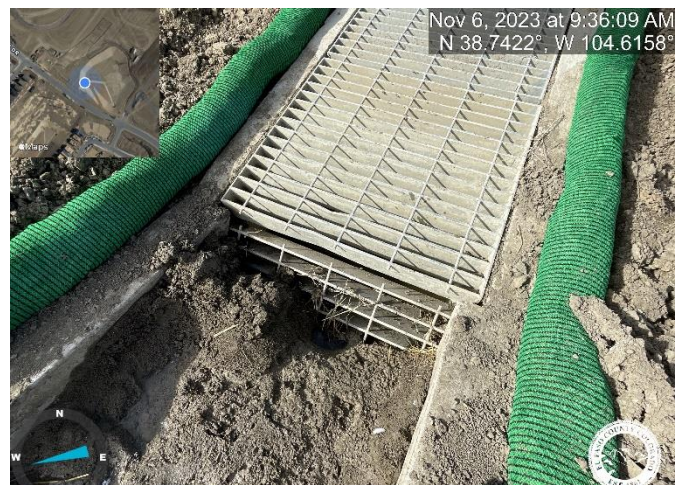
Photo 24: Pond C4: Remove debris and sediment from outlet structure micropool.
